MINERALS PROGRAM INSPECTION REPORT
PHONE: (303) 866-3567

MINE NAME: Apex Lode	MINE/PROSPECTING ID#: M-2014-011	MINERAL: Zinc and silver	COUNTY: Garfield
INSPECTION TYPE: Monitoring	INSPECTOR(S): Amy Yeldell	INSP. DATE: July 17, 2020	INSP. TIME: 09:00
OPERATOR: Strong Mining Company	OPERATOR REPRESENTATIVE: Ed Tacker	TYPE OF OPERATION: 110(1) - Hard Rock Limited Impact	
REASON FOR INSPECTION: Surety Related	BOND CALCULATION TYPE: Complete Bond	BOND AMOUNT: \$34,308.00	
DATE OF COMPLAINT: NA	POST INSP. CONTACTS: DRMS	JOINT INSP. AGENCY: None	
WEATHER: Clear	INSPECTOR'S SIGNATURE:

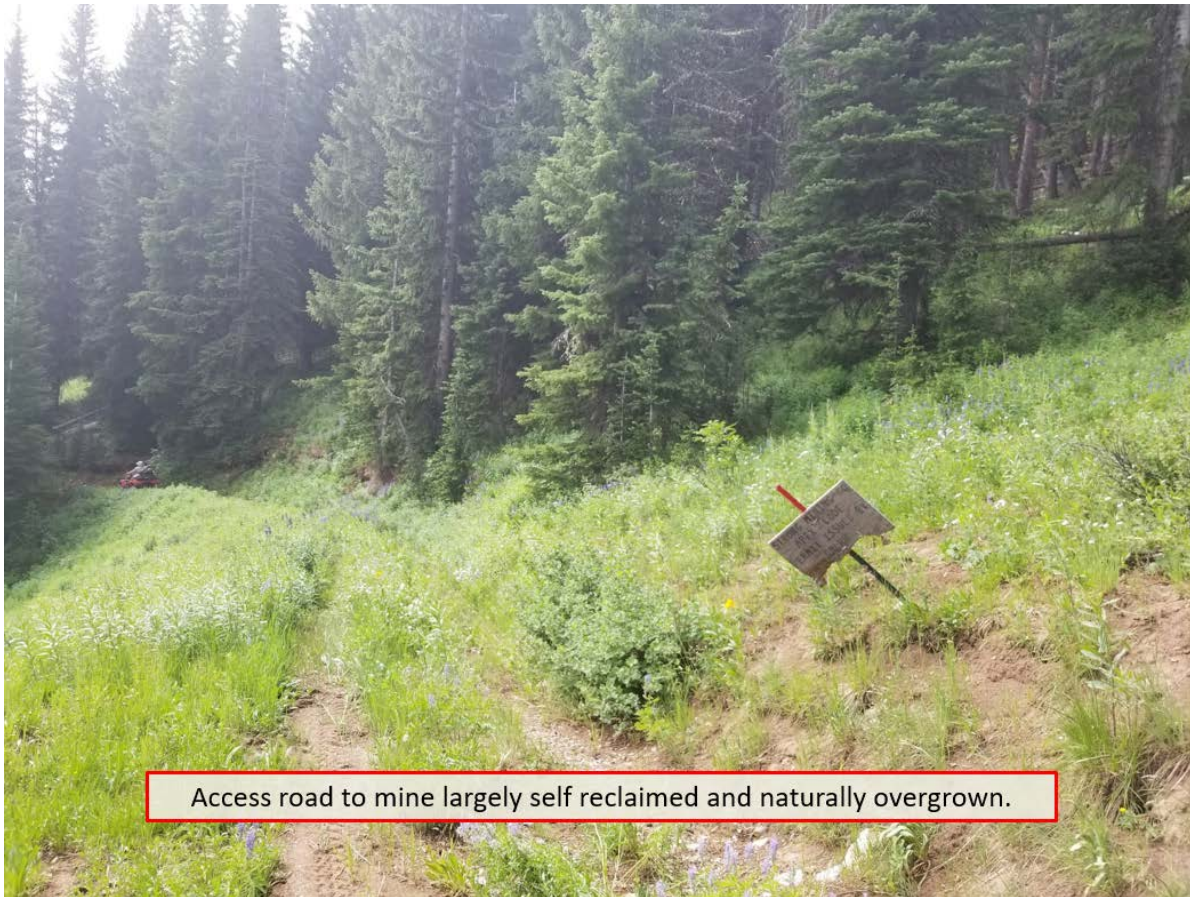
The access road to the mine site is largely overgrown with native vegetation due to limited use. Overall cover of the access road is near 90%. Vegetation around the cabin area is in similar condition. A few select spots have decreased cover otherwise the majority of the area is overgrown and blends naturally with undisturbed areas. The trail to the portals and staging area have slightly less vegetation, approximately 80% cover. Furthermore the portals are located on a steep rocky slope where native areas have relatively low vegetation densities compared to the flat areas. In general only minimal spot seeding would be necessary. However the site will likely be disturbed more during final reclamation (portal closures and cabin removal). Based on the information provided in TR-3 approximately one acre will need to be revegetated.

Access road to mine largely self reclaimed and naturally overgrown.

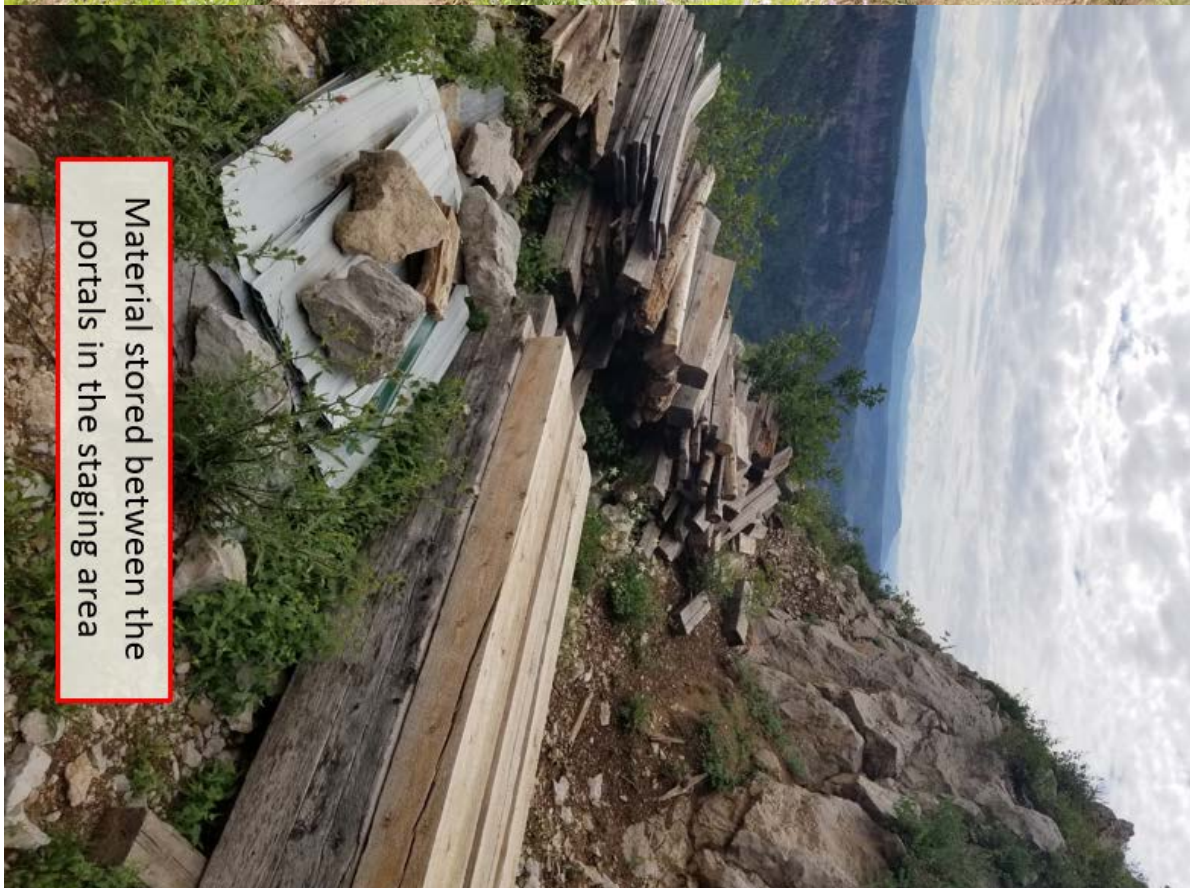
There are two portals located to the southeast of the cabins. There are timbers on the flat staging area between the two portals. To access the lower portal one walks across a wooden boardwalk since the slope of the hill is quite steep. This boardwalk will be removed upon final reclamation (phase 1). The adit itself has several wood timbers to protect it from rock falling from the hillside above. This structure will be removed if PUF closure is used. If a grate is placed the USFS will likely want the structure to remain to grant future access if need be. The upper portal was not inspected at this time. The Operator has elected a PUF closure of what remains of this opening. Furthermore the 2" rail tracks are to be removed from site. No railroad ties were observed.

Material stored between the portals in the staging area

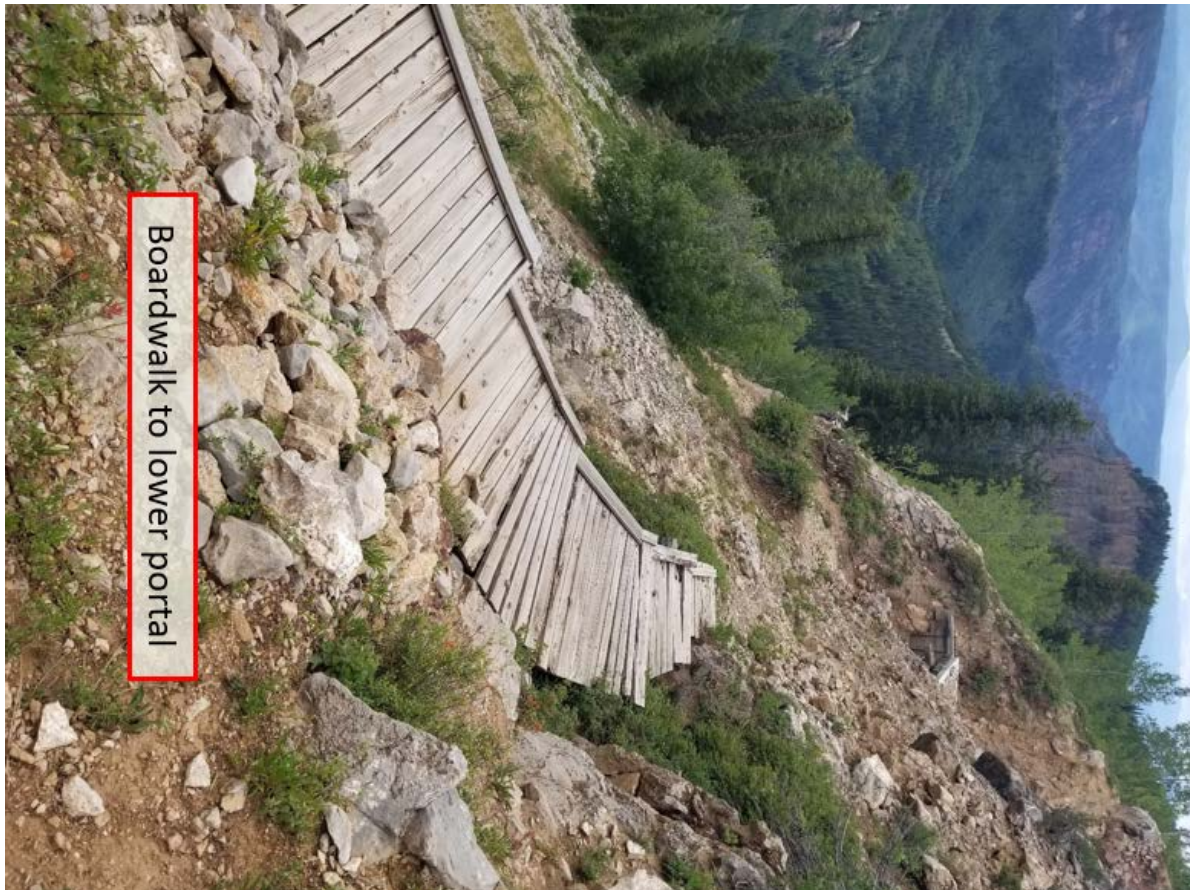
Boardwalk to lower portal

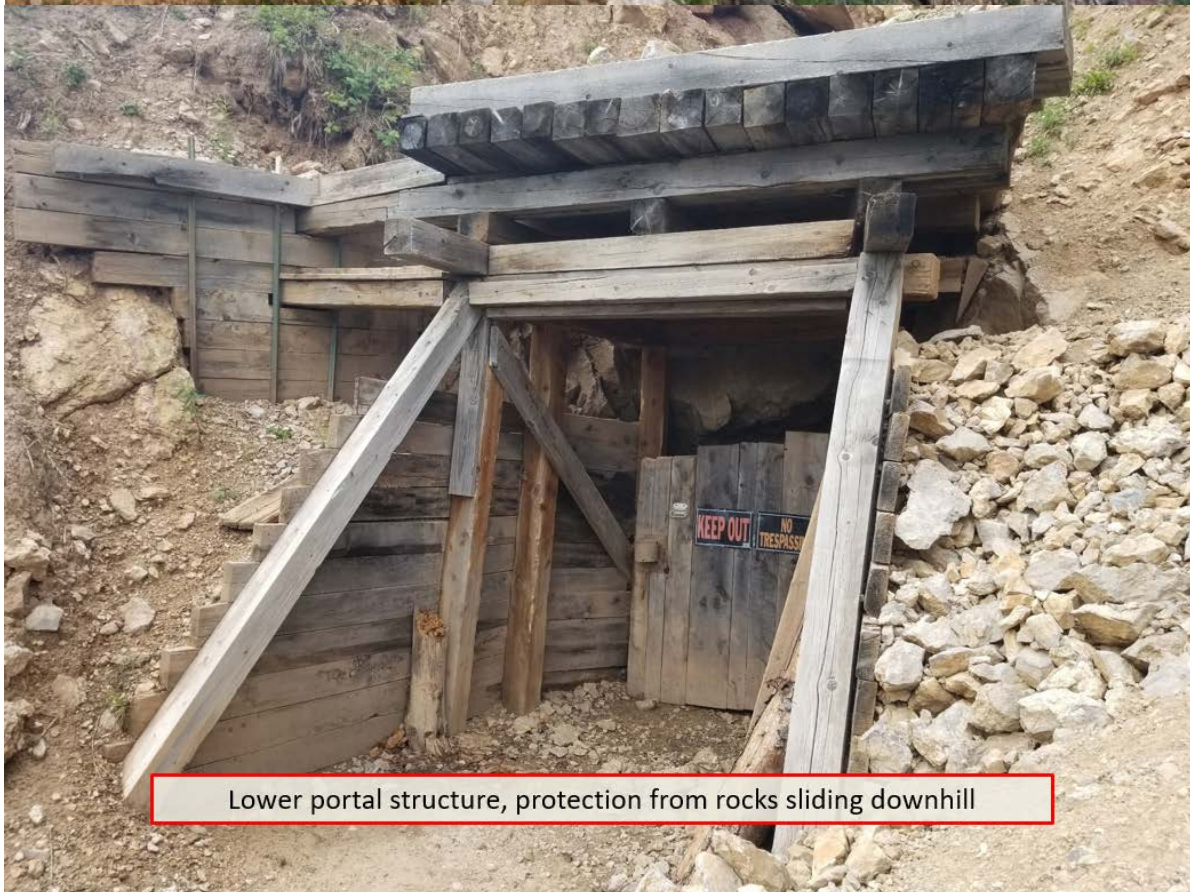
Lower portal structure, protection from rocks sliding downhill
