MINERALS PROGRAM INSPECTION REPORT

MINE NAME: Harmony Windsor Site	MINE/PROSPECTING ID#: M-2017-056	MINERAL: Sand and gravel	COUNTY: Weld
INSPECTION TYPE: Surety Release Inspection	INSPECTOR(S): Peter Hays	INSP. DATE: July 15, 2020	INSP. TIME: 10:30
OPERATOR: Serfer Land Ventures, LLC.	OPERATOR REPRESENTATIVE: Kevin Anderson	TYPE OF OPERATION: 110c - Construction Limited Impact	
REASON FOR INSPECTION: Surety Release Requested	BOND CALCULATION TYPE: None	BOND AMOUNT: \$53,470.00	
DATE OF COMPLAINT: NA	POST INSP. CONTACTS: None	JOINT INSP. AGENCY: None	
WEATHER: Clear	INSPECTOR'S SIGNATURE:

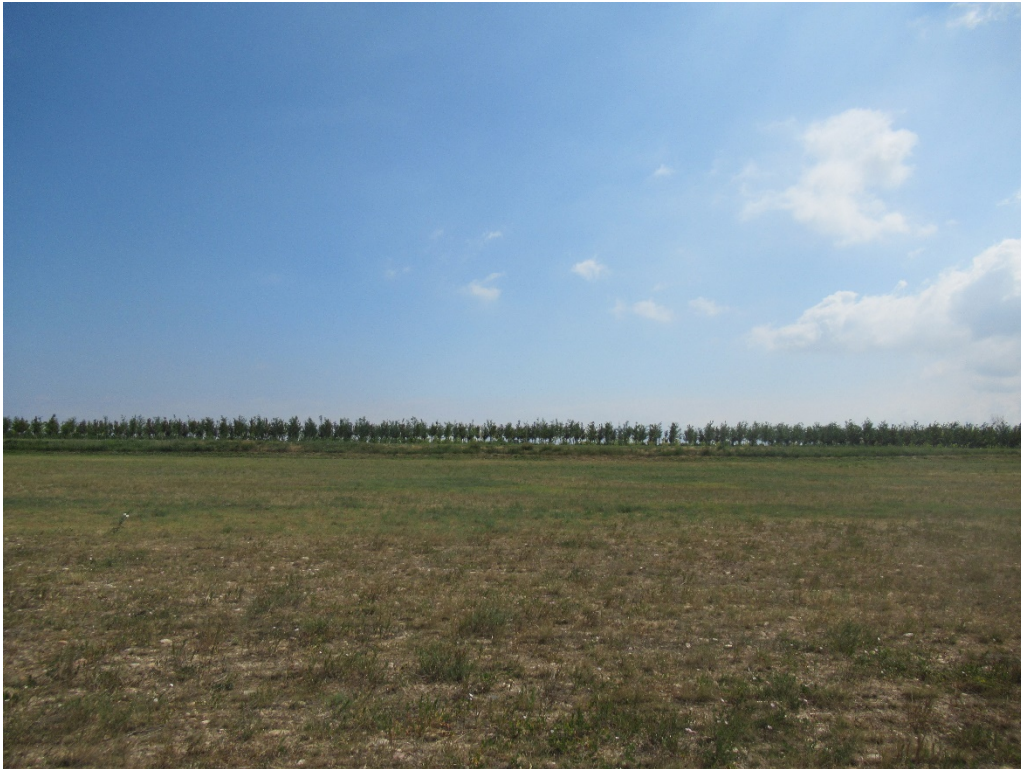
View of Phase 1 from the south side looking north

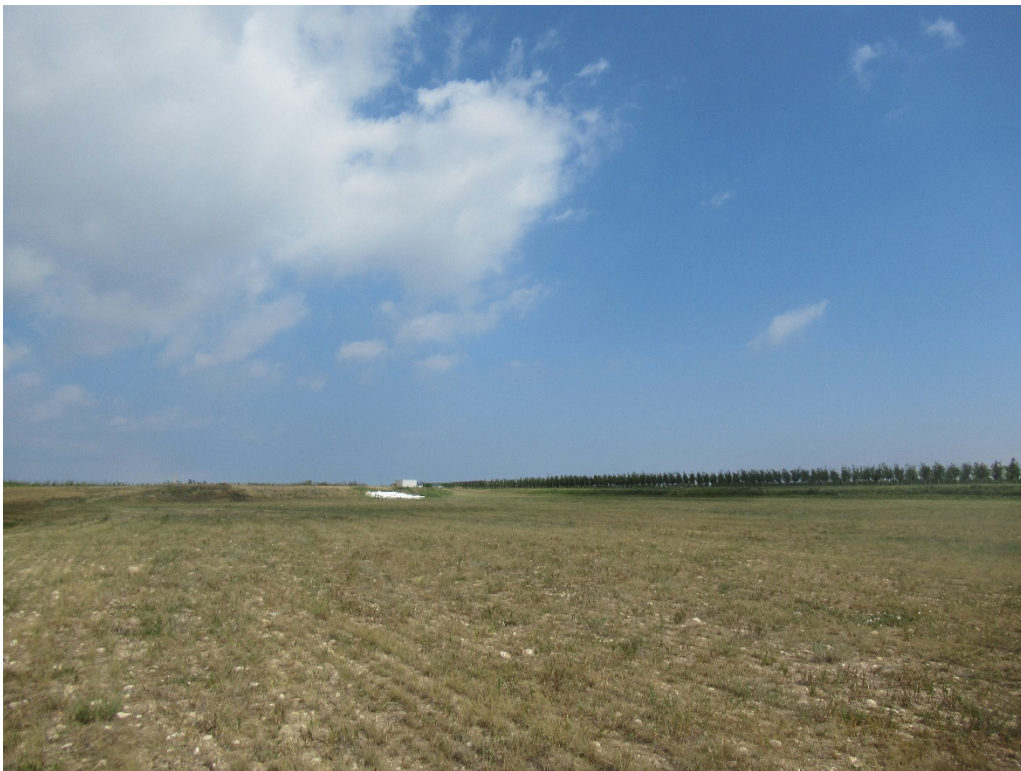
View of the western portion of Phase 1 looking west

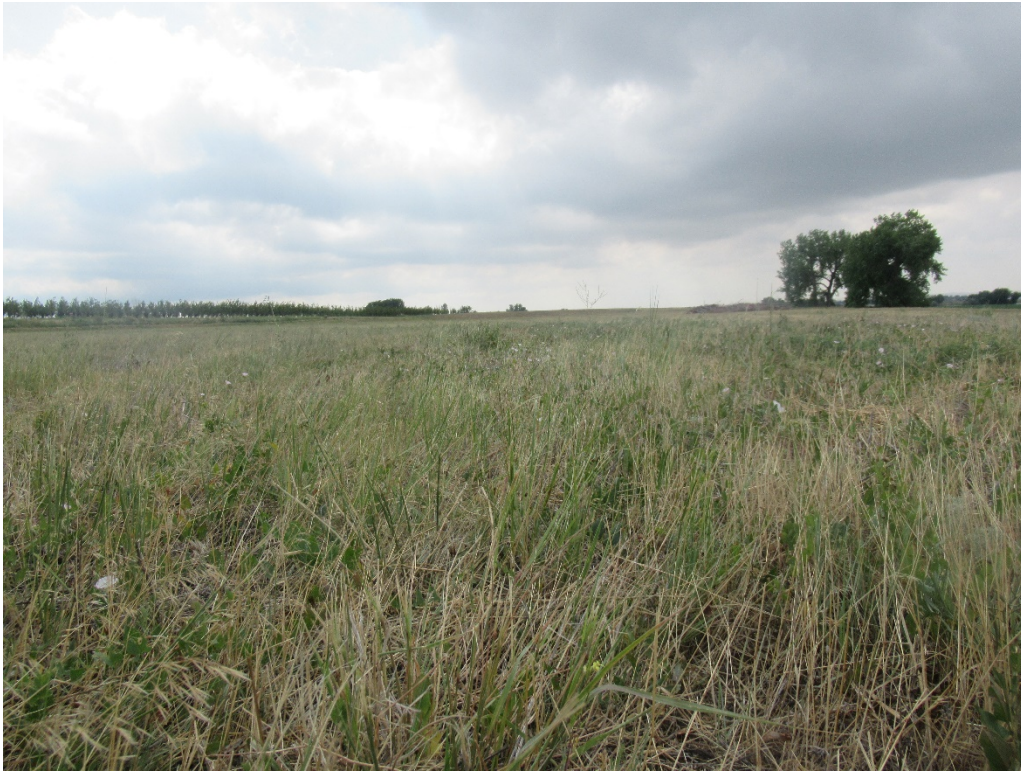
View of the vegetation on the pit floor of Phase 1 looking west

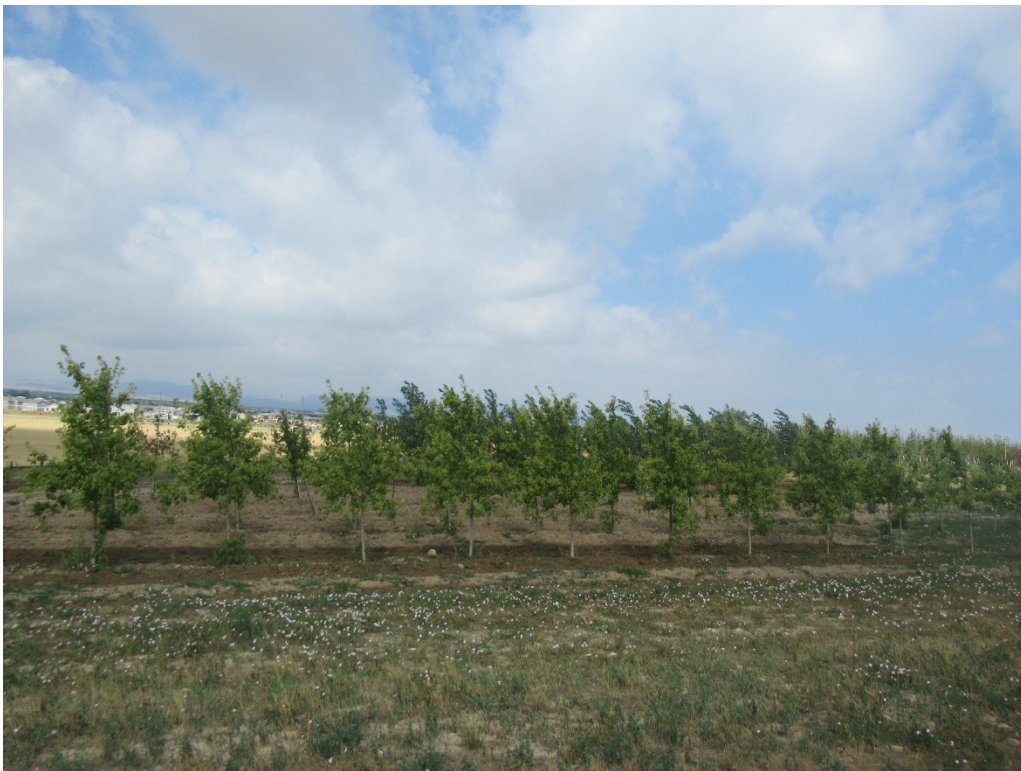
View of Phase 2 from the northeast corner of the phase looking west

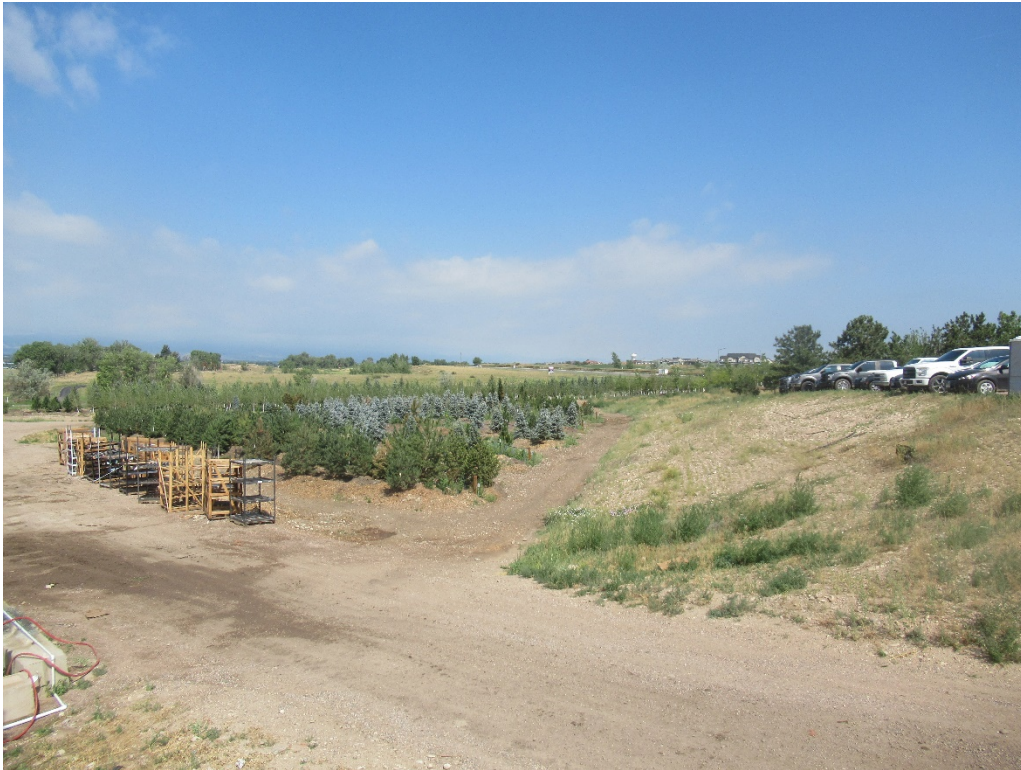
View of Phase 3 from the northeast corner of the phase looking northwest

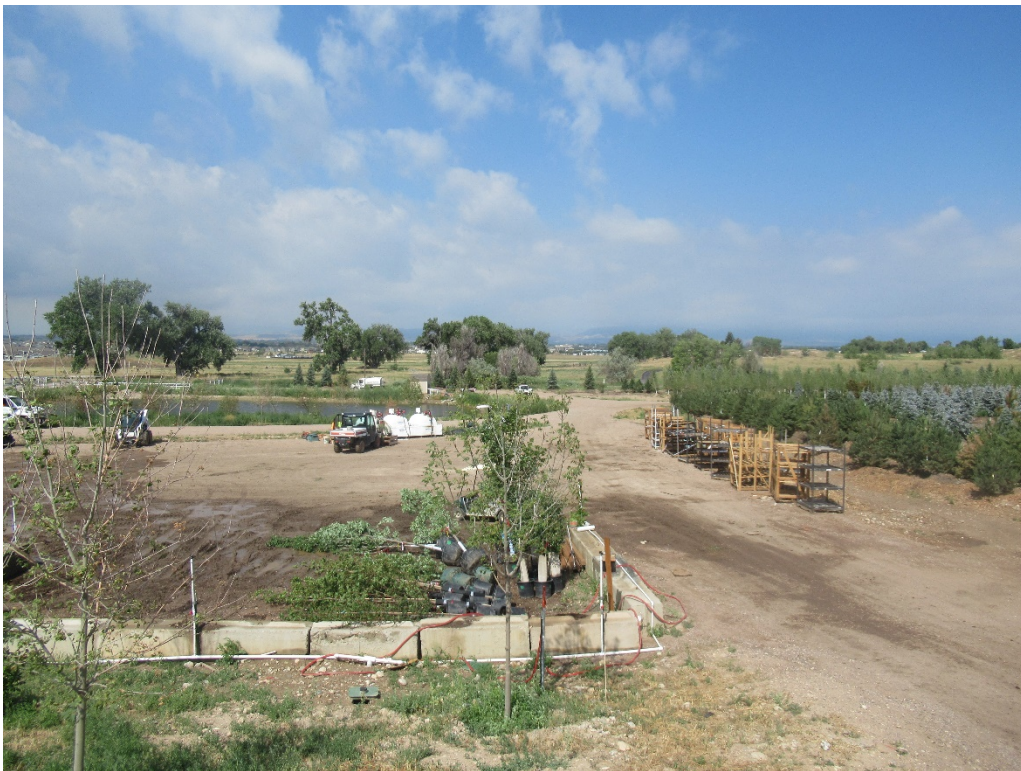
View of Phase 3 from the northeast corner of the phase looking west

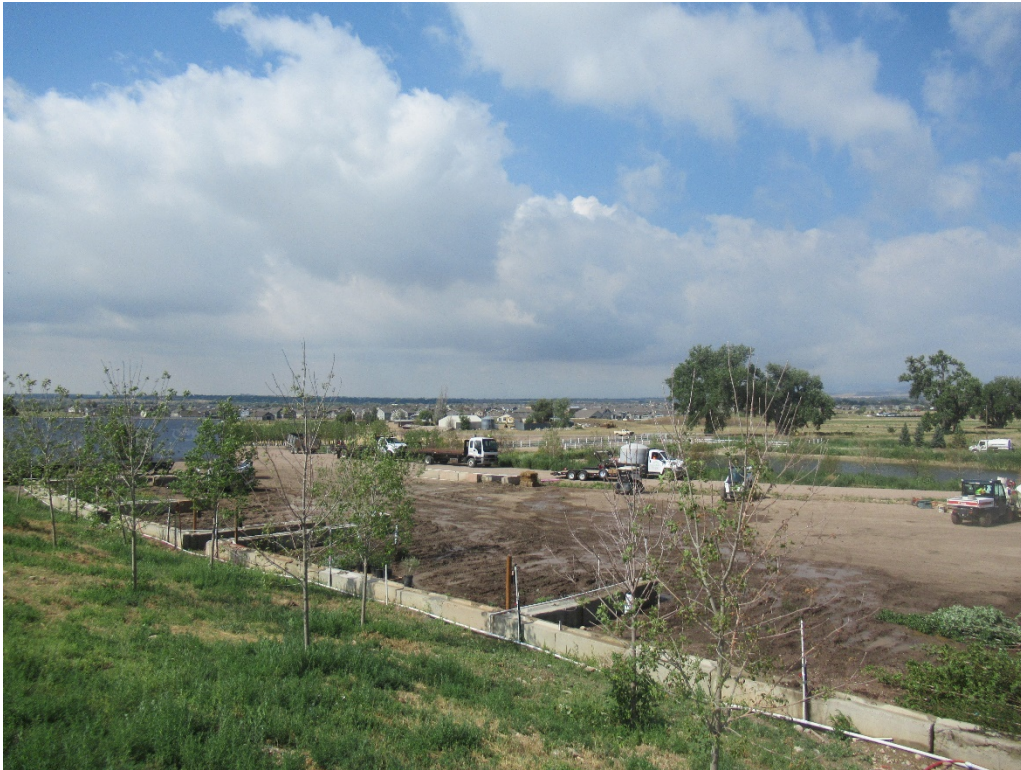
View of Phase 3 from the northeast corner of the phase looking southwest
