MINERALS PROGRAM INSPECTION REPORT
PHONE: (303) 866-3567

MINE NAME: Harmony Gardens Site	MINE/PROSPECTING ID#: M-2017-021	MINERAL: Sand and gravel	COUNTY: Weld
INSPECTION TYPE: Surety Release Inspection	INSPECTOR(S): Peter Hays	INSP. DATE: July 15, 2020	INSP. TIME: 10:00
OPERATOR: Connell Resources, Inc.	OPERATOR REPRESENTATIVE: Kevin Anderson	TYPE OF OPERATION: 110c - Construction Limited Impact	
REASON FOR INSPECTION: Surety Release Requested	BOND CALCULATION TYPE: None	BOND AMOUNT: \$51,335.00	
DATE OF COMPLAINT: NA	POST INSP. CONTACTS: None	JOINT INSP. AGENCY: None	
WEATHER: Clear	INSPECTOR'S SIGNATURE:

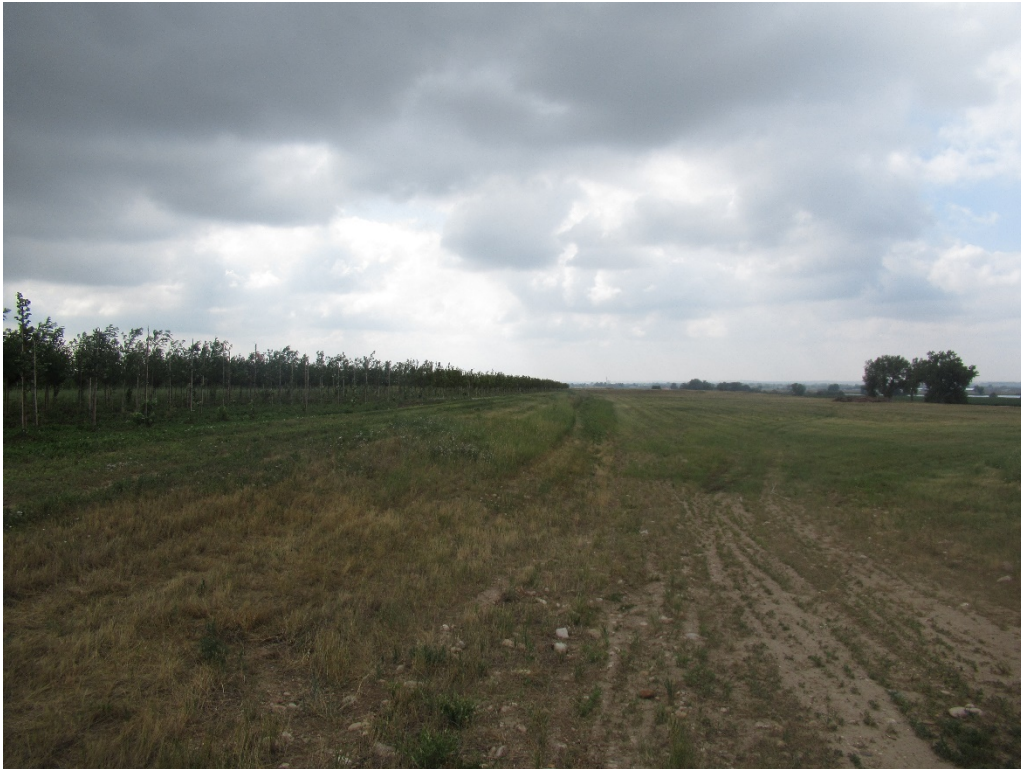
View of the East Pit from the northwest corner of the pit looking east

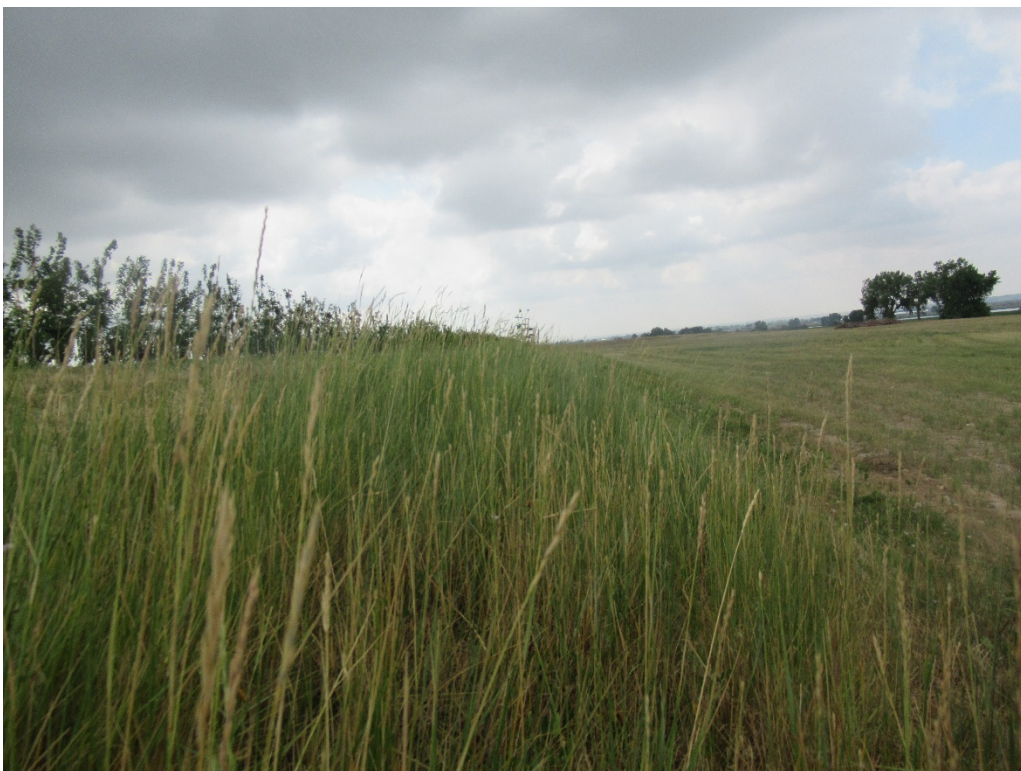
View of the vegetation on the north slope of the East Pit looking east

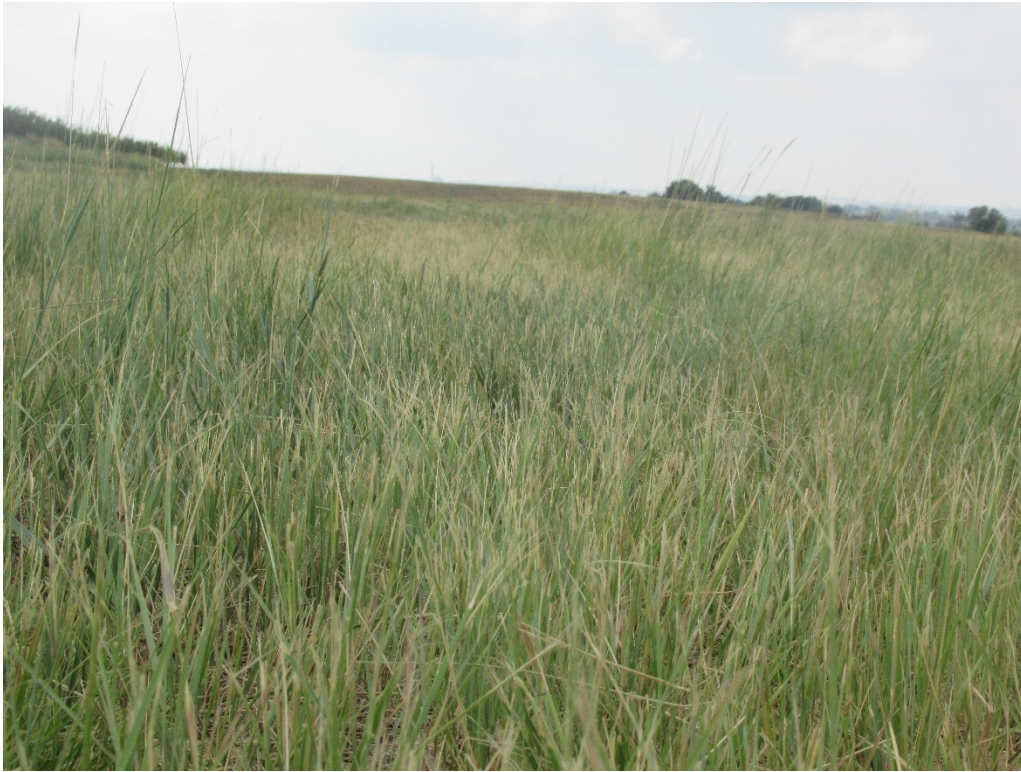
View of the vegetation on the pit floor of the East Pit

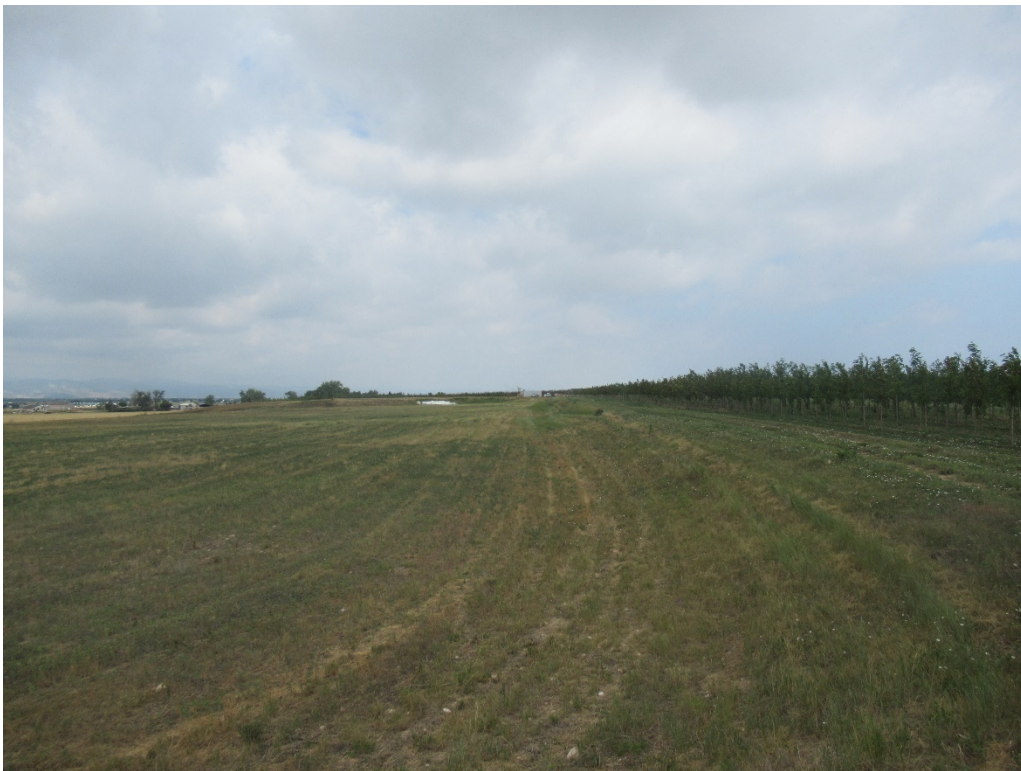
View of the East Pit from the northeast corner of the pit looking west

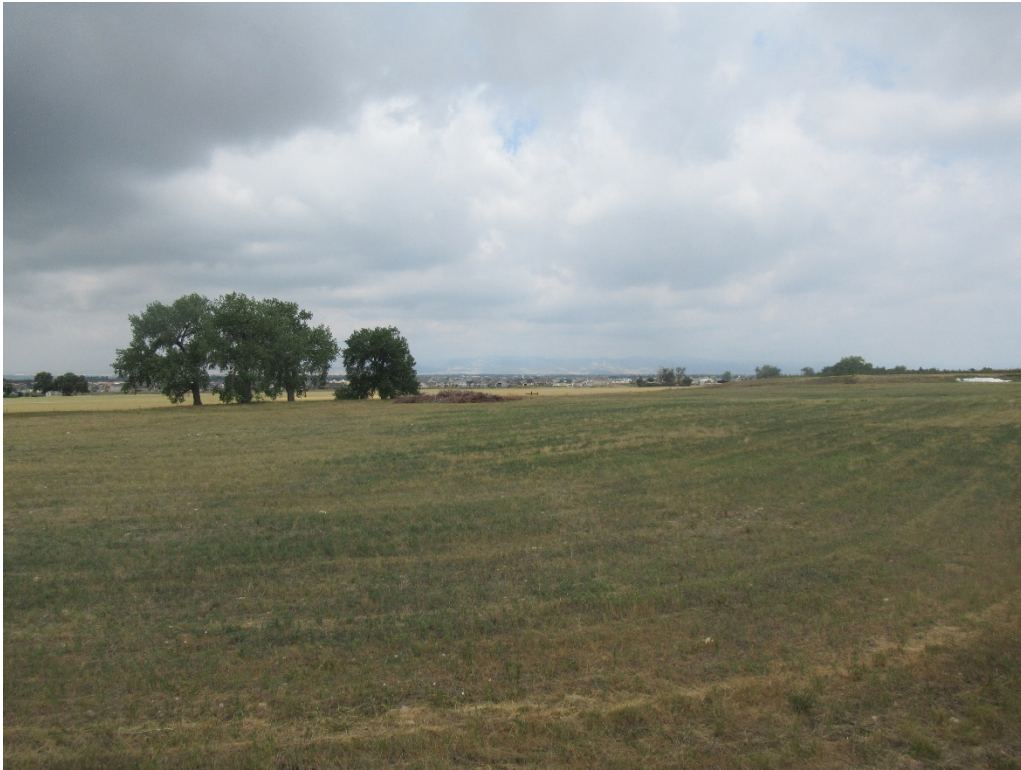
View of the East Pit from the northeast corner of the pit looking southwest

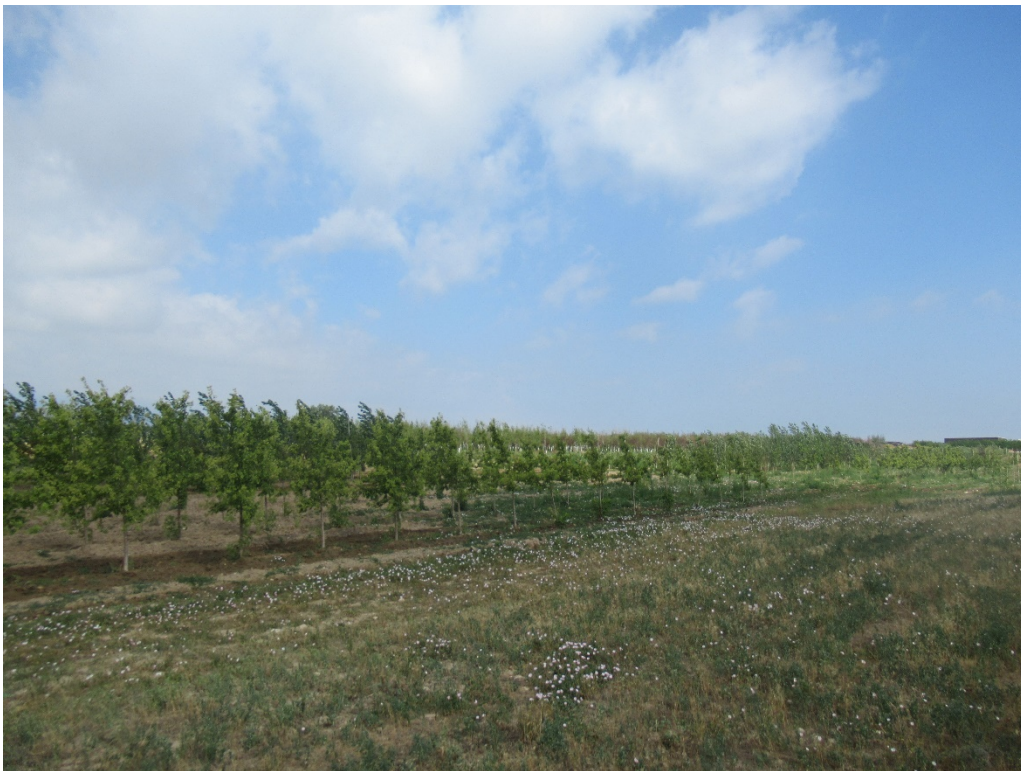
View of the West Pit from the southeast corner of the pit looking northwest

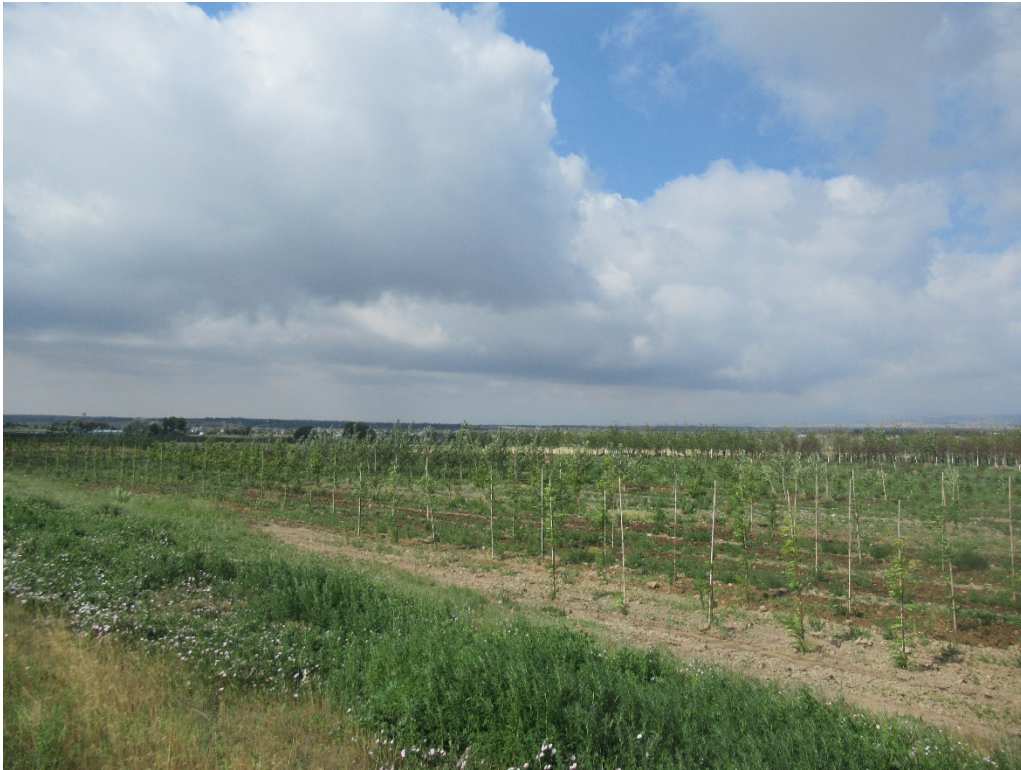
View of the West Pit from the northeast corner of the pit looking southwest

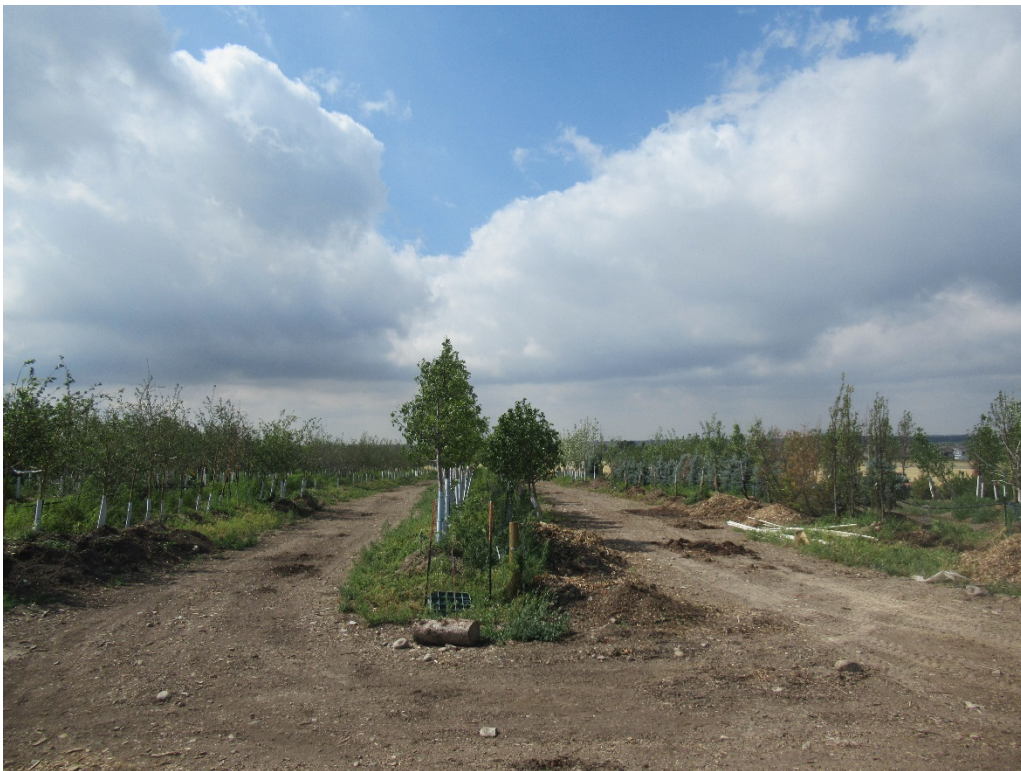
View of the West Pit from the north side of the pit looking south
