**MINERALS PROGRAM INSPECTION REPORT**  
**PHONE: (303) 866-3567**

<b>MINE NAME:</b> Morrison Quarry	<b>MINE/PROSPECTING ID#:</b> M1973-021	<b>MINERAL:</b> aggregate	<b>COUNTY:</b> Jefferson
<b>INSPECTION TYPE:</b> Monitoring	<b>INSPECTOR(S):</b> Eric Scott /Michael Cunningham	<b>INSP. DATE:</b> July 10, 2020	<b>INSP. TIME:</b> 10:00
<b>OPERATOR:</b> Aggregate Industries	<b>OPERATOR REPRESENTATIVE:</b> Jeremy Dueto	<b>TYPE OF OPERATION:</b> 112c - Construction Regular Operation

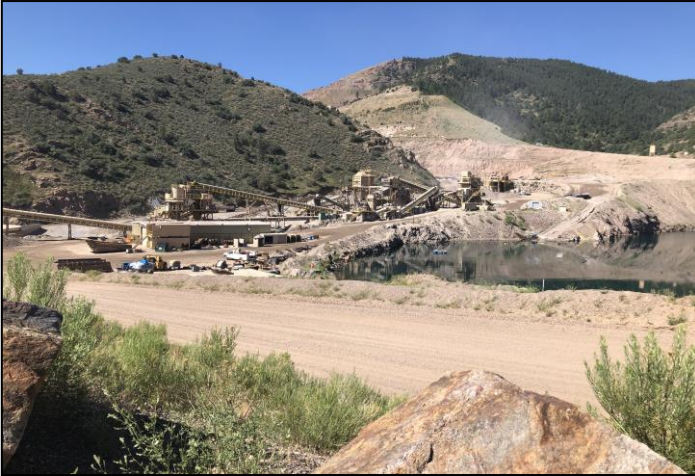
The site tour started at the office overlooking the North Reservoir and process areas (photos 1 and 2). Overall, the field conditions were largely unchanged from the previous inspection conducted in early 2019.

**Photo 1 – Process area and North Reservoir**

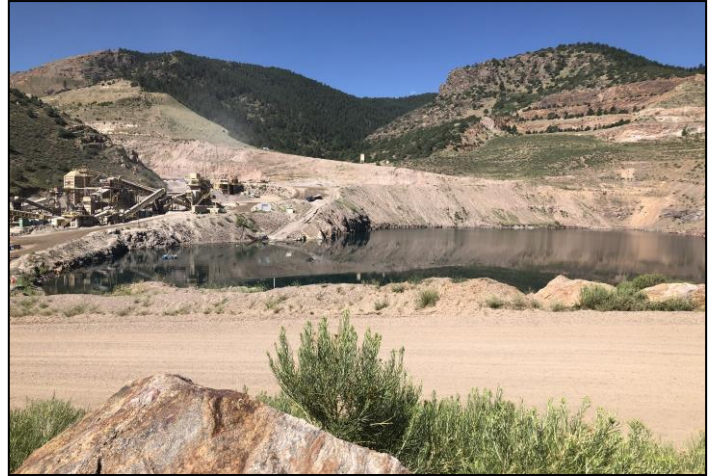
**Photo 2 – Process area and North Reservoir**

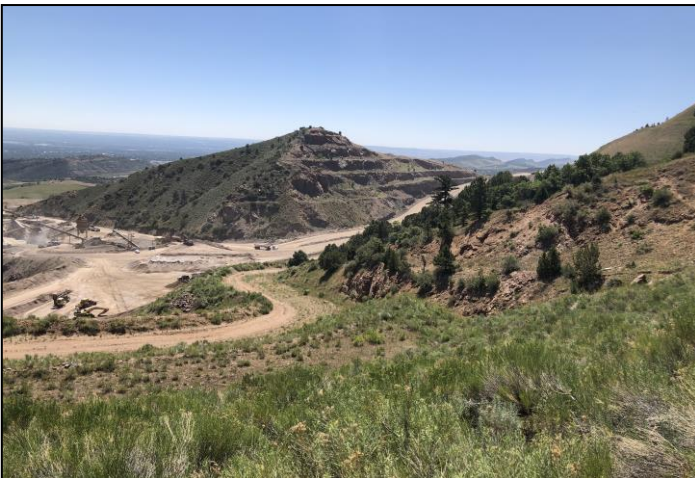
The areas of the North Quarry that have been reclaimed appear to be stable and well vegetated (photo 3). A small amount of knapweed was observed in some of the more recently disturbed areas and near the site office trailer. Weed control efforts will need to be maintained across the site where appropriate to keep noxious weeds from becoming established.

**Photo 3 – Reclaimed area of North Quarry looking SE**

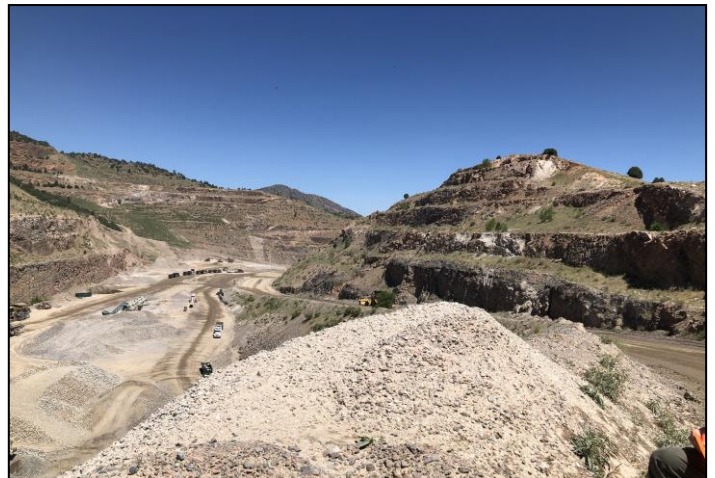
The Central Quarry area has been fully backfilled to final grade at this time and is serving as a product stockpile, process and fueling area (photo 4).

**Photo 4 – Central Quarry area looking north**

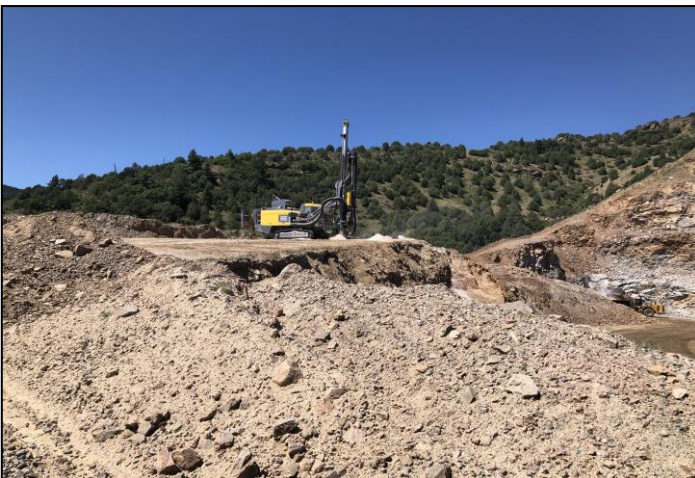
The south high wall of the South Quarry (photo 5) is the currently active phase of the mine. Slope survey/monitoring points were observed in several locations in the south quarry so that the operator can monitor for any slope movement and evaluate if corrective action is necessary. During the inspection the slopes and benches appeared to be stable, and the completed upper portions of the active slope are currently under reclamation and revegetation.

**Photo 5 – Drill rig on South side of South Quarry area looking SW**

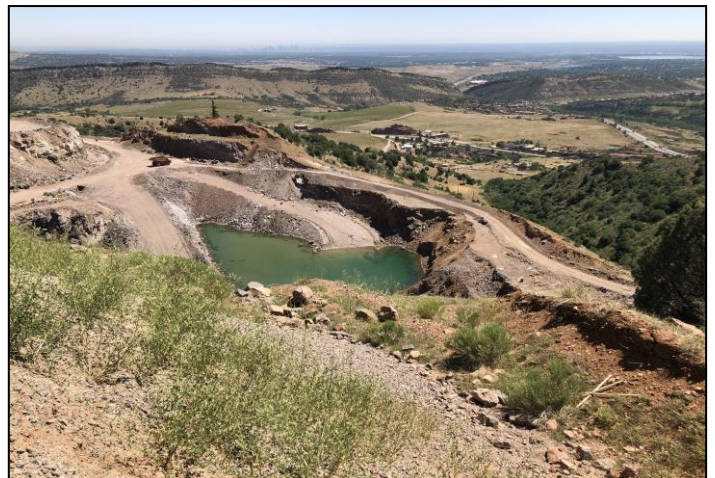
**PROBLEM/POSSIBLE VIOLATION:** Problem: During the inspection it was noted that surface runoff at the south end of the quarry had been impounded (Photo 6). All surface water runoff is required to be discharged into the original drainage within 72 hours if the site is not free draining.

The only issues noted during this inspection requiring correction have been listed above: the existing access road and associated features will need to be included in the permit area; and impounded surface runoff will need to be discharged from the site (Photo 6). The operator will need to provide proof of discharge of impounded surface water by the corrective action due date listed (8/15/20), and submit a permit amendment application to address the haul road (at a minimum) to DRMS, complete for review, no later than 10/1/20.

**Photo 6 – Impounded surface runoff in SE corner of South Quarry area that needs to be discharged from site.**

**CORRECTIVE ACTIONS:** Pump the water out of the impounded area and return the water to the appropriate surface water drainage. Provide documentation to DRMS (photos of dewatered area will be appropriate) that this has been completed by the Corrective Action Due Date.

**CORRECTIVE ACTION DUE DATE:** 8/15/20
