MINERALS PROGRAM INSPECTION REPORT
PHONE: (303) 866-3567

MINE NAME: Henderson Mine	MINE/PROSPECTING ID#: M-1977-342	MINERAL: Molybdenum	COUNTY: Clear Creek, Grand
INSPECTION TYPE: Monitoring	INSPECTOR(S): Peter Hays	INSP. DATE: July 14, 2020	INSP. TIME: 10:00
OPERATOR: Climax Molybdenum Company	OPERATOR REPRESENTATIVE: Aaron Hilshorst	TYPE OF OPERATION: 112d-3 - Designated Mining Operation	
REASON FOR INSPECTION: Normal I&E Program	BOND CALCULATION TYPE: Partial Bond	BOND AMOUNT: \$37,993,785.00	
DATE OF COMPLAINT: NA	POST INSP. CONTACTS: None	JOINT INSP. AGENCY: None	
WEATHER: Clear	INSPECTOR'S SIGNATURE:

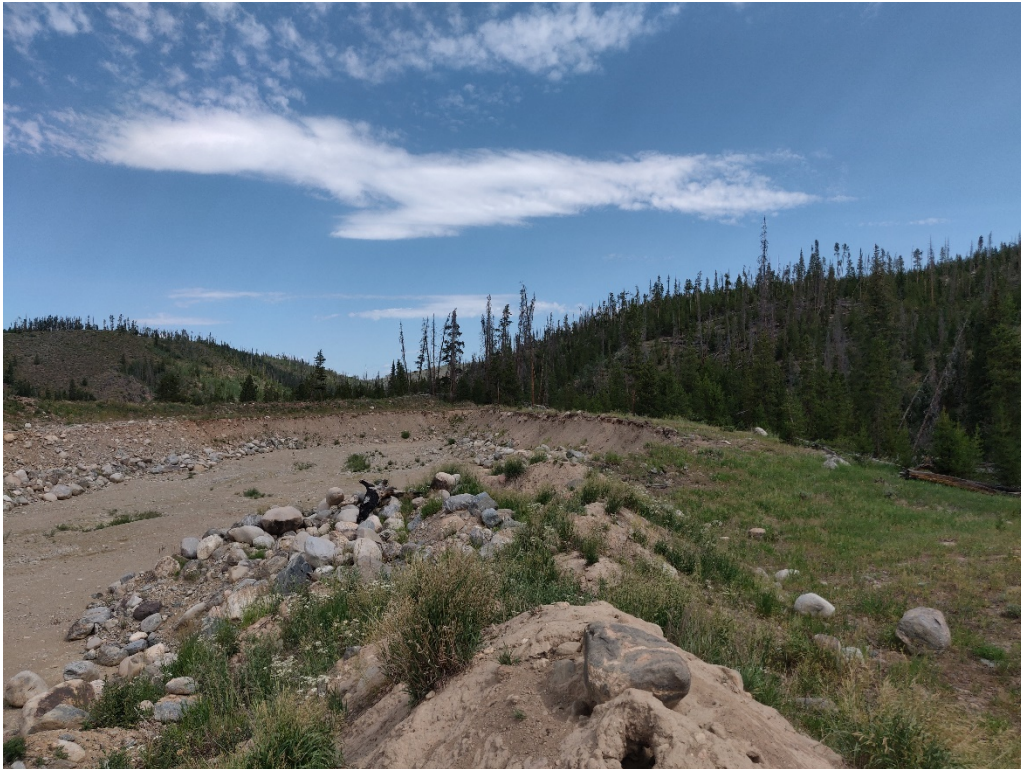
View of the north end of the gravel pit from the east side looking north

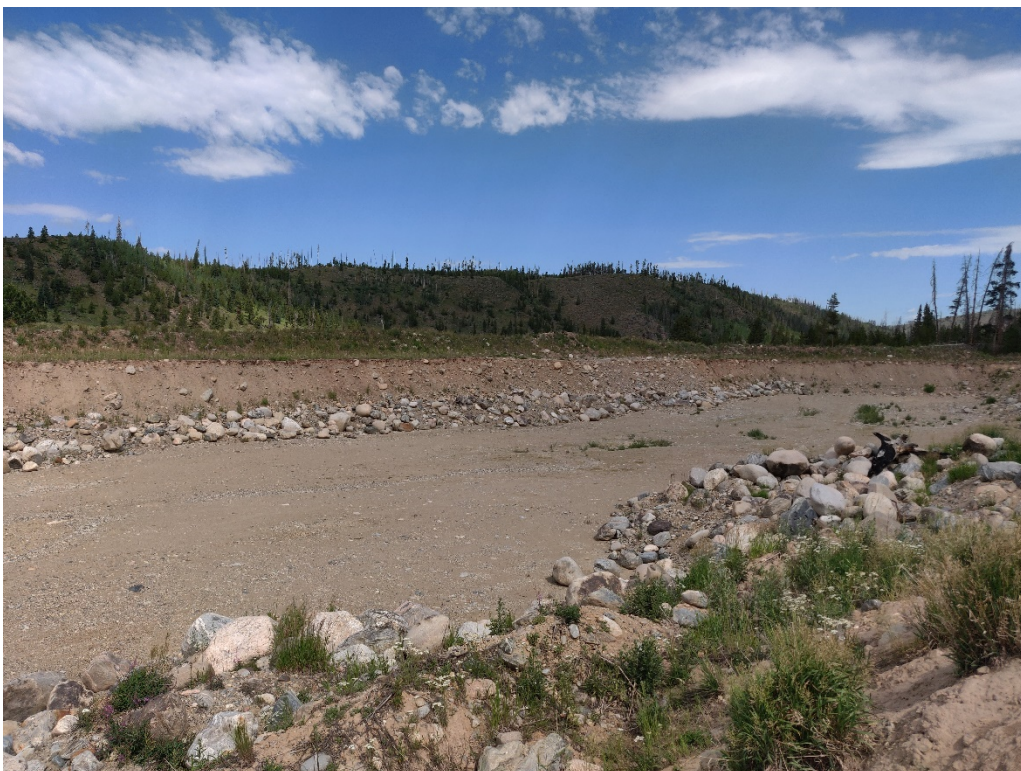
View of the north end of the gravel pit from the east side looking northwest

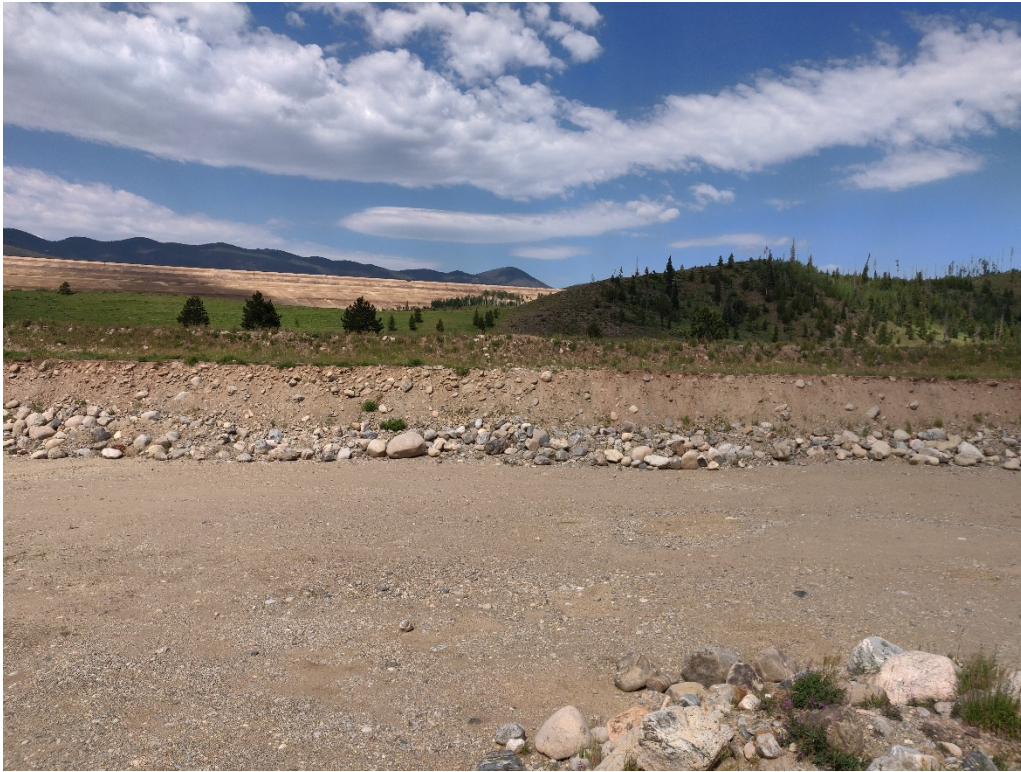
View of the north end of the gravel pit from the east side looking west

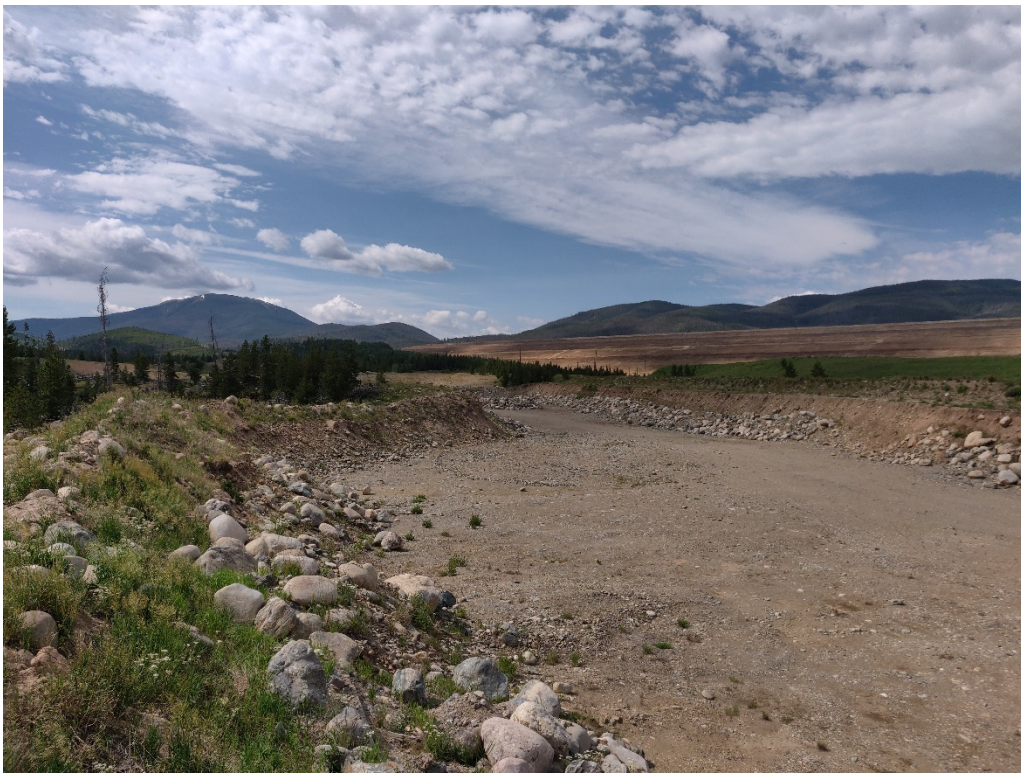
View of the north end of the gravel pit from the east side looking southwest

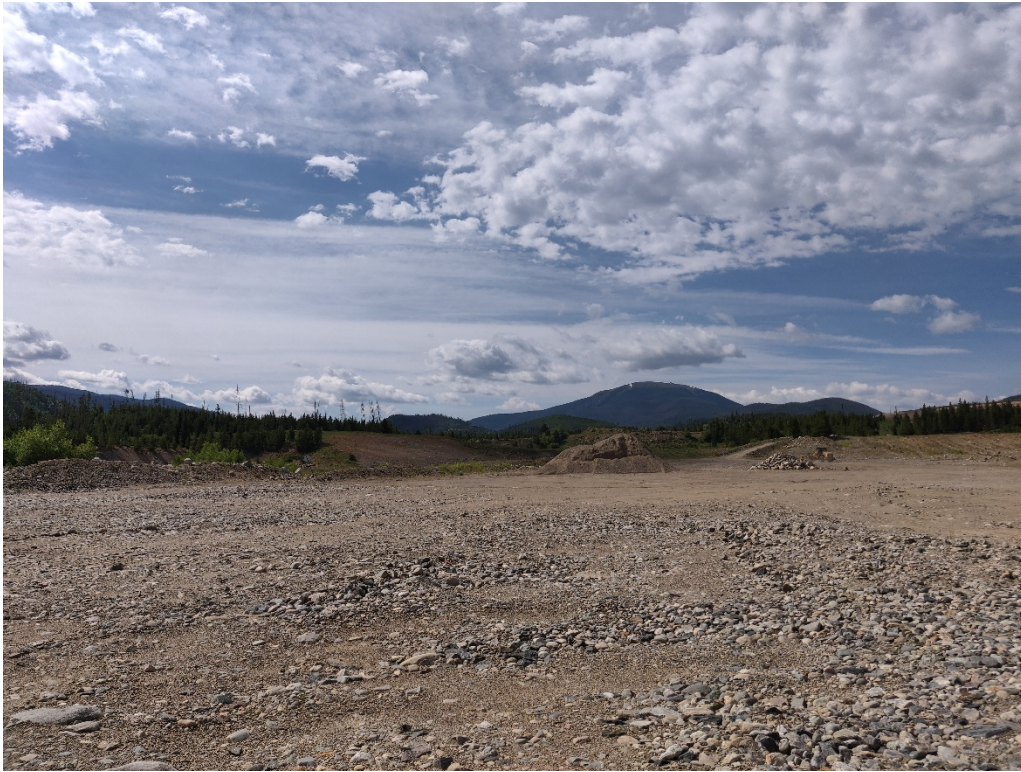
View of the south end of the gravel pit from the pit floor looking south

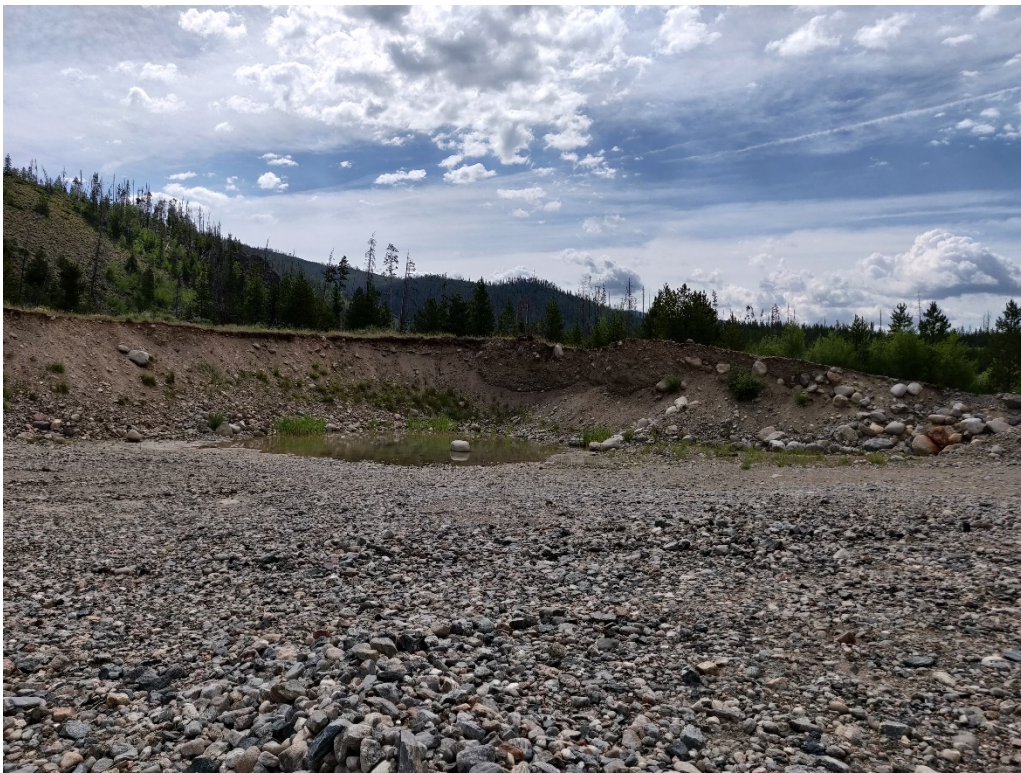
The gravel pit was inactive at the time of the inspection. Imported stockpiles of course and fine roadbase material were observed on the pit floor. One area of exposed groundwater was observed along the east side of the pit. According to the letter dated September 30, 2011 from W. W. Wheeler and Associates, Inc., approximately 2.64 acres of groundwater was exposed prior to December 31, 1980. As indicated in the letter dated November 8, 2011 from the Division of Water Resources a well permit and augmentation plan are not required if there is to be no further use of the groundwater and the pre-law amount of exposed groundwater is not exceeded. The Division estimated 0.1 acres of exposed groundwater during the inspection.

View of the current exposed groundwater pond in the gravel pit

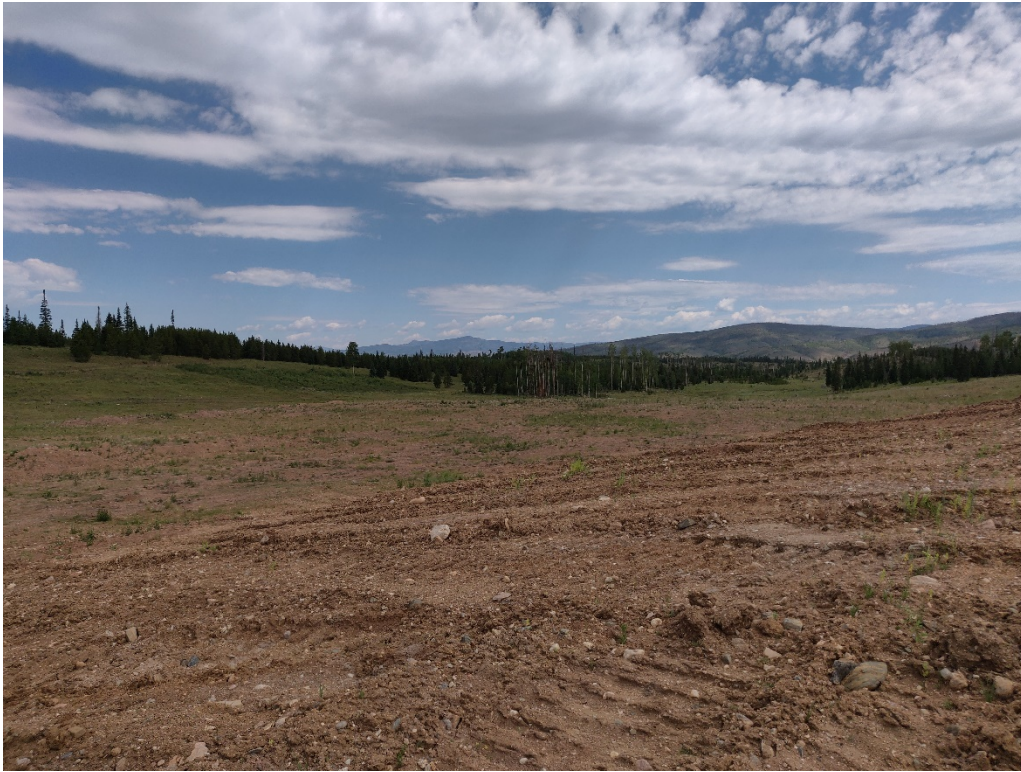
The topsoil stockpiles in Ranger Gulch, near the water tank and adjacent to CR3 across from East Branch Reservoir were observed. All of the topsoil stockpiles appeared stable with no erosion features observed during the inspection. The Ranger Gulch stockpile and the bare areas of the water tank stockpile are scheduled to be hydroseeded this fall. The topsoil stockpile adjacent to CR3 was well-vegetated with native grasses. The Operator is planning to construct revegetation test plots on the tailings impoundment to determine the best construction method and profile for reclaiming the impoundment in the next few years.

View of the Ranger Gulch topsoil storage area

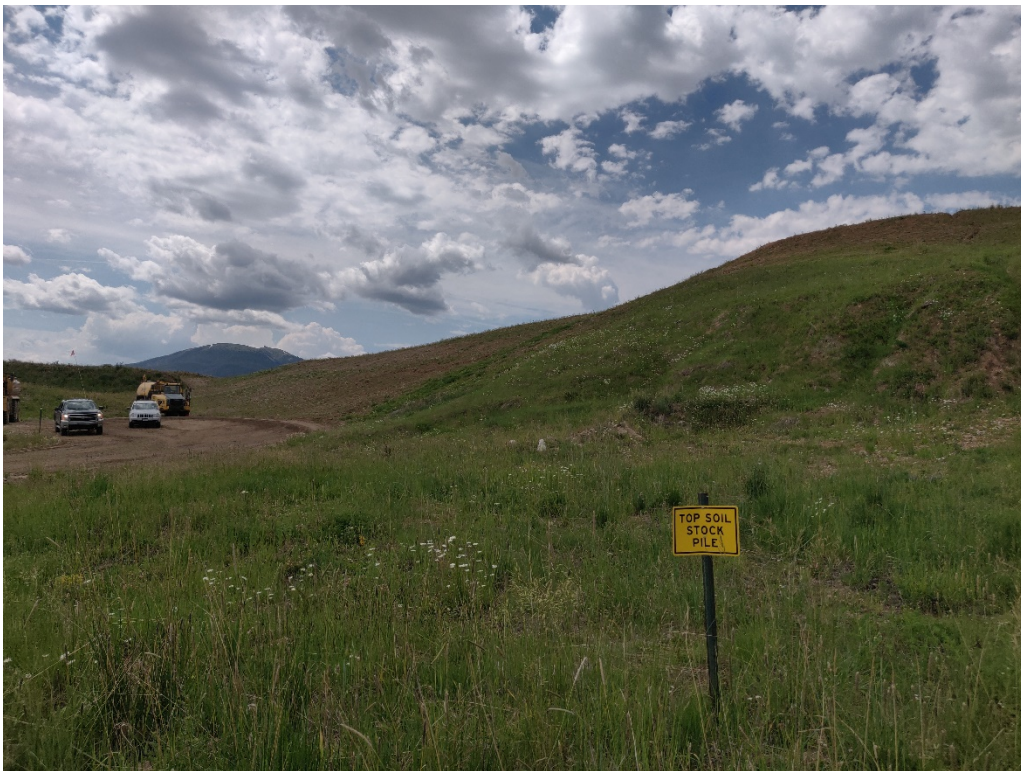
View of the water tank topsoil stockpile

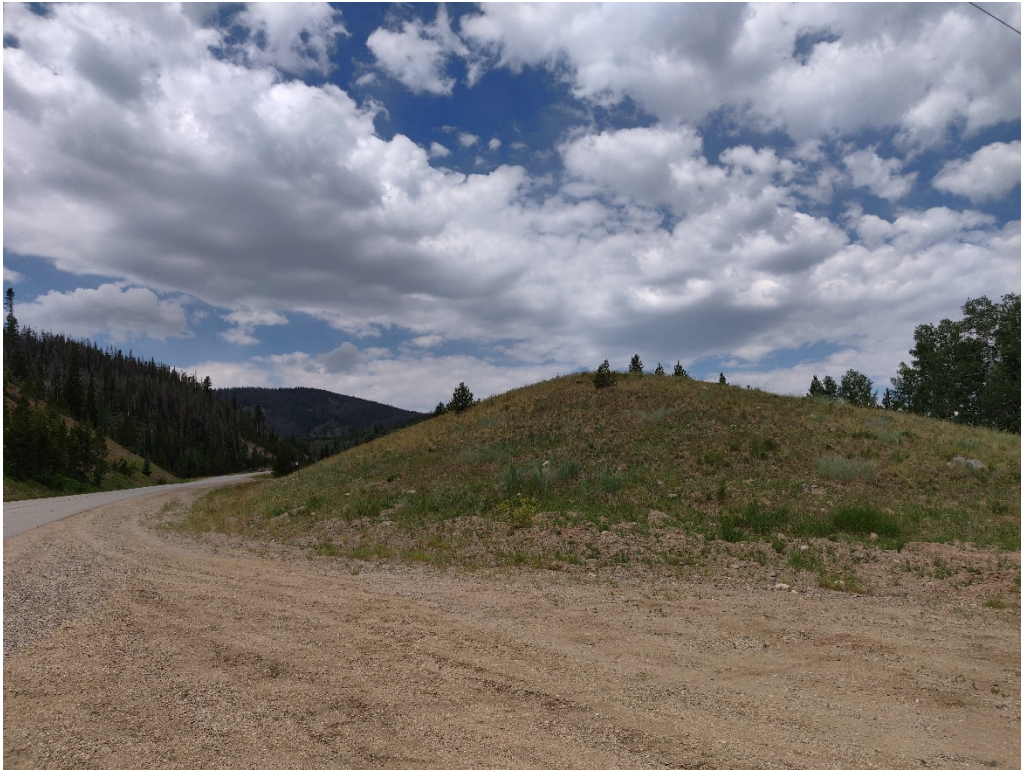
View of the topsoil stockpile adjacent to CR3

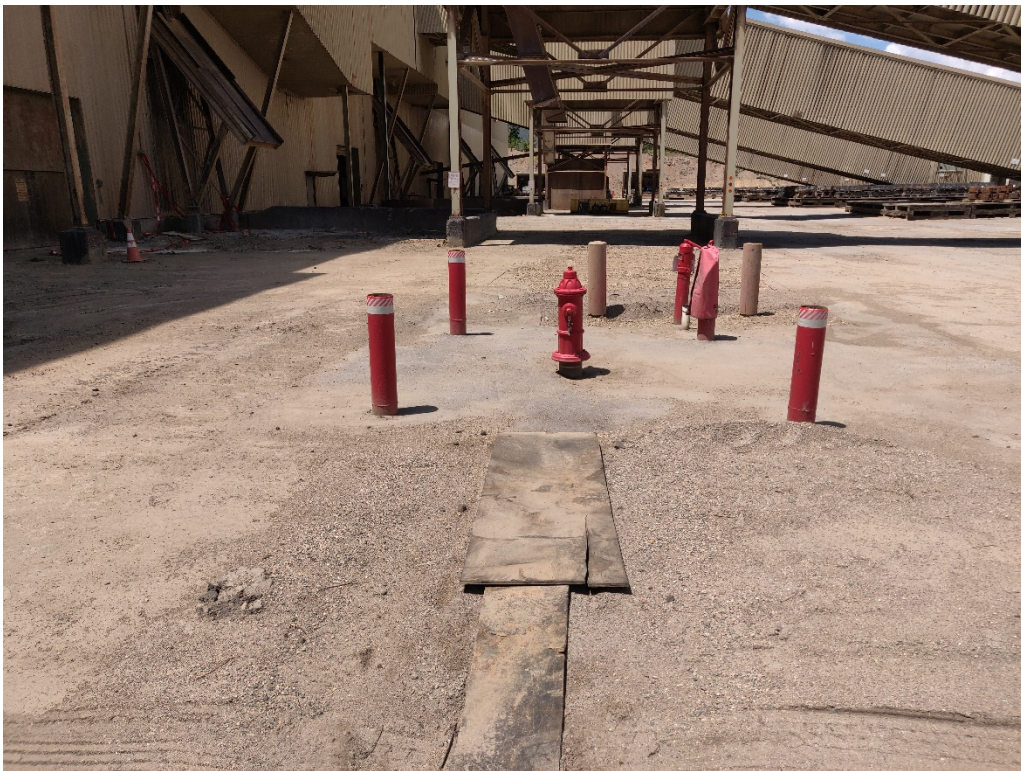
On November 5, 2019, the Division received written follow-up notice of a release of process water from the fire water line from the Mill Process Water Storage Tanks to the site's fire water distribution and suppression systems. The repair of the water line near hydrant #7 was observed during the June inspection. During the repair the Operator discovered another possible leak near fire hydrant #6 located west of the first repair area.

View of the repaired area around fire water hydrant #7
