# **Horse Gulch Fill Quarterly Inspection Report**

**Second Quarter 2020**

**Trapper Mining Inc.  
Trapper Mine  
Craig, Colorado**

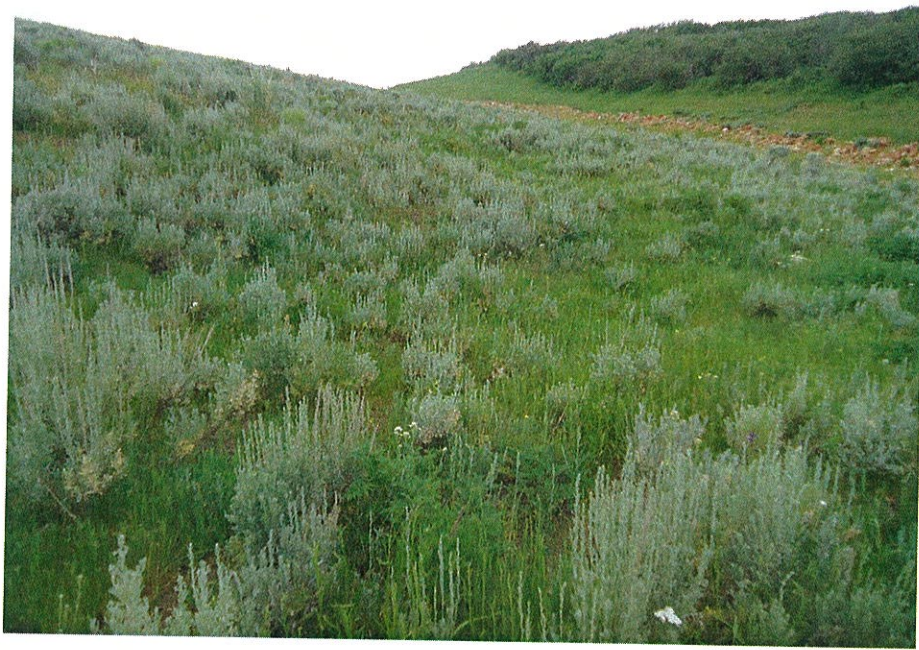
The two spots above the 7350' elevation on the south side of the dump that showed some differential settling in the second quarter of 2013 were inspected and there was no additional settling (Photographs 1 and 2). These two sites were surveyed on June 26, 2020 (via drone). The recent survey shows the volume for the north depression is less than the volume from the 2019 survey. The south depression's volume is more than 2019 survey but less than the 2018 survey. The vegetation growth has caused discrepancies with the calculated volumes. It appears there has been no change in volume for either depression areas in the past year. Monitoring these areas on a regular basis will continue. The table below shows how the recent survey compares to the surveys done on June 8, 2018 and June 26, 2019 (via drone):

*Photograph 1: South Site above the 7350 Bench Elevation (6/25/2020)*

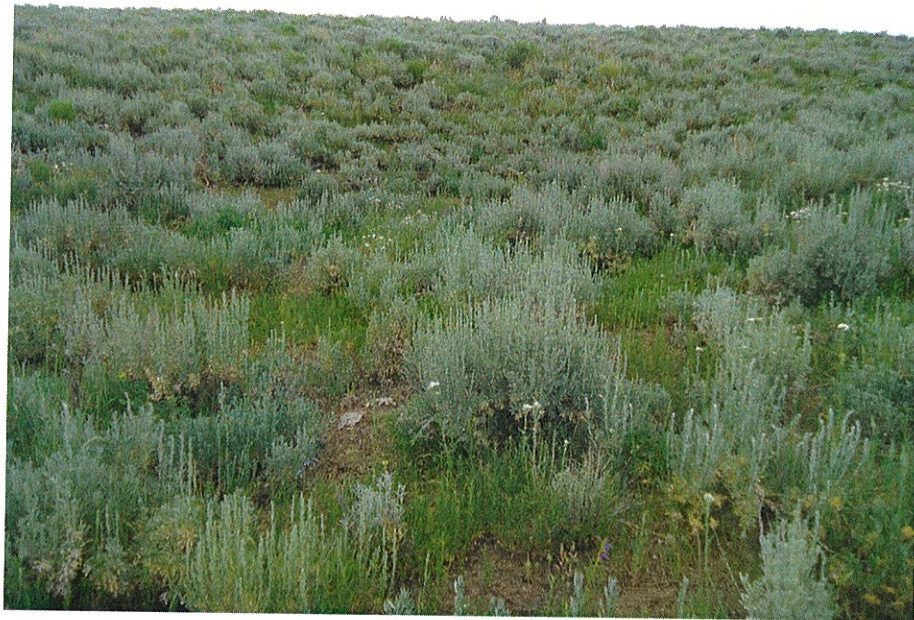
*Photograph 2: North Site above the 7350 Bench Elevation (6/25/2020)*

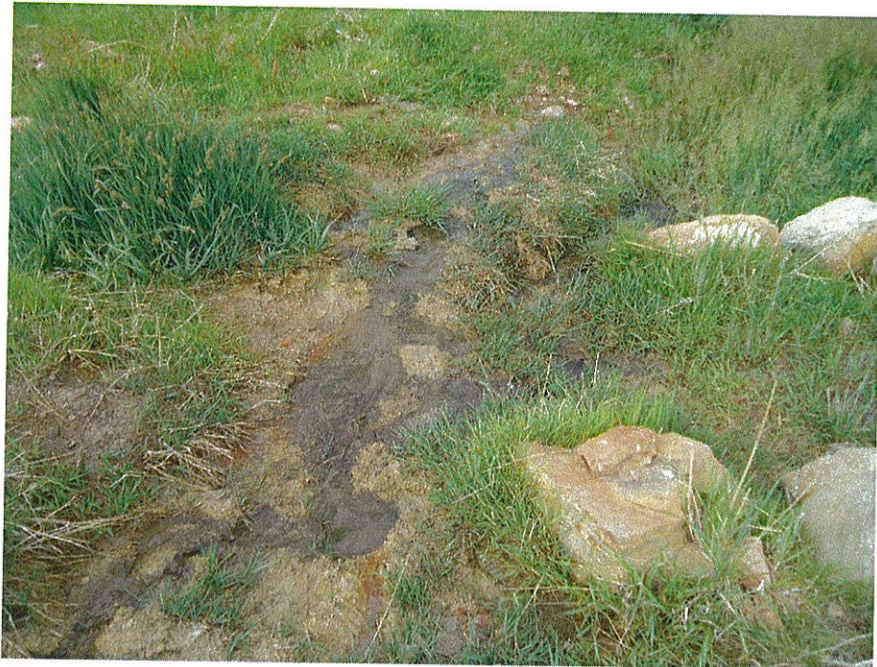
The underdrainage system was completed in the first quarter of 2010; additional work on this system is not anticipated. During the time of the inspection, there was approximately a gallon per minute of water flow. (Photograph 3).

*Photograph 3: Water from the Underdrainage System (6/25/2020)*

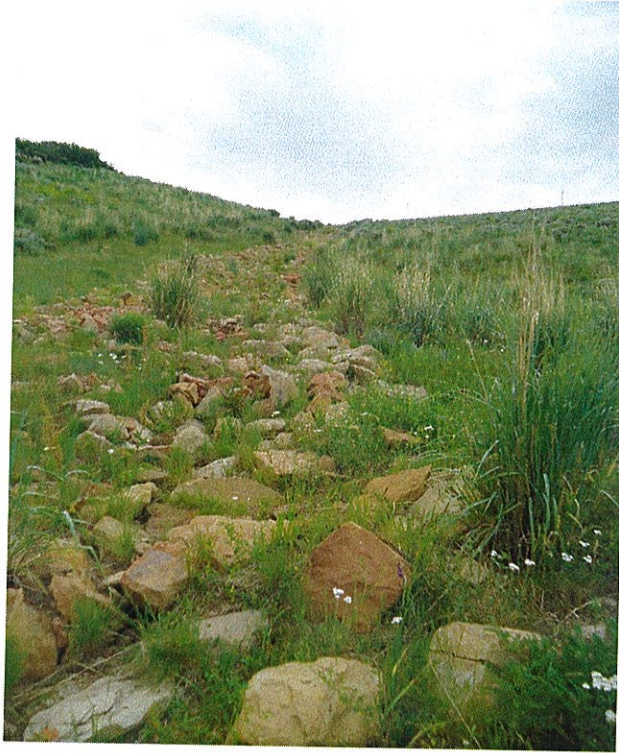
Both the north and south surface drains were inspected (Photographs 4 and 5). At the time of the inspection there was no water flow.

*Photograph 4: North Surface Drain Looking East (6/25/2020)*

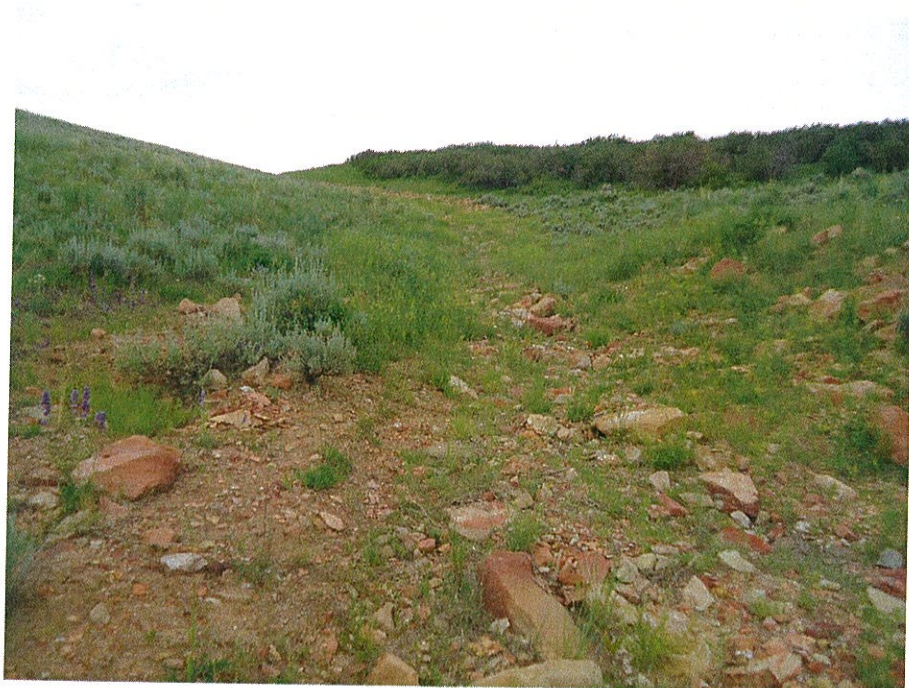
*Photograph 5: South Surface Drain Looking Southeast (6/25/2020)*

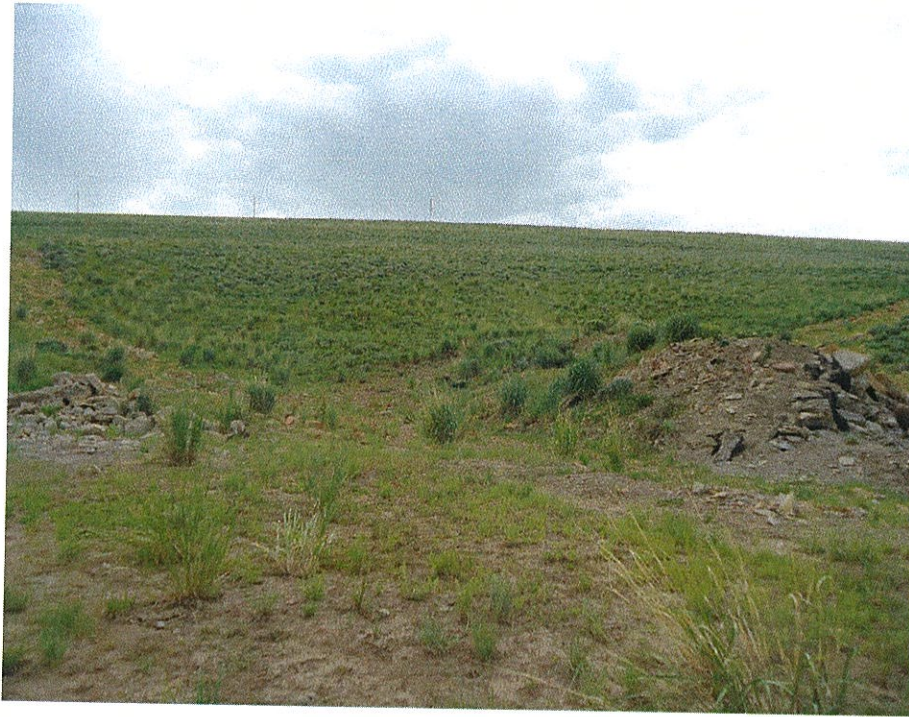
Photograph 6 depicts the west facing slope of the fill in the area where the slope of the fill is at 3H: 1V.

*Photograph 6: West Side Fill 3H: 1V Face Looking East (6/25/2020)*
