**MINERALS PROGRAM INSPECTION REPORT**  
**PHONE: (303) 866-3567**

| <b>MINE NAME:</b><br>Schwartzwalder Mine | <b>MINE/PROSPECTING ID#:</b><br>M-1977-300 | <b>MINERAL:</b><br>Uranium | <b>COUNTY:</b><br>Jefferson |
| <b>INSPECTION TYPE:</b><br>Monitoring | <b>INSPECTOR(S):</b><br>Amy Eschberger, Michael Cunningham | <b>INSP. DATE:</b><br>June 26, 2020 | <b>INSP. TIME:</b><br>09:30 |

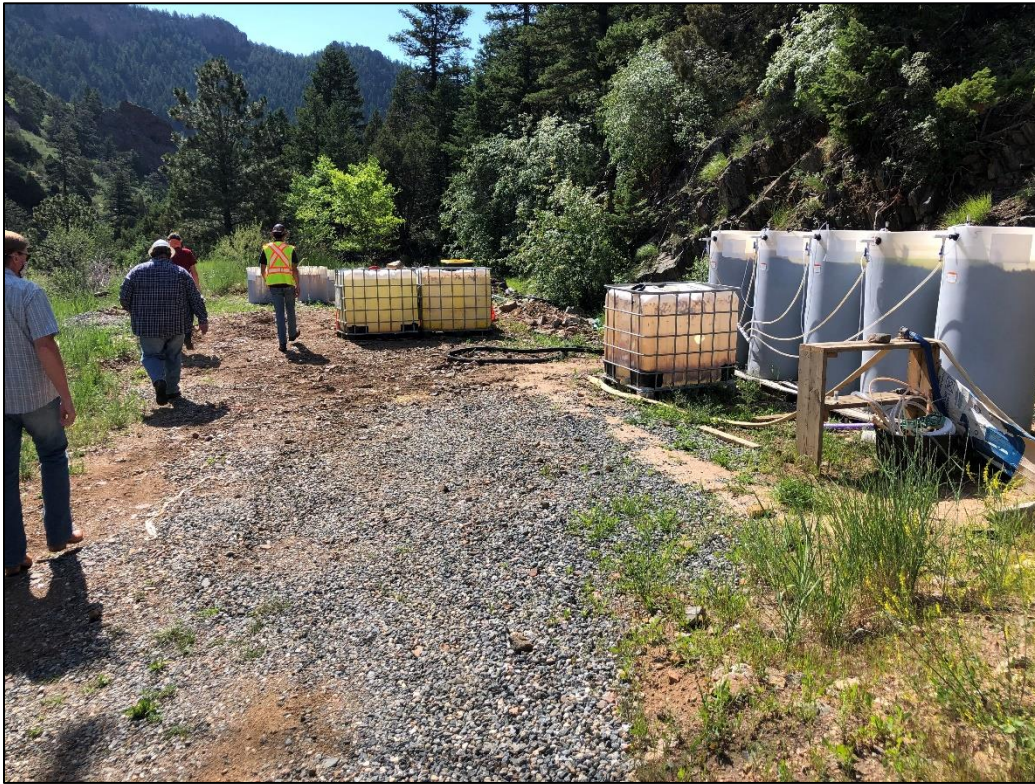
**Photo 1.** View looking southeast across area east of water treatment plant where wetland and BCR pilot-scale study is conducted.

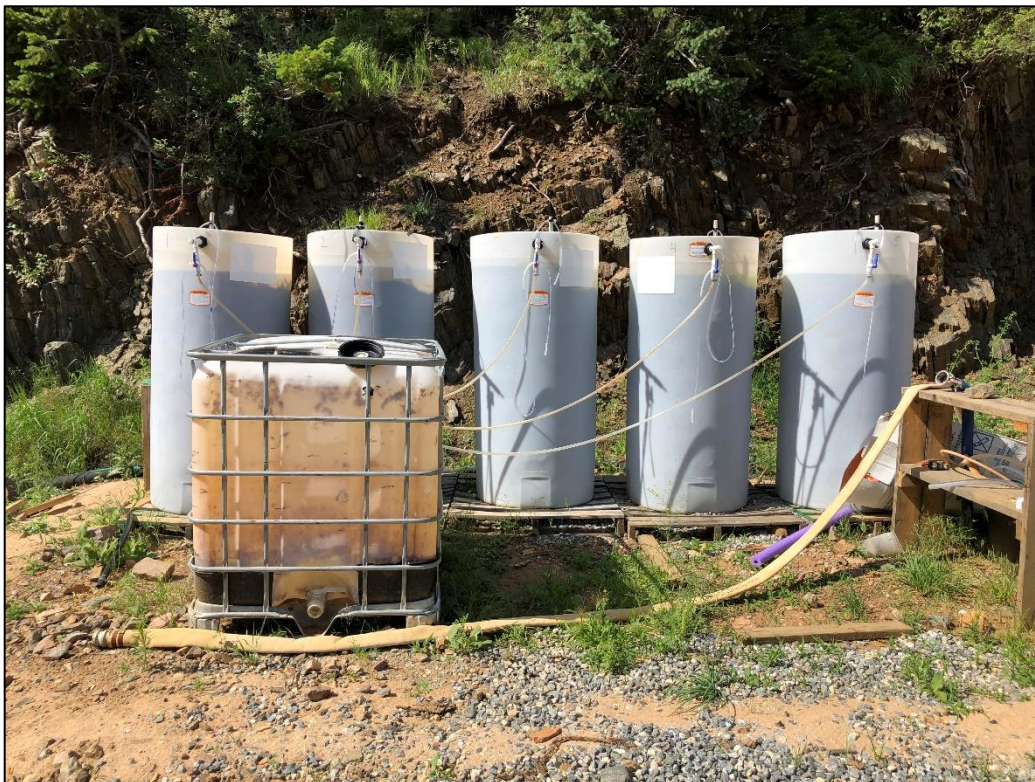
**Photo 2.** View looking south at BCR system set up for pilot-scale study conducted in area east of water treatment plant.

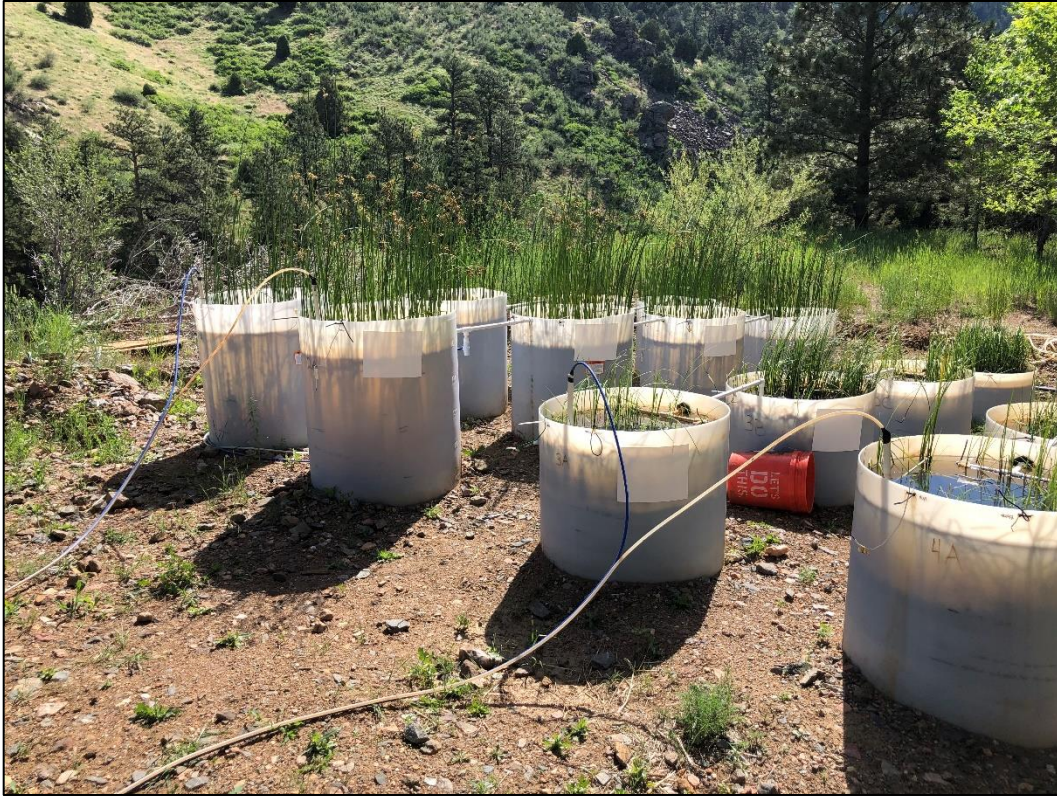
**Photo 3.** View looking southeast at wetland treatment system set up for pilot-scale study conducted in area east of water treatment plant.

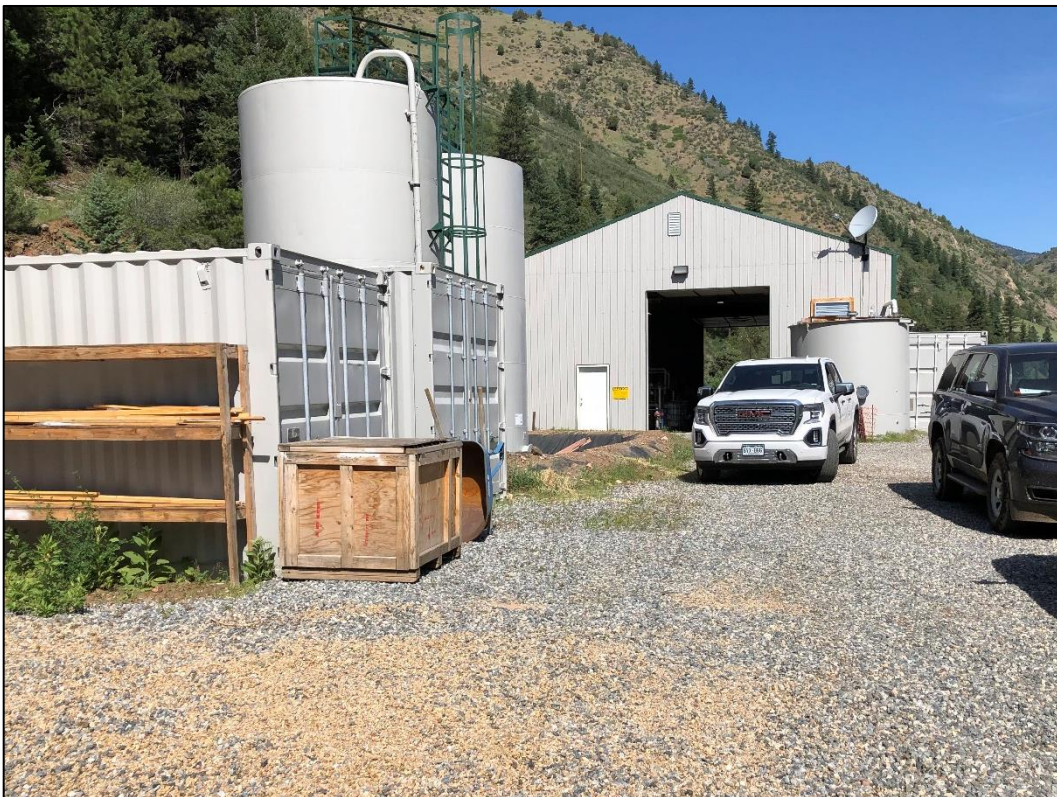
**Photo 4.** View looking northwest at new water treatment plant constructed on top of mesa south of Ralston Creek.

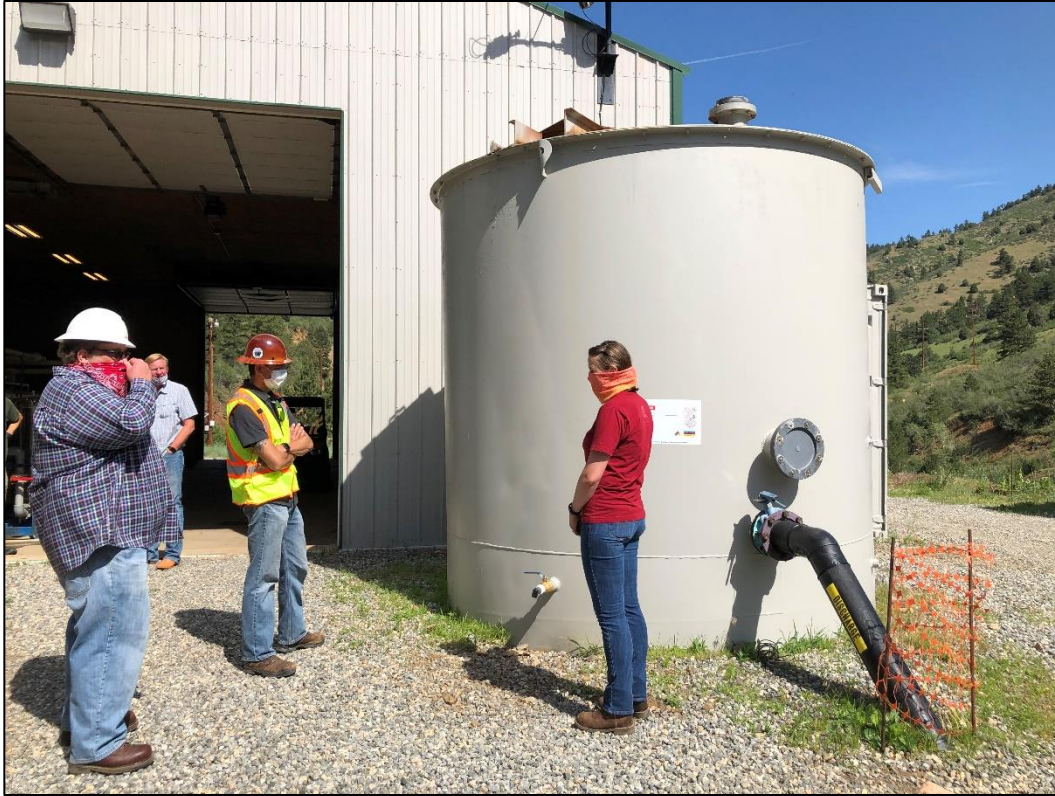
**Photo 5.** View looking northwest at discharge tank located at southeastern corner of water treatment plant, from which treated water is discharged (through pipeline shown at bottom right) to Ralston Creek at SW-BPL.

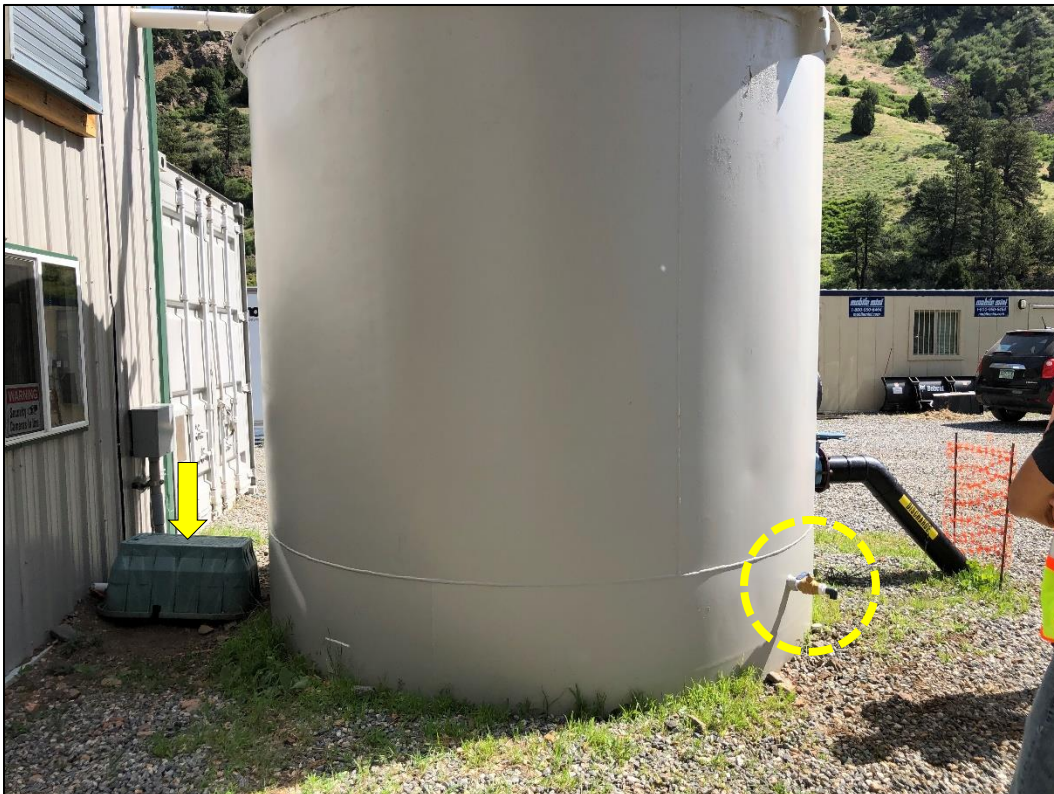
The Division observed the discharge tank located at the southeastern corner of the water treatment plant from which water treated through the plant is discharged via pipeline to Ralston Creek at surface monitoring location SW-BPL under the CDPHE discharge permit. The operator had recently completed a deep clean on the tank and also installed a new sampling port which had not been used yet. This work was done after the operation failed a routine Whole Effluent Toxicity (WET) test completed in June per the CDPHE discharge permit. The operator is currently performing accelerated testing per CDPHE protocols. Depending on the results of the additional testing, CDPHE may require an increased frequency of routine monitoring or a Toxicity Identification (or Reduction) Evaluation be performed. If no pattern of toxicity is found, the operator can return to routine WET testing as outlined in the permit. The operator indicated the preliminary laboratory results are looking good so far. It appears that cleaning the tank may have mitigated the issues which led to the initial WET test failure. The operator also believes that using the new sample port for future sampling will provide a more representative sample of the water that is discharged from the tank. If CDPHE were to issue a notice of non-compliance or a violation for the operation, the operator must notify the Division of such notice and include a plan for regaining compliance.

**Photo 6.** Side view of discharge tank shown in Photo 5. This tank was deep cleaned recently and a new sampling port was installed (circled). The old sampling port is located at the back of the tank (under green bucket; location indicated with arrow).

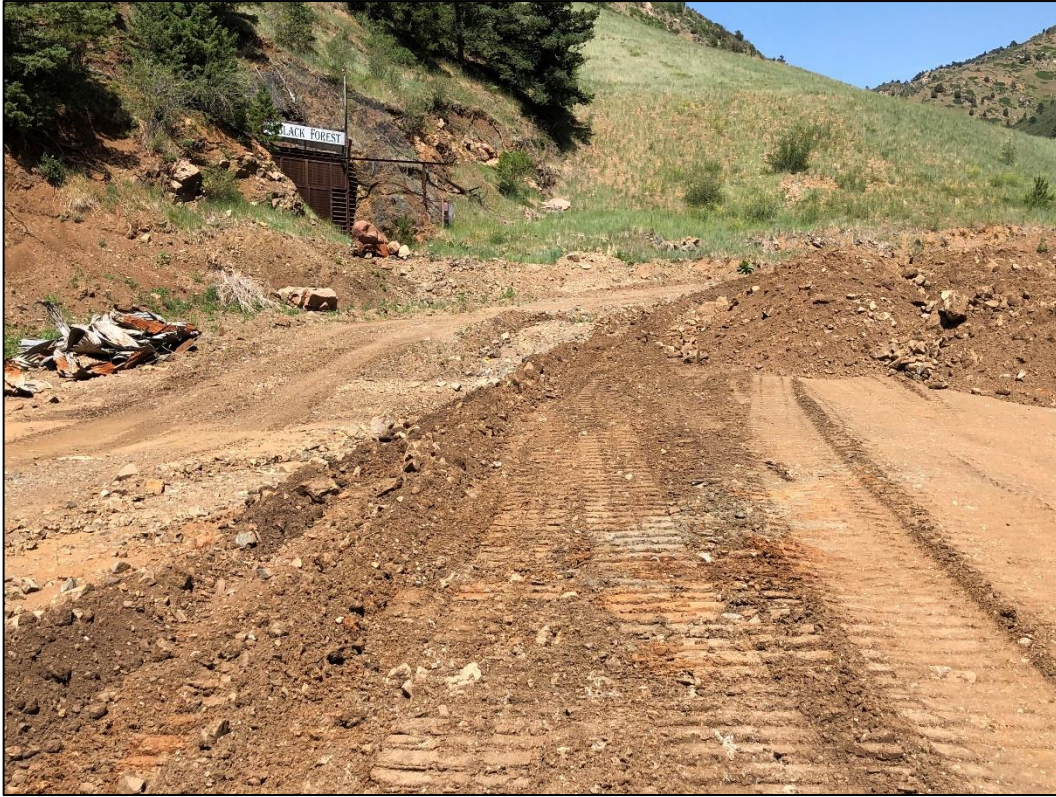
**Photo 7.** View looking north across northern portion of northern excavation area located south of SWRP near Black Forest Mine portal (visible in background, at top left of photo).

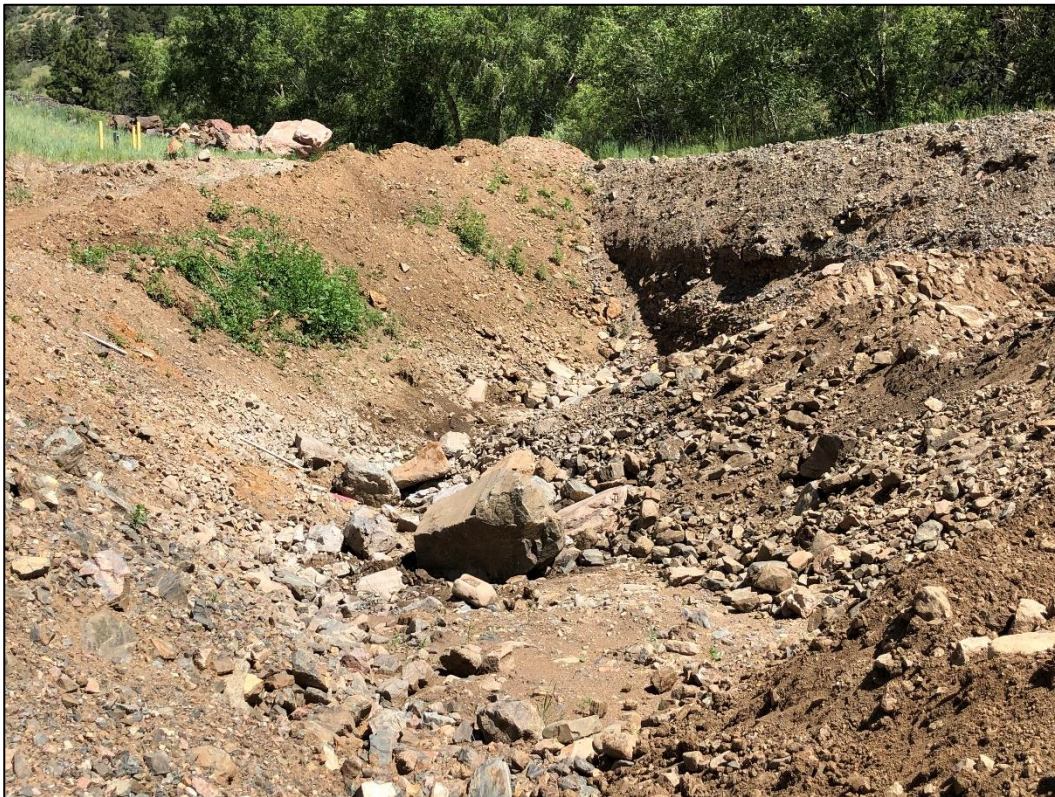
**Photo 8.** View looking northeast across northern edge of northern excavation area located south of SWRP near Black Forest Mine portal.

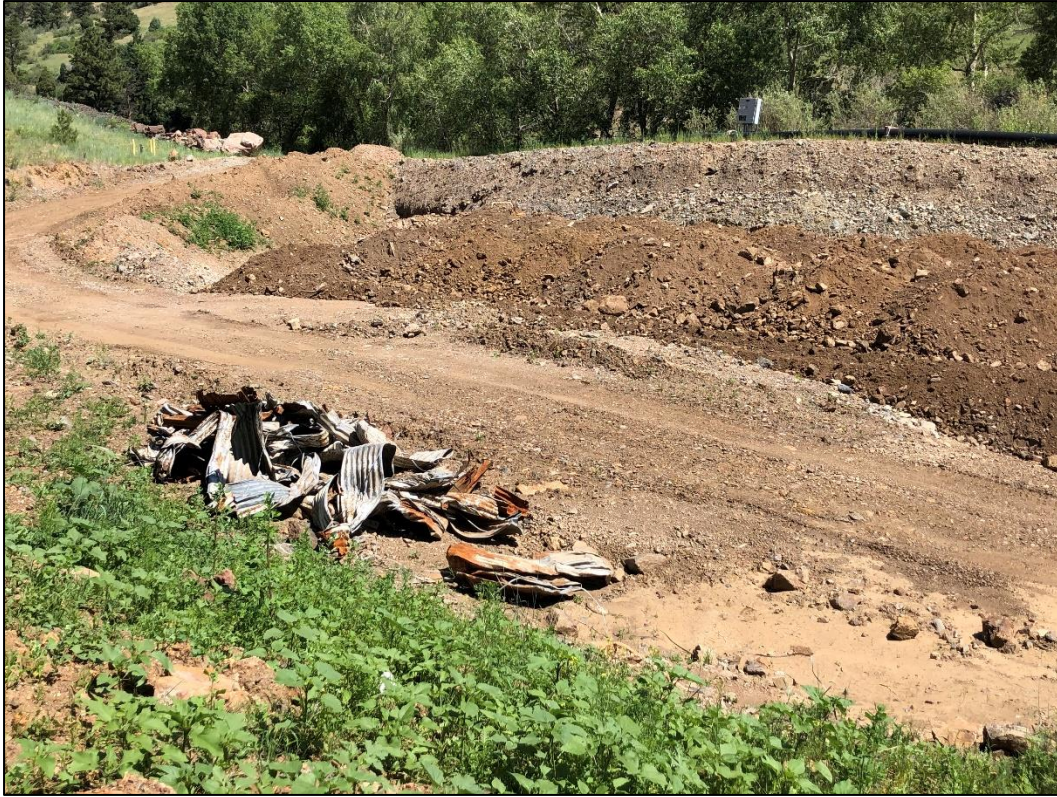
**Photo 9.** View looking northeast across northern portion of northern excavation area located south of SWRP near Black Forest Mine portal.

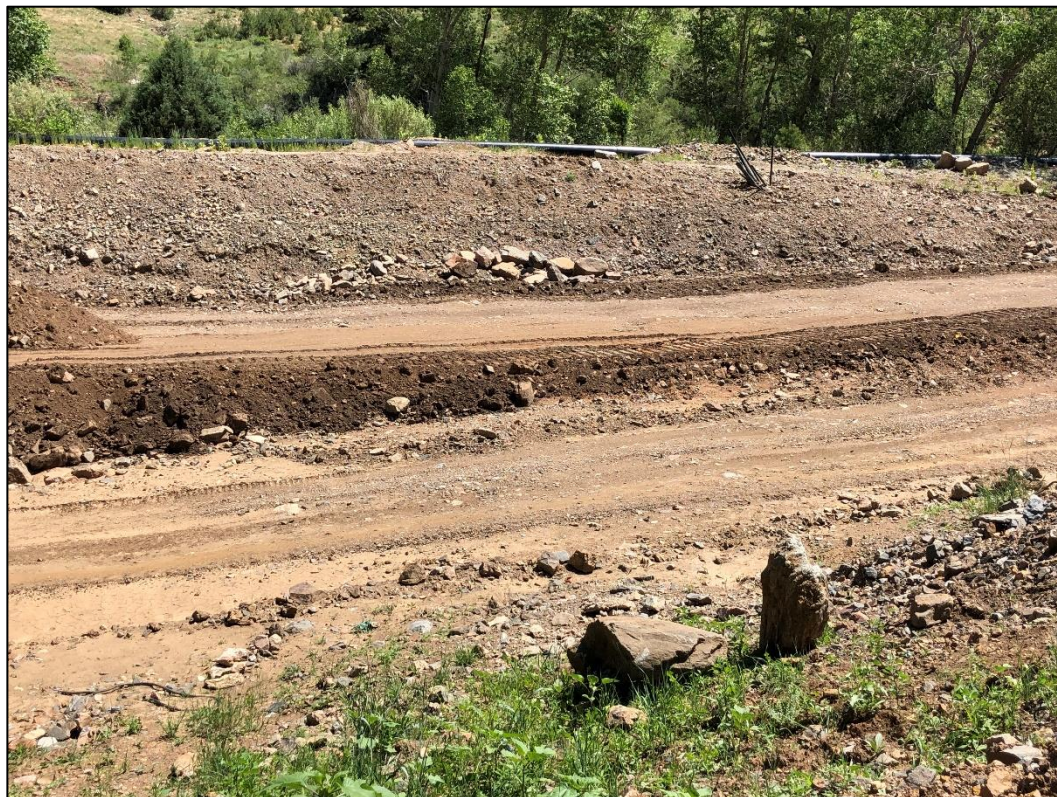
**Photo 10.** View looking east across northern portion of northern excavation area located south of SWRP near Black Forest Mine portal.

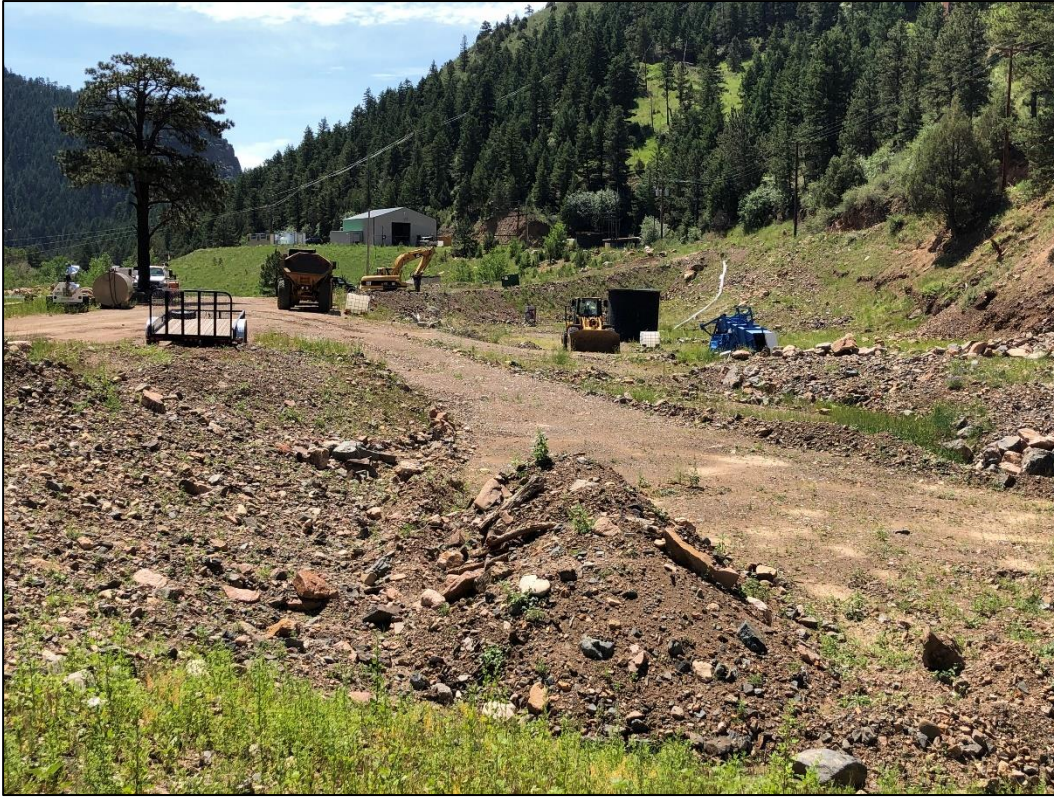
**Photo 11.** View looking southeast across central portion of northern excavation area.

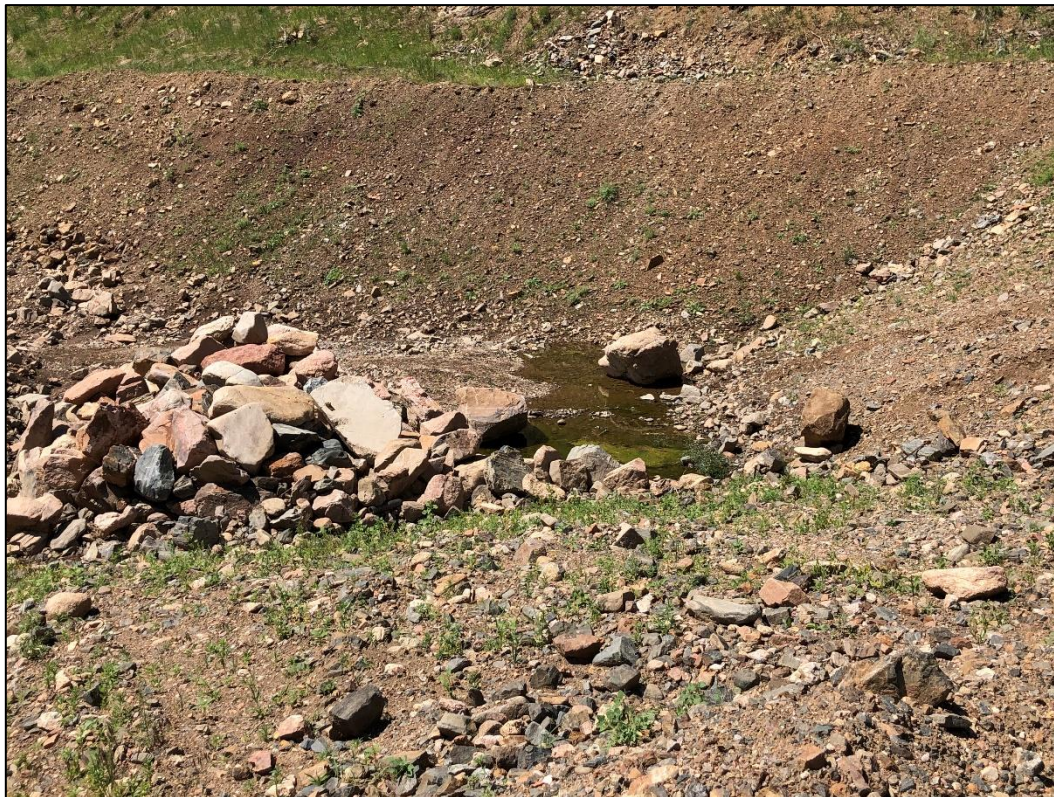
**Photo 12.** View looking west across central portion of northern excavation area.

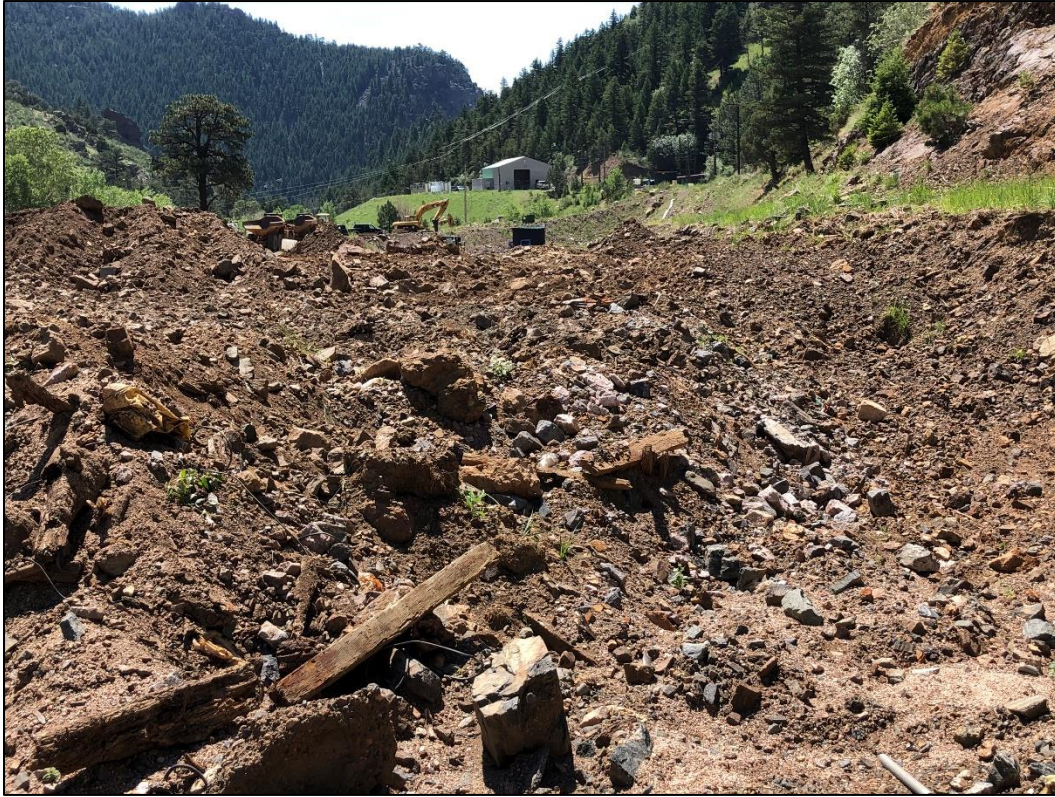
**Photo 13.** View looking southeast across northern portion of northern excavation area.

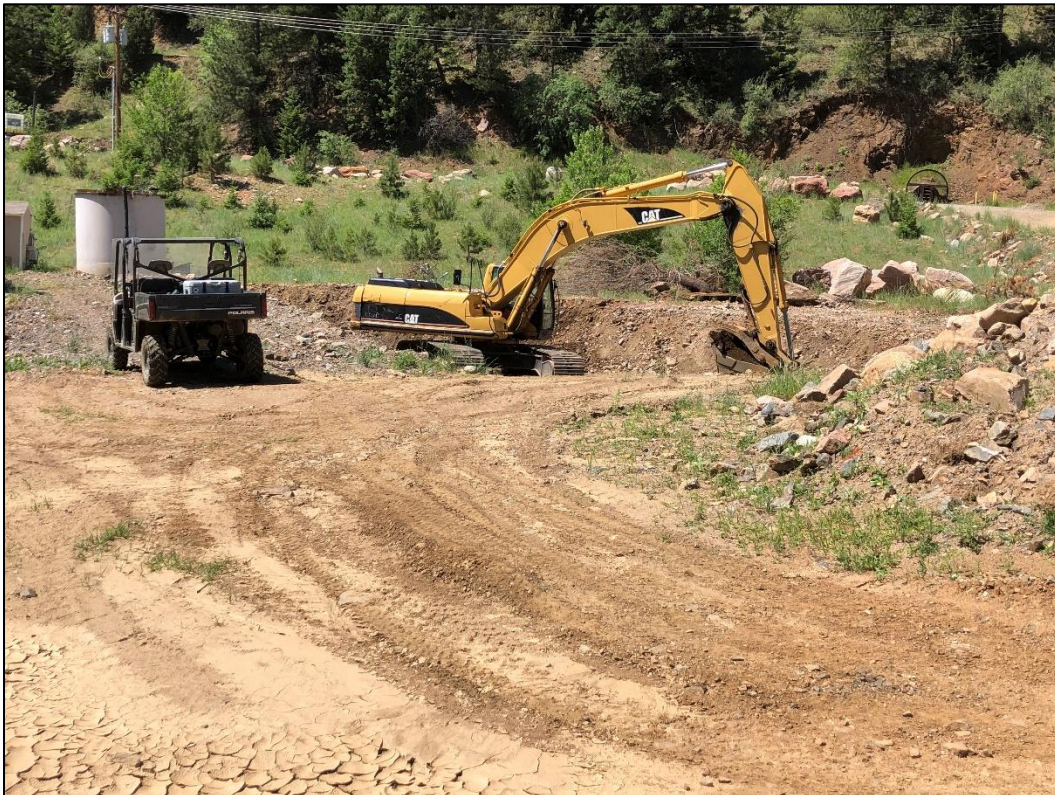
**Photo 14.** View looking south across southern portion of northern excavation area located near new water treatment plant area.

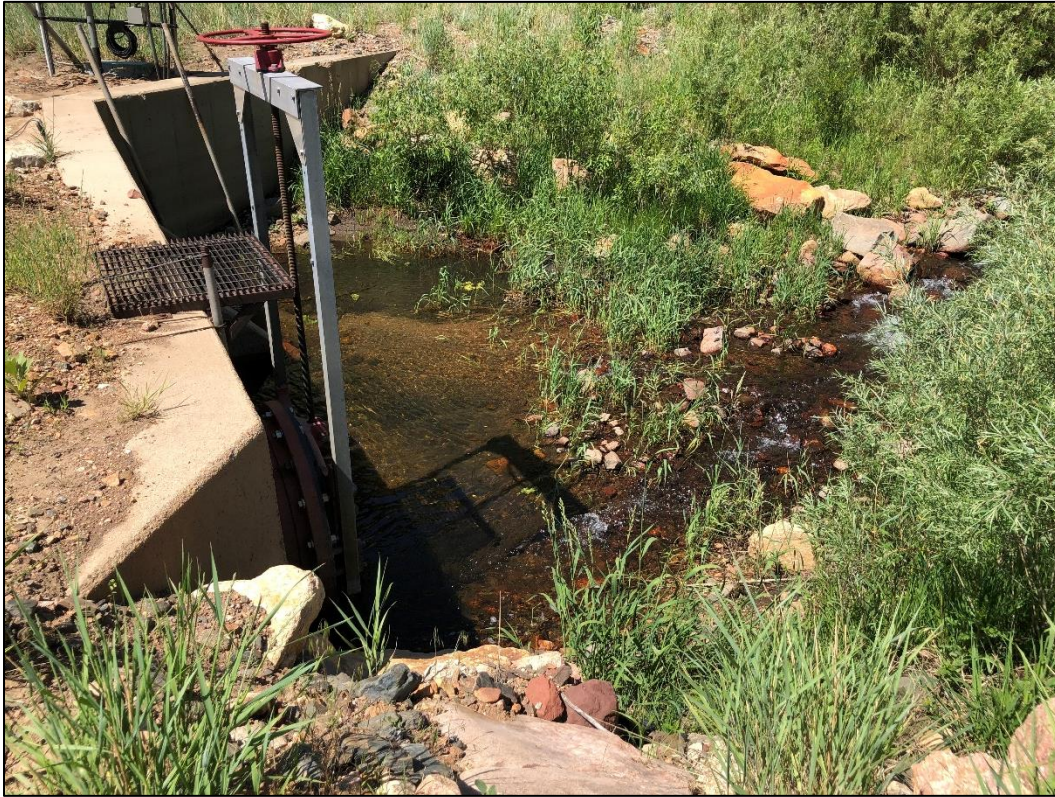
**Photo 15.** View looking at upgradient cutoff wall/headgate in Ralston Creek, showing creek flowing upstream of cutoff wall during inspection.

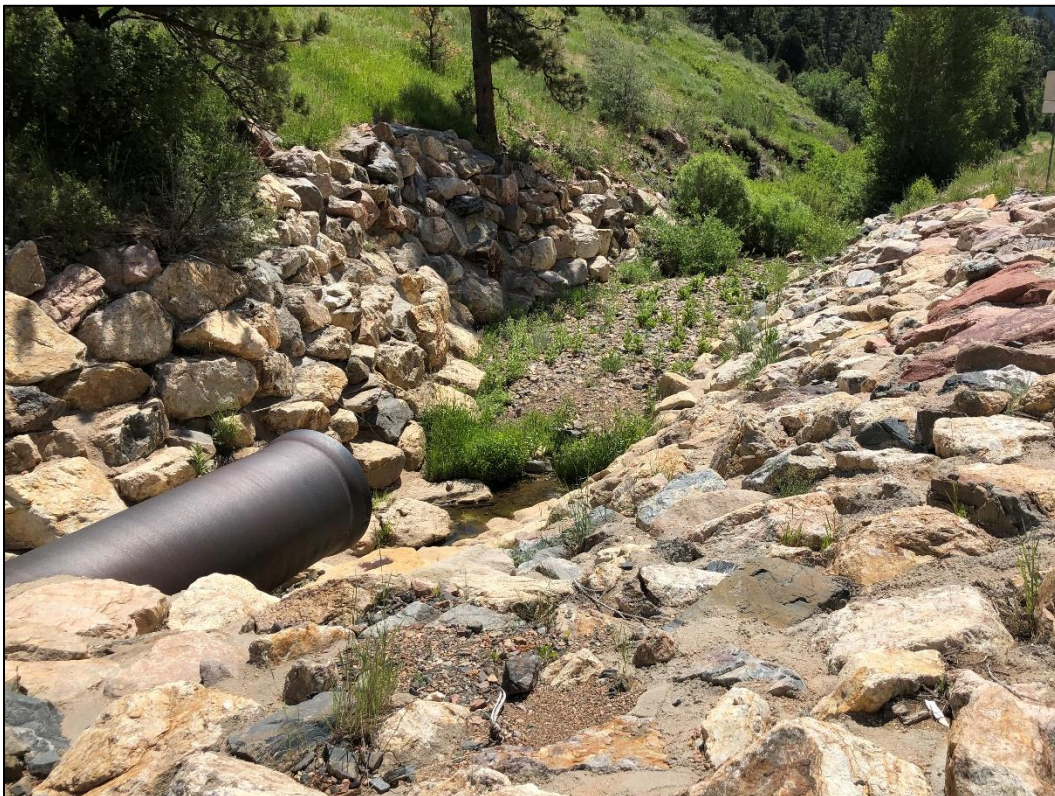
**Photo 16.** View looking downstream from upgradient cutoff wall in Ralston Creek, showing creek channel dry downstream of cutoff wall during inspection.

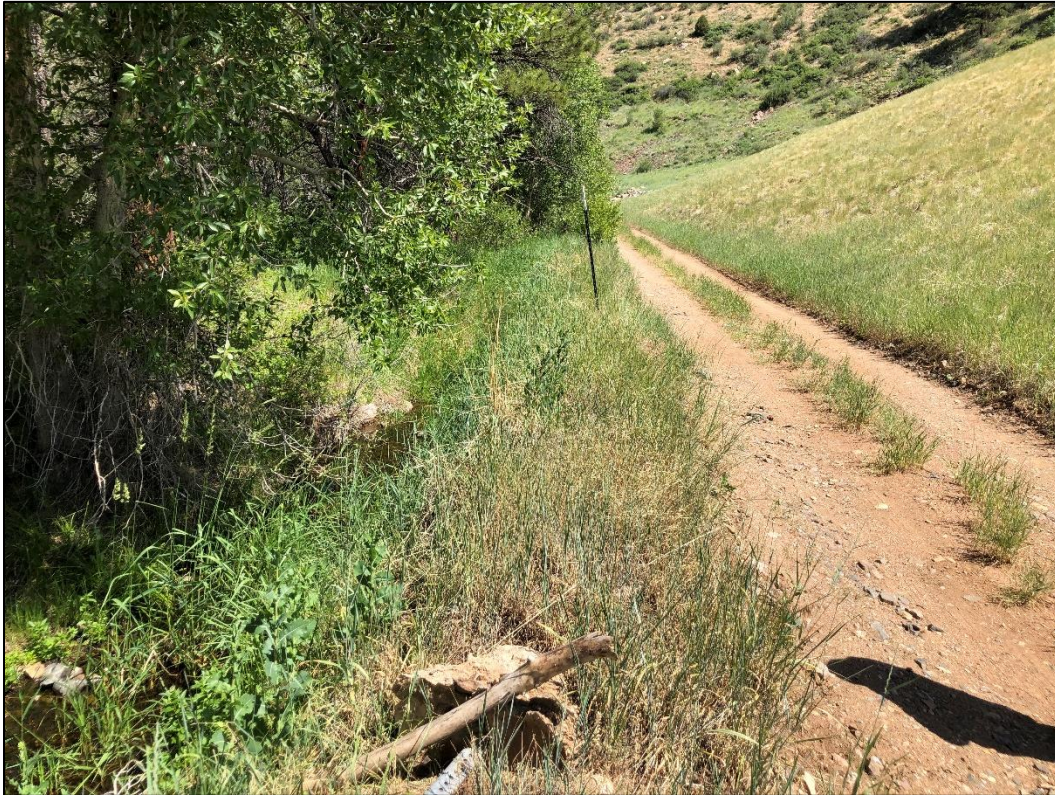
The Division inspected the upgradient cutoff wall and observed that all flows in Ralston Creek were being routed through the bypass pipeline. The Division also inspected the areas adjacent to Glencoe Valley Road (near the toe of the NWRP) located upstream from the cutoff wall, where red-and green-colored ponded water was observed during the Division's March 22, 2019 inspection. Based on the known stormwater management issues that exist at the NWRP and the water quality data the operator obtained from the ponded water, this water is believed to represent seep water from the NWRP. These "seep areas" were dry during the Division's November 7, 2019 inspection and were not inspected during the Division's February 26, 2020 inspection. During the current inspection, the Division observed red-colored water ponded in the wooded area adjacent to the creek and slightly green-colored water ponded in the roadside ditch near the toe of the NWRP. The Division is not aware of any additional water quality sampling of this ponded water that has occurred besides the samples that were collected in March of 2019. It is assumed the ponded water observed during the current inspection is similarly impacted. This matter was cited as a problem pursuant to Rule 3.1.6(1) in the Division's April 9, 2019 inspection report. On May 9, 2019, the operator submitted Technical Revision No. 28 (TR-28) to address this issue by installing a stormwater diversion structure along the edge of the NWRP to direct surface flows (particularly from the ephemeral drainage above) around the pile.

**Photo 17.** View looking north along Glencoe Valley Road at toe of NWRP, showing roadside ditch (at left) in which slightly green-colored water was ponded during inspection. This water is believed to be “seep water” from the NWRP.

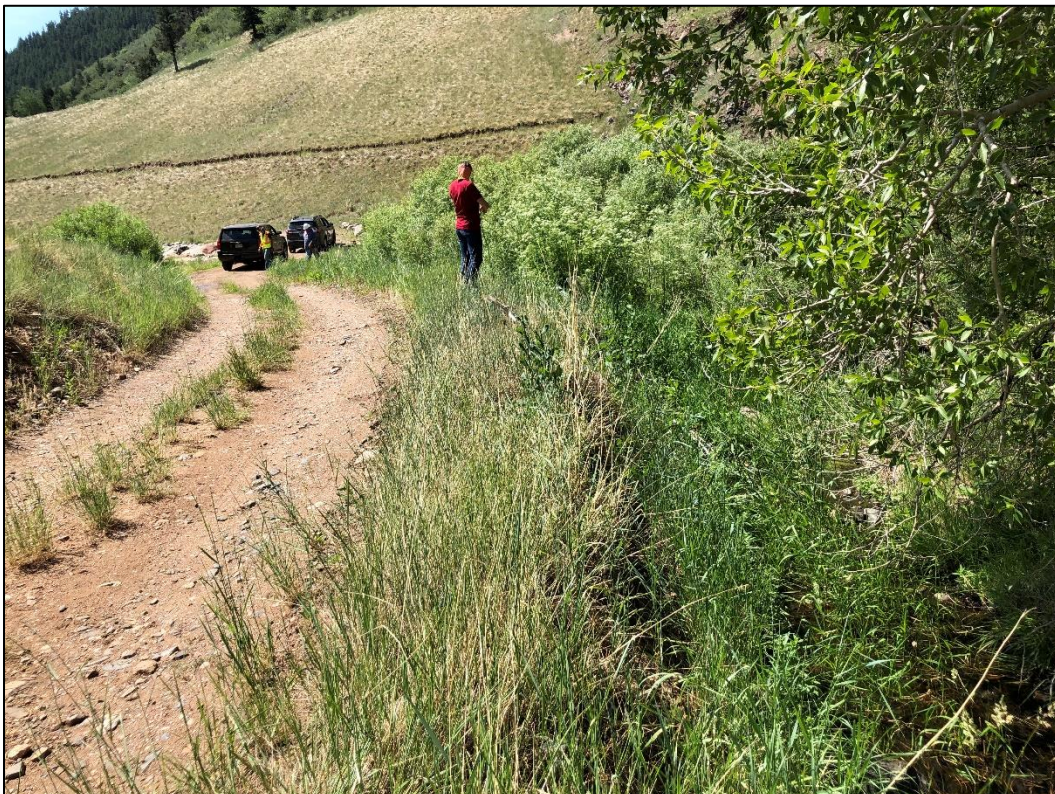
**Photo 18.** View looking south along Glencoe Valley Road at toe of NWRP, showing roadside ditch (at right) in which slightly green-colored water was ponded during inspection. This water is believed to be “seep water” from the NWRP.

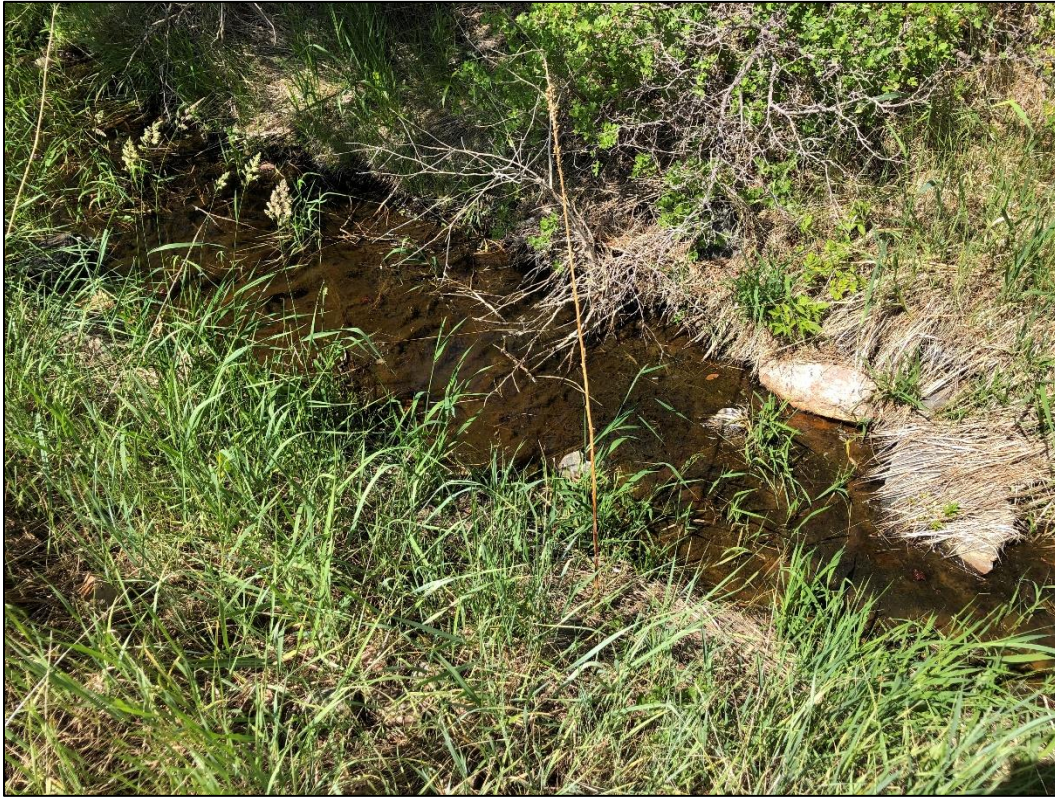
**Photo 19.** View of slightly green-colored water ponded in roadside ditch near toe of NWRP during inspection. This water is believed to be “seep water” from the NWRP.

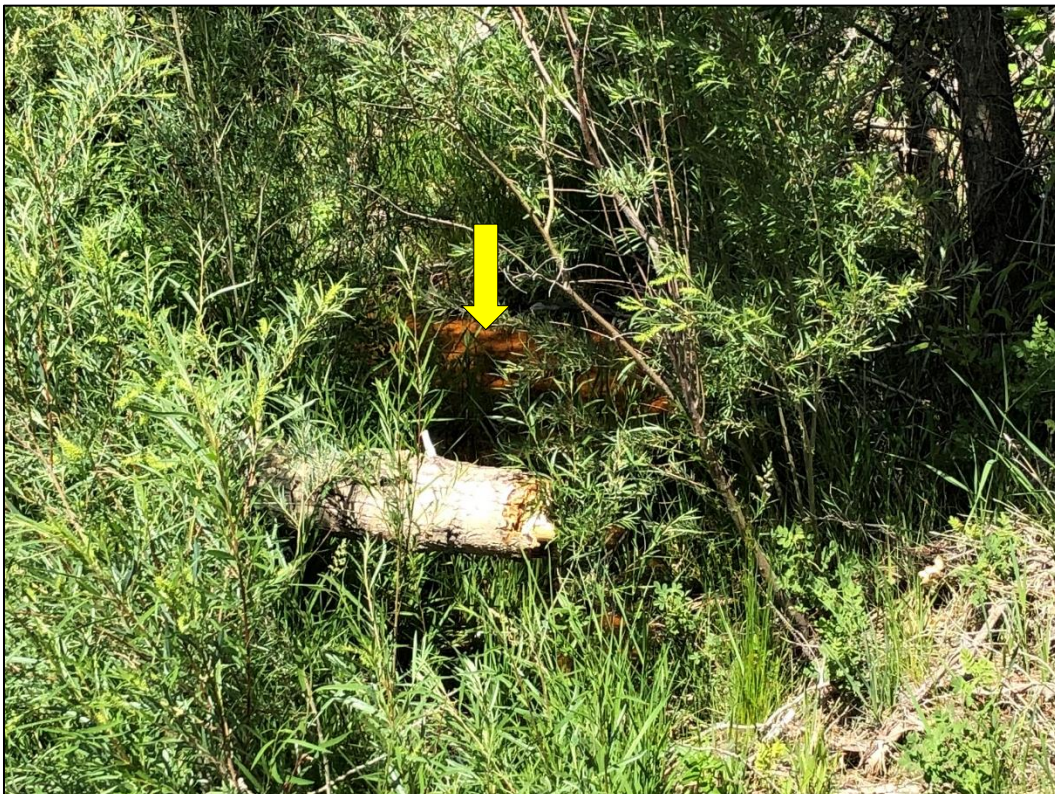
**Photo 20.** View of red-colored water ponded (indicated) in wooded area between Ralston Creek and road near toe of NWRP. This water is believed to be “seep water” from the NWRP.

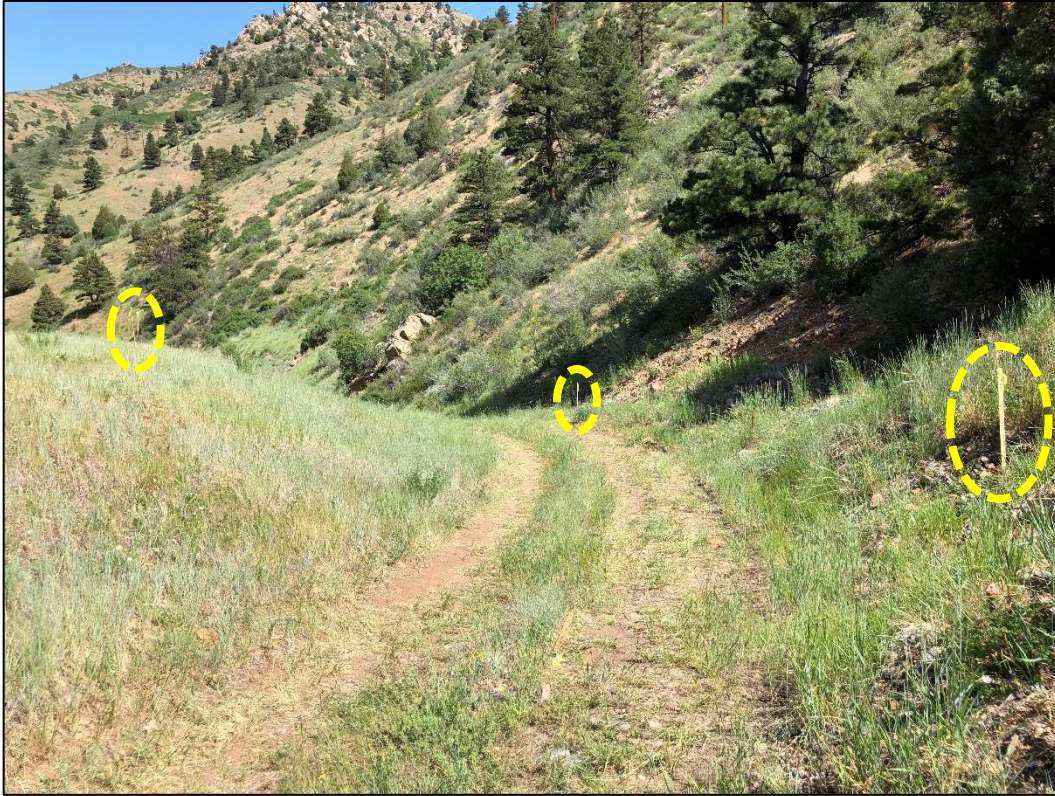
**Photo 21.** View looking northwest across northern edge of NWRP where alignment of stormwater diversion channel (approved in TR-28) has been staked out (stakes circled).

The stormwater diversion structure design approved in TR-28 (on March 27, 2020) includes installation of a concrete-filled geoweb channel along the northern edge of the NWRP to convey surface flows from the drainage around the pile to the creek below (above the cutoff wall). The intake structure of the channel will include a concrete seal wall designed to intercept potential groundwater by being embedded into the shallow bedrock. A perforated pipe will be buried parallel to the seal wall to collect any groundwater that reaches the wall and convey it downhill in a solid PVC pipe to discharge into the channel. The estimated schedule

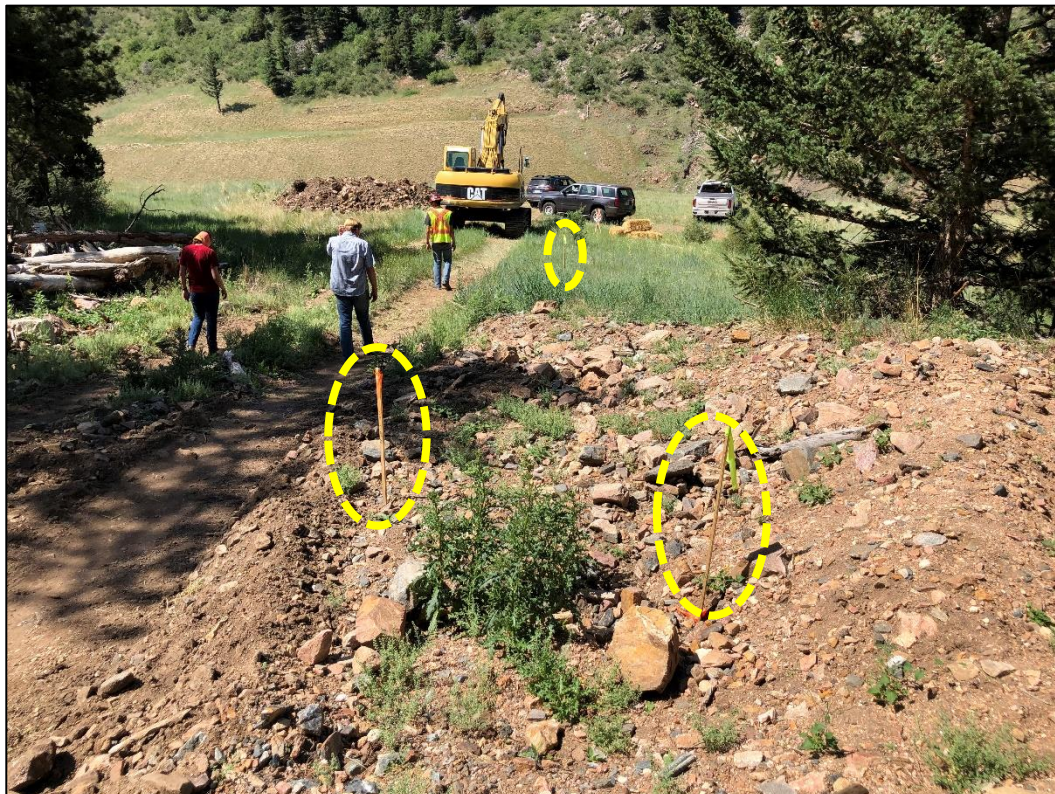
**Photo 22.** View looking southwest across northern edge of NWRP where alignment of stormwater diversion channel (approved in TR-28) has been staked out (stakes circled).

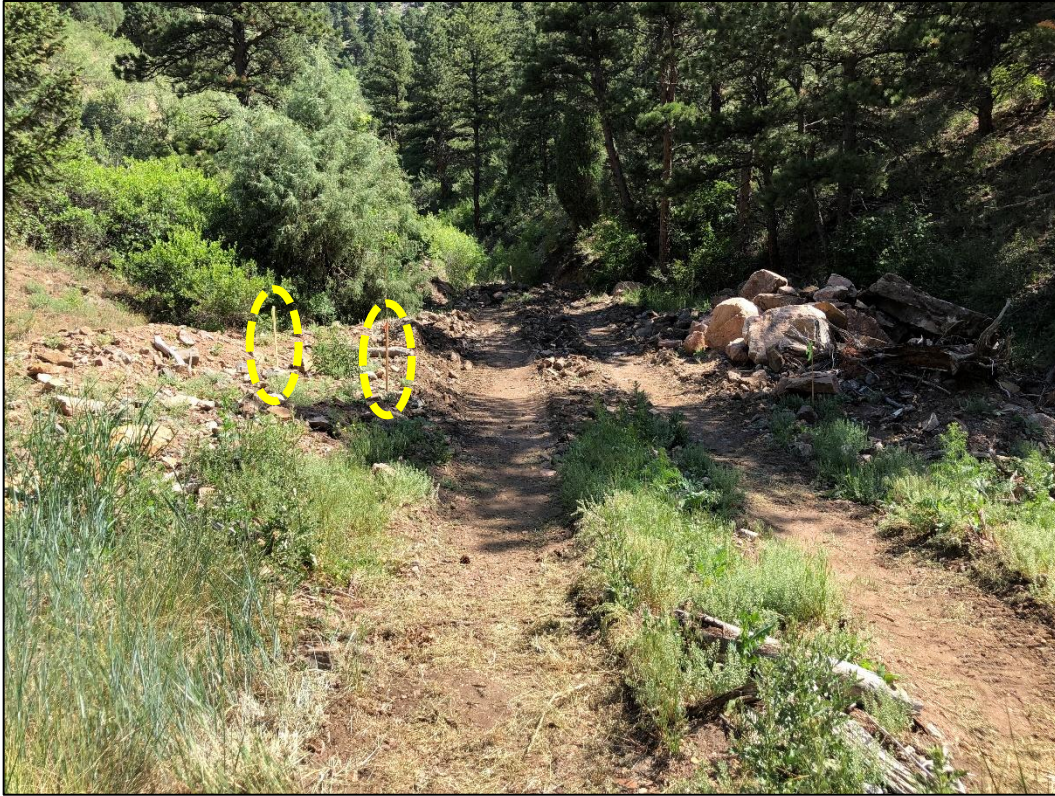
**Photo 23.** View looking northeast across top of NWRP toward ephemeral drainage above the pile (in background). Note alignment of stormwater diversion channel (approved in TR-28) has been staked out (stakes circled).

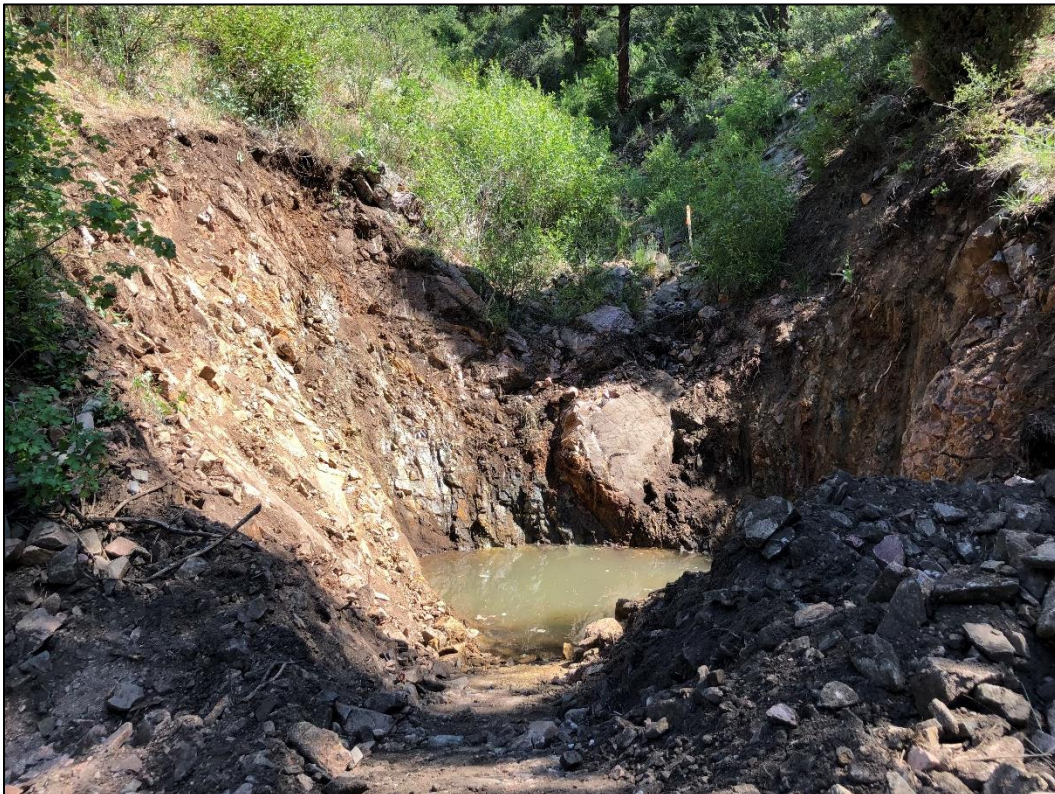
**Photo 24.** View looking northeast across excavated area at top of NWRP where concrete seal wall will be installed in accordance with TR-28.

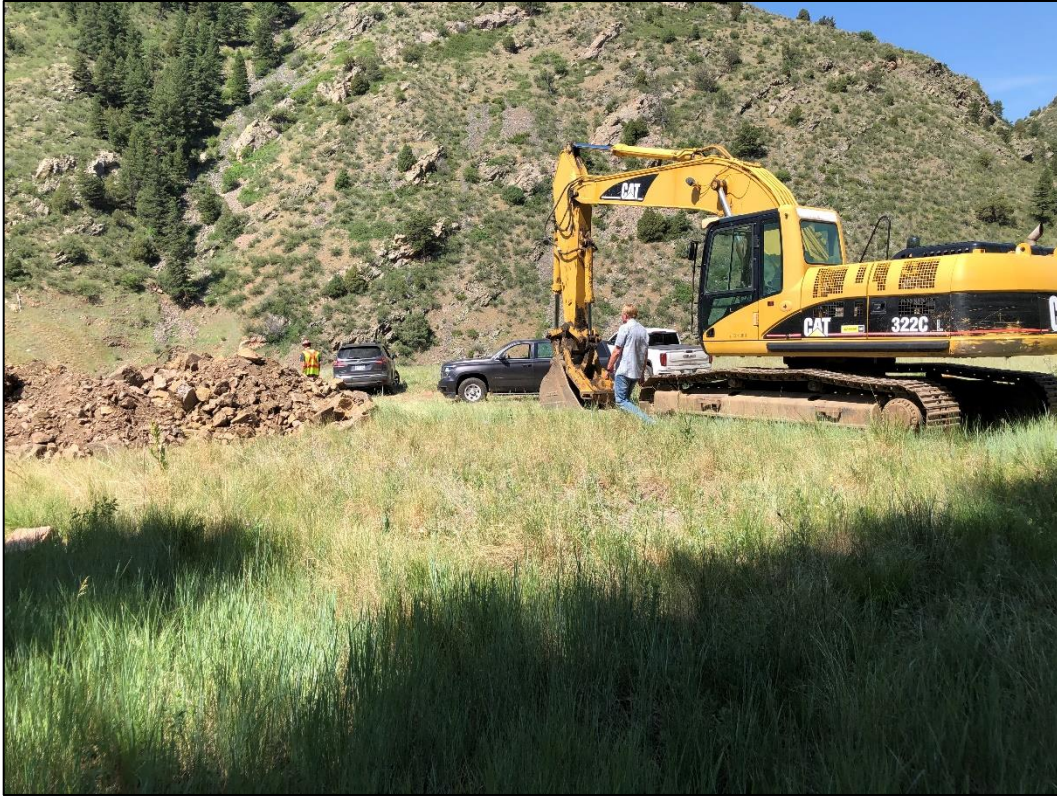
**Photo 25.** View looking southwest across top of NWRP showing excavator and stockpiled material excavated from drainage area temporarily stored on top of pile.
