**MINERALS PROGRAM INSPECTION REPORT**  
**PHONE: (303) 866-3567**

| <b>MINE NAME:</b><br>Schwartzwalder Mine | <b>MINE/PROSPECTING ID#:</b><br>M-1977-300 | <b>MINERAL:</b><br>Uranium | <b>COUNTY:</b><br>Jefferson |
| <b>INSPECTION TYPE:</b><br>Monitoring | <b>INSPECTOR(S):</b><br>Amy Eschberger, Michael Cunningham | <b>INSP. DATE:</b><br>June 26, 2020 | <b>INSP. TIME:</b><br>09:30 |

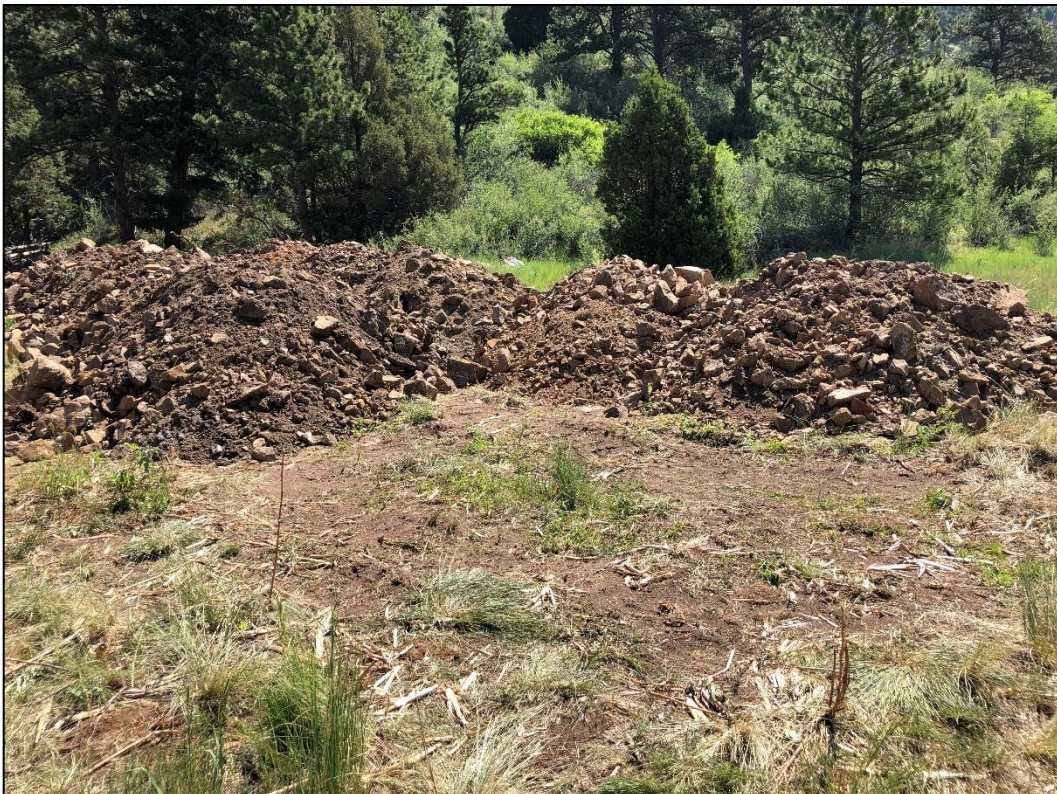
**Photo 26.** Closer view of stockpiled material excavated from drainage area temporarily stored on top of NWRP. Radiation testing will be performed on this material to determine whether it will require disposal in the Minnesota Mine.

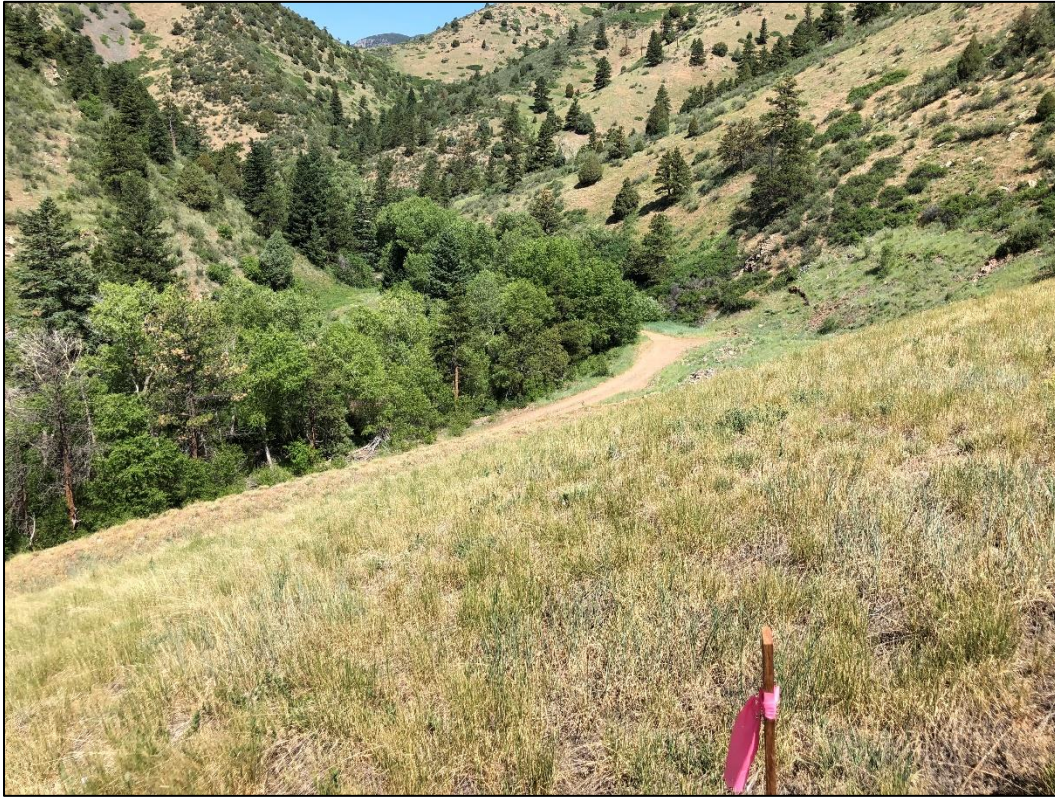
**Photo 27.** View looking northwest from top edge of NWRP showing Glencoe Valley Road (near center) and Ralston Creek (in wooded area near road).

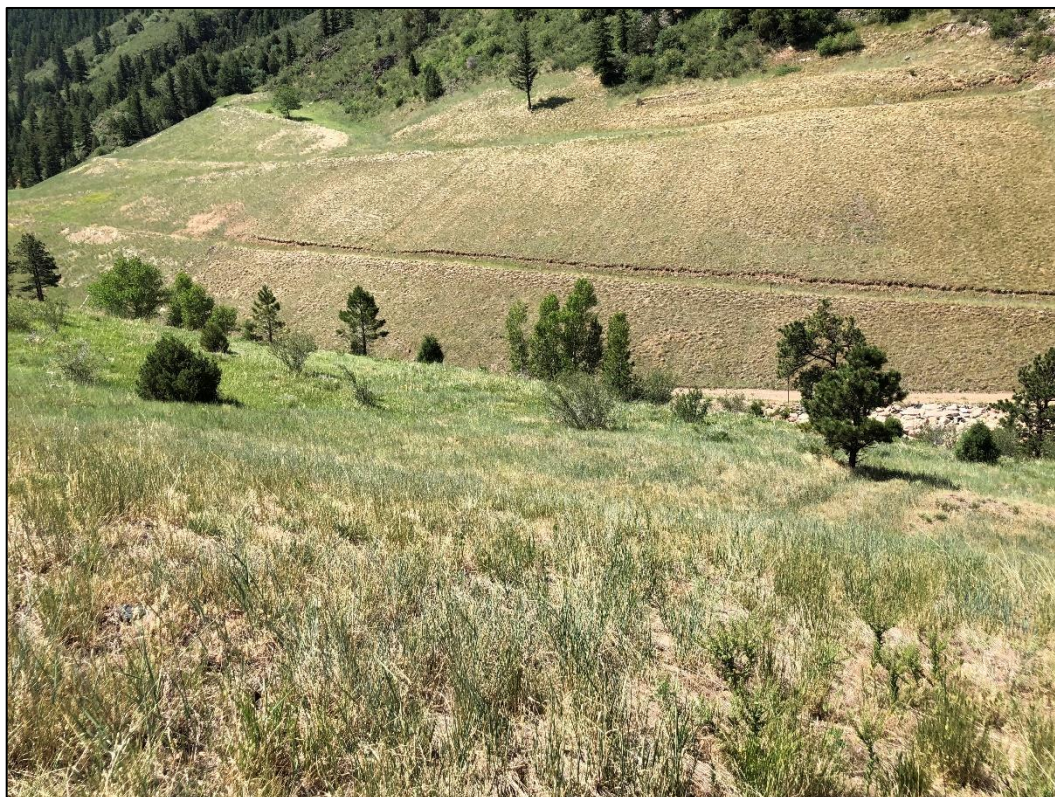
**Photo 28.** View looking south from top edge of NWRP showing SWRP located on other side (south) of creek, stable with good grass cover.

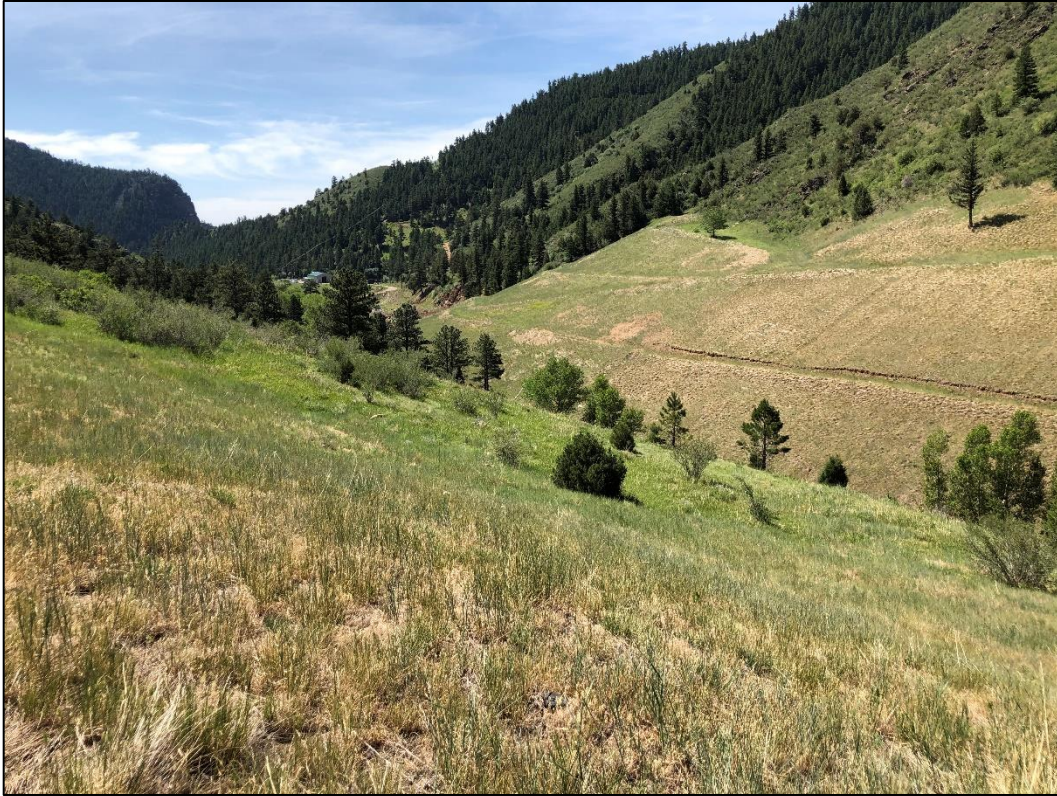
**Photo 29.** View looking southeast from top edge of NWRP toward mine site (in far background). Note portion of SWRP shown at right, stable with good grass cover.

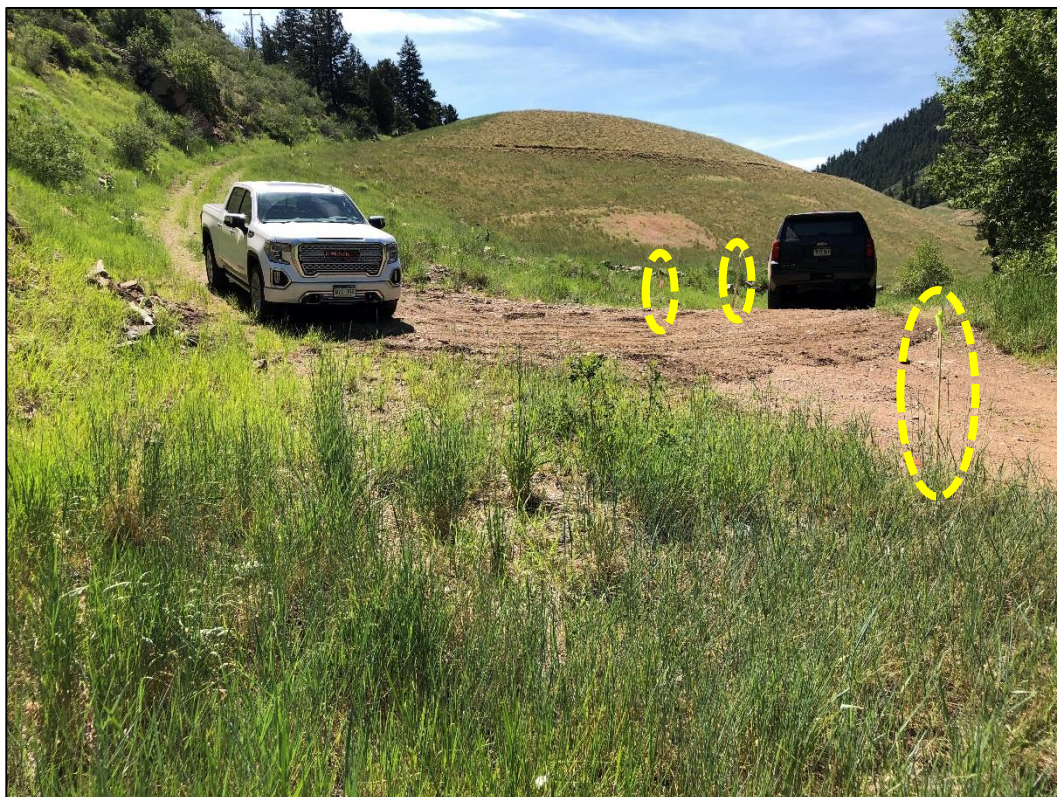
**Photo 30.** View looking east across area located north of NWRP where stormwater diversion channel dissipation basin (approved in TR-28) will be installed. Stakes (circled) mark alignment of this structure.

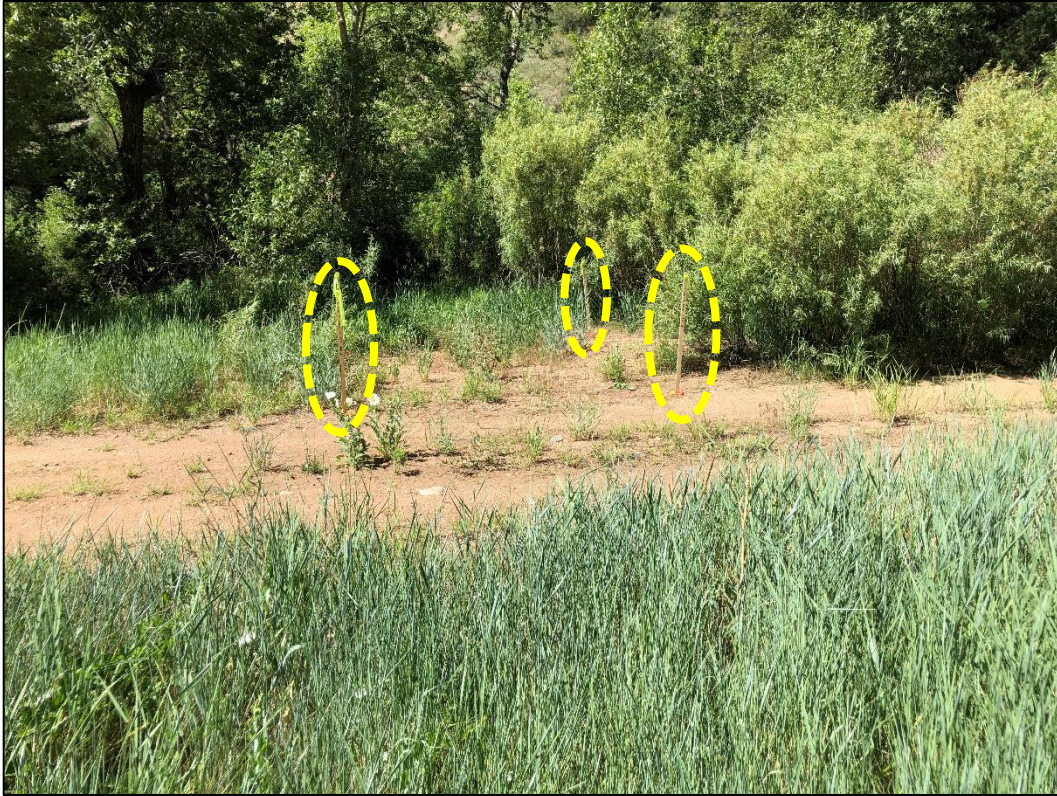
**Photo 31.** View looking west across Glencoe Valley Road from north of NWRP showing area where stormwater diversion channel dissipation basin roadway crossing (approved in TR-28) will be installed. Stakes (circled) mark alignment of this structure.

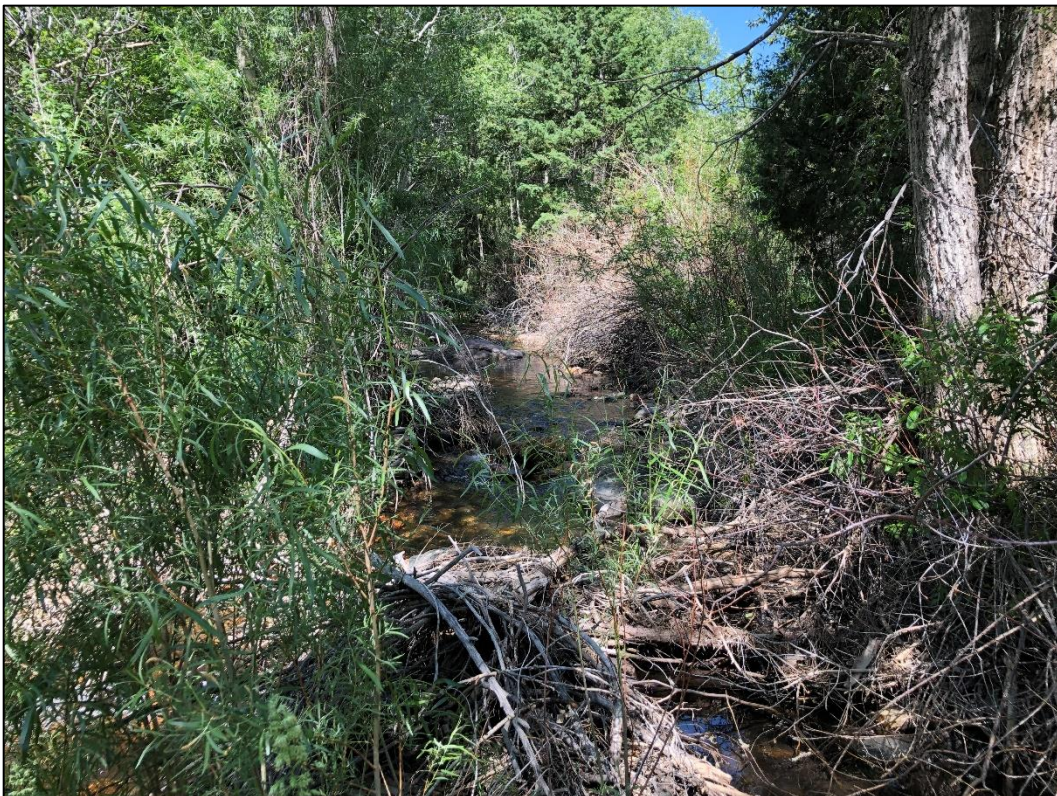
**Photo 32.** View looking upstream in Ralston Creek at surface water monitoring location SW-AWD located upstream of all mine disturbance (including waste rock piles).

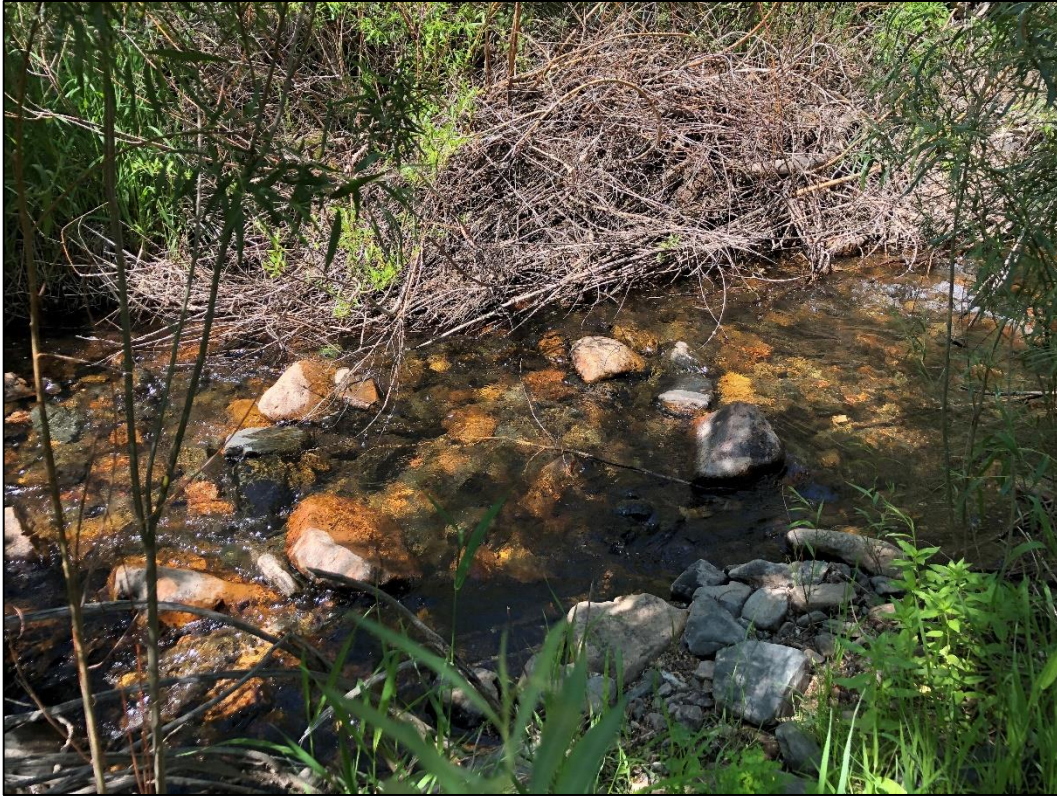
**Photo 33.** Closer view of Ralston Creek at surface water monitoring location SW-AWD, located upstream from all mine disturbance (including waste rock piles).

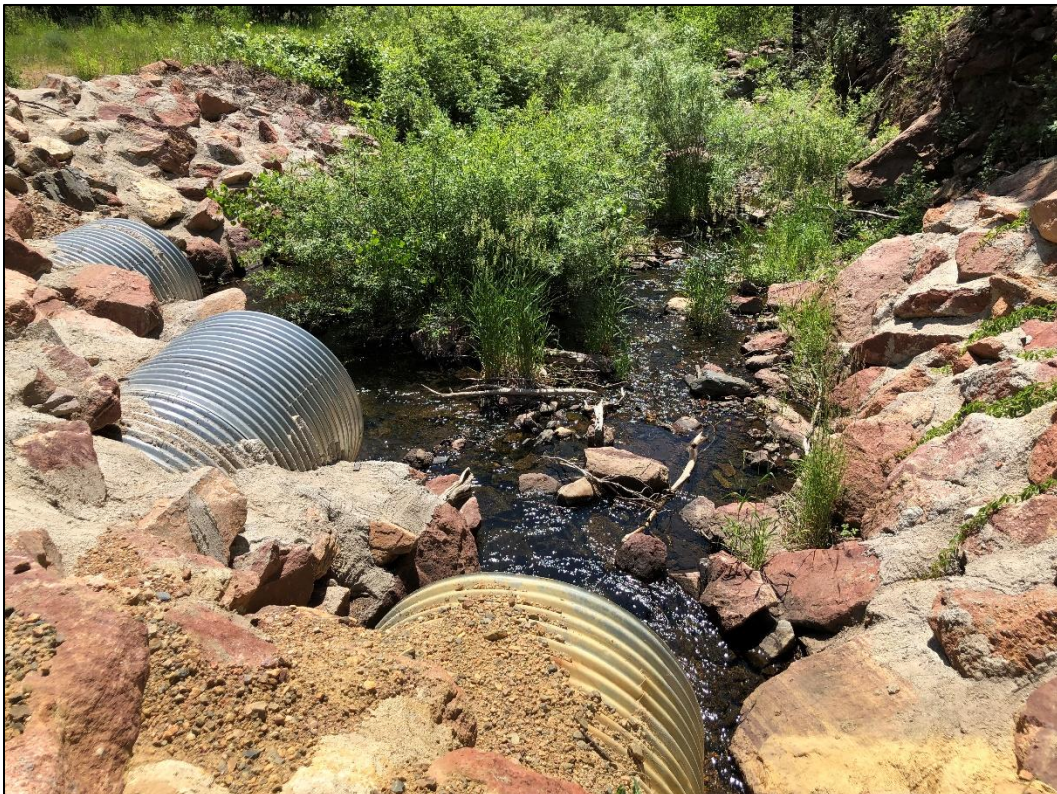
**Photo 34.** View looking downstream on Ralston Creek at surface water monitoring location SW-FBRG located downstream of mine site (outside permit area), below SW-BPL.

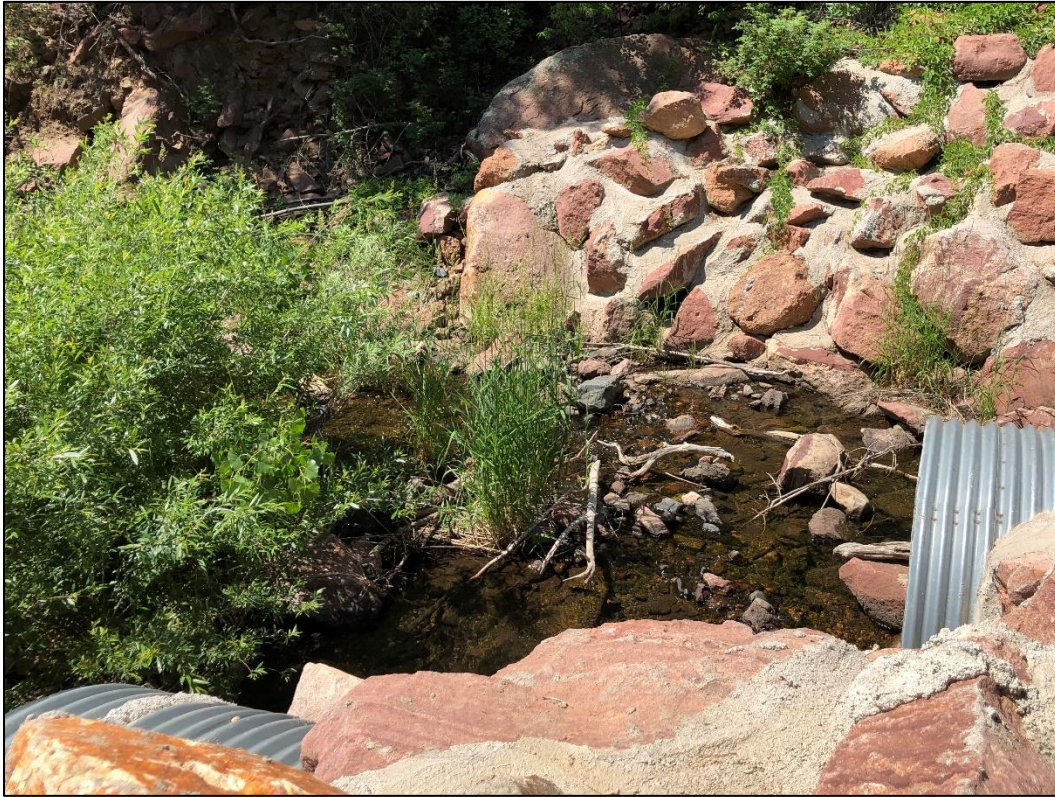
**Photo 35.** Closer view of Ralston Creek at surface water monitoring location SW-FBRG located downstream of mine site (outside permit area), below SW-BPL.

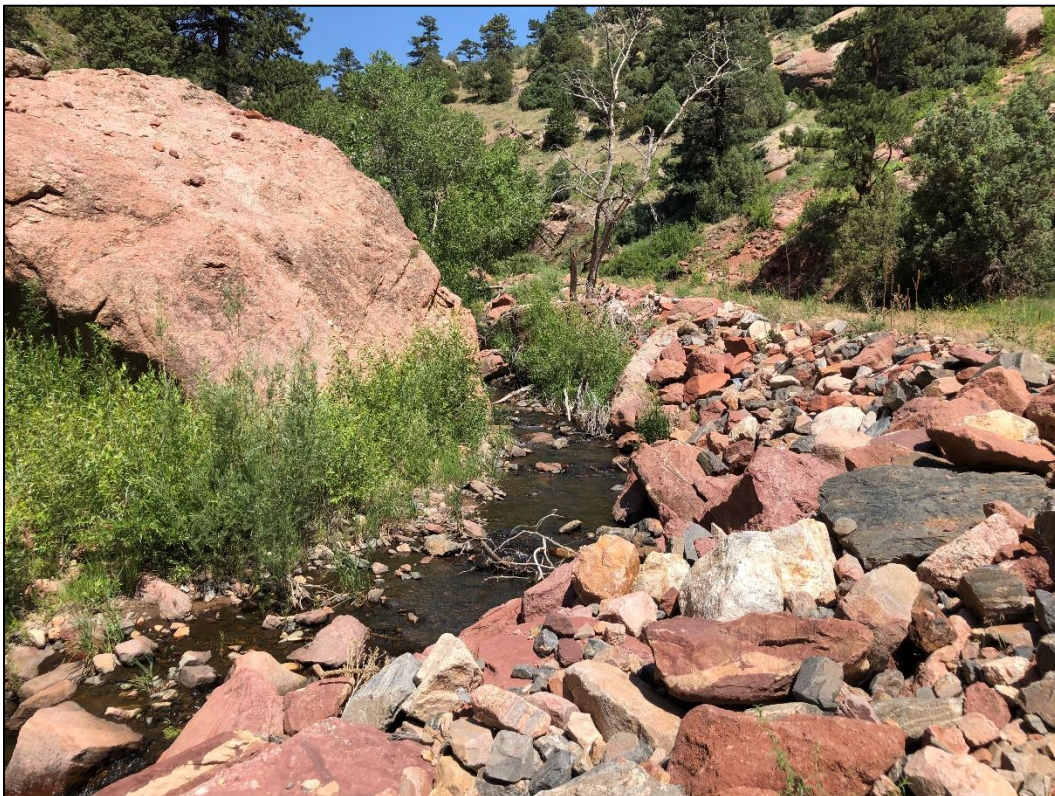
**Photo 36.** View looking upstream on Ralston Creek at surface water monitoring location SW-ARH located downstream of mine site (outside permit area), below SW-FBRG.

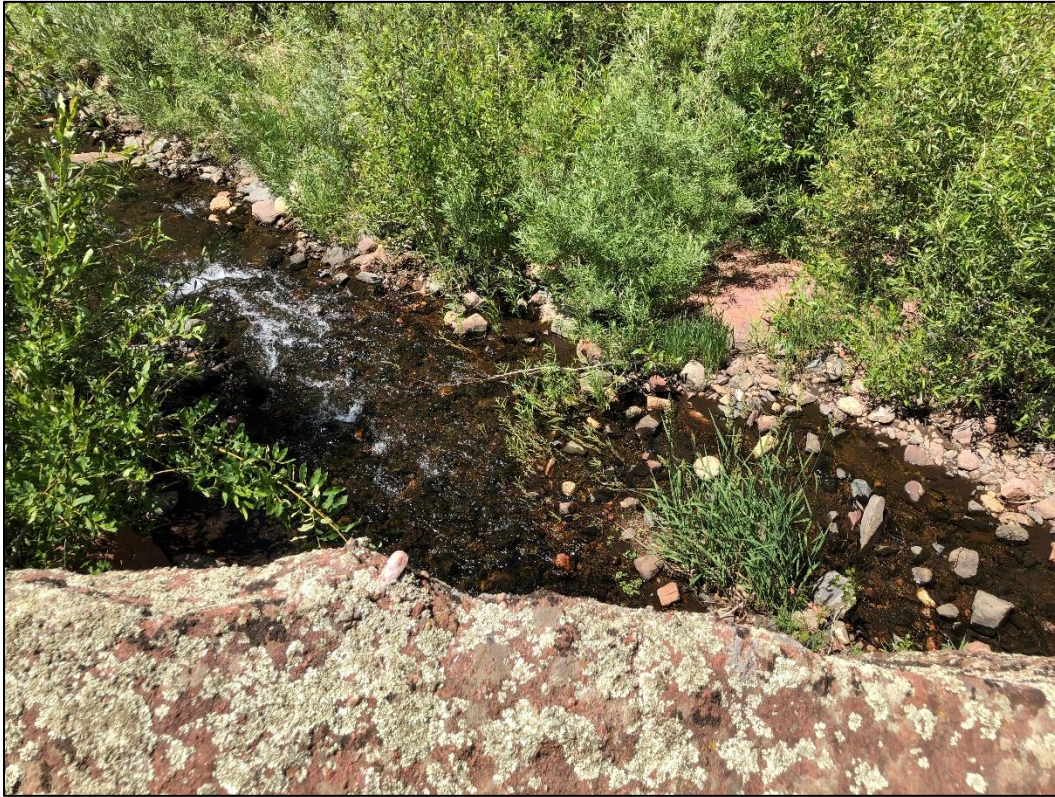
**Photo 37.** Closer view of Ralston Creek at surface water monitoring location SW-ARH located downstream of mine site (outside permit area), below SW-FBRG.

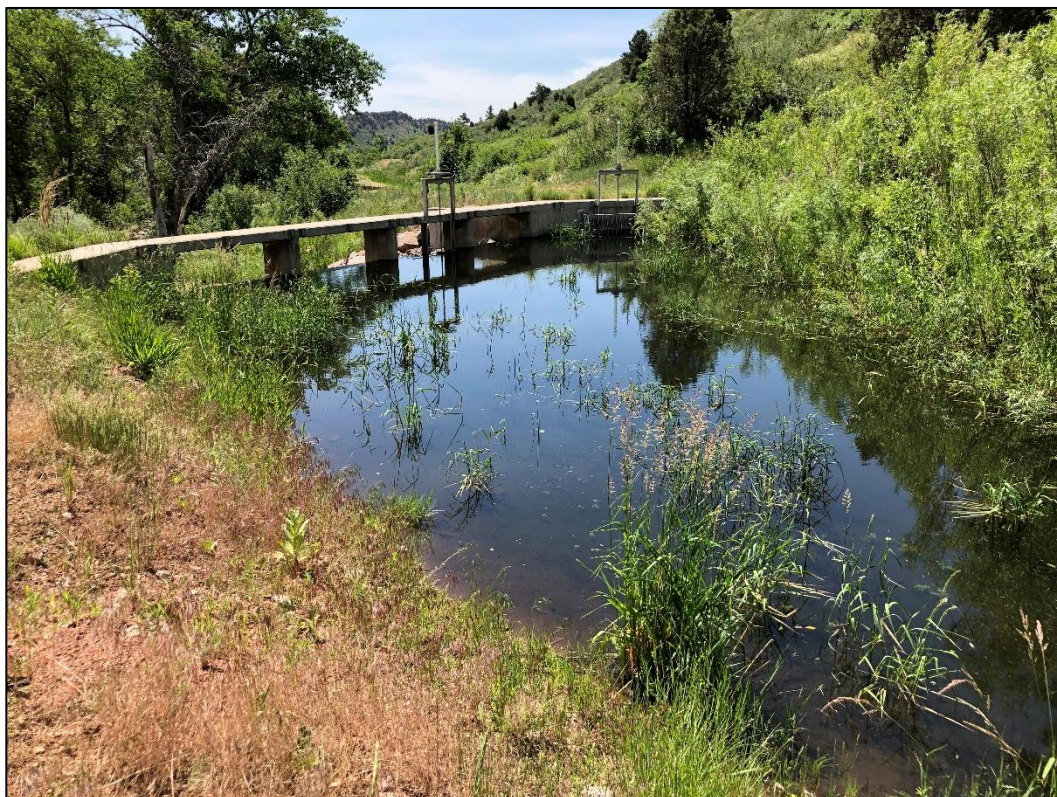
**Photo 38.** View looking downstream on Ralston Creek at surface water monitoring location SW-LLHG located downstream of mine site (outside permit area) at Long Lake Headgate, below SW-ARH.

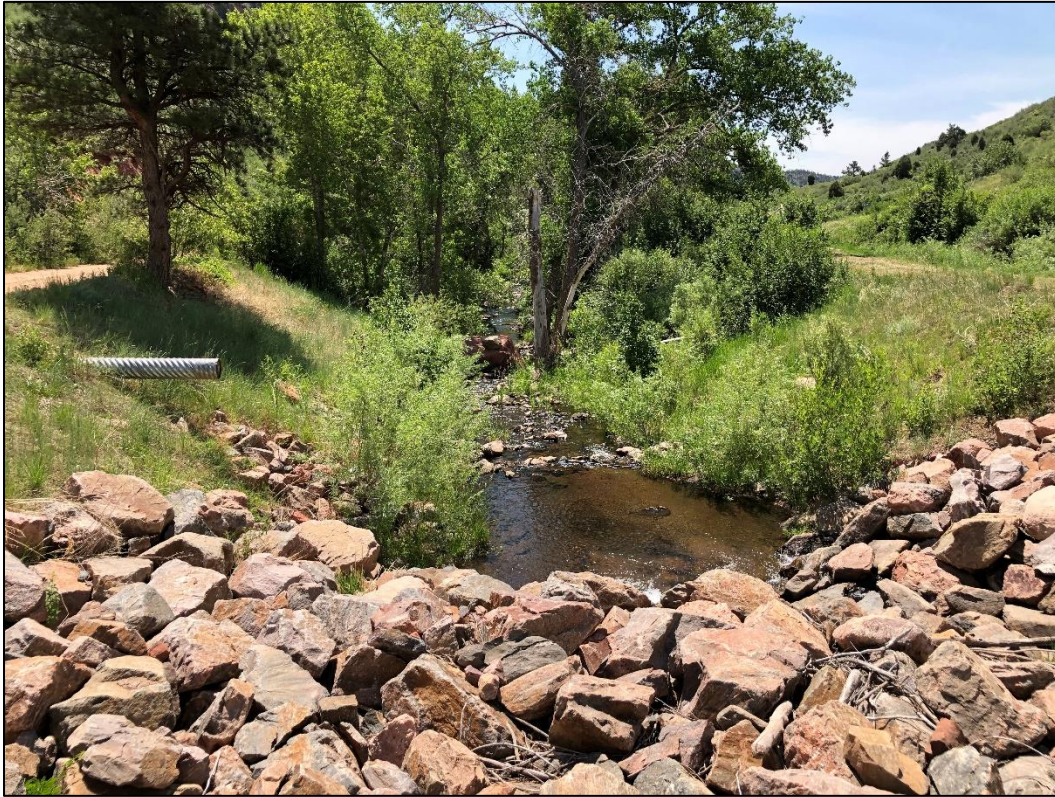
**Photo 39.** View looking downstream from surface water monitoring location SW-LLHG located downstream of mine site (outside permit area), below SW-ARH.
