MINERALS PROGRAM INSPECTION REPORT
PHONE: (303) 866-3567

MINE NAME: Three Bells Pit	MINE/PROSPECTING ID#: M-1979-191	MINERAL: Sand and gravel	COUNTY: Larimer
INSPECTION TYPE: Surety Release Inspection	INSPECTOR(S): Amy Eschberger	INSP. DATE: July 16, 2020	INSP. TIME: 10:00
OPERATOR: Martin Marietta Materials, Inc.	OPERATOR REPRESENTATIVE: Julie Mikulas	TYPE OF OPERATION: 112c - Construction Regular Operation	
REASON FOR INSPECTION: Surety Release Requested	BOND CALCULATION TYPE: Complete Bond	BOND AMOUNT: \$3,294,000.00	
DATE OF COMPLAINT: NA	POST INSP. CONTACTS: None	JOINT INSP. AGENCY: None	
WEATHER: Clear	INSPECTOR'S SIGNATURE:

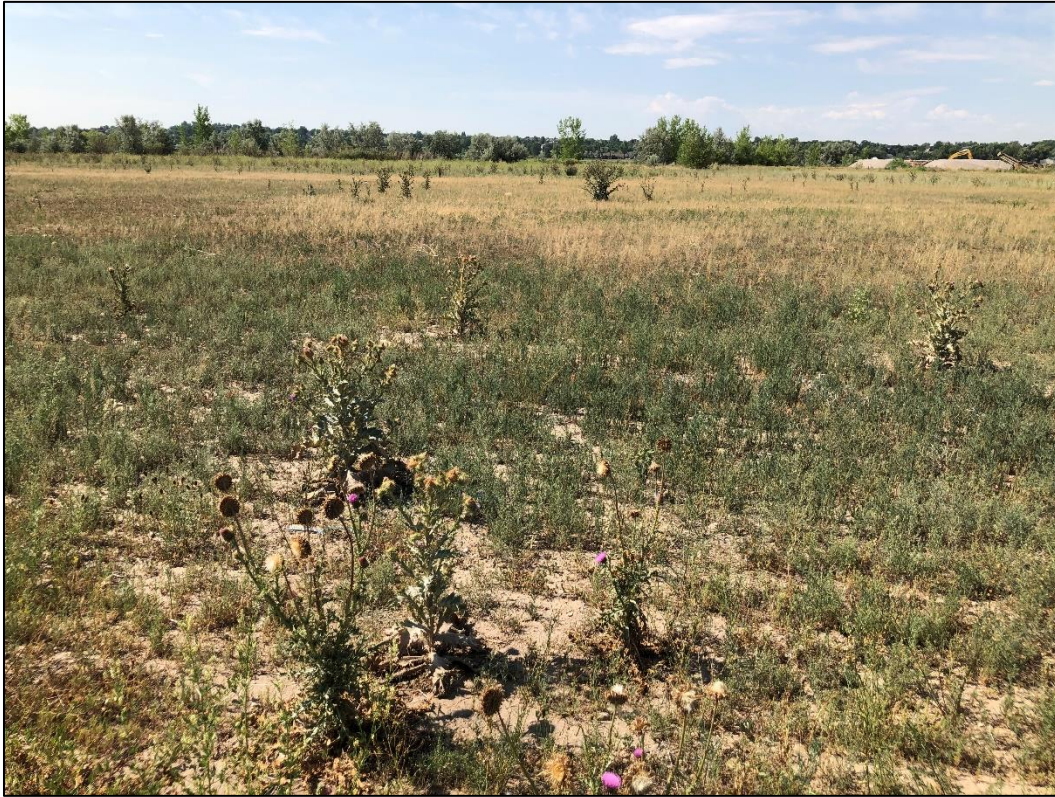
Photo 3. View looking southwest across DiTullio phase 4 backfill area, showing vegetative cover consisting of grasses and weeds. Note Canada thistle present in this area (a few of these plants visible in foreground). Additional weed management and interseeding is required in this area.

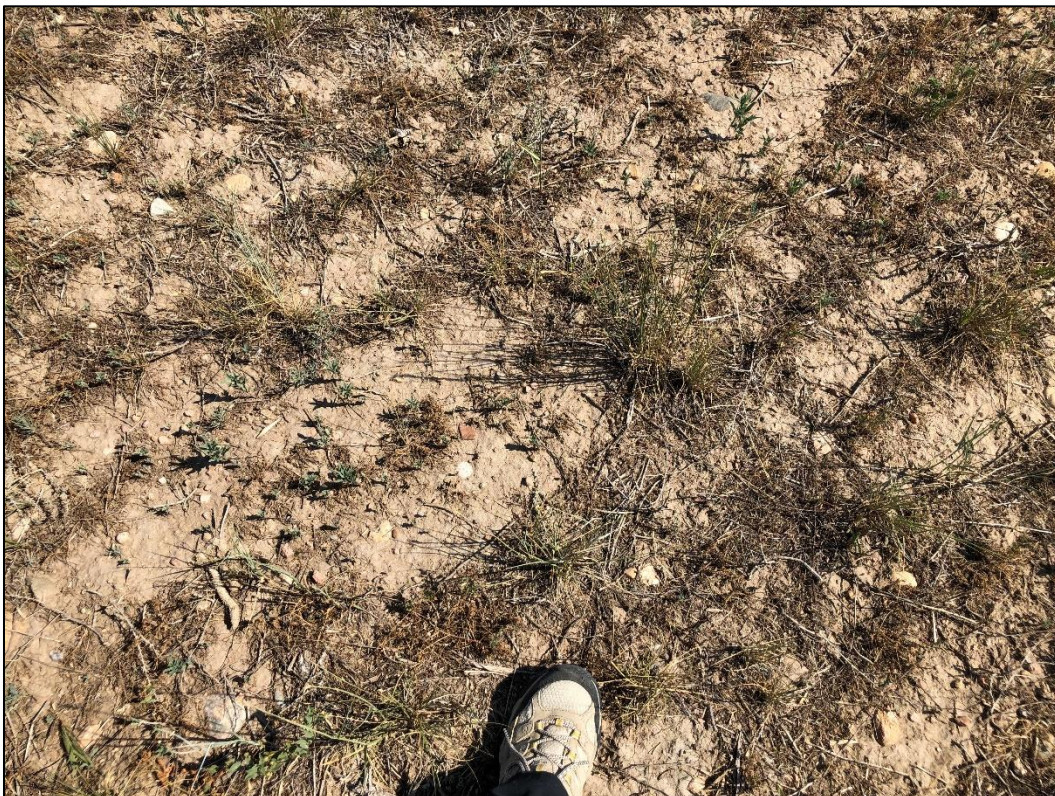
Photo 4. Closer view of vegetative cover present in DiTullio phase 4 backfill area. Additional weed management and interseeding is required in this area.

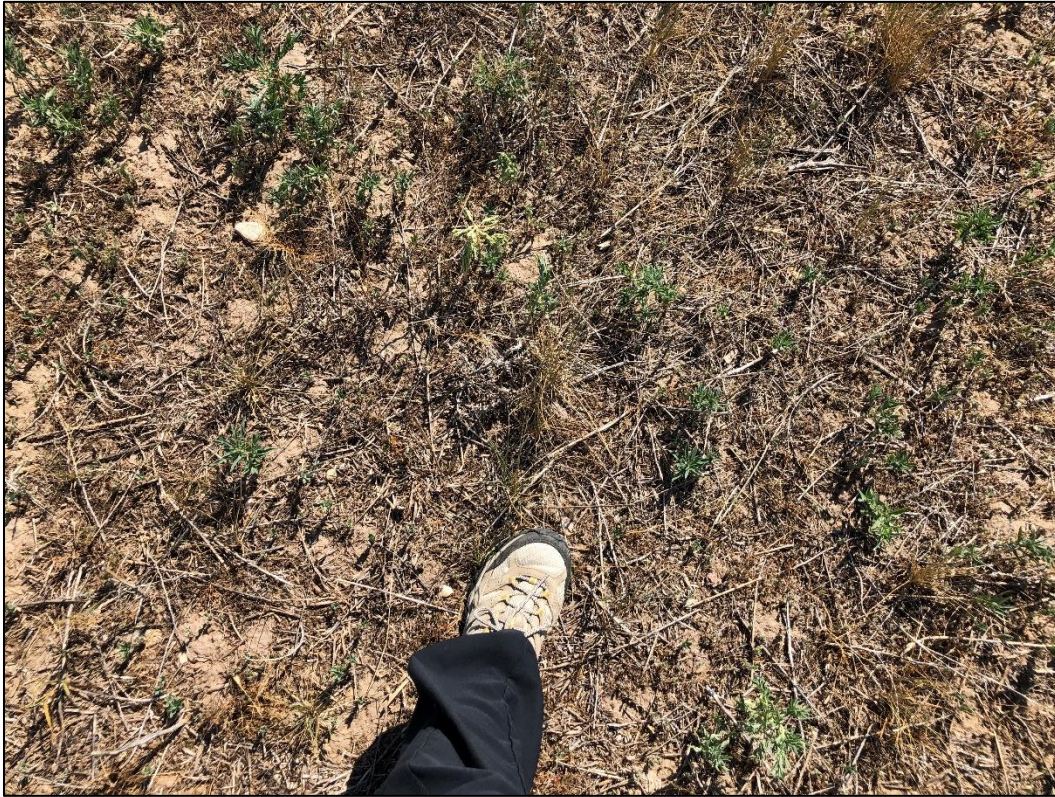
Photo 5. Closer view of vegetative cover present in DiTullio phase 4 backfill area. Additional weed management and interseeding is required in this area.

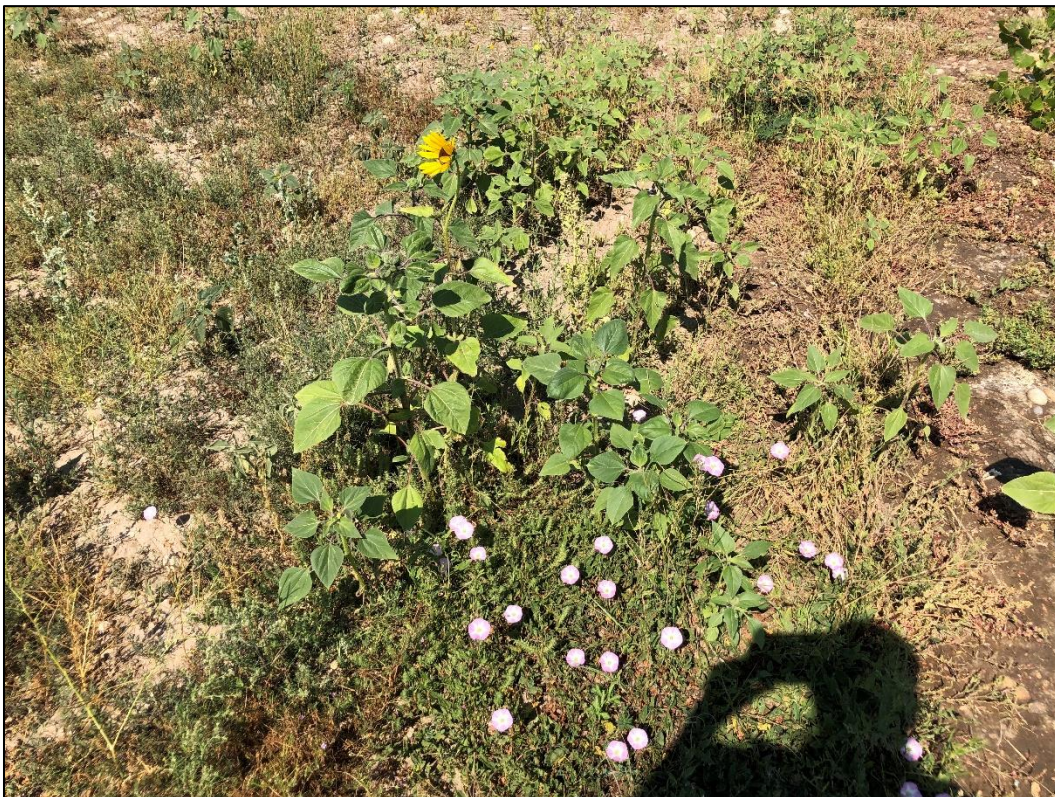
Photo 6. Closer view of vegetative cover present in DiTullio phase 4 backfill area, showing wild sunflowers and field bindweed. Additional weed management and interseeding is required in this area.

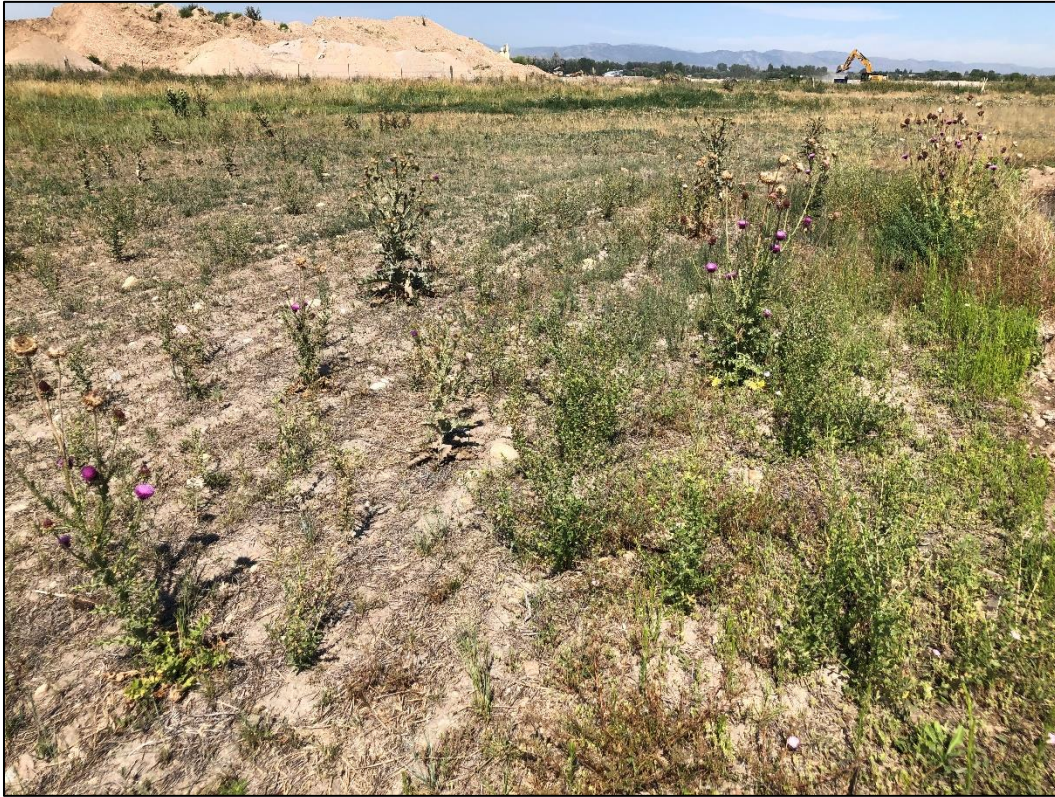
Photo 7. View looking west across DiTullio phase 4 backfill area, showing fairly sparse vegetative cover consisting primarily of weeds. Note Canada thistle present in this area. Additional weed management and interseeding is required in this area.

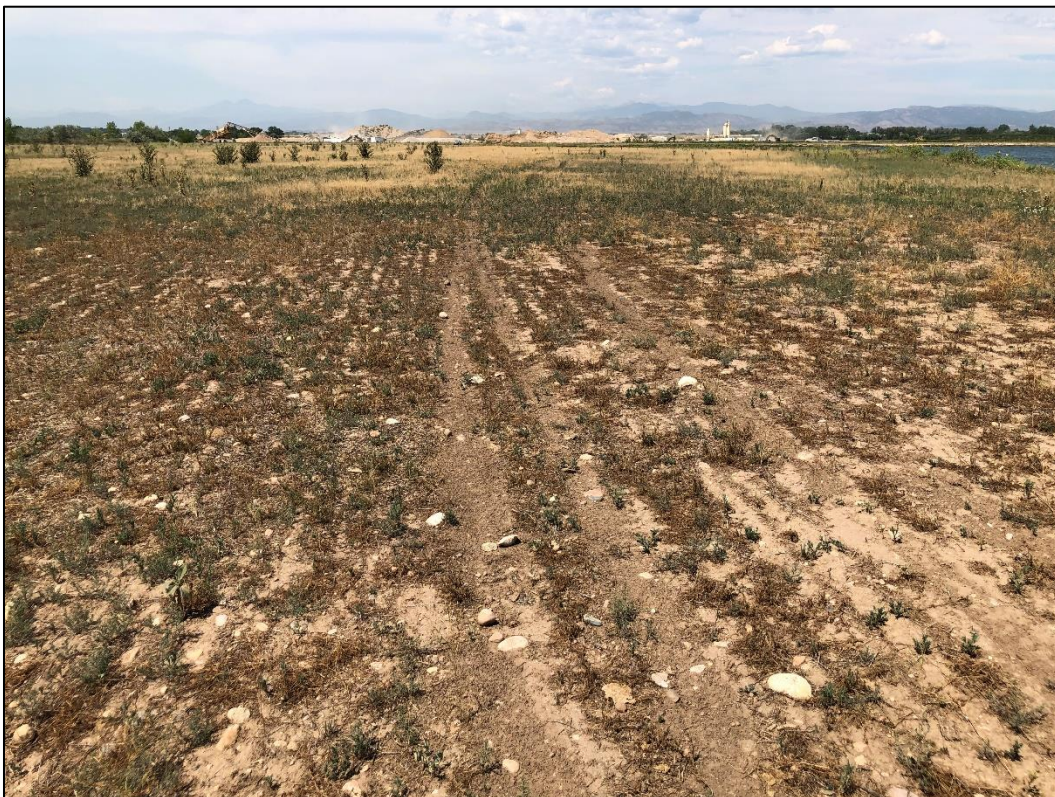
Photo 8. View looking west across DiTullio phase 4 backfill area, showing fairly sparse vegetative cover consisting primarily of weeds. Additional weed management and interseeding is required in this area.

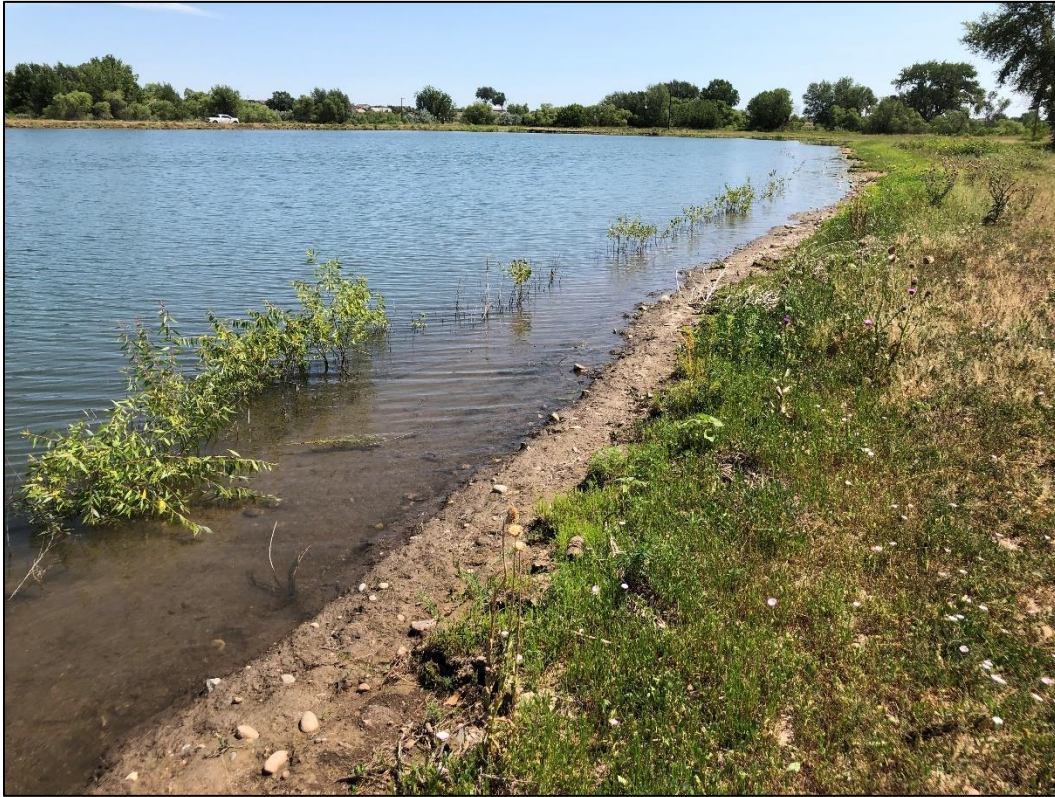
Photo 9. View looking east across southern shoreline of DiTullio phase 4 reservoir, showing slopes at a stable configuration. Note volunteer trees growing along shoreline which must be removed. Additional weed management is required, particularly for field bindweed and Canada thistle.

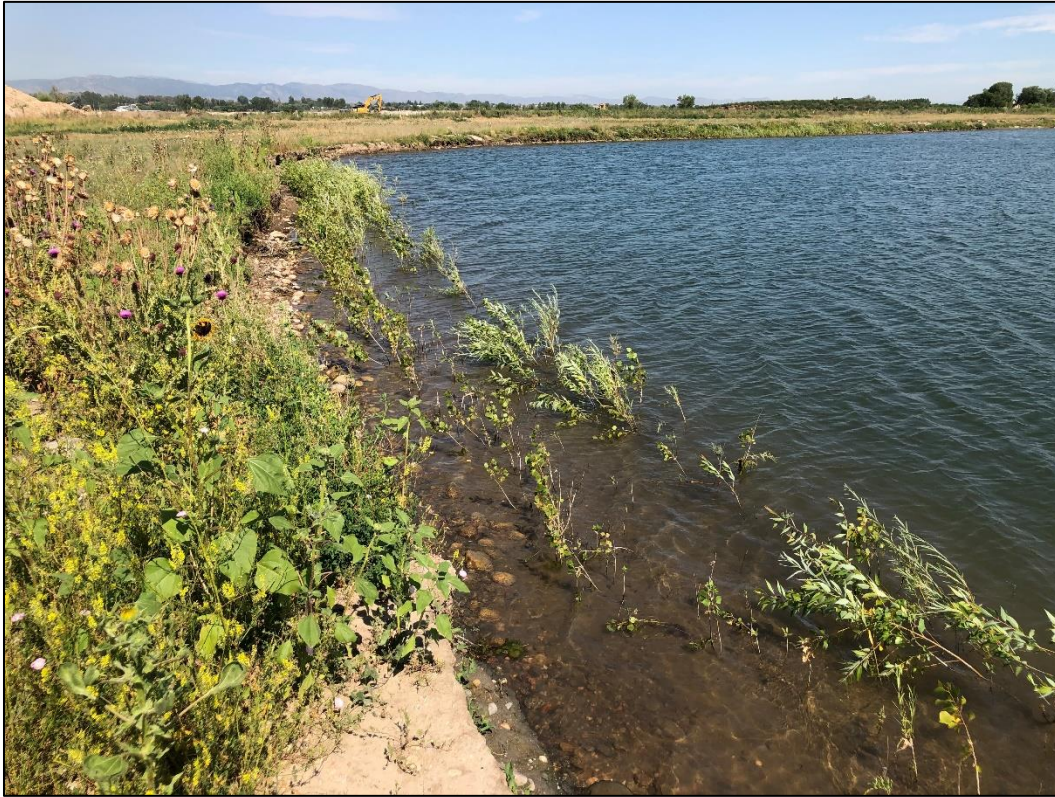
Photo 11. View looking west across southern shoreline of DiTullio phase 4 reservoir, showing slopes at a stable configuration. Note volunteer trees growing along shoreline which must be removed. Additional weed management is required, particularly for field bindweed and Canada thistle.

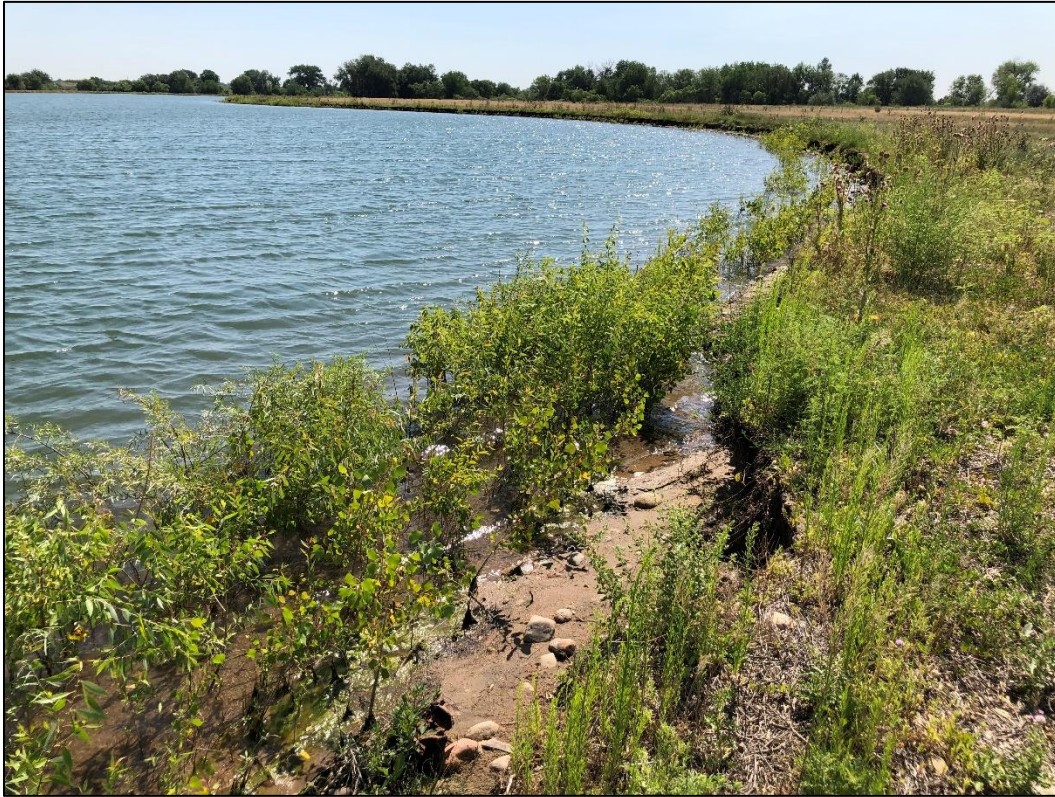
Photo 13. View looking east across southeastern shoreline of DiTullio phase 4 reservoir, showing slopes at a stable configuration with a natural terrace created along the shoreline. Note volunteer trees growing along shoreline which must be removed. Additional weed management is required, particularly for field bindweed and Canada thistle.

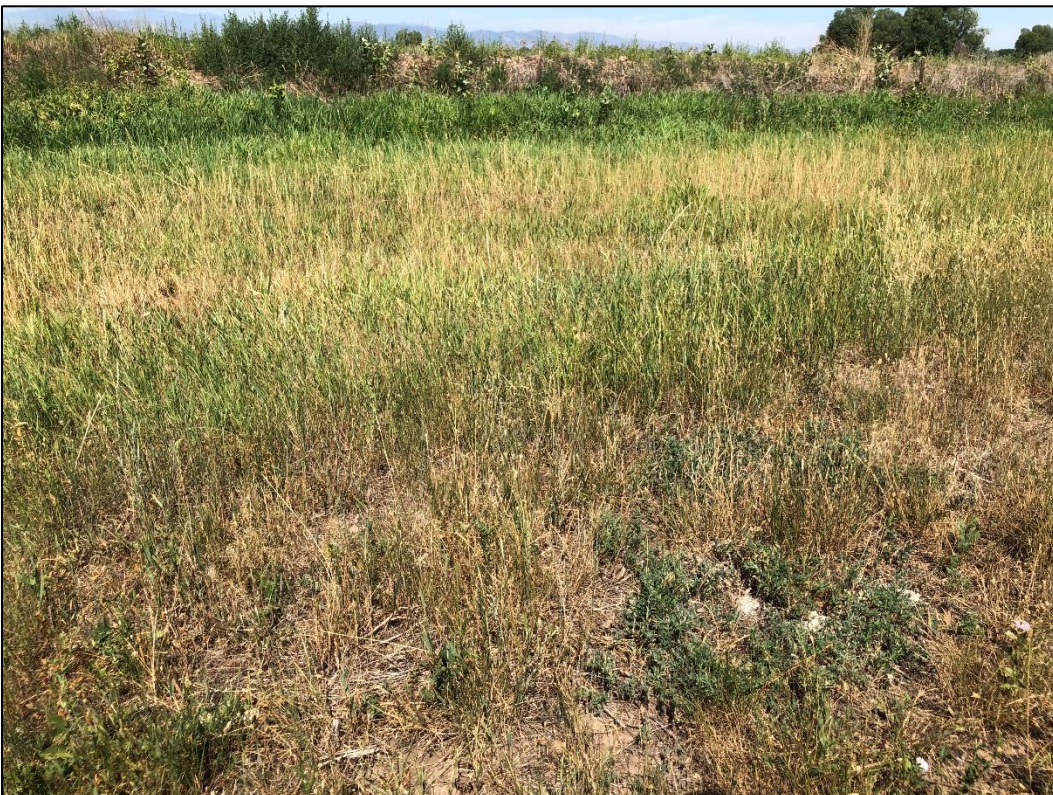
Photo 16. View looking west across area west of DiTullio phase 4 reservoir, showing established grasses present in this area. However, additional weed management is required (note field bindweed at bottom right of photo).

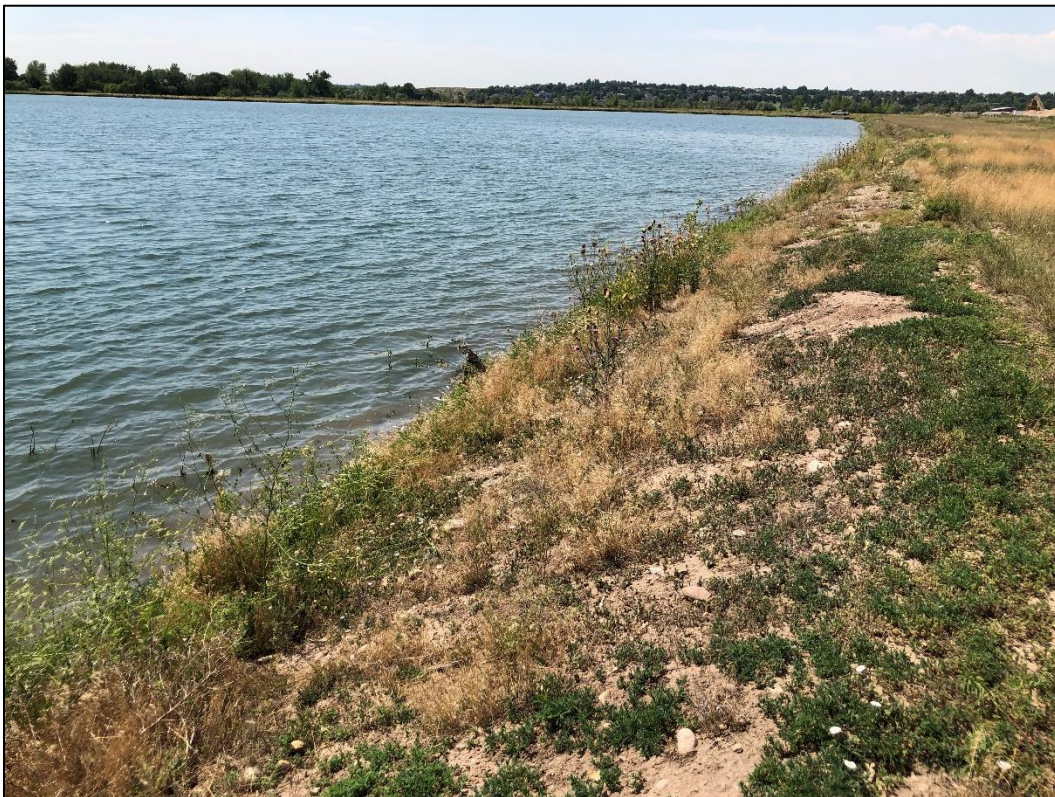
Photo 18. View looking south across western shoreline of DiTullio phase 4 reservoir, showing slopes graded to stable configuration. However, vegetative cover along slopes consists primarily of weeds. Additional weed management and interseeding is required in this area.

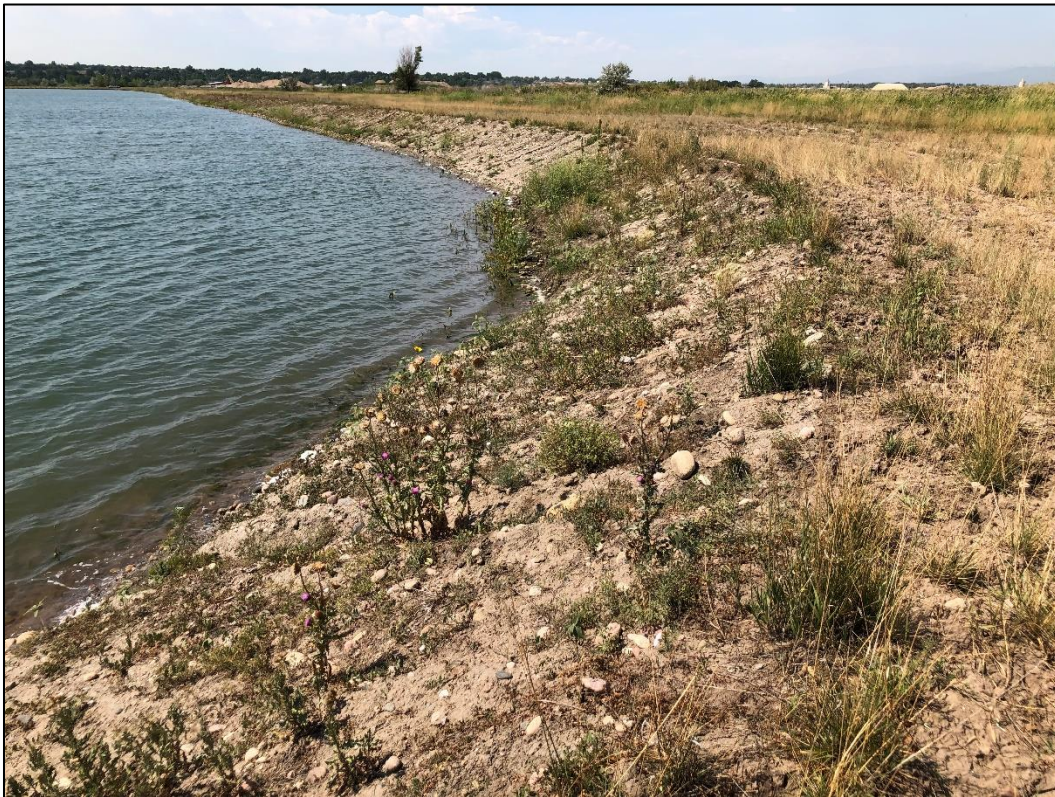
Photo 20. View looking southwest across northwestern shoreline of DiTullio phase 4 reservoir, showing slopes graded to stable configuration. However, vegetative cover along slopes consists primarily of weeds. Additional weed management and interseeding is required in this area.

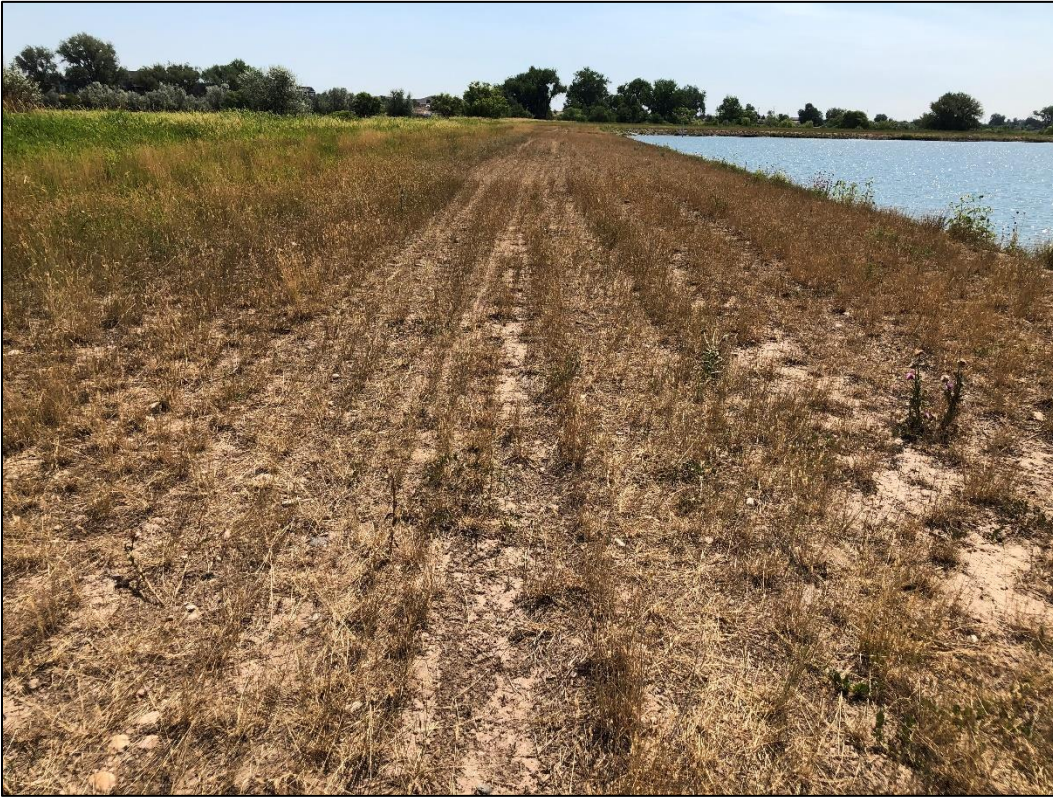
Photo 21. View looking east across area north of DiTullio phase 4 reservoir, showing vegetative cover consists primarily of grasses in this area. However, additional weed management is required, particularly for Canada thistle and field bindweed. Additional interseeding may also be necessary.

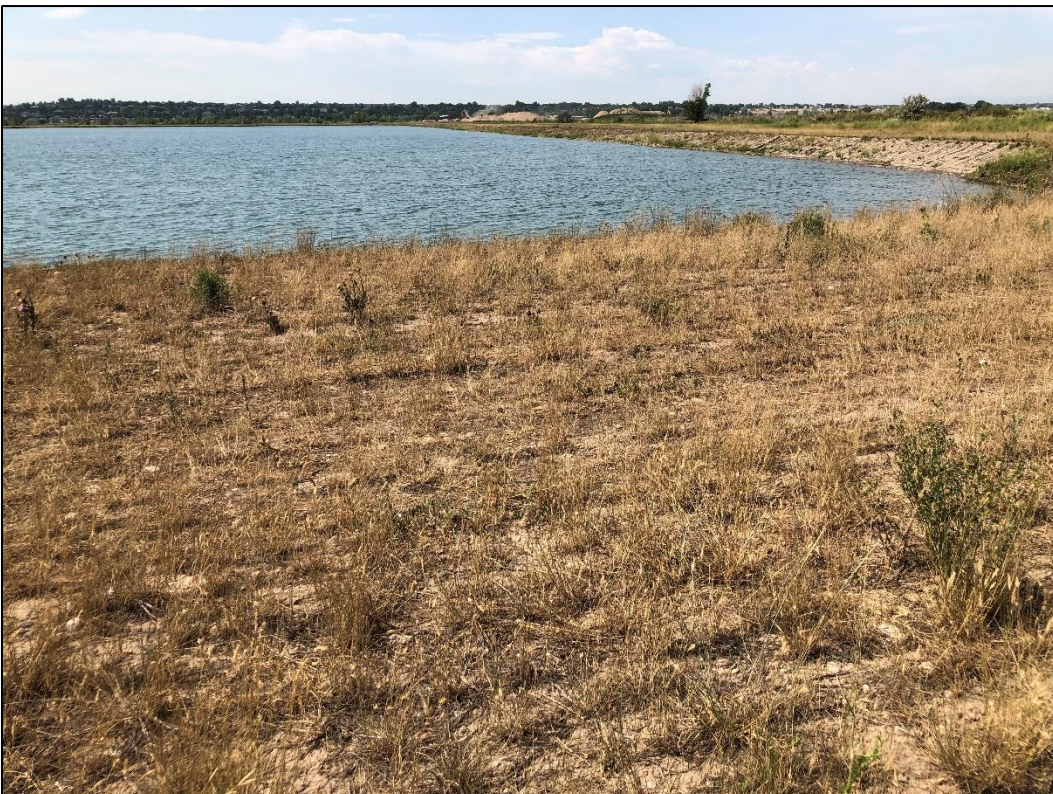
Photo 22. View looking southwest across area north of DiTullio phase 4 reservoir, showing vegetative cover consists primarily of grasses in this area. However, additional weed management is required, particularly for Canada thistle and field bindweed. Additional interseeding may also be necessary.

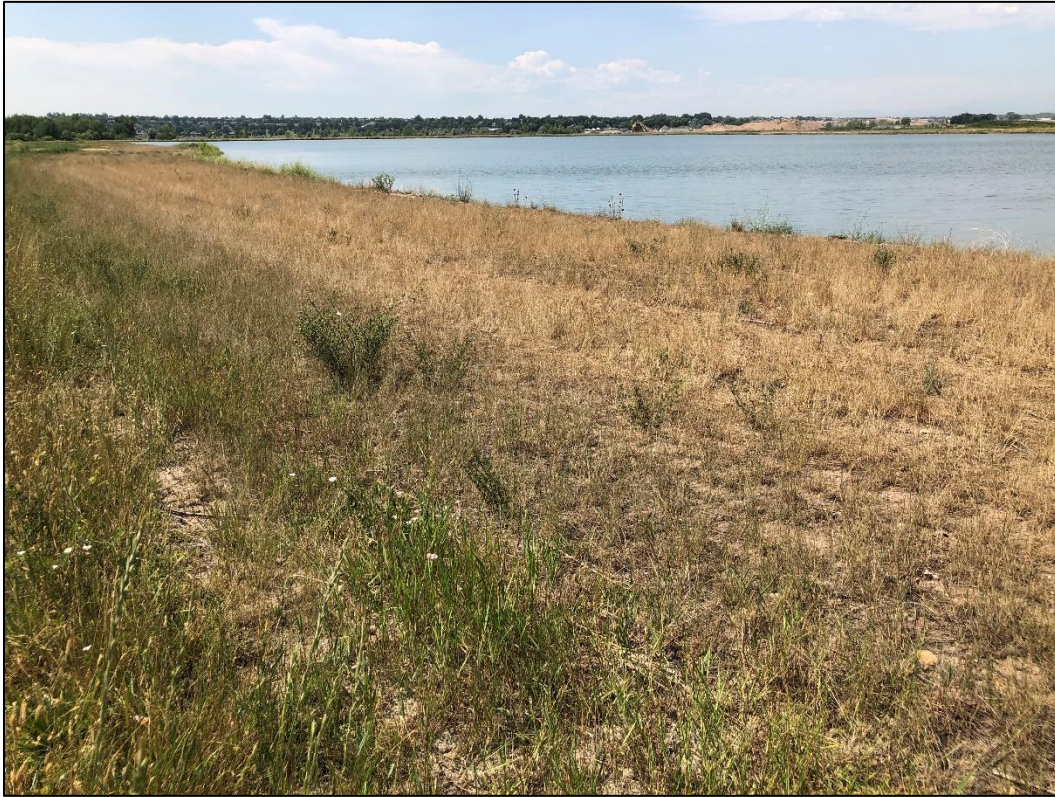
Photo 27. View looking southwest across area east of DiTullio phase 4 reservoir, showing vegetative cover consists primarily of grasses in this area. However, additional weed management is required, particularly for Canada thistle and field bindweed. Additional interseeding may also be necessary.

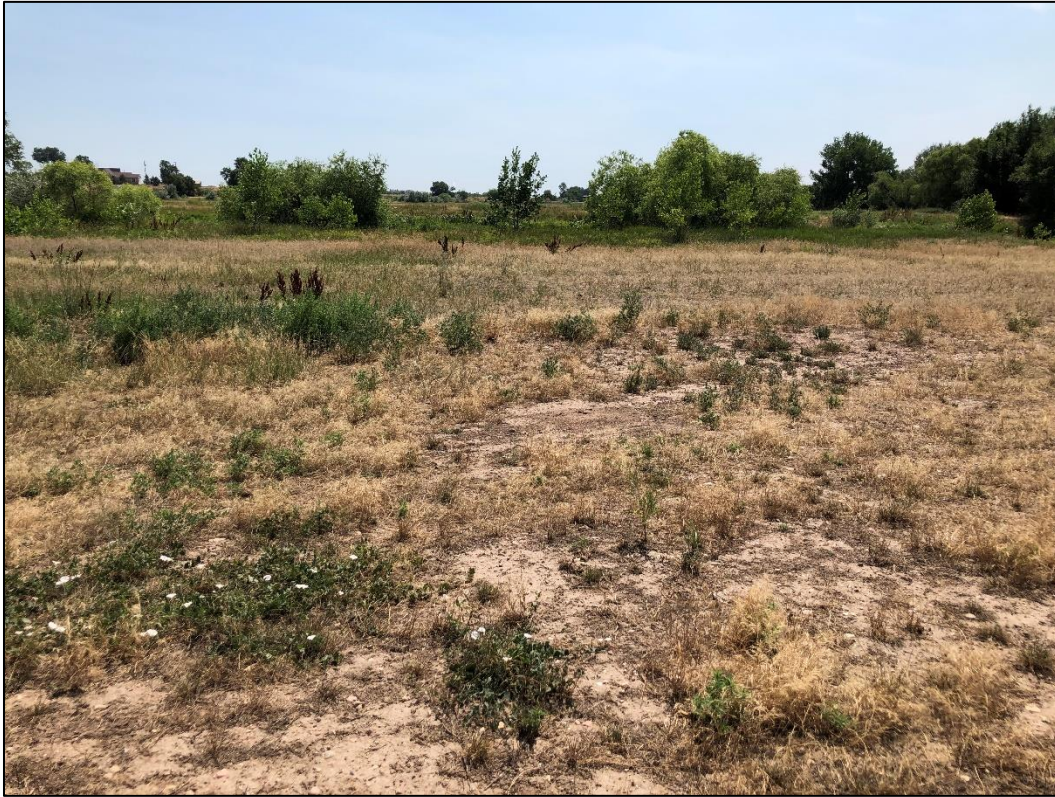
Photo 29. View looking east across area east of DiTullio phase 4 reservoir, showing fairly sparse vegetative cover in this area consisting primarily of weeds (downy brome, field bindweed, kochia, and curly dock). Additional weed management and interseeding is required in this area.

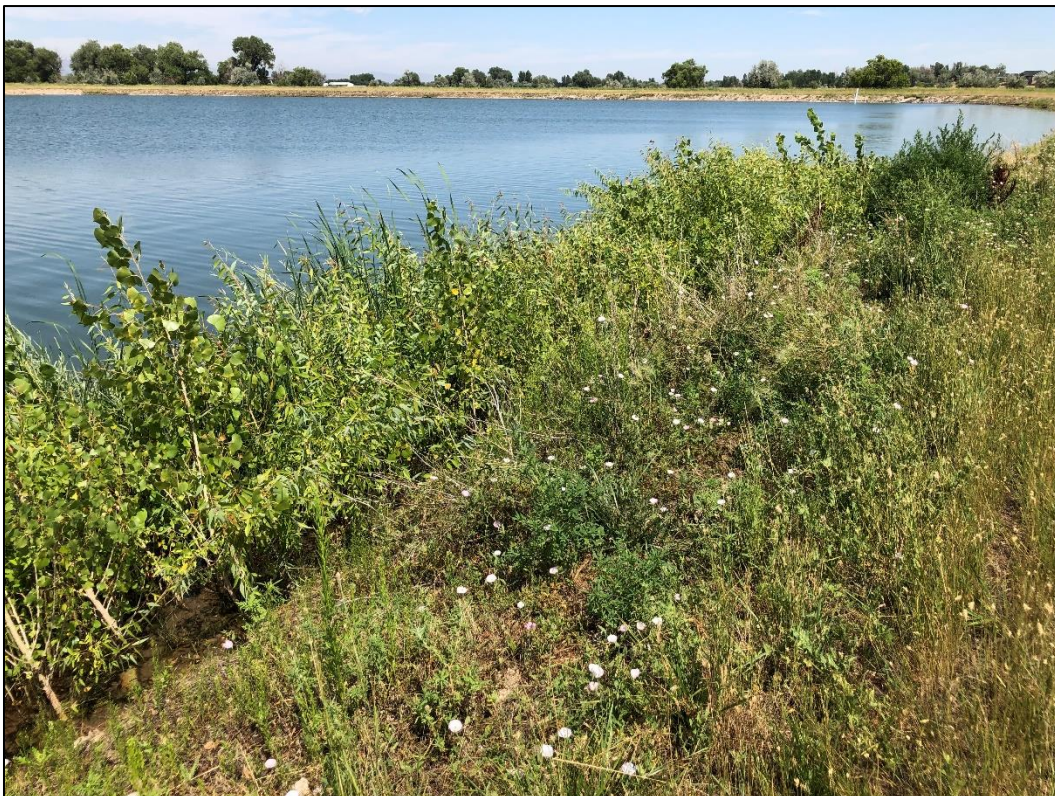
Photo 30. View looking north across eastern shoreline of DiTullio phase 4 reservoir, showing slopes graded to stable configuration with good vegetative cover. Additional weed management is required in this area. Also note volunteer trees growing along shoreline which must be removed.

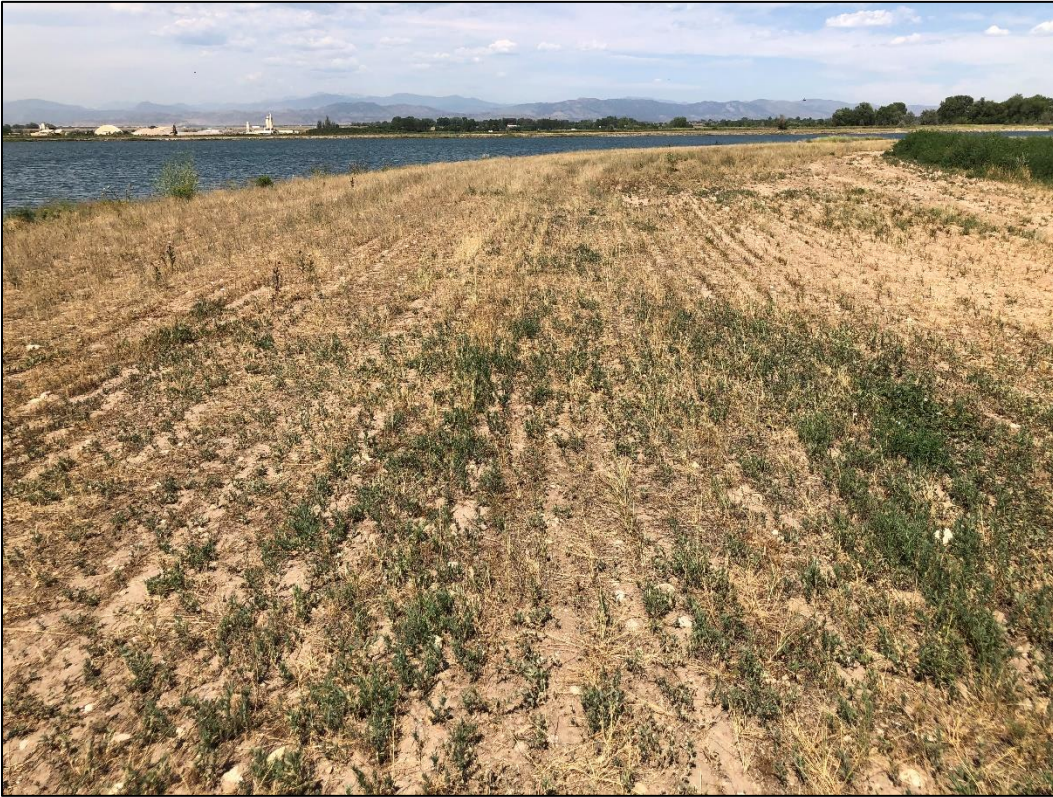
Photo 31. View looking northwest across area east of DiTullio phase 4 reservoir, showing vegetative cover consisting of grasses and weeds. Additional weed management is required, particularly for Canada thistle and field bindweed. Additional interseeding may also be necessary.

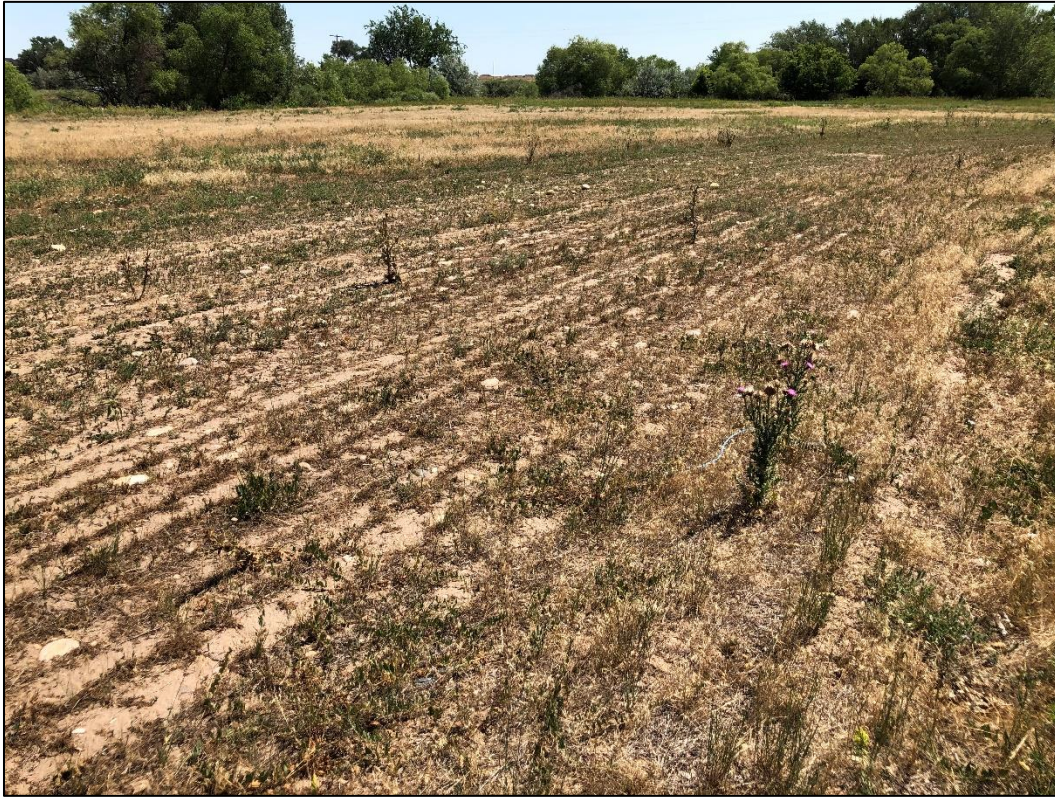
Photo 33. View looking southeast across area southeast of DiTullio phase 4 reservoir, showing vegetative cover consisting of some grasses and abundant weeds. Additional weed management is required in this area, particularly for Canada thistle, field bindweed, and downy brome. Additional interseeding may also be necessary.

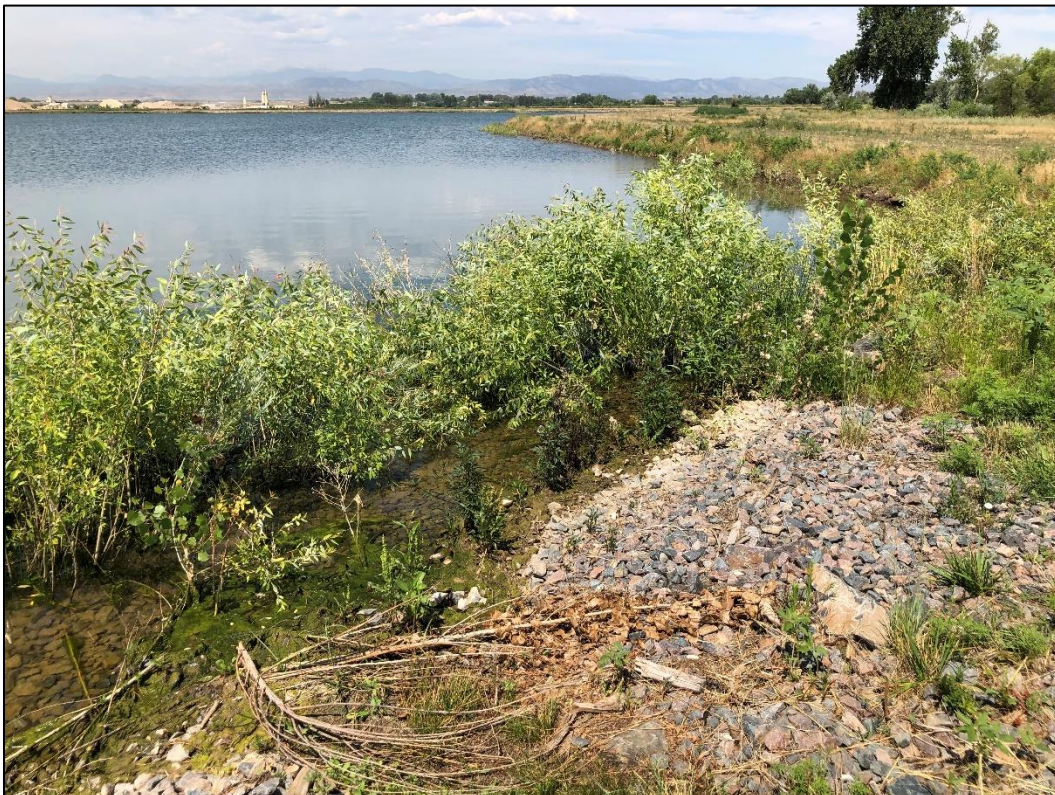
Photo 34. View looking northeast across southeastern shoreline of DiTullio phase 4 reservoir, showing volunteer trees growing along shoreline which must be removed.

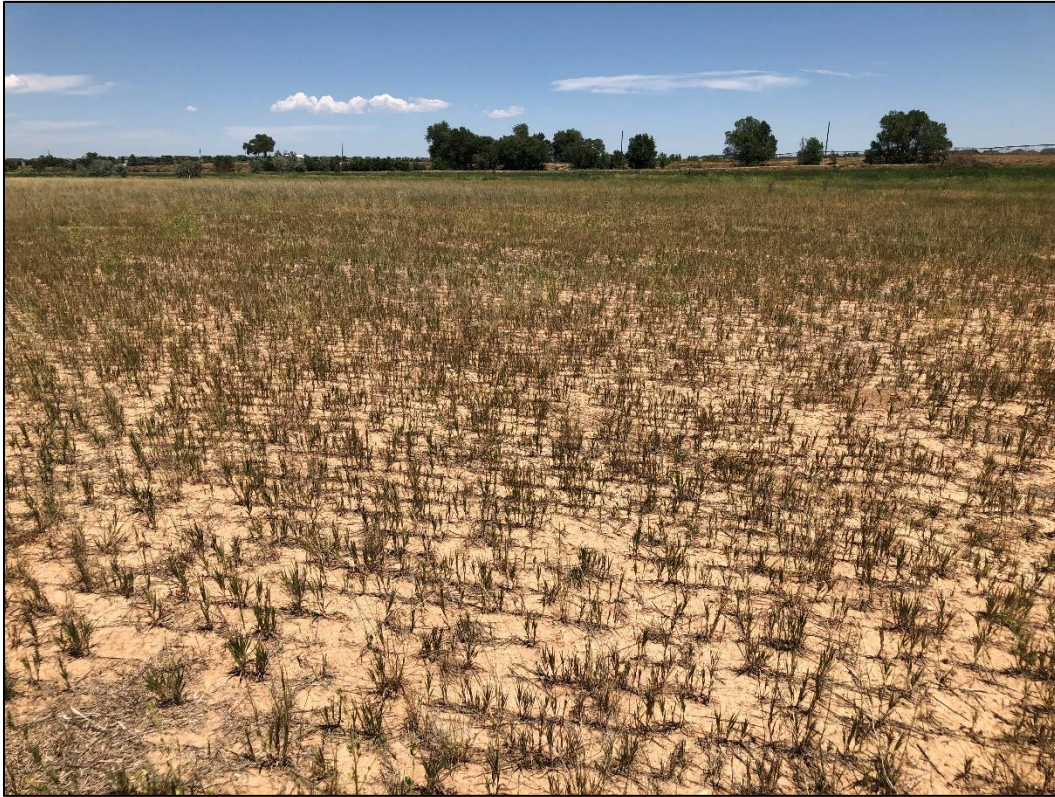
Photo 35. View looking northeast across DiTullio phase 5 backfill area, showing vegetative cover consisting primarily of grasses. Some additional weed management and interseeding may be required in this area.

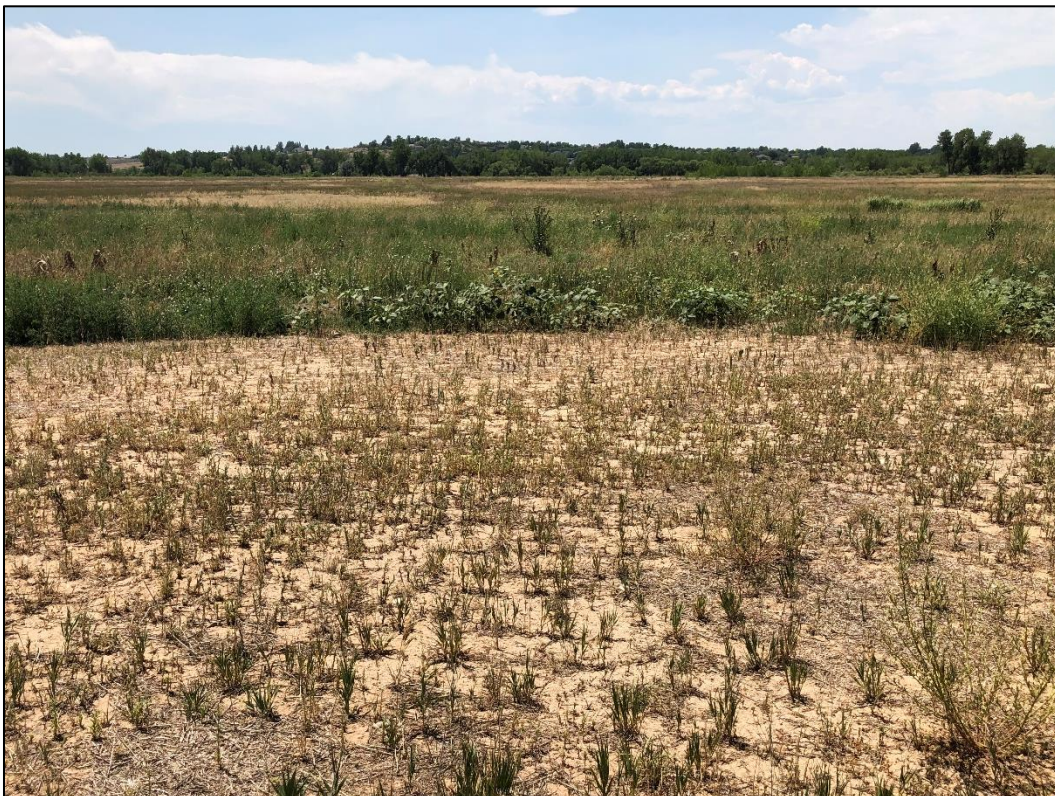
Photo 36. View looking south across DiTullio phase 5 backfill area, showing vegetative cover consisting of grasses (in foreground) and weeds (in background). Additional weed management is required in this area. Additional interseeding may also be necessary.

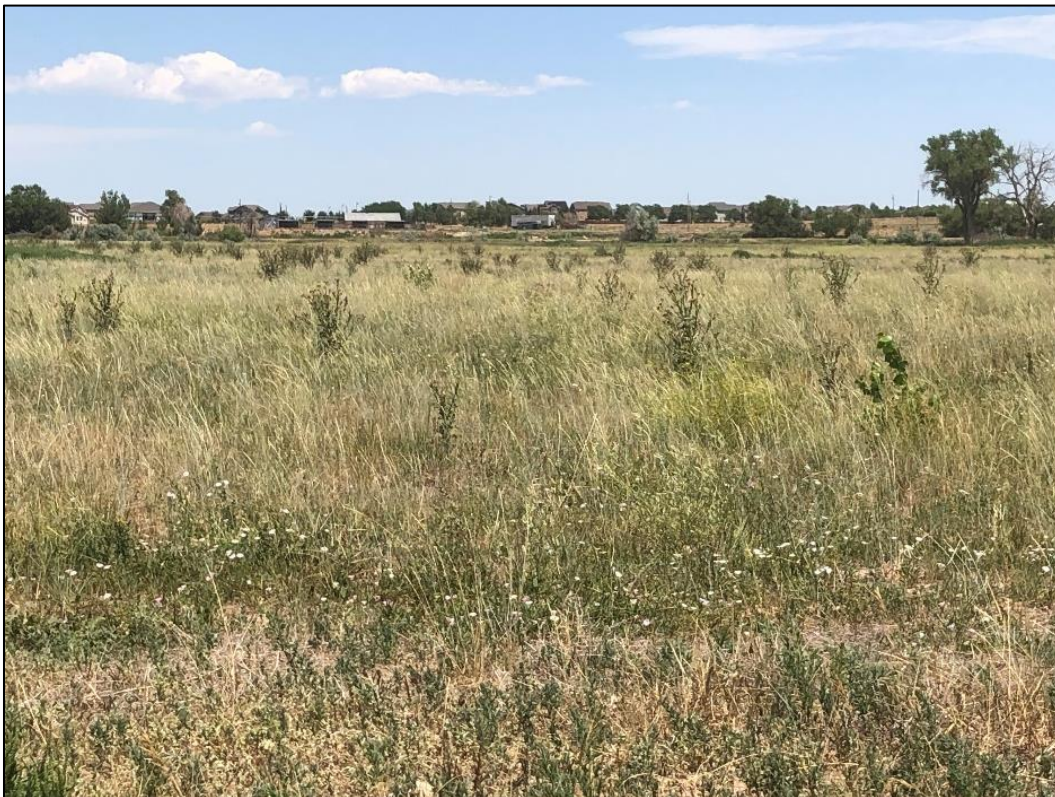
Photo 38. View looking north across DiTullio phase 2 backfill area, showing established grasses in this area. Additional weed management is required, particularly for field bindweed, Canada thistle, and downy brome

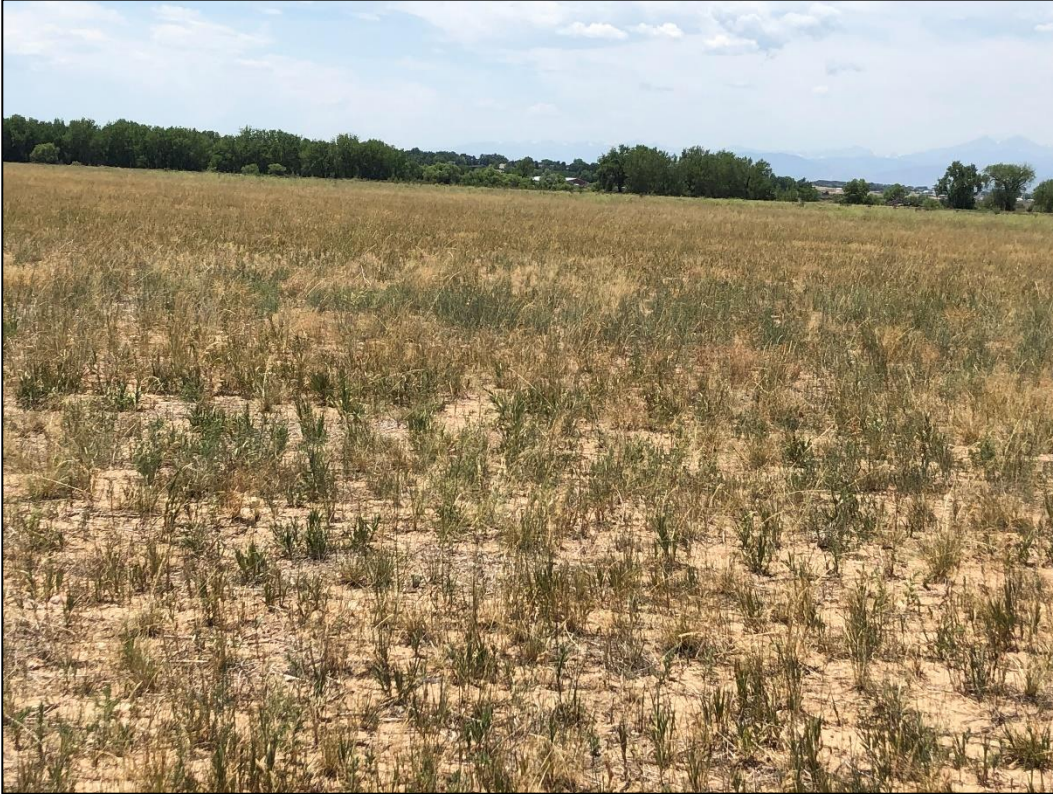
Photo 39. View looking southeast across DiTullio phases 2 and 5 backfill areas, showing vegetative cover consisting primarily of grasses. Some additional weed management and interseeding may be required in this area.

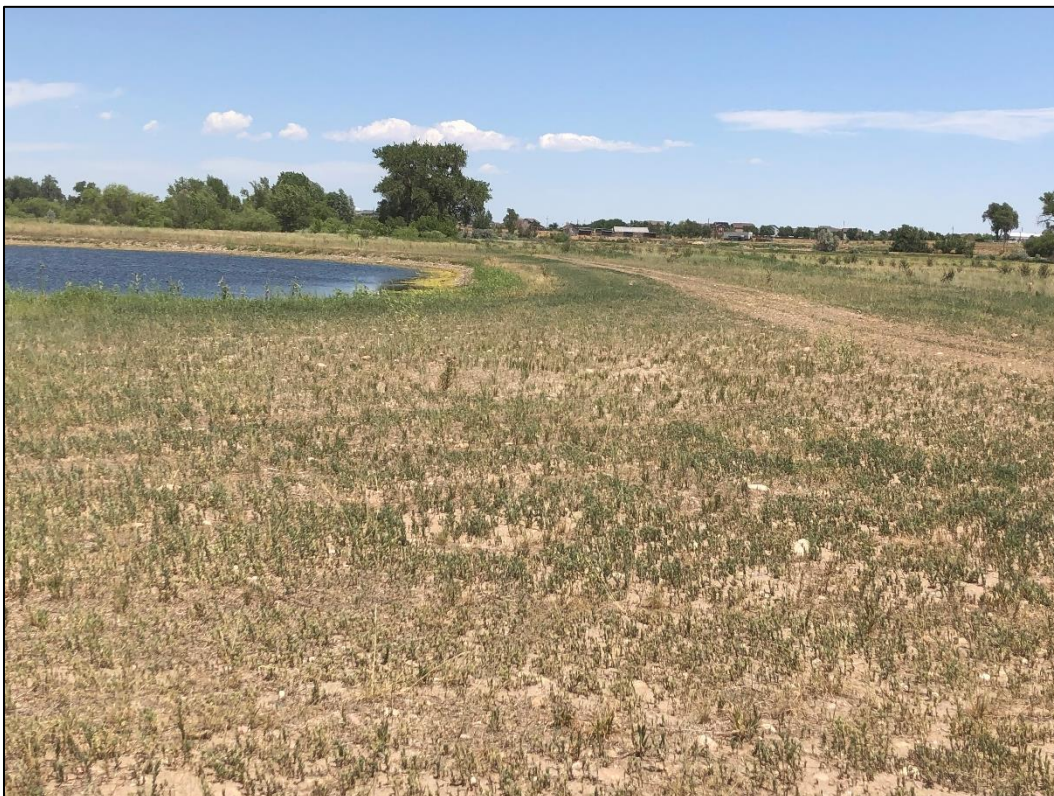
Photo 40. View looking northeast across area southeast of DiTullio phase 1 reservoir, showing vegetative cover consisting of grasses and weeds. Additional weed management is required in this area. Additional interseeding may also be necessary.
