MINERALS PROGRAM INSPECTION REPORT
PHONE: (303) 866-3567

MINE NAME: Three Bells Pit	MINE/PROSPECTING ID#: M-1979-191	MINERAL: Sand and gravel	COUNTY: Larimer
INSPECTION TYPE: Surety Release Inspection	INSPECTOR(S): Amy Eschberger	INSP. DATE: July 16, 2020	INSP. TIME: 10:00
OPERATOR: Martin Marietta Materials, Inc.	OPERATOR REPRESENTATIVE: Julie Mikulas	TYPE OF OPERATION: 112c - Construction Regular Operation	
REASON FOR INSPECTION: Surety Release Requested	BOND CALCULATION TYPE: Complete Bond	BOND AMOUNT: \$3,294,000.00	
DATE OF COMPLAINT: NA	POST INSP. CONTACTS: None	JOINT INSP. AGENCY: None	
WEATHER: Clear	INSPECTOR'S SIGNATURE:

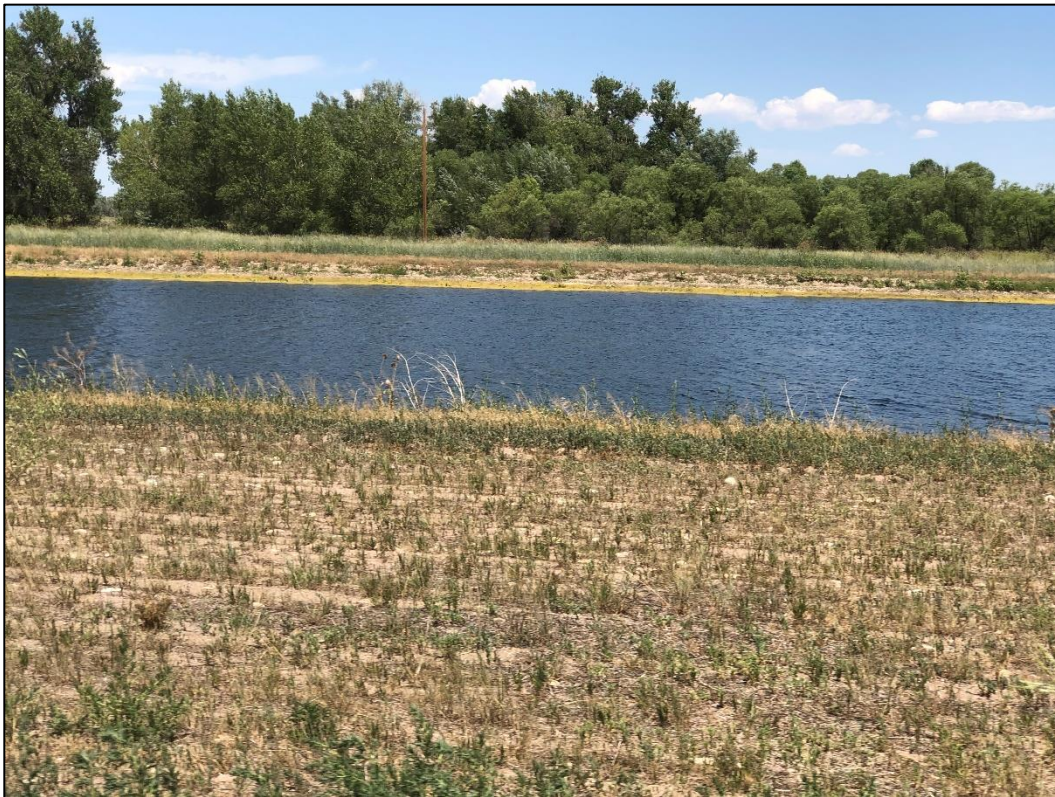
Photo 42. View looking north across area south of DiTullio phase 1 reservoir, showing vegetative cover fairly sparse in some areas consisting of grasses and weeds. Additional weed management is required in this area. Additional interseeding may also be necessary.

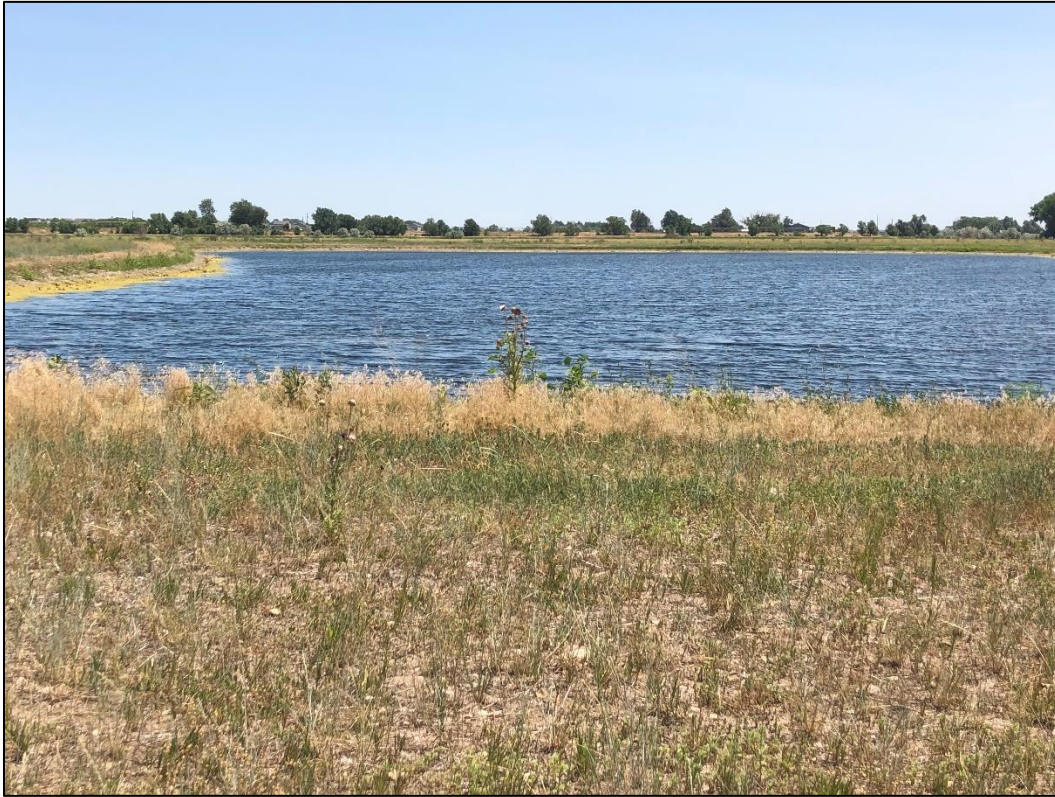
Photo 43. View looking east across area west of DiTullio phase 1 reservoir, showing good grass growth in this area. Additional weed management is required, particularly for Canada thistle, field bindweed, and downy brome.

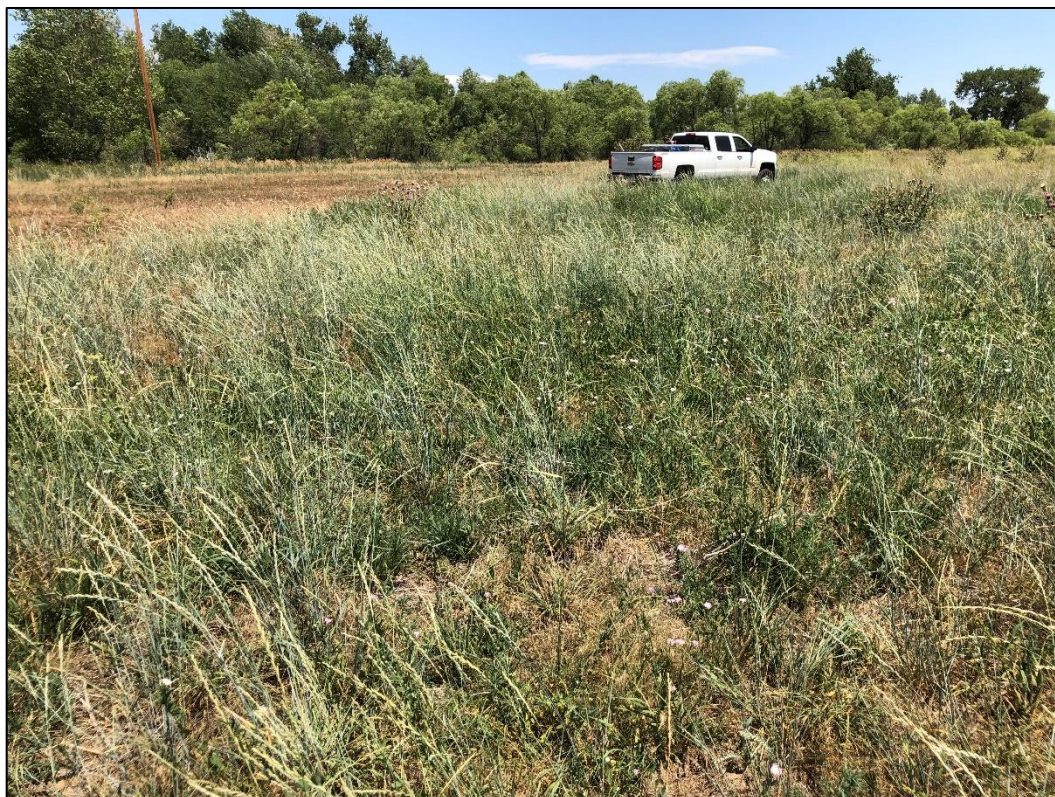
Photo 44. View looking west across area northwest of DiTullio phase 1 reservoir, showing established grasses in this area. Additional weed management is required, particularly for Canada thistle, field bindweed, and downy brome.

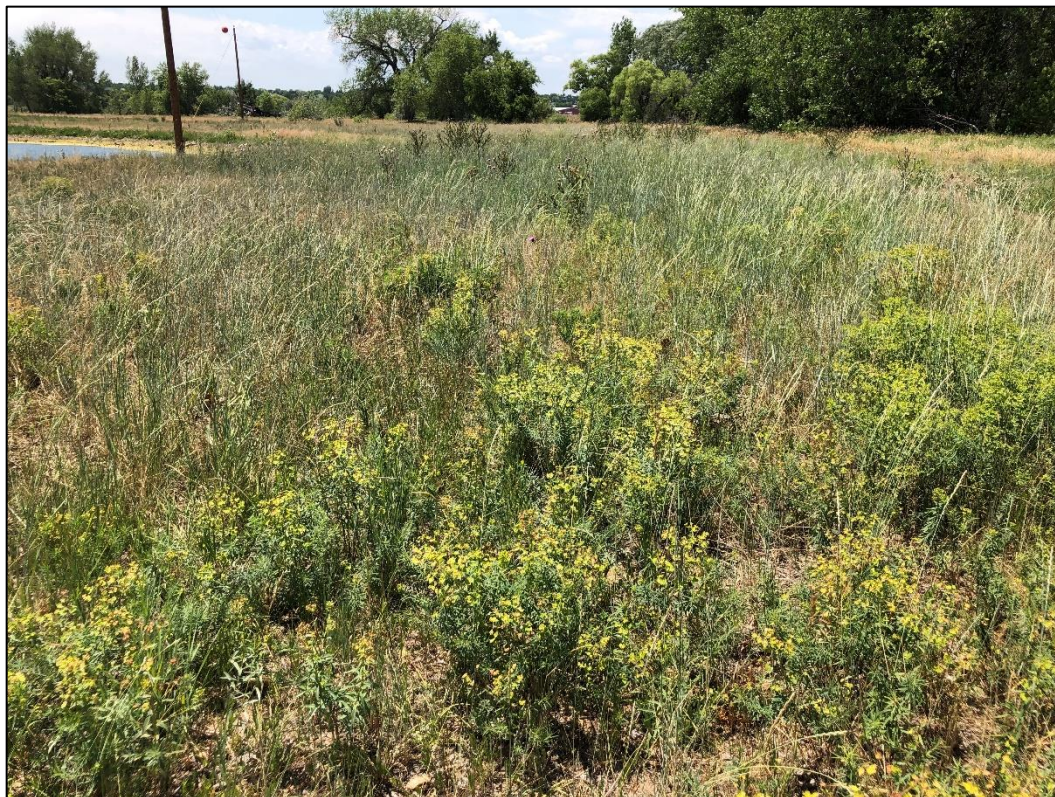
Photo 46. View looking west across area north of DiTullio phase 1 reservoir, showing leafy spurge, a state-listed noxious weed species, present in this area. Additional weed management is required, particularly for leafy spurge, Canada thistle, field bindweed, and downy brome.

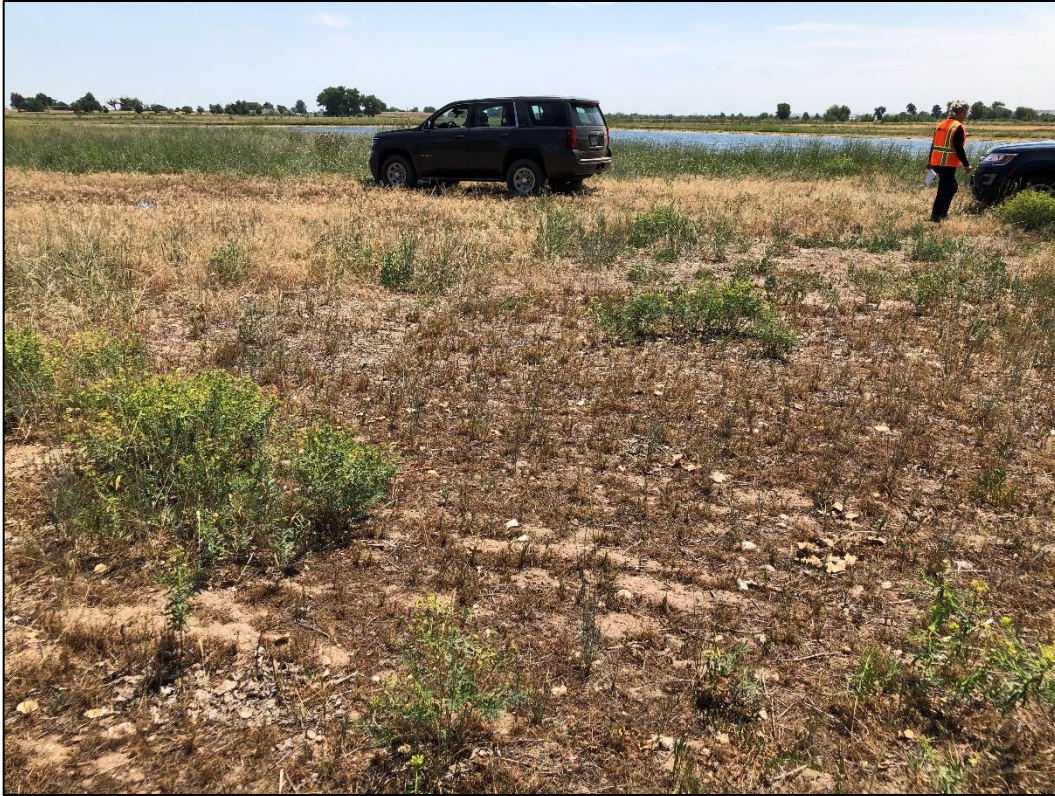
Photo 47. View looking south across area north of DiTullio phase 1 reservoir, showing area with sparse vegetative cover consisting of some grasses and abundant weeds. Additional weed management is required, particularly for leafy spurge, Canada thistle, field bindweed, and downy brome. Additional interseeding may also be necessary.

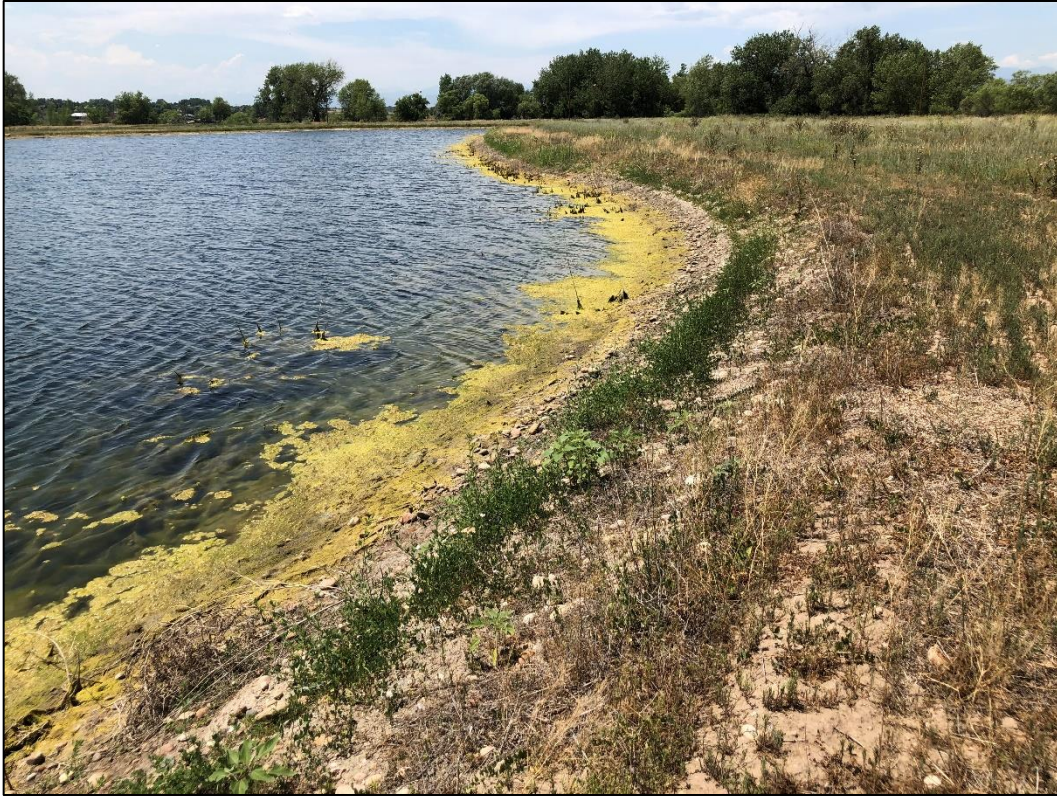
Photo 49. View looking southwest across northern shoreline of DiTullio phase 1 reservoir, showing slopes graded to stable configuration with good vegetative cover. Additional weed management is required in this area.

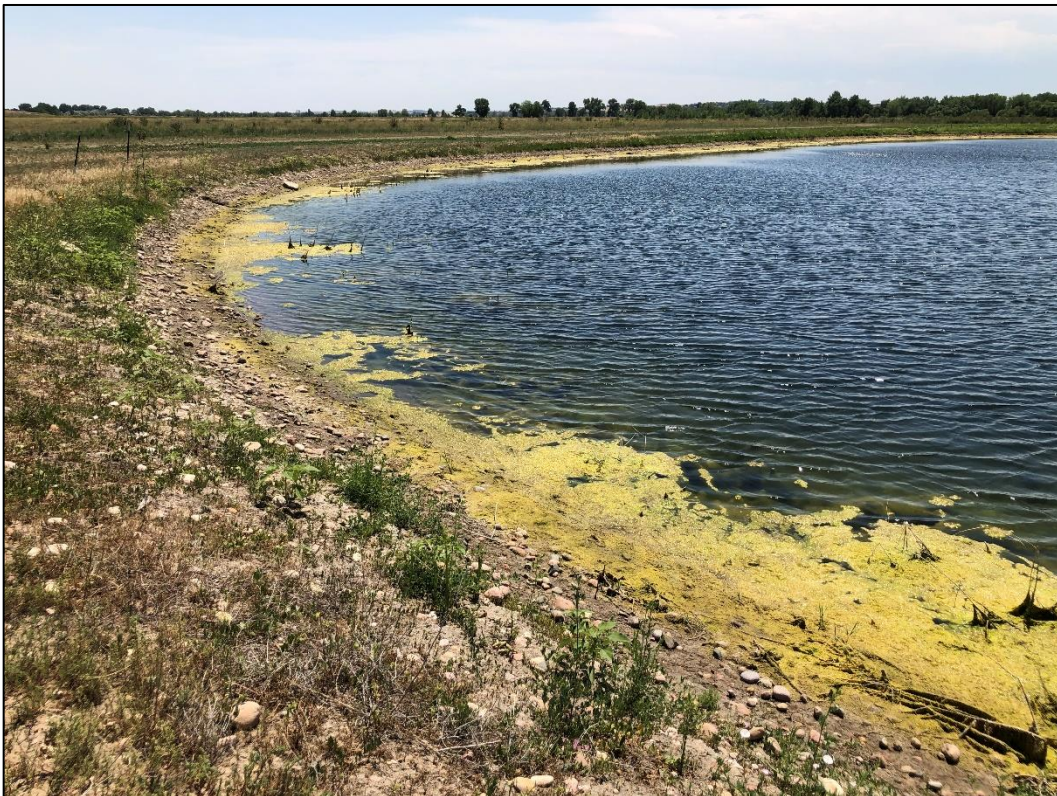
Photo 50. View looking northeast across northern shoreline of DiTullio phase 1 reservoir, showing slopes graded to stable configuration with good vegetative cover. Additional weed management is required in this area.

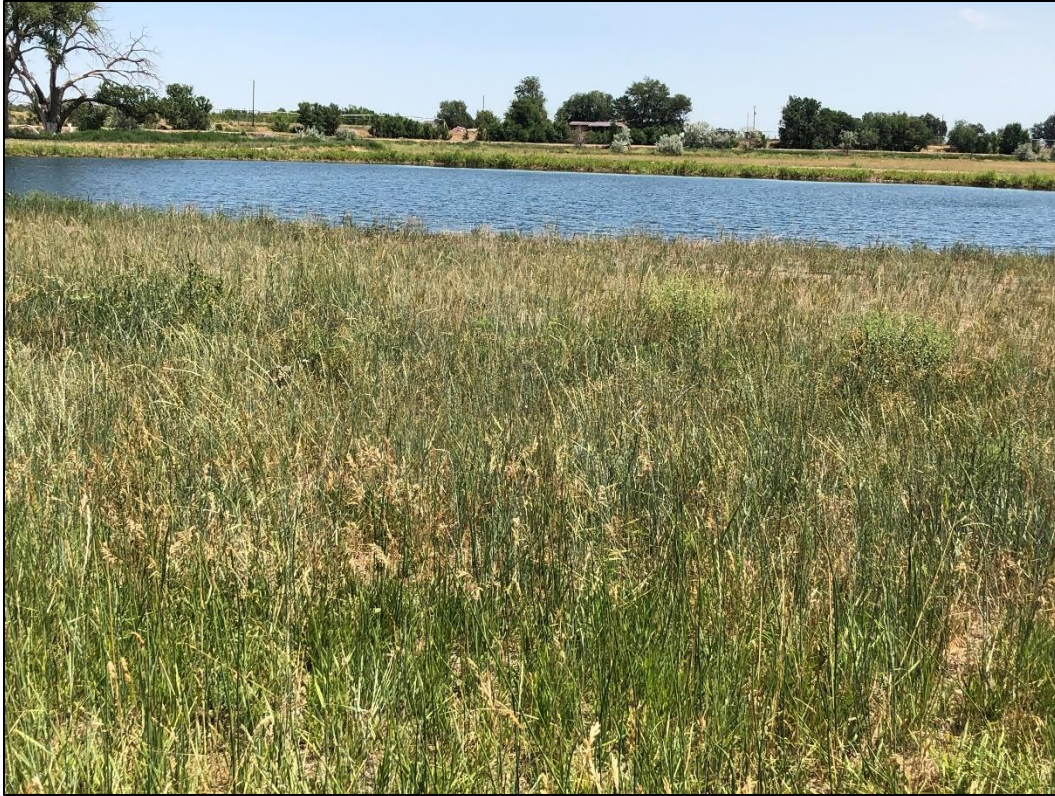
Photo 55. View looking east across area west of DiTullio phase 3 reservoir, showing area with good grass establishment. Additional weed management is required in this area.

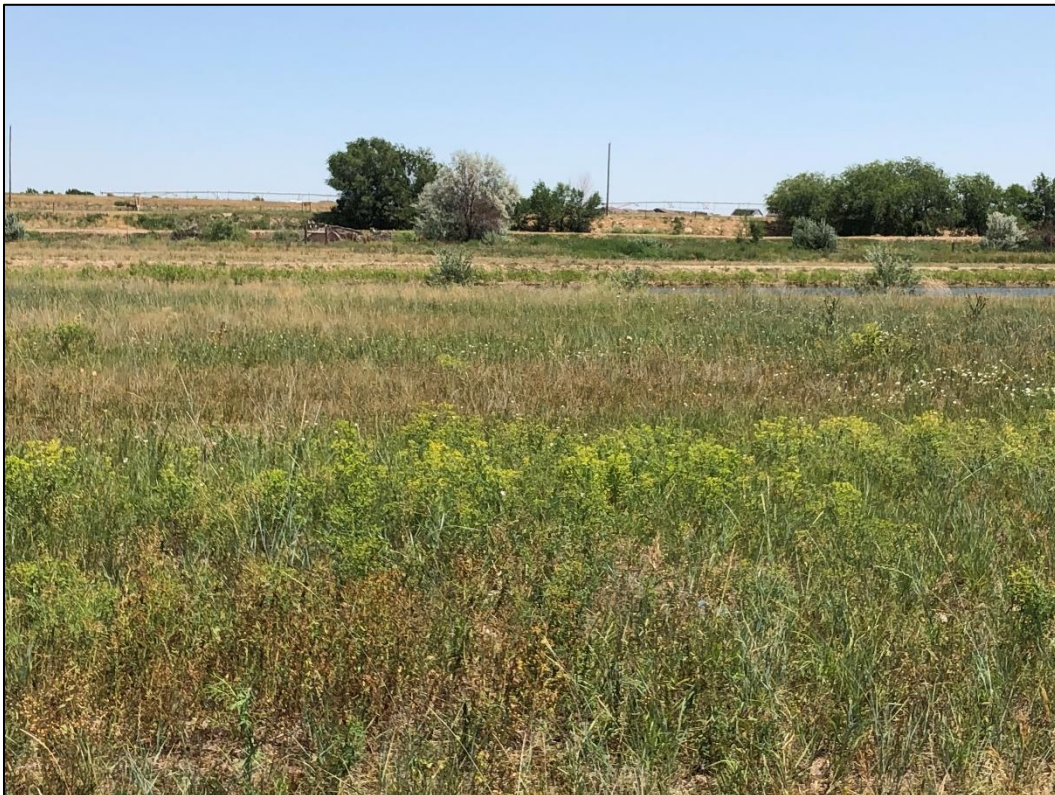
Photo 56. View looking east across area west of DiTullio phase 3 reservoir, showing leafy spurge, a state-listed noxious weed species, present in this area. Additional weed management is required, particularly for leafy spurge, Canada thistle, field bindweed, and downy brome.

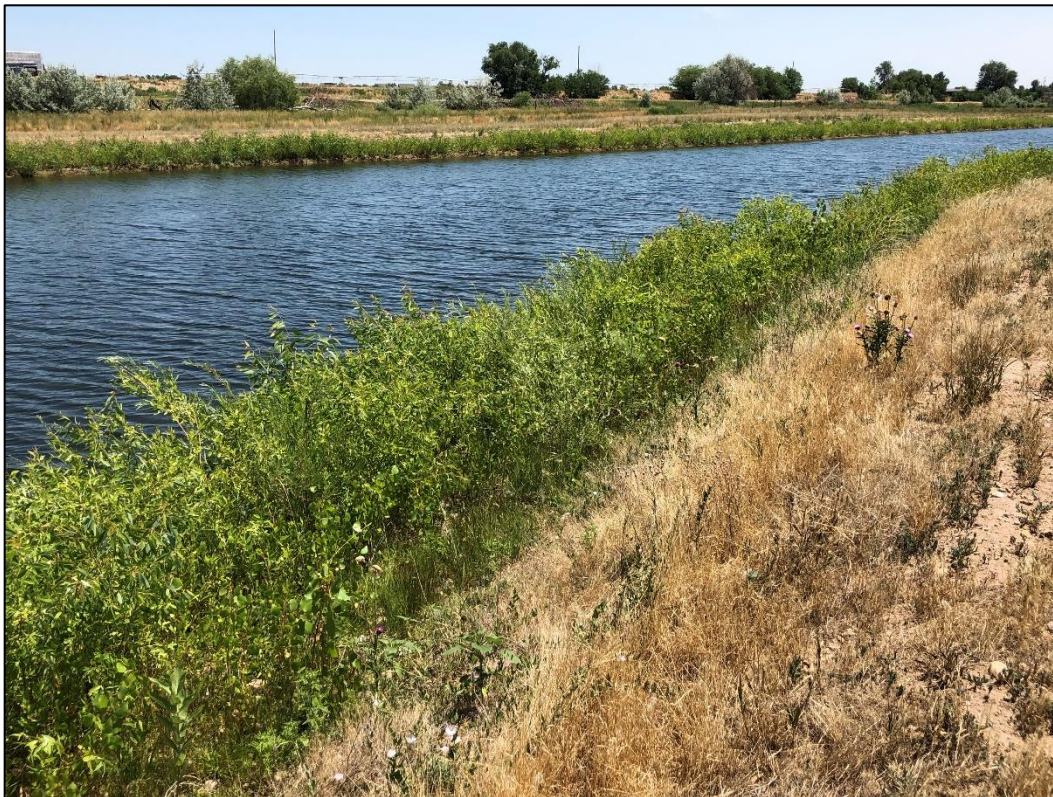
Photo 58. View looking southeast across southern shoreline of DiTullio phase 3 reservoir, showing slopes graded to stable configuration with good vegetative cover. Volunteer trees (e.g., cottonwoods, willows) must be removed from the shoreline. Additional weed management is required in this area.

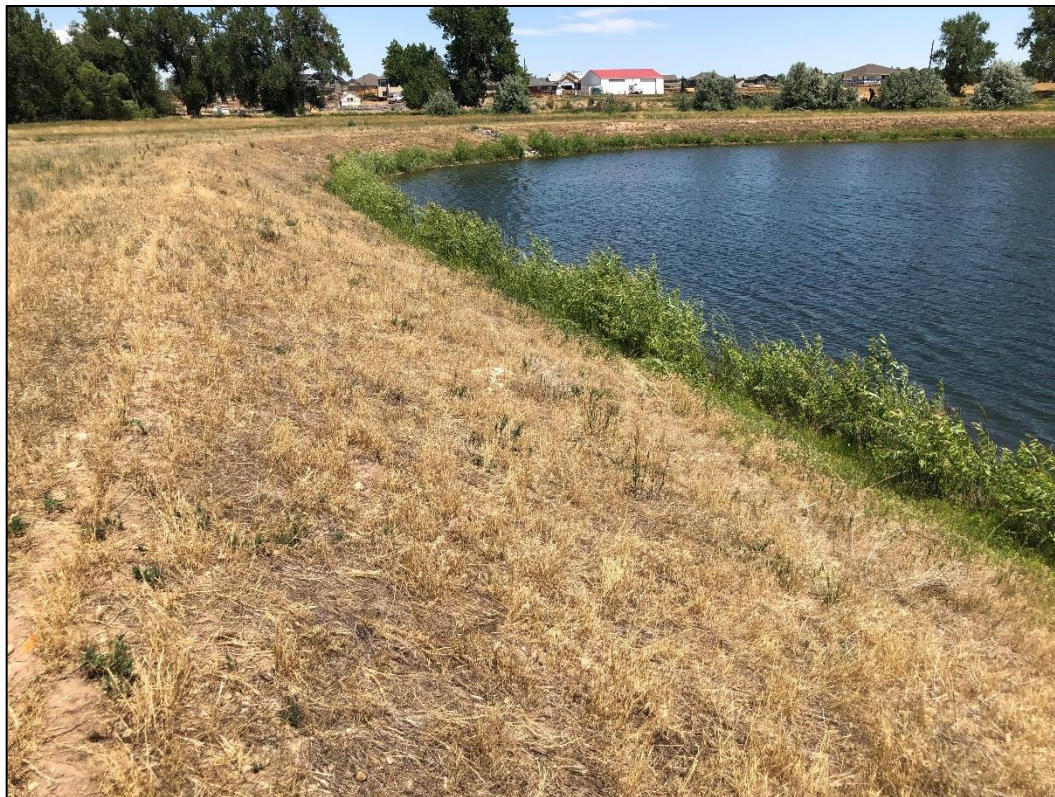
Photo 60. View looking north across western shoreline of DiTullio phase 3 reservoir, showing slopes graded to stable configuration with good grass cover. Volunteer trees (e.g., cottonwoods, willows) must be removed from the shoreline. Additional weed management is required in this area.

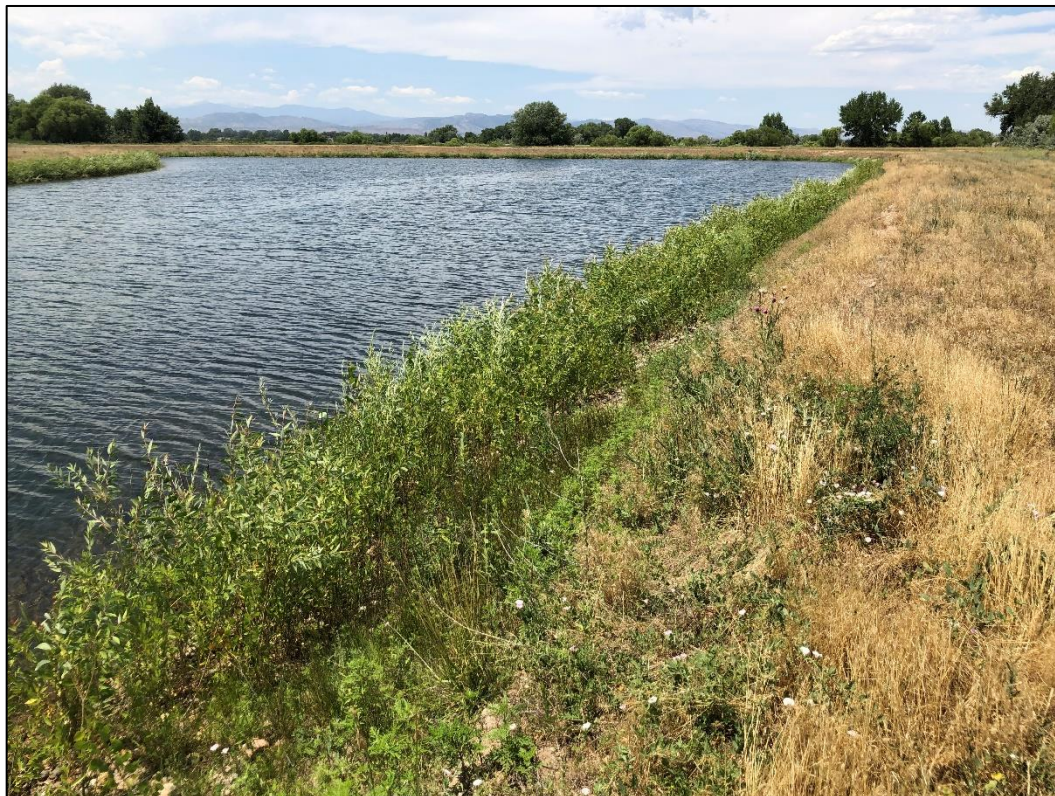
Photo 62. View looking northwest across northern shoreline of DiTullio phase 3 reservoir, showing slopes graded to stable configuration with good grass cover. Volunteer trees (e.g., cottonwoods, willows) must be removed from the shoreline. Additional weed management is required in this area, particularly for Canada thistle and field bindweed.

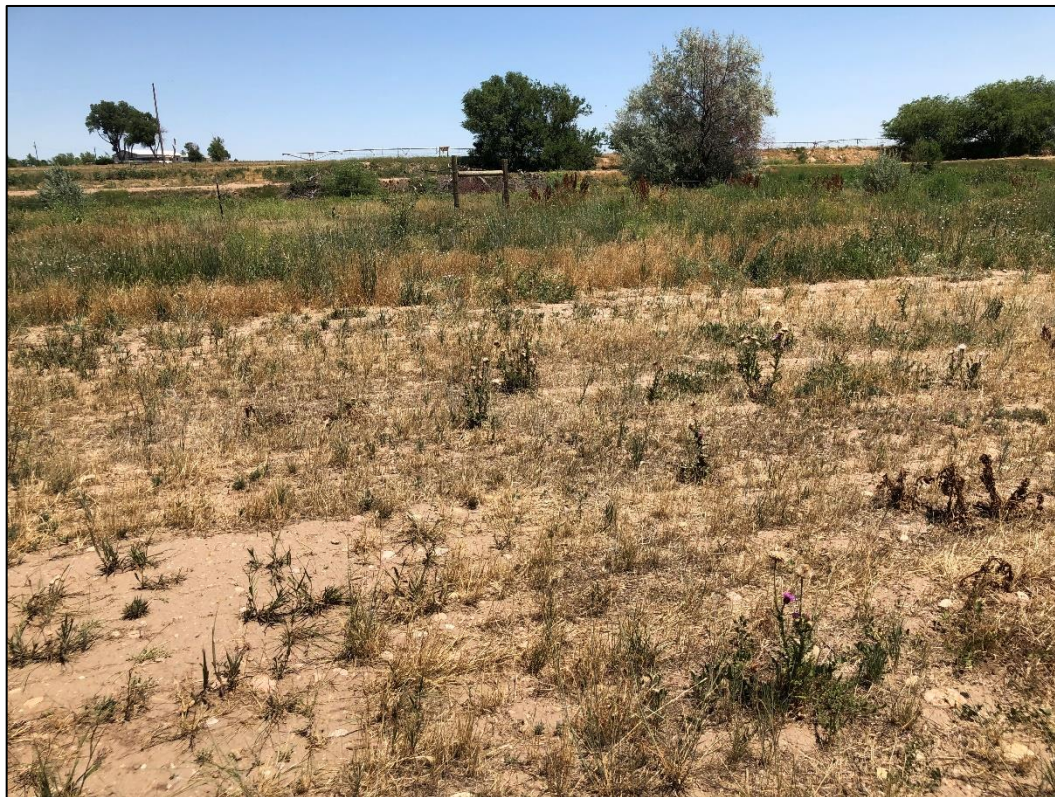
Photo 64. View looking east across area northeast of DiTullio phase 3 reservoir, showing area with fairly sparse vegetative growth consisting of grasses and abundant weeds. Additional weed management is required in this area. Additional interseeding may also be necessary.

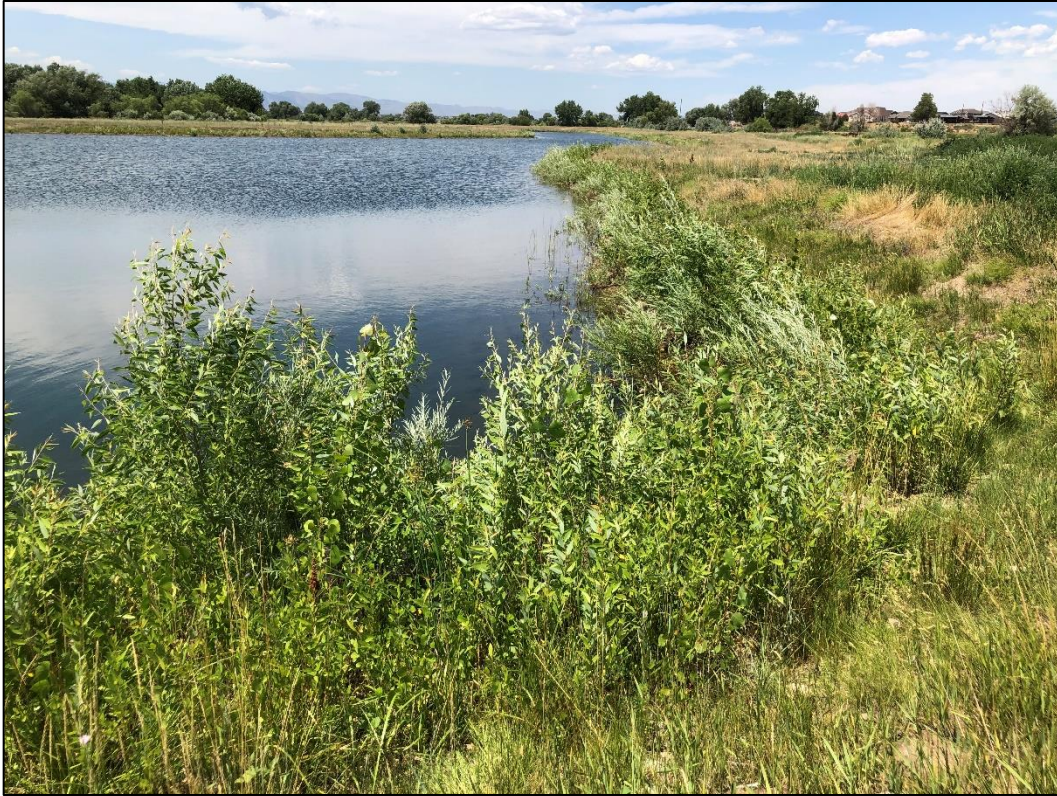
Photo 65. View looking northwest across southeastern shoreline of DiTullio phase 3 reservoir, showing slopes graded to stable configuration with good grass cover. Volunteer trees (e.g., cottonwoods, willows) must be removed from the shoreline. Additional weed management is required.

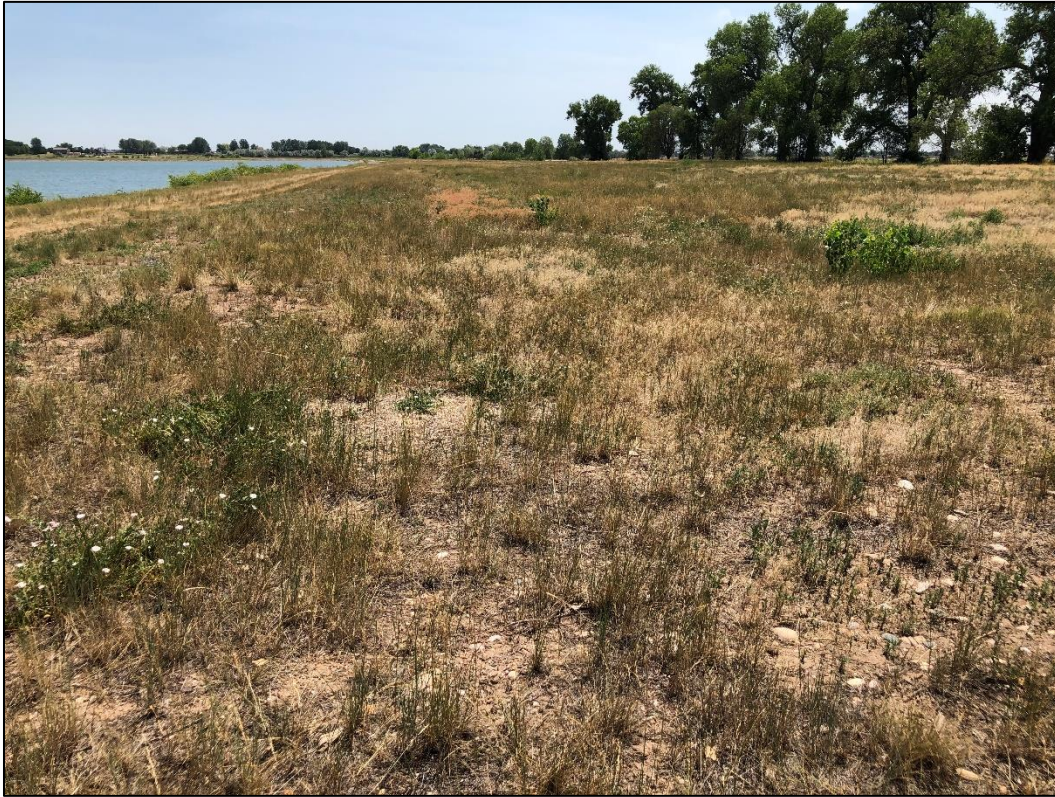
Photo 67. View looking east across area south of Veldman reservoir, showing good establishment of grasses with abundant weeds in this area. Additional weed management is required in this area, particularly for Canada thistle, field bindweed, and downy brome.

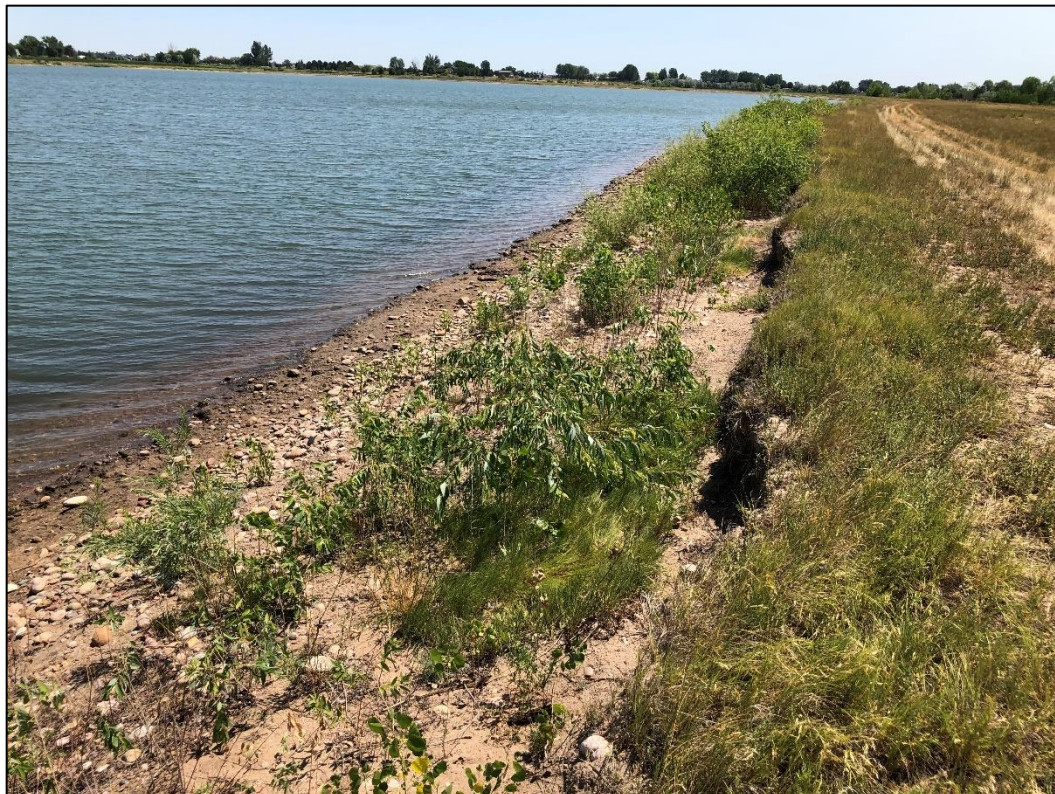
Photo 68. View looking east across southern shoreline of Veldman reservoir, showing terraced slopes which appear to be at a stable configuration. Volunteer trees (e.g., cottonwoods, willows) must be removed from the shoreline. Note good grass growth adjacent to shoreline.

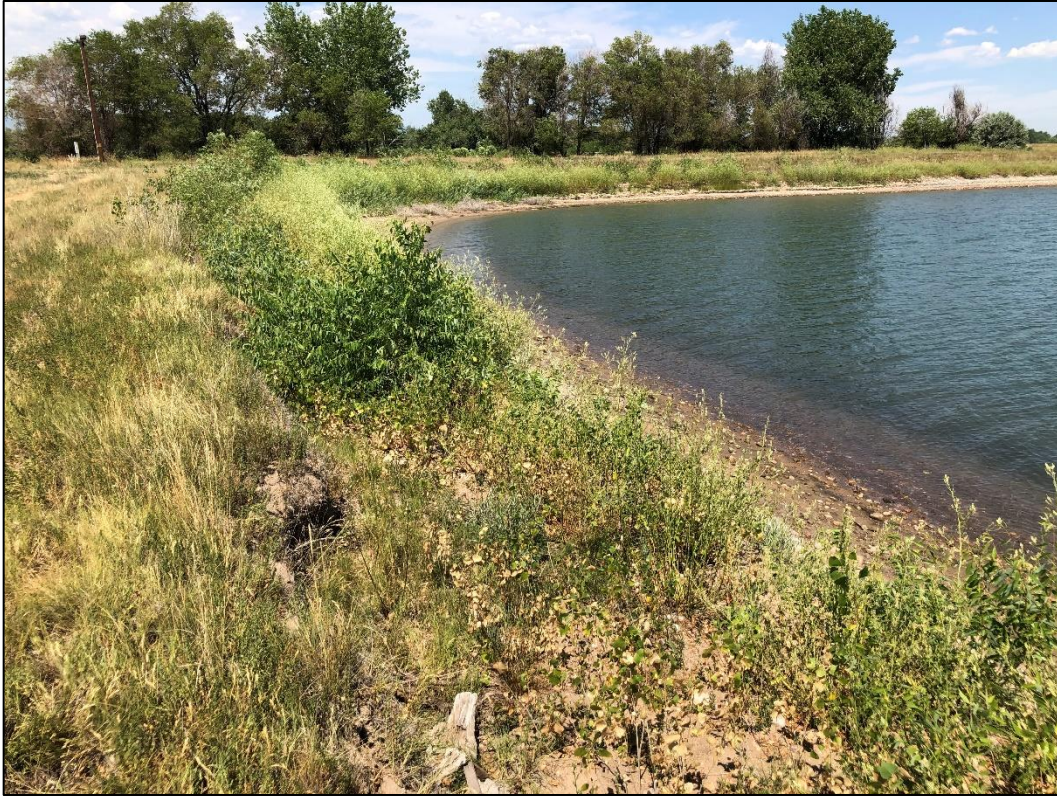
Photo 69. View looking west across southwestern shoreline of Veldman reservoir, showing terraced slopes which appear to be at a stable configuration. Volunteer trees (e.g., cottonwoods, willows) must be removed from the shoreline. Note good grass growth adjacent to shoreline.

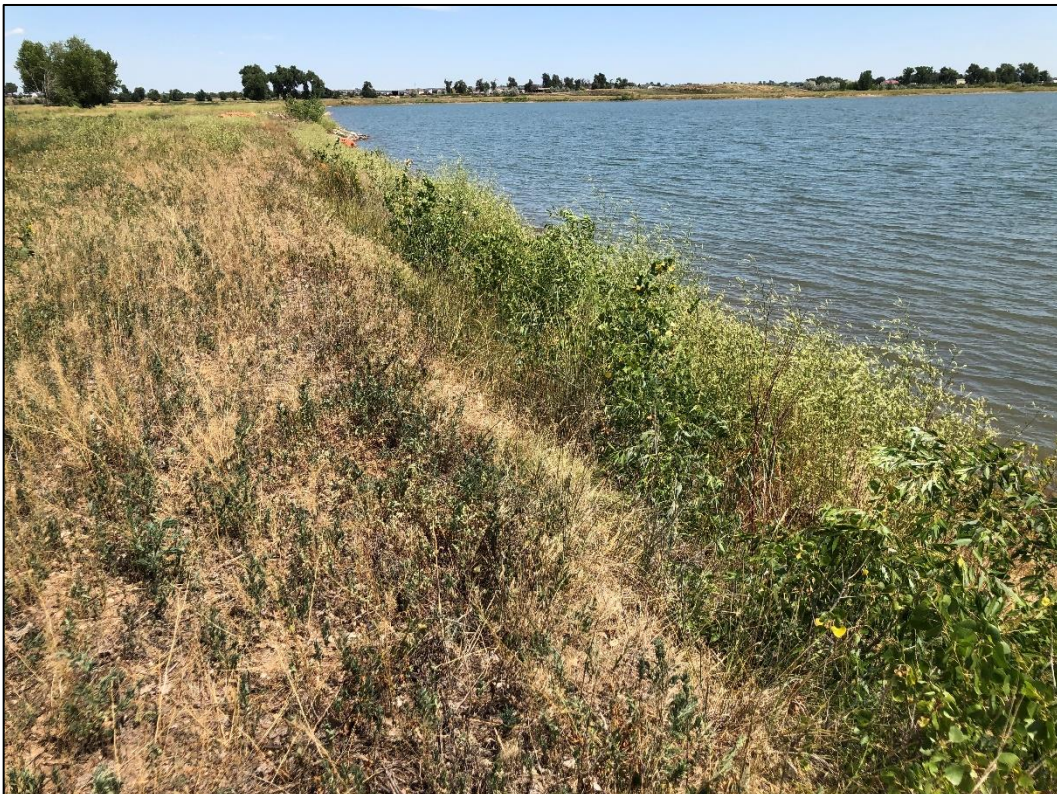
Photo 70. View looking north across western shoreline of Veldman reservoir, showing slopes at a stable configuration with good vegetative cover. Volunteer trees (e.g., cottonwoods, willows) must be removed from the shoreline. Additional weed management is required in this area.

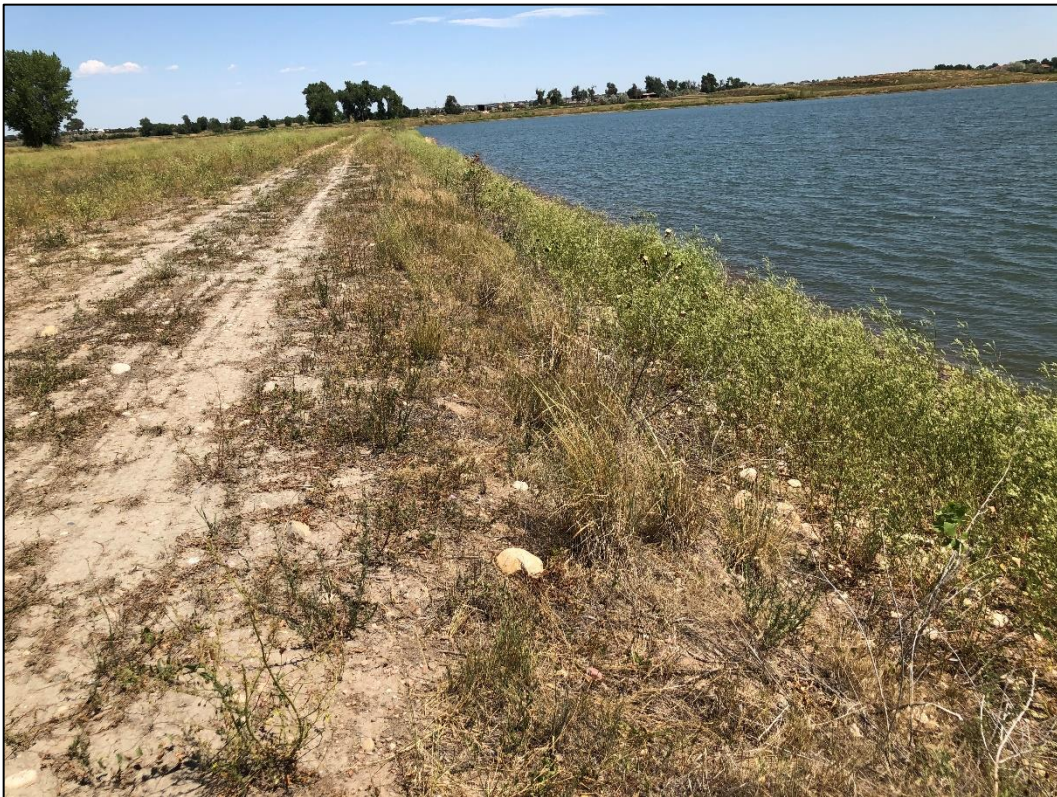
Photo 72. View looking north across western shoreline of Veldman reservoir, showing slopes at a stable configuration with good vegetative cover. Volunteer trees must be removed from the shoreline. Additional weed management is required in this area. Note haul road that remains (at left).

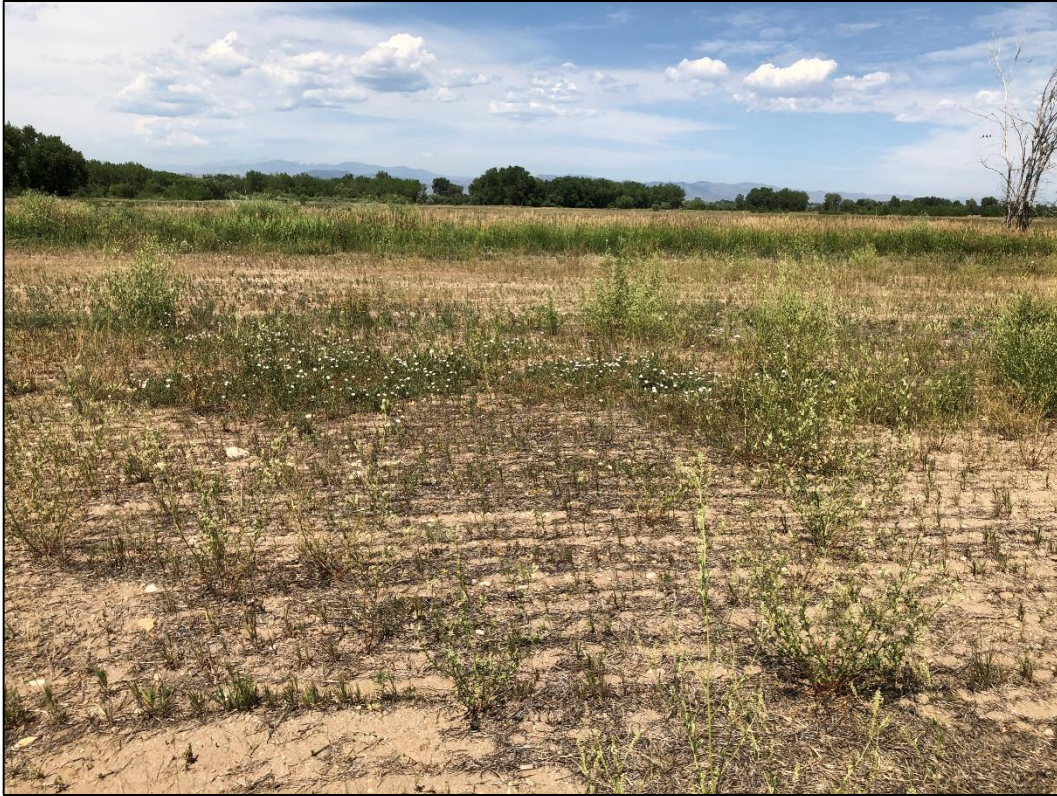
Photo 73. View looking west across area west of Veldman reservoir, showing area where vegetative cover is fairly sparse consisting primarily of weeds. Additional weed management is required in this area. Additional interseeding may also be necessary.

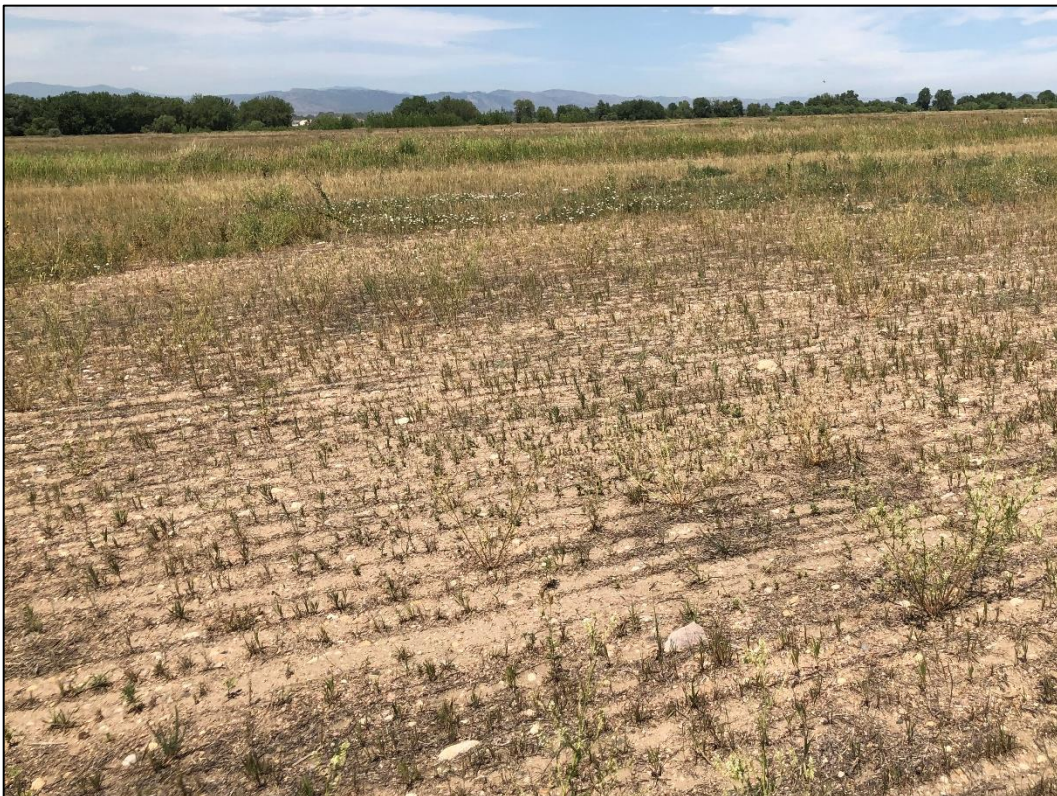
Photo 74. View looking northwest across area west of Veldman reservoir, showing area where vegetative cover is fairly sparse consisting primarily of weeds. Additional weed management is required in this area. Additional interseeding may also be necessary.
