**MINERALS PROGRAM INSPECTION REPORT**  
**PHONE: (303) 866-3567**

<b>MINE NAME:</b> Siloam Mine	<b>MINE/PROSPECTING ID#:</b> M-1977-326	<b>MINERAL:</b> Clay (general) and ag	<b>COUNTY:</b> Pueblo
<b>INSPECTION TYPE:</b> Monitoring	<b>INSPECTOR(S):</b> Patrick Lennberg	<b>INSP. DATE:</b> July 14, 2020	<b>INSP. TIME:</b> 15:15
<b>OPERATOR:</b> General Shale Brick, Inc.	<b>OPERATOR REPRESENTATIVE:</b> Jason McGraw	<b>TYPE OF OPERATION:</b> 110c - Construction Limited Impact	
<b>REASON FOR INSPECTION:</b> Normal I&E Program	<b>BOND CALCULATION TYPE:</b> Complete Bond	<b>BOND AMOUNT:</b> \$28,000.00	
<b>DATE OF COMPLAINT:</b> NA	<b>POST INSP. CONTACTS:</b> None	<b>JOINT INSP. AGENCY:</b> None	
<b>WEATHER:</b> Cloudy	<b>INSPECTOR'S SIGNATURE:</b>

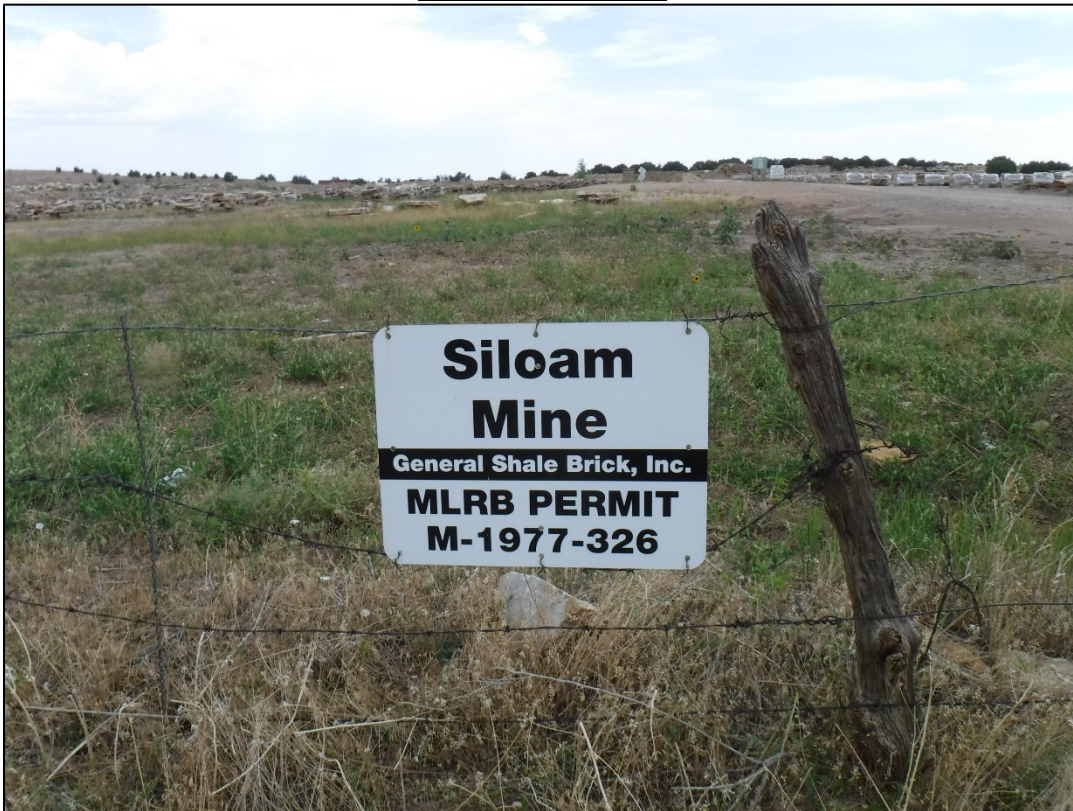
The Siloam Mine is located in Pueblo County approximately 20 miles southwest of Pueblo, Colorado. The mine is a 110 construction materials permit for 9.9 acres. The primary commodity being mined at the site is clay. The approved post-mining land use is rangeland. The mine site was surrounded by the following land uses: industrial/commercial, mining, rural residential and rangeland. The Siloam Mine is located within the permit boundary of the 112c Bedrock Mine #1 (M1997-086) and is immediately east of the 110c Pinon Mine (M1997-094) both operated by Siloam Stone Inc. The two operators have a working relationship where they operate and stockpile materials on each other's permit areas. A mine sign was observed as required by Rule 3.1.12.

**Photo 1:** Mine sign at entrance to mine site

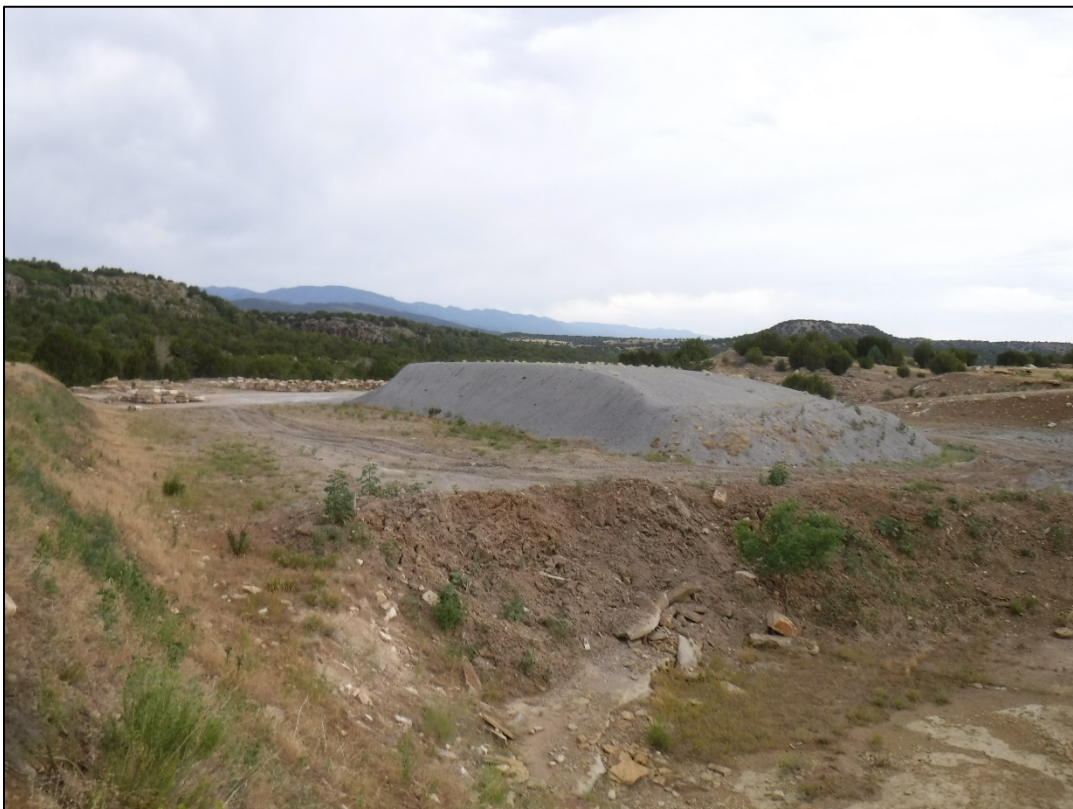
**Photo 2:** Stockpile of gray clay product used to load trucks

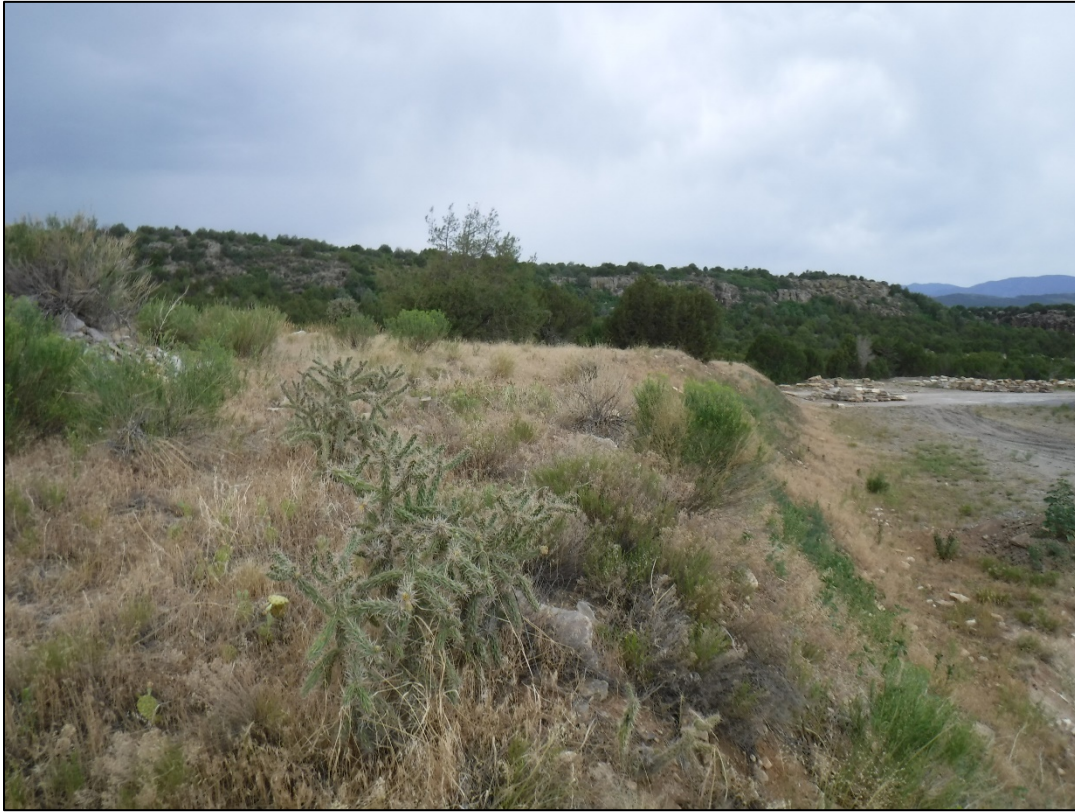
**Photo 3:** Well vegetated stockpile of topsoil

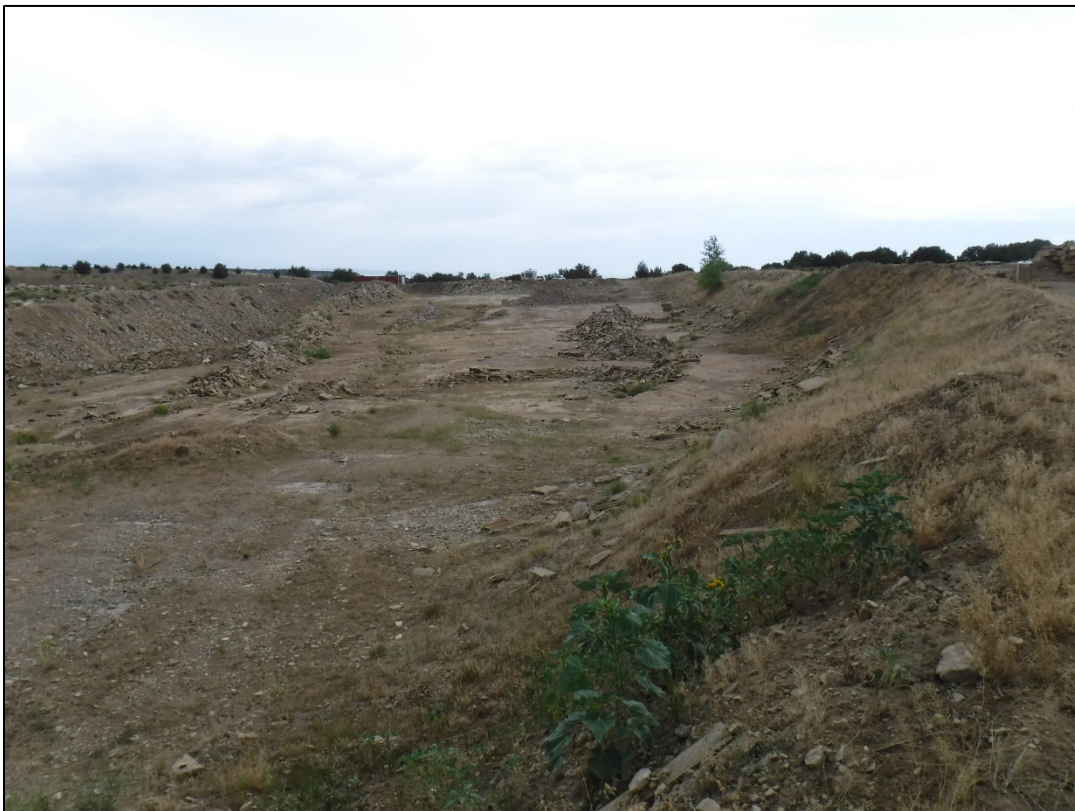
**Photo 4:** Mined area of permit, topsoil/overburden stockpile to right of photo

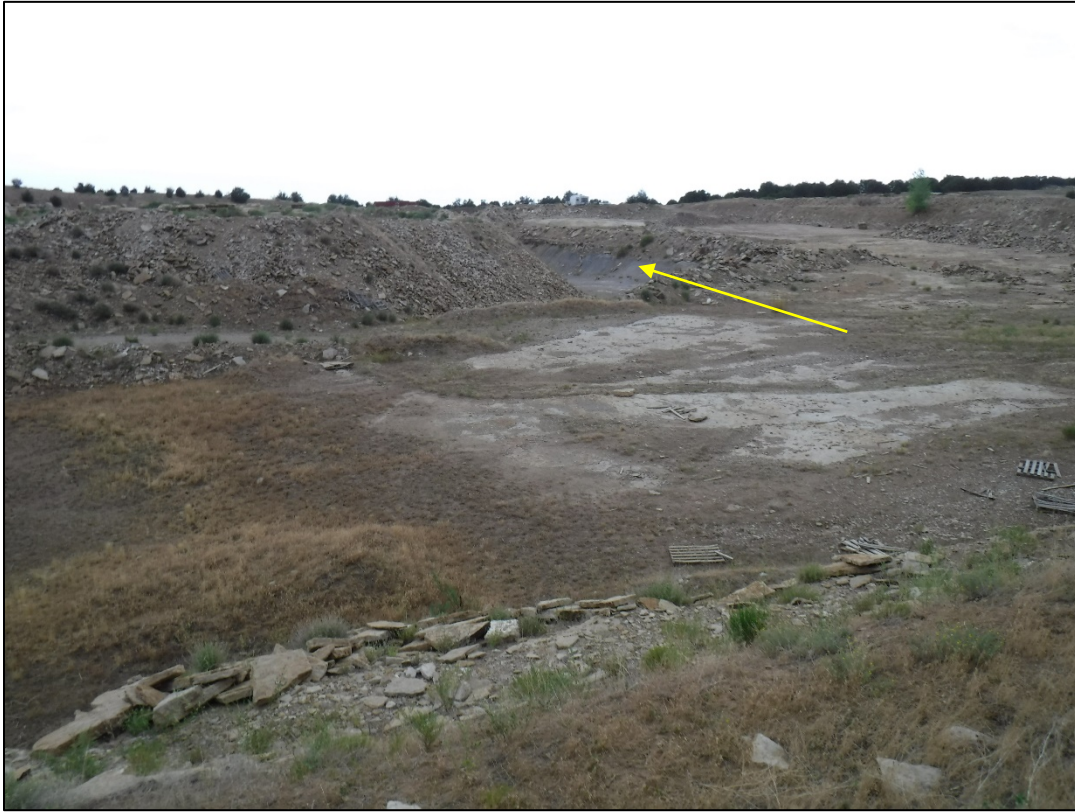
**Photo 5:** Southern extent of mining highwall, indicated by arrow

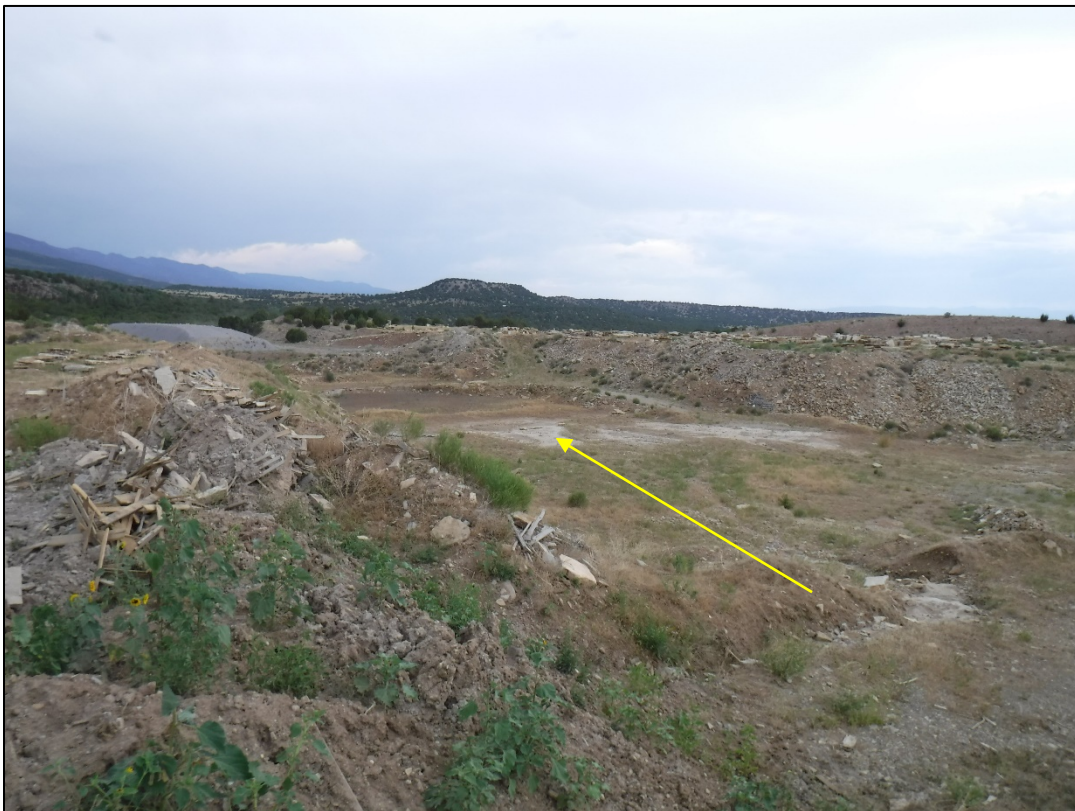
**Photo 6:** Area of potential pond (arrow) that should be graded to prevent ponding

The site was not active at the time of the inspection. Typically mining occurs to produce a large stockpile of material that is then used to load trucks on an as-needed basis. A large stockpile of gray material was observed at the site. The Operator indicated that the stockpile could last a couple of years. The mining pit highwall was observed to be approximately 400 to 500 feet long and 10 to 15 feet in height. Topsoil and overburden stockpiles were located around the perimeter of the permit boundary. All stockpiles were stable and had good diverse vegetation growing upon them. All haul roads associated with the permit were in stable condition. It appears that stormwater drains into the permit area but does not appear to detain water for long periods of time. An area was pointed out to the Operator where water may collect for longer periods of time. It was suggested that when mining resumes that this area be filled in to eliminate potential ponding.
