COLORADO
Division of Reclamation,
Mining and Safety
Department of Natural Resources

Permit Number: C-1981-019 Mine Name: Colowyo Coal Mine Operator: Colowyo Coal Company L.P. Operator Address: Mr Tony Tennyson 5731 State Highway 13 Meeker, CO 81641	County: Moffat, Rio Blanco Operation Type: Surface Permit Status: Active Ownership: Private
	Operator Representative Present: Tom Fry
Operator Representative Signature: (Field Issuance Only)

Inspection Start Date: July 23, 2020 Inspection Start Time: 07:00 Inspection End Date: July 23, 2020 Inspection End Time: 14:00		Inspection Type: Coal Partial Inspection Inspection Reason: Normal I&E Program Weather: Clear	
Joint Inspection Agency: None		Joint Inspection Contacts: None	
Post Inspection Agency: None		Post Inspection Contacts: None	
Inspector(s): Zach Trujillo	Inspector's Signature:

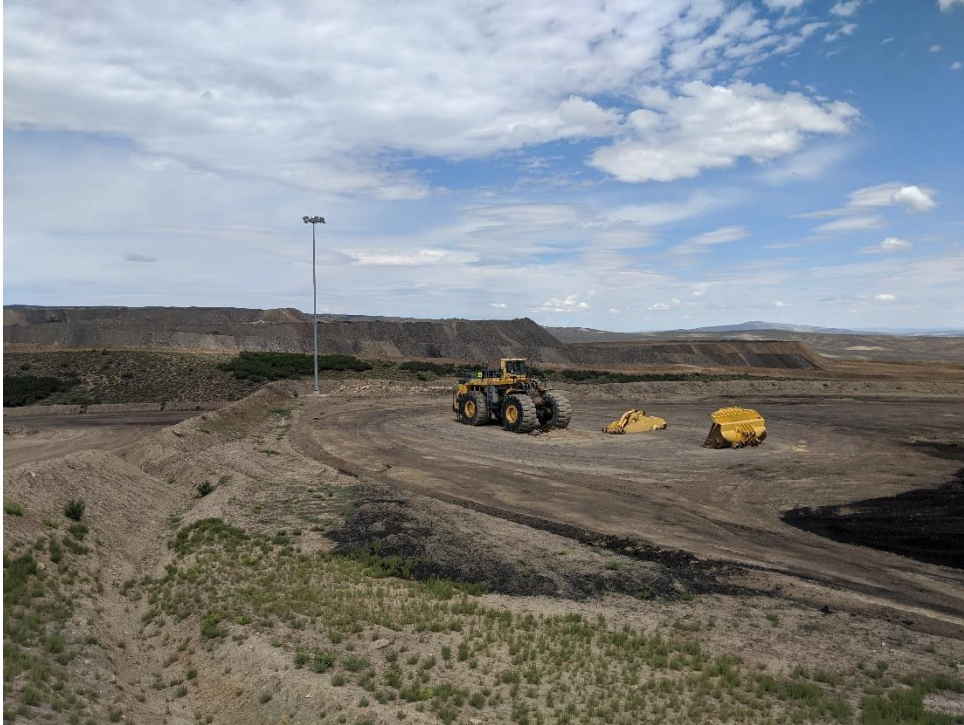
The Collom Temporary Spoil Pile continues to expand. With the approval and issuance of MR-219, Colowyo has been approved to expand the total volume of the spoil pile by 5.5 million cubic yards. Spoil is being placed in lifts and expanding to the north.

Collom Temporary Spoil Pile.

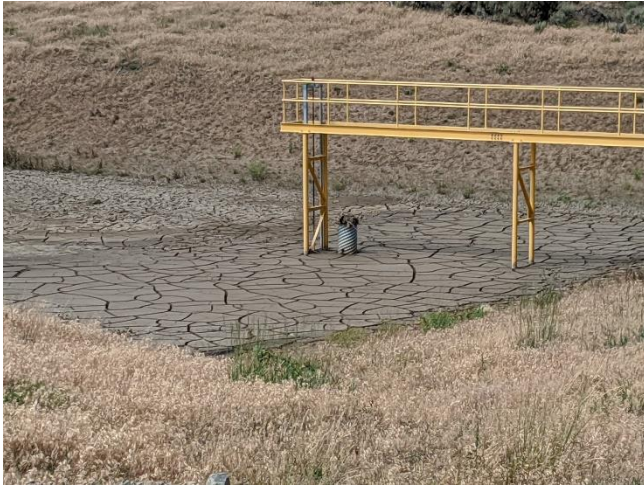
Most ponds held minimal water with no discharge or were dry. Section 36 pond had sediment levels up to the weep hole of the primary discharge. Section 36 Pond is the first of a series of three sediment pond and any discharge from the Section 36 pond will then flow into the Middle and Section 25 ponds before final discharge. Maintenance was being performed at the Stoker Siding Pond. The primary discharge was being replaced at the time of the inspection. Water from the Stoker pond was pumped out prior to the maintenance allowing for the embankment to be excavated and a new primary discharge to be installed. All ponds were stable and functional.

Section 36 Pond.

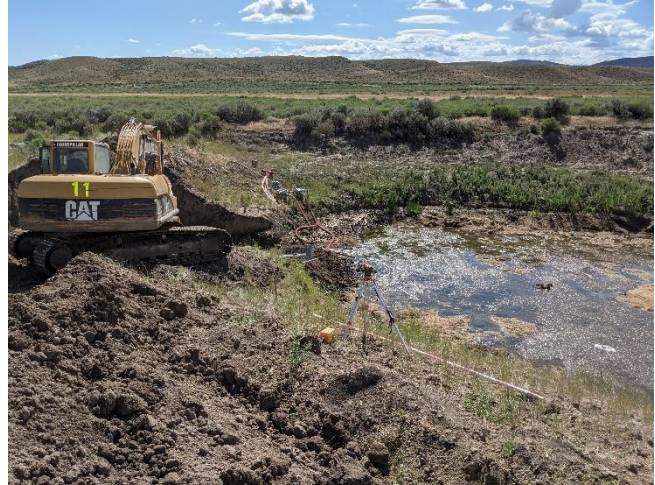
Stoker Pond maintenance.

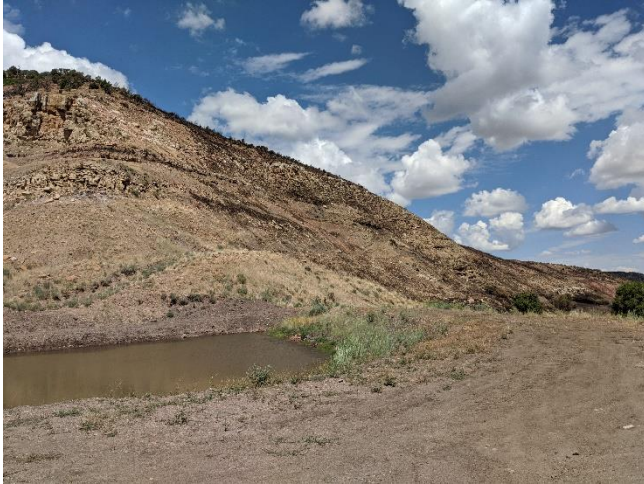
On July 7, 2020, a wildfire occurred within the Colowyo Mine permit boundary as well as adjacent lands. The fire spread along the Highway 13 corridor from the Streeter Pond north to the Wilson Reservoir and roughly burned 1,600 acres. The wildfire was not related to mining activities associated with Colowyo.

Burn area from Streeter Pond.
