MINERALS PROGRAM INSPECTION REPORT
PHONE: (303) 866-3567

MINE NAME: Pinon Mine	MINE/PROSPECTING ID#: M-1997-094	MINERAL: Stone	COUNTY: Pueblo
INSPECTION TYPE: Monitoring	INSPECTOR(S): Patrick Lennberg	INSP. DATE: July 14, 2020	INSP. TIME: 13:50
OPERATOR: Siloam Stone, Inc.	OPERATOR REPRESENTATIVE: Matt Mueller	TYPE OF OPERATION: 110c - Construction Limited Impact	
REASON FOR INSPECTION: Normal I&E Program	BOND CALCULATION TYPE: Complete Bond	BOND AMOUNT: \$8,300.00	
DATE OF COMPLAINT: NA	POST INSP. CONTACTS: None	JOINT INSP. AGENCY: None	
WEATHER: Cloudy	INSPECTOR'S SIGNATURE:

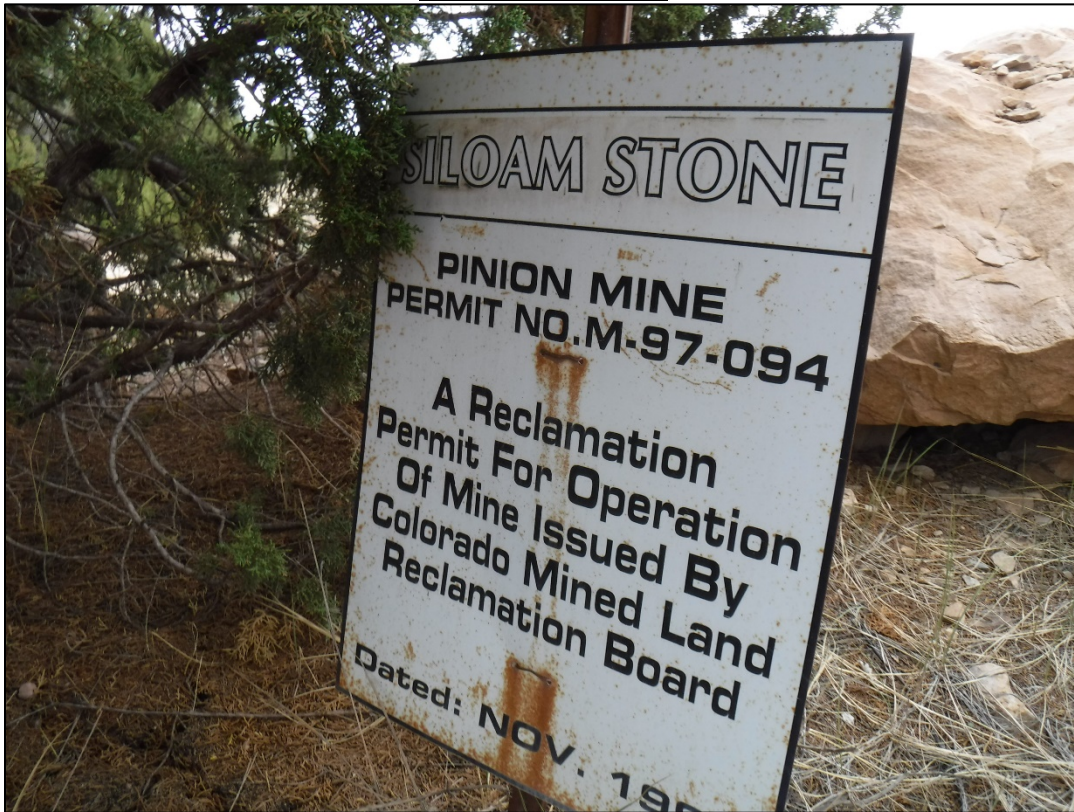
The Pinon Mine is located in Pueblo County approximately 20 miles southwest of Pueblo, Colorado. The mine is a 110 construction materials permit for 6.3 acres. The primary commodity that was mined at the site was decorative sandstone. The approved post-mining land use is rangeland. The mine site was surrounded by the following land uses: industrial/commercial, mining, rural residential and rangeland. The Pinon Mine is located within the permit boundary of the 112c Bedrock Mine #1 (M1997-086), also operated by Siloam Stone, and is immediately west of the 110c Siloam Mine (M1977-326) operated by General Shale. The two operators have a working relationship where they operate and stockpile materials on each other's permit areas. A mine sign was observed as required by Rule 3.1.12. The Division recommended relocating the mine sign to the main entrance with the other mine signs.

Photo 1: Mine sign at entrance to mine site

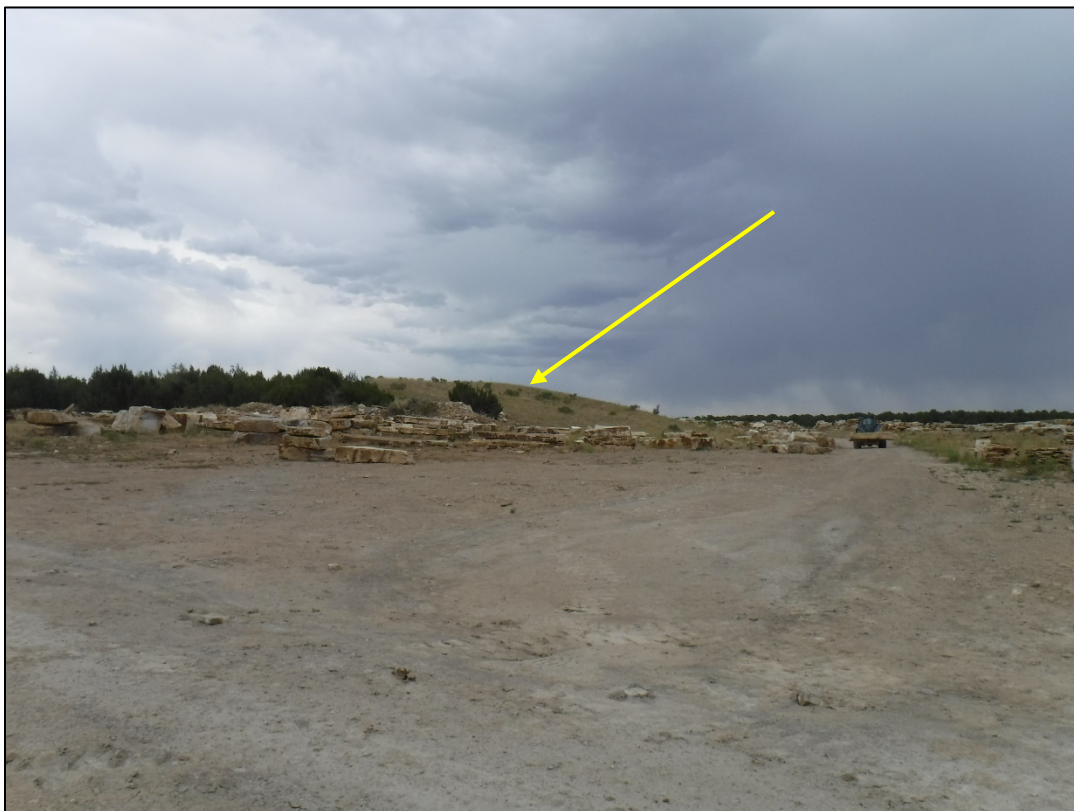
The mine was not active at the time of inspection. However, the permit area is being used for a variety of purposes related to the Bedrock Mine #1. There are pallets of product that are being stored in the permit area, various haul roads crisscross the permit, and there are stockpiles of overburden and topsoil on the permit area. The mining of the permit area was completed a while ago and the affected land was reclaimed with only seeding remaining. There was plant growth on the overburden and topsoil stockpiles, and throughout the rest of the affected lands. The growth in the affected area and on stockpiles appears to be volunteer vegetation, comprised of annual weeds, and native vegetation. The growth on the stockpiles is sufficient to prevent wind and water erosion.

Photo 2: Looking east across the permit area, topsoil stockpile yellow arrow

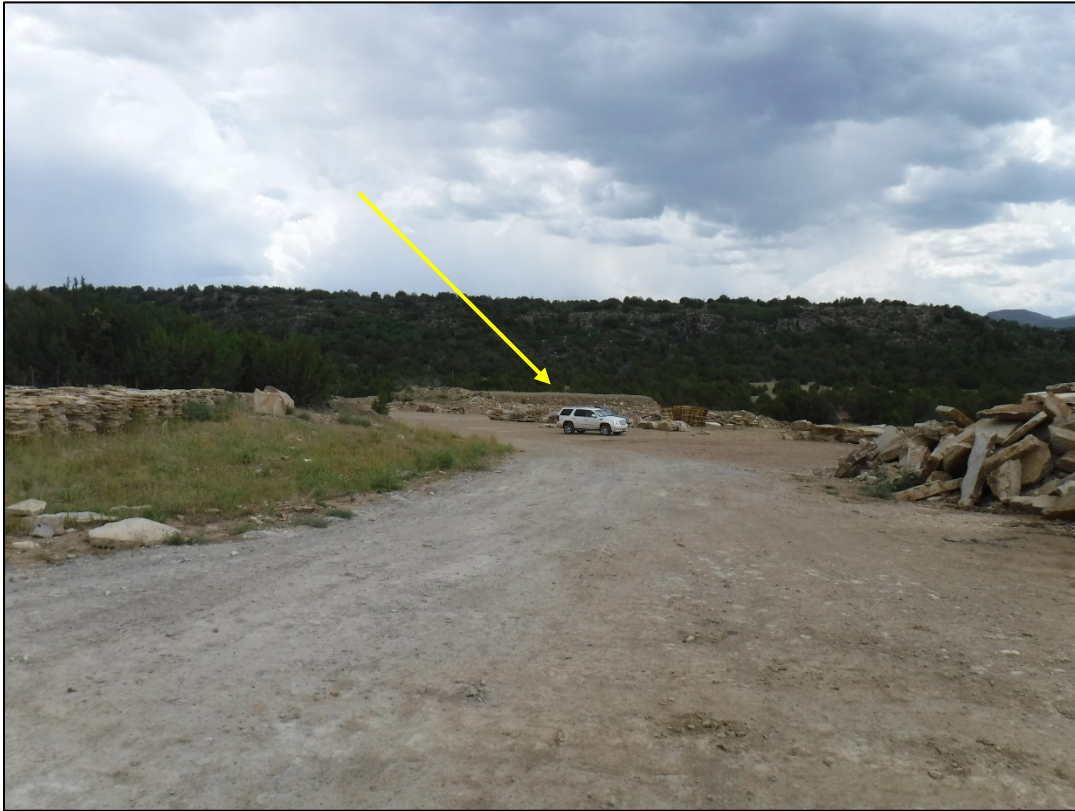
Photo 3: Looking southwest across the permit area, topsoil stockpile

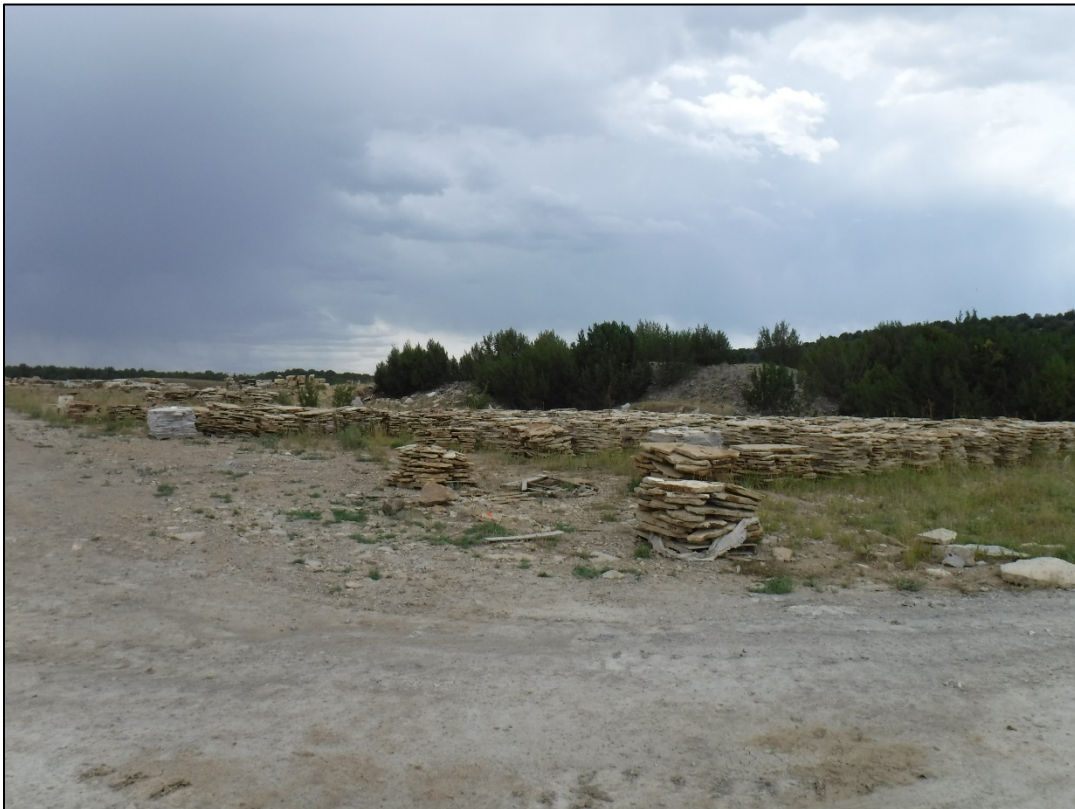
Photo 4: Pre-law stockpile located immediately outside the permit boundary
