**PERMIT INFORMATION**

<b>Permit Number:</b> C-1981-018 <b>Mine Name:</b> Deserado Mine <b>Operator:</b> Blue Mountain Energy, Inc. <b>Operator Address:</b> Mr. Kurtis Blunt 3607 County Road 65 Rangely, CO, 81648	<b>County:</b> Moffat, Rio Blanco <b>Operation Type:</b> Underground <b>Permit Status:</b> Active <b>Ownership:</b> Private
	<b>Operator Representative Present:</b>  Kurt Blunt
<b>Operator Representative Signature:</b> (Field Issuance Only)

<b>Inspection Start Date:</b> July 22, 2020 <b>Inspection Start Time:</b> 11:15 <b>Inspection End Date:</b> July 22, 2020 <b>Inspection End Time:</b> 13:20		<b>Inspection Type:</b> Coal Partial Inspection <b>Inspection Reason:</b> Normal I&E Program <b>Weather:</b> Cloudy	
<b>Joint Inspection Agency:</b>  None		<b>Joint Inspection Contacts:</b>  None	
<b>Post Inspection Agency:</b>  None		<b>Post Inspection Contacts:</b>  None	
<b>Inspector(s):</b>  Clayton Wein	<b>Inspector's Signature:</b>  <i>Clayton Wein</i>		<b>Signature Date:</b>  7/30/2020

This was a partial inspection of the Deserado Mine conducted on July 22, 2020. The inspection was completed by Clayton Wein of the Division. Kurt Blunt of Blue Mountain Energy, Inc. (BME) wa

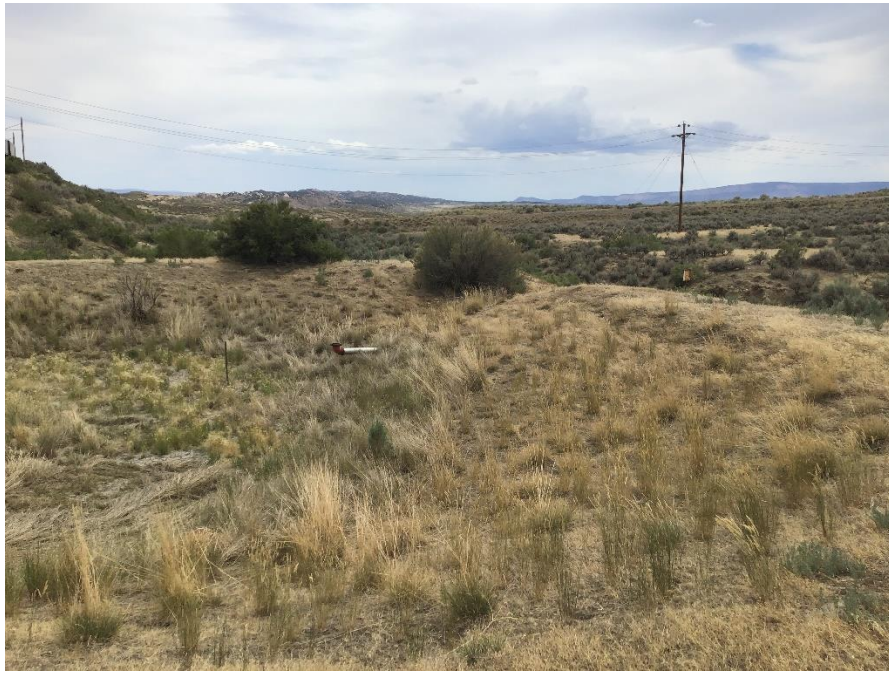
The pond (RR-1) and Sump (RS-1) located on the south side of the rail loadout were inspected. The RR-1 Pond was dry during the inspection (Photo 1). The embankment was vegetated and stable. There were no indications of erosional features. The spillway was clear of debris. The RS-1 Sump was also dry during the inspection. The embankments of the sump were stable with vegetation. There were no indications of erosion. The outlet for the sump was in good repair and was unobstructed.

**Photo 1:** The embankment of the RR-1 Pond.

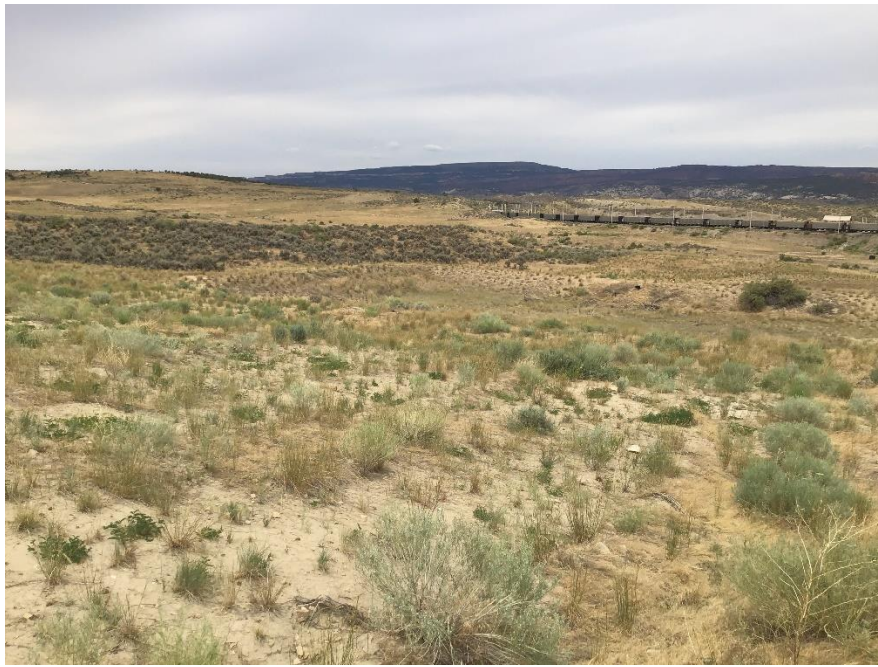
The SS-2 Pond (Photo 2) located at the northwest base of the Slot Storage was dry at the time of the inspection. The embankment for the pond was vegetated and stable. There were no erosional features identified. The outlet for the pond was clear of debris.

**Photo 2:** The SS-2 Pond.

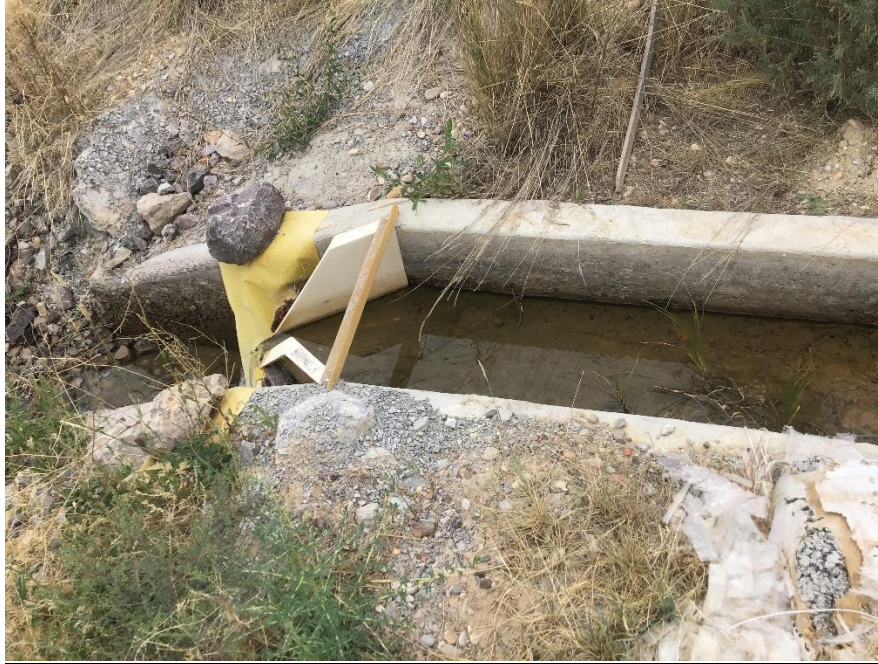
All Cells of the B Seam No. 1 Dewatering system were impounding water. The embankments between the cells were vegetated and stable. There were no erosional features. The Last Chance Pond was completely full and discharging through the primary spillway (Photo 3). The embankment of the pond was stable with vegetation. There were no indications of erosion. The primary spillway was clear of debris.

**Photo 3:** The discharging outlet of the Last Chance Pond.

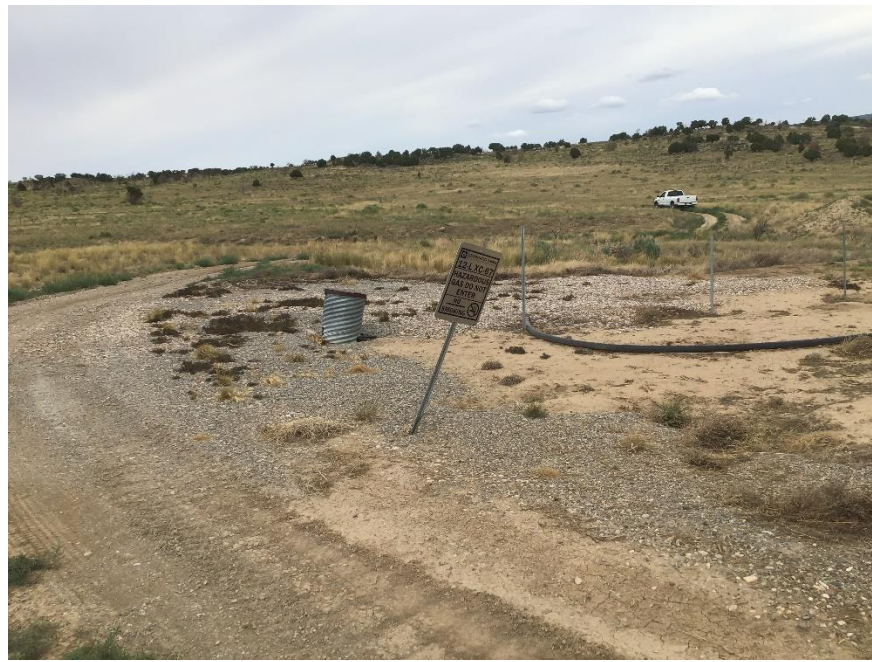
Several nitrogen injection pads and one return shaft were inspected. Inspected injection pads included; 12-L XC-67 (Photo 4), 12-I XC-53 (Photo 5), 13-L XC-60, 13-L XC-47 and a couple others. The pads for the sites were stable. The gravel on the pads was intact and well distributed. There were no erosional features identified at the sites. No off- site impacts had occurred. The 13 L shaft (Photo 6) was included in the inspection. The pad was stable There were no erosional features on the pad. The cut-slope for the pad was stable and there were no signs of sloughage. The fill slope of the pad was stable with vegetation. There were no erosional features.

**Photo 4:** The 12-L XC-67 Pad.

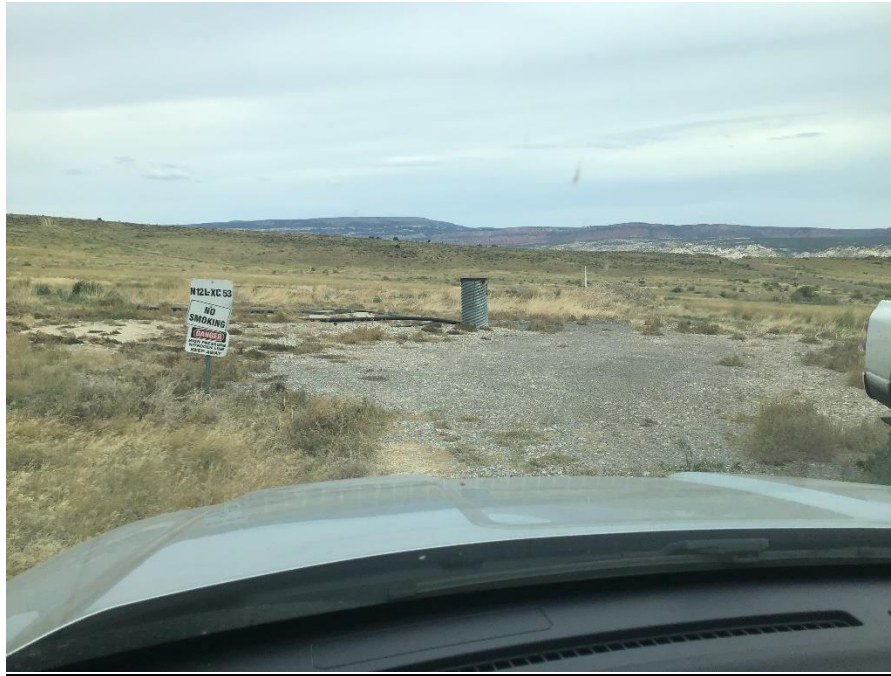
**Photo 5:** The 13-L XC-53 Pad.

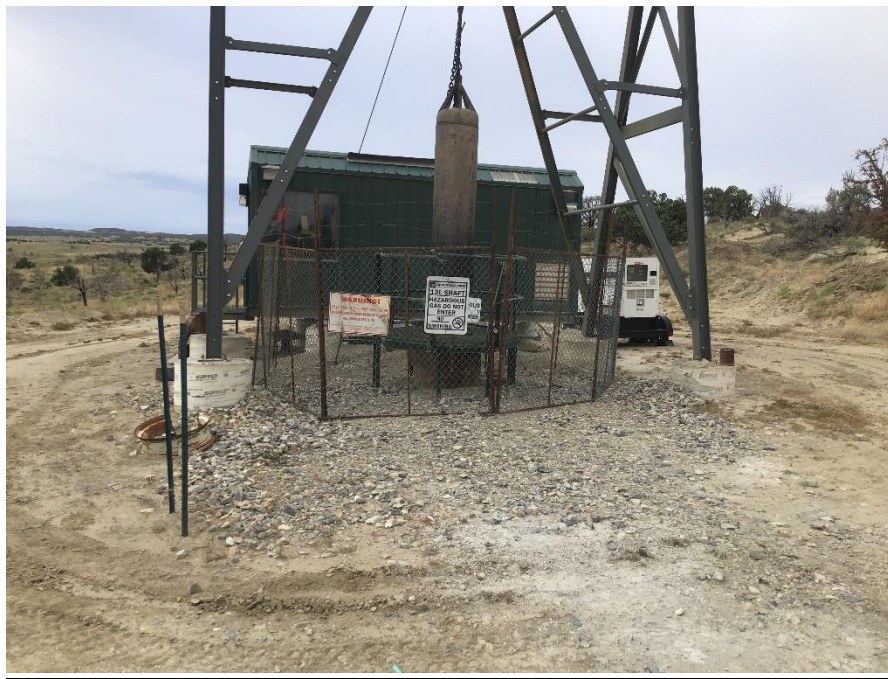
**Photo 6:** The 13 L Return Shaft and pad.
