MINERALS PROGRAM INSPECTION REPORT
PHONE: (303) 866-3567

MINE NAME: Bedrock Mine #1	MINE/PROSPECTING ID#: M-1997-086	MINERAL: Stone and stone	COUNTY: Pueblo
INSPECTION TYPE: Monitoring	INSPECTOR(S): Patrick Lennberg	INSP. DATE: July 14, 2020	INSP. TIME: 14:00
OPERATOR: Siloam Stone, Inc.	OPERATOR REPRESENTATIVE: Matt Mueller	TYPE OF OPERATION: 112c - Construction Regular Operation	
REASON FOR INSPECTION: Normal I&E Program	BOND CALCULATION TYPE: Complete Bond	BOND AMOUNT: \$88,157.06	
DATE OF COMPLAINT: NA	POST INSP. CONTACTS: None	JOINT INSP. AGENCY: None	
WEATHER: Cloudy	INSPECTOR'S SIGNATURE:

SIGNATURE DATE: July 31, 2020

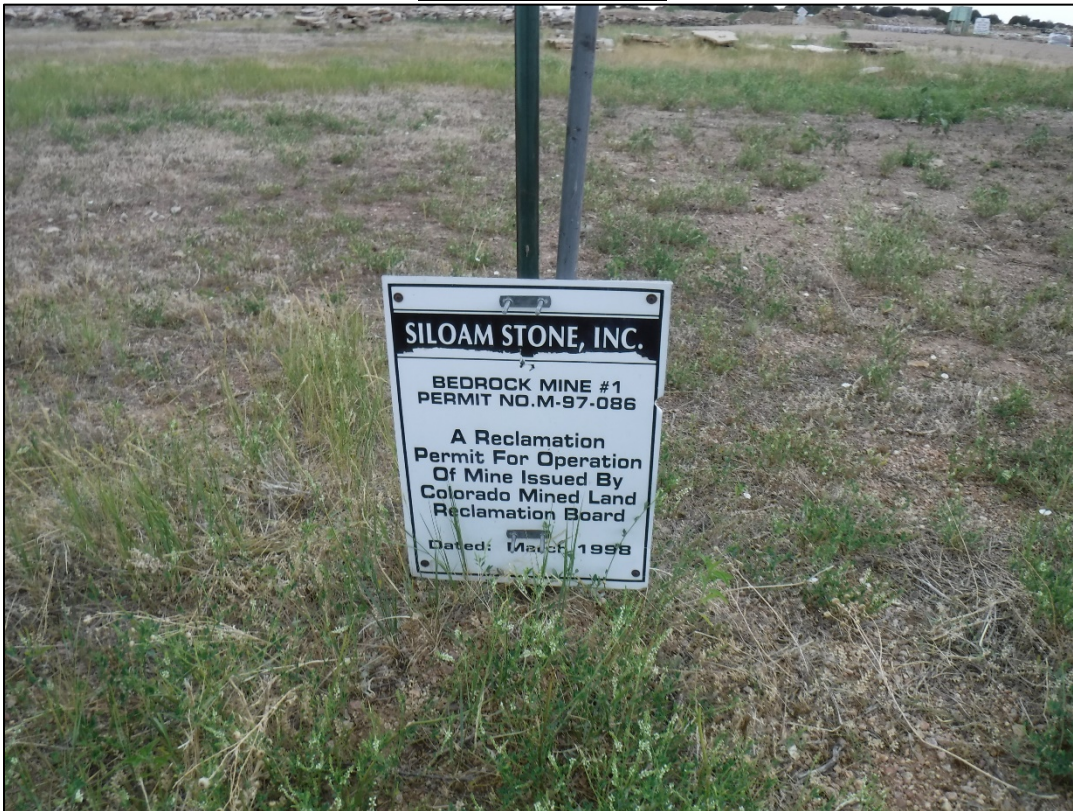
Photo 1: Mine sign at entrance to mine site

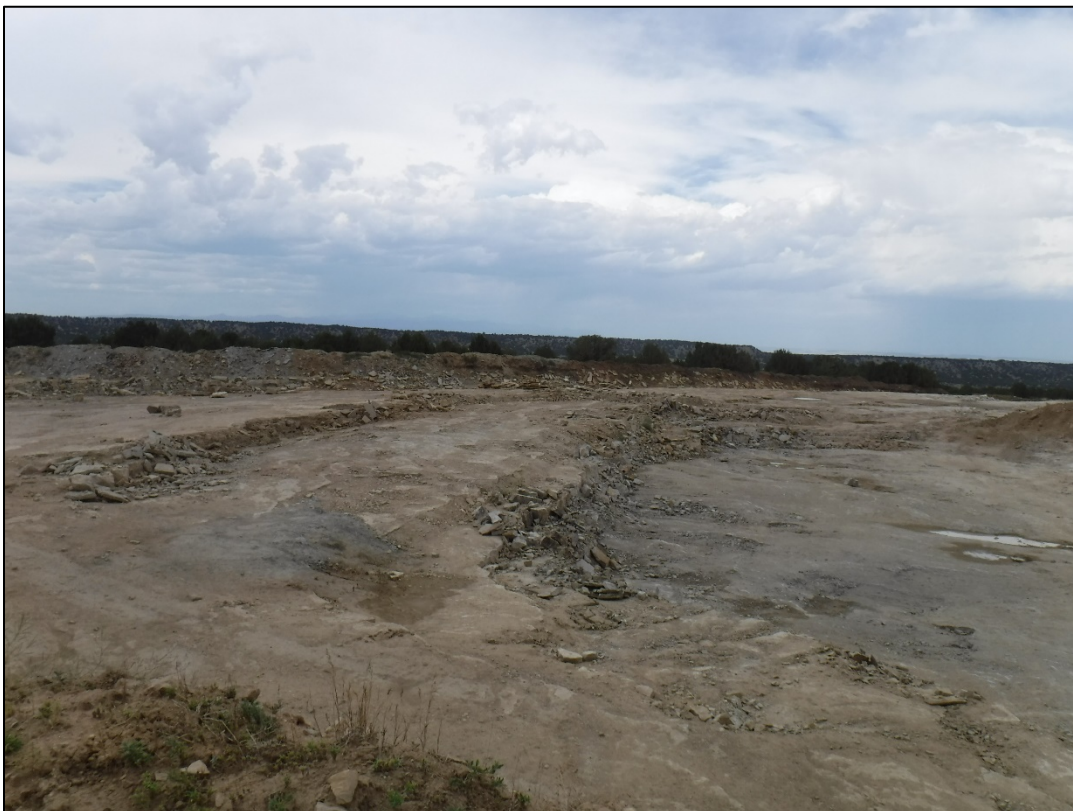
Photo 2: Typical slab stone mining pit area

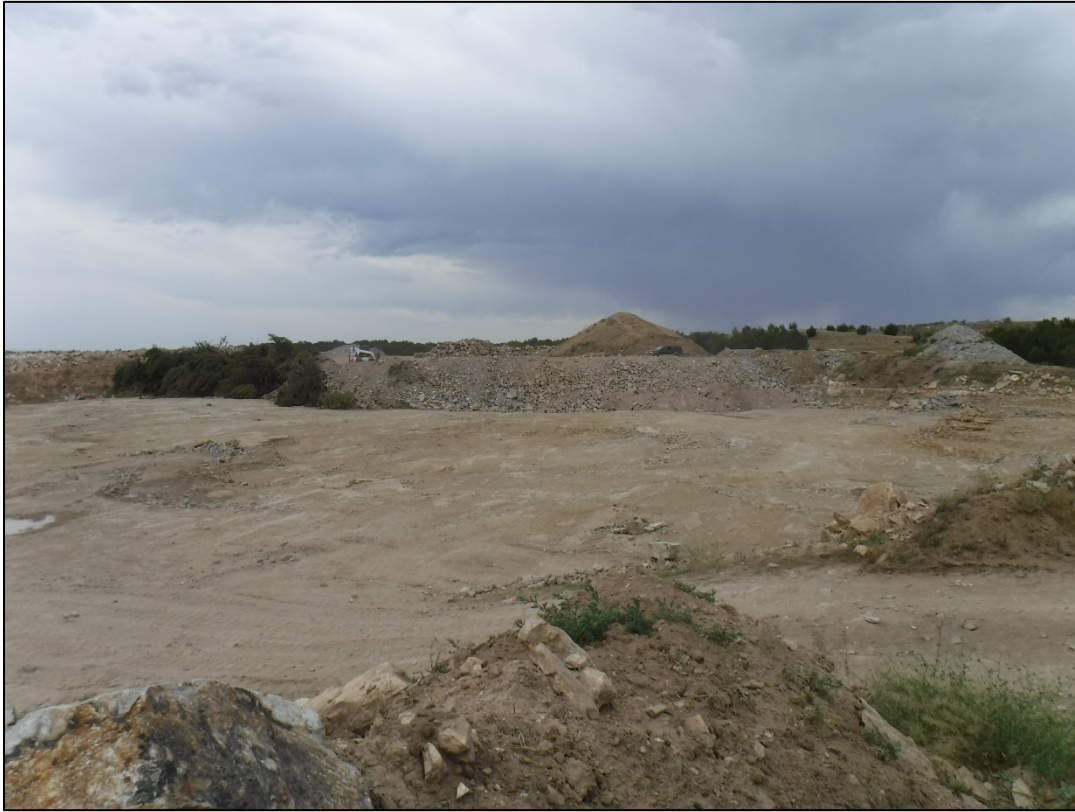
Photo 3: Slab stone mining area with overburden staged along perimeter of pit

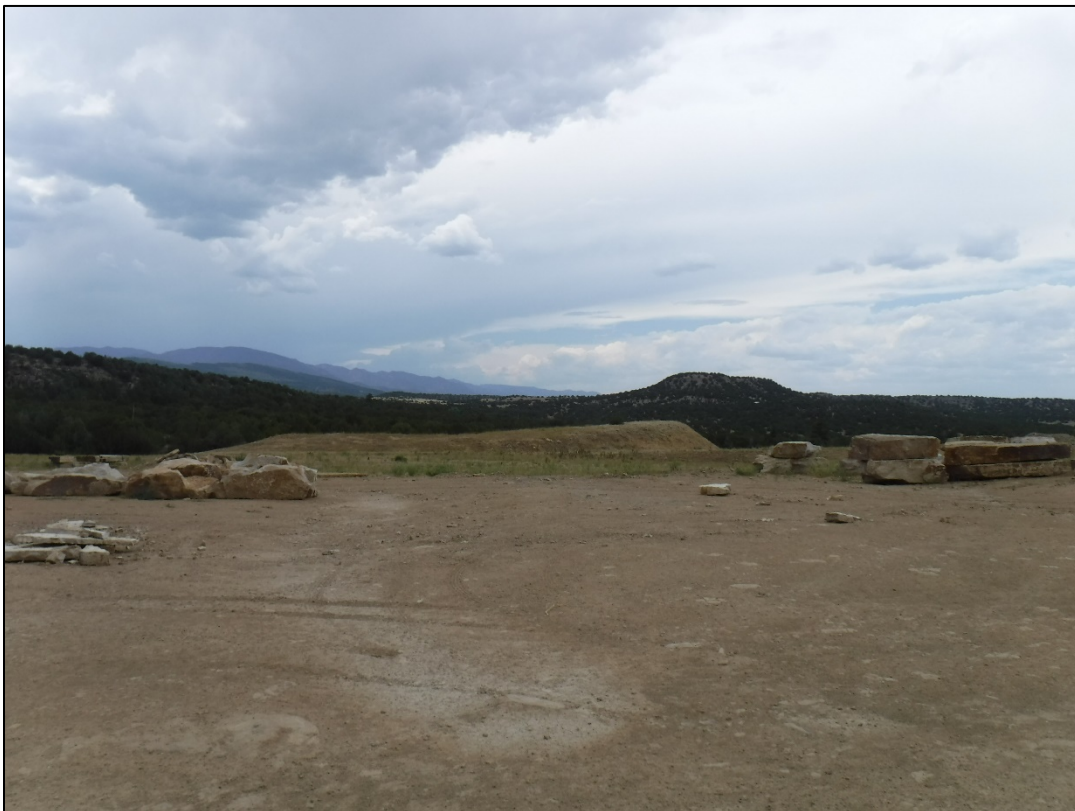
Photo 4: Topsoil stockpile (1.45 acre) located in the western portion of permit

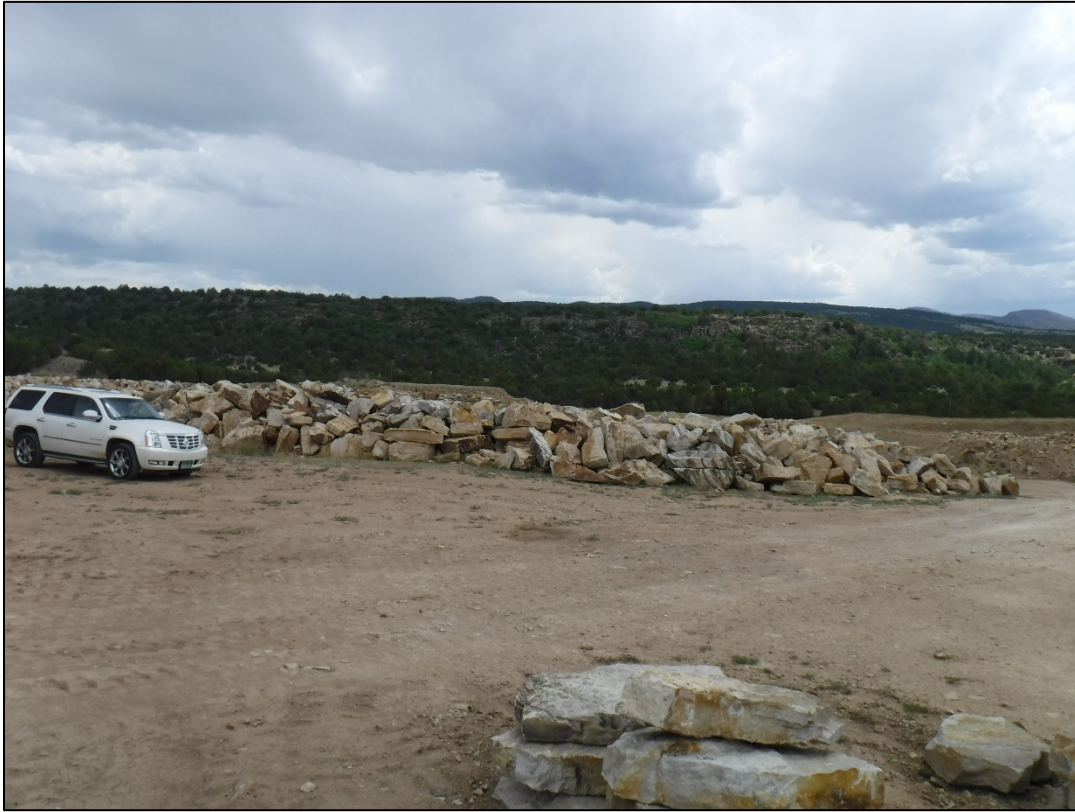
Photo 5: Stockpiled boulder product

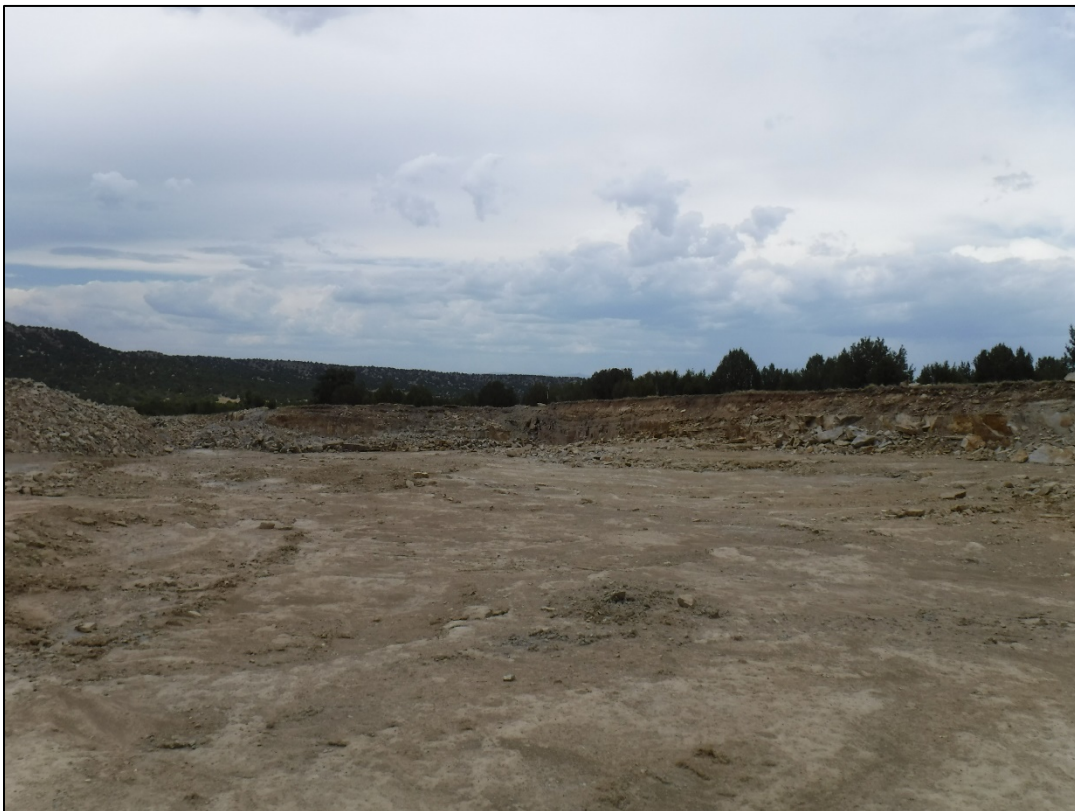
It appears that the Operator is conducting concurrent reclamation as mining progresses. As an area is mined out overburden material is used to backfill the pit area. There is a highwall located in the northwestern portion of the mining area and it was estimated to be 1,000 feet long and 10 to 15 feet in height. Numerous topsoil stockpiles are located throughout the permit area but most of them are located near the active mining area. These stockpiles appear to be stable with no erosion gullies visible. Volunteer vegetation consisting of annual weeds and native vegetation are growing and stabilizing the piles. All haul roads are in good condition. No groundwater was visible and stormwater appears to easily infiltrate into the ground.

Photo 6: Typical mining highwall

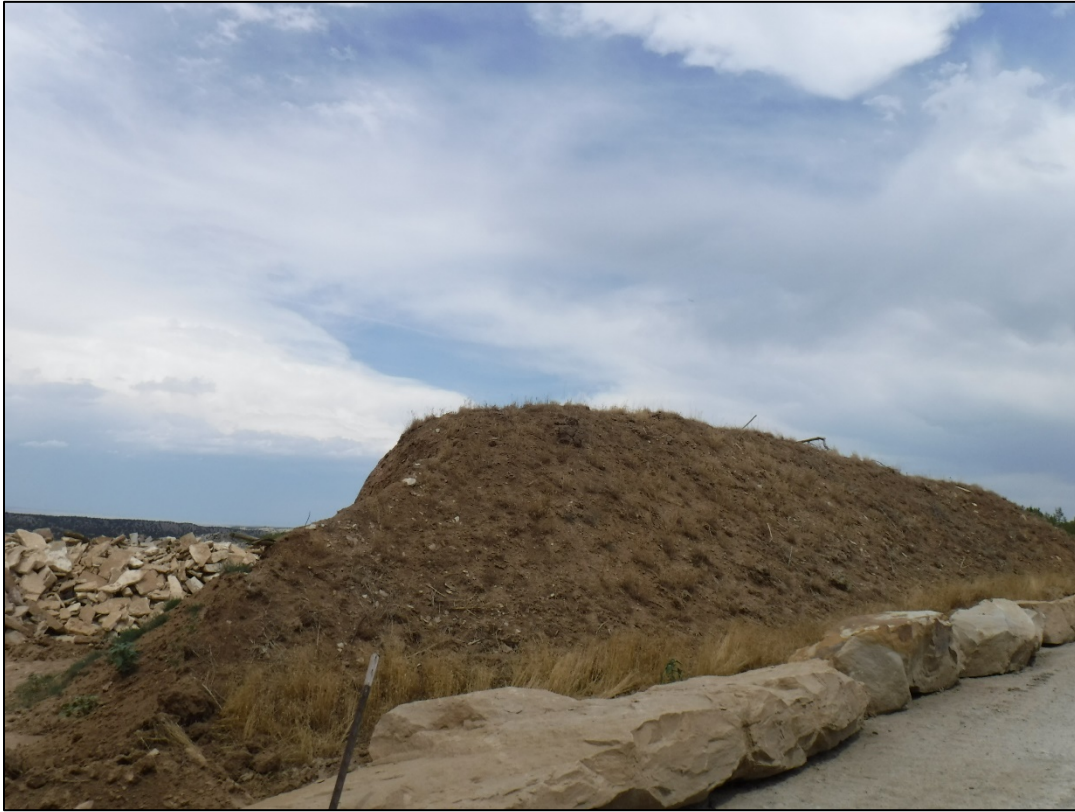
Photo 7: Topsoil stockpile located in a partially reclaimed area

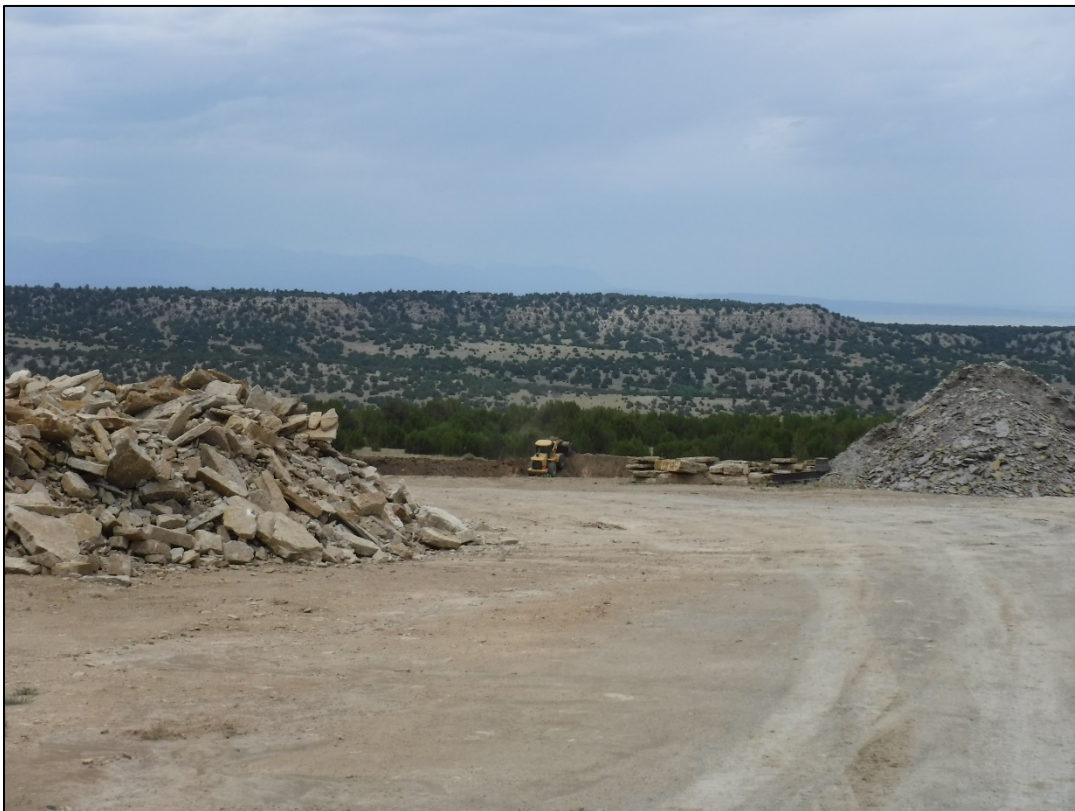
Photo 8: Clearing activities to open up additional mining area

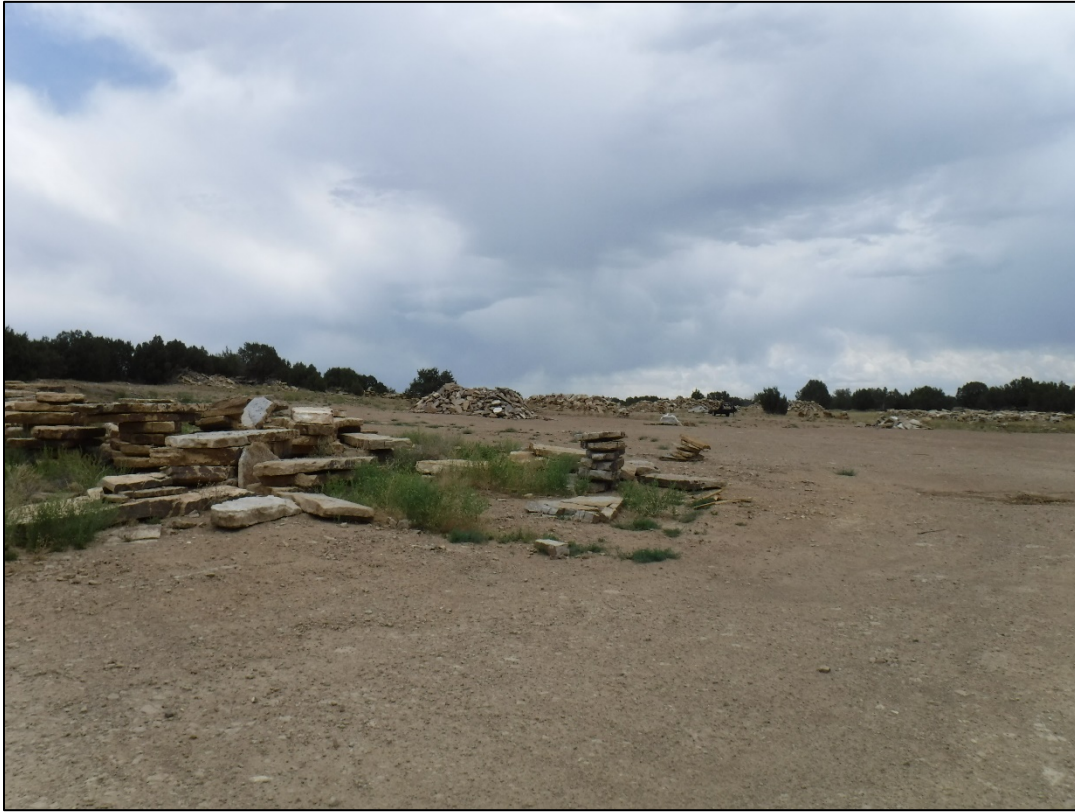
Photo 9: Processing area and temporary stone storage area, east southeast

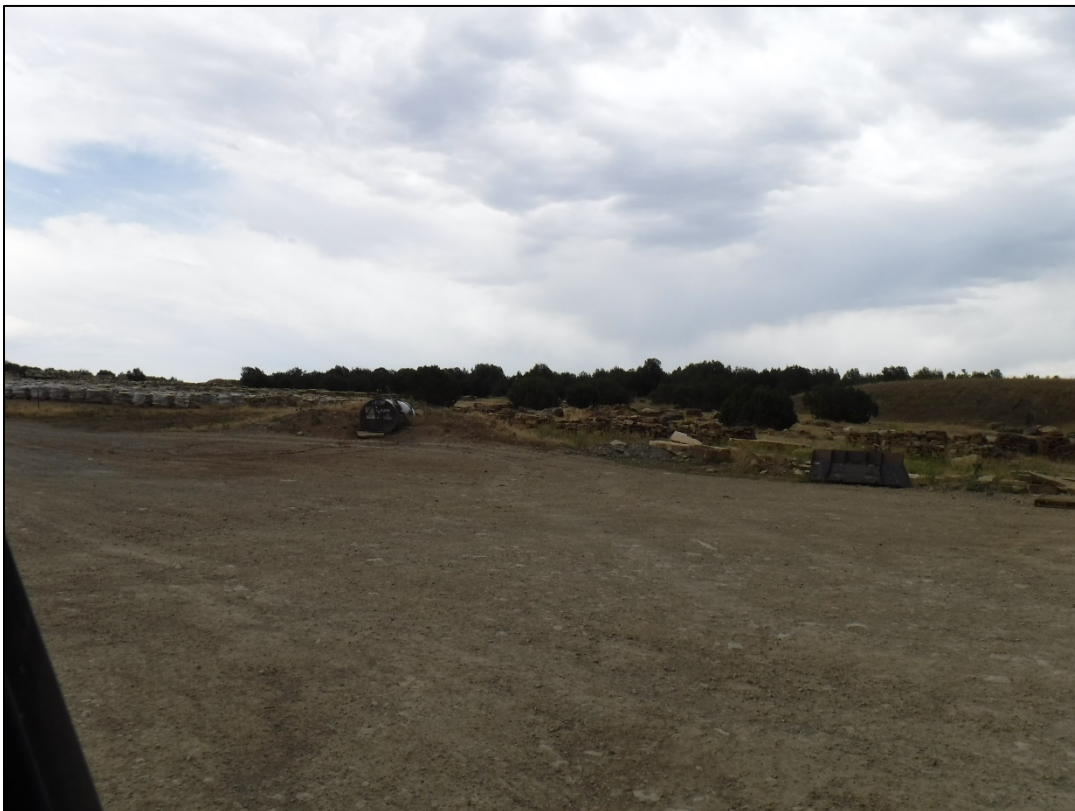
Photo 10: Processing area and temporary stone storage area, looking northeast
