**MINERALS PROGRAM INSPECTION REPORT**  
**PHONE: (303) 866-3567**

| <b>MINE NAME:</b><br>Cottonwood Pit | <b>MINE/PROSPECTING ID#:</b><br>M-1988-042 | <b>MINERAL:</b><br>Sand and gravel | <b>COUNTY:</b><br>Weld |
| <b>INSPECTION TYPE:</b><br>Monitoring | <b>INSPECTOR(S):</b><br>Peter Hays | <b>INSP. DATE:</b><br>June 26, 2020 | <b>INSP. TIME:</b><br>09:30 |

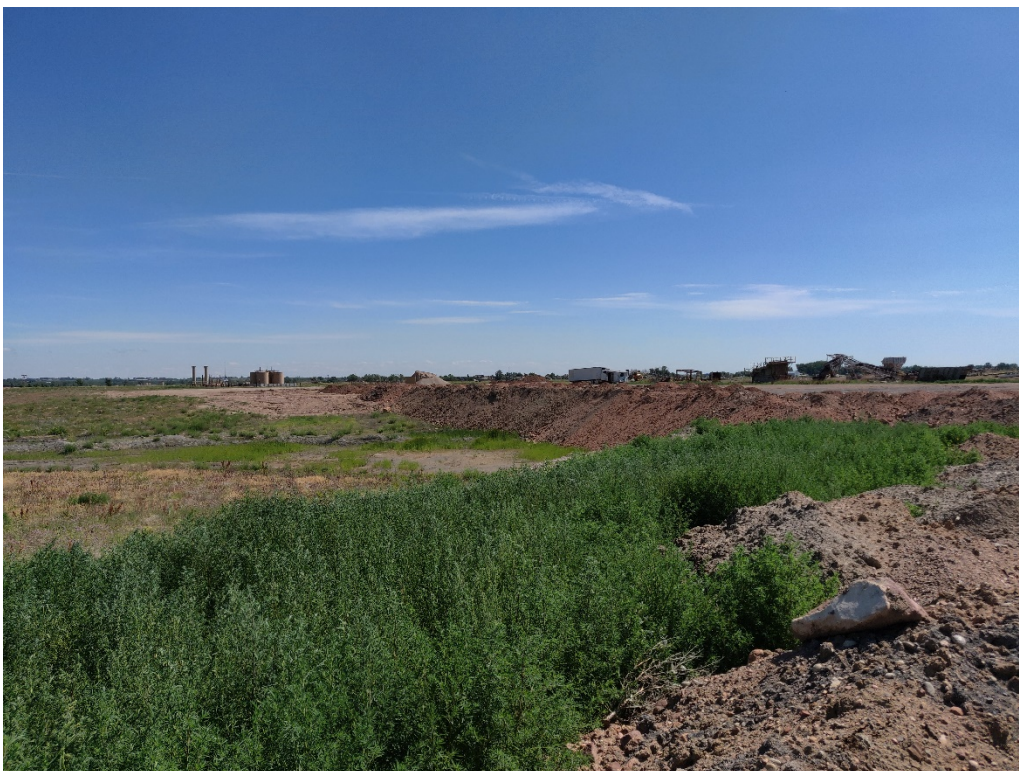
View of the backfill operation in area 8 as identified in the 2020 Annual Report Map

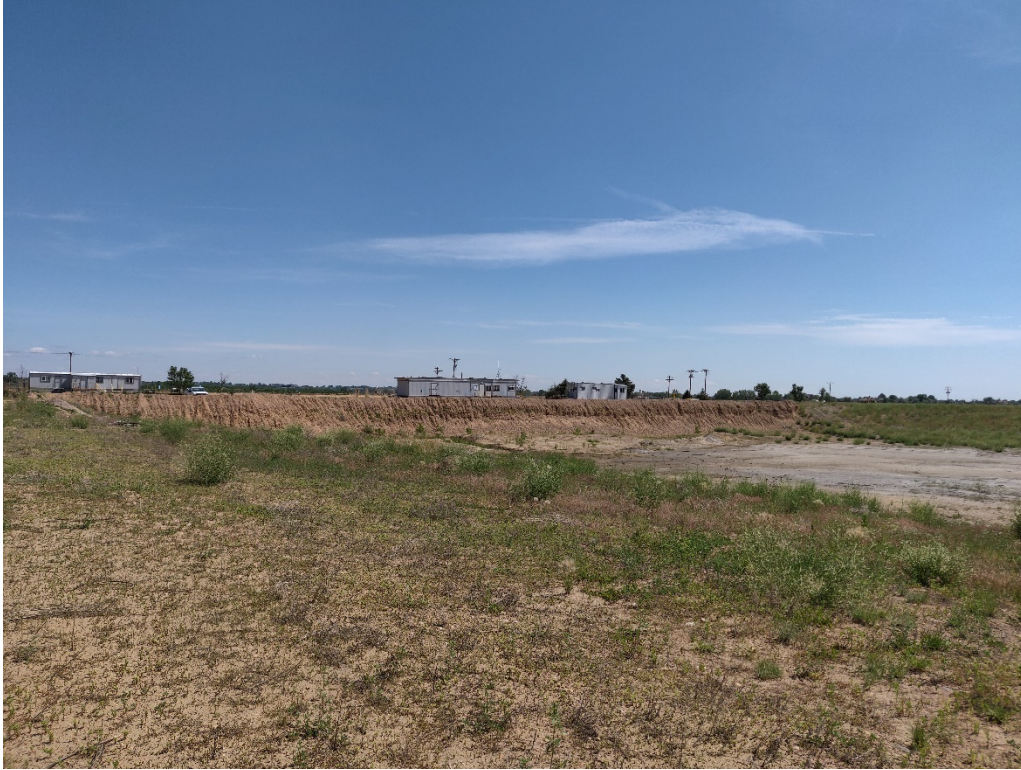
View of the last area to be mined identified as area 4 on the 2020 Annual Report Map

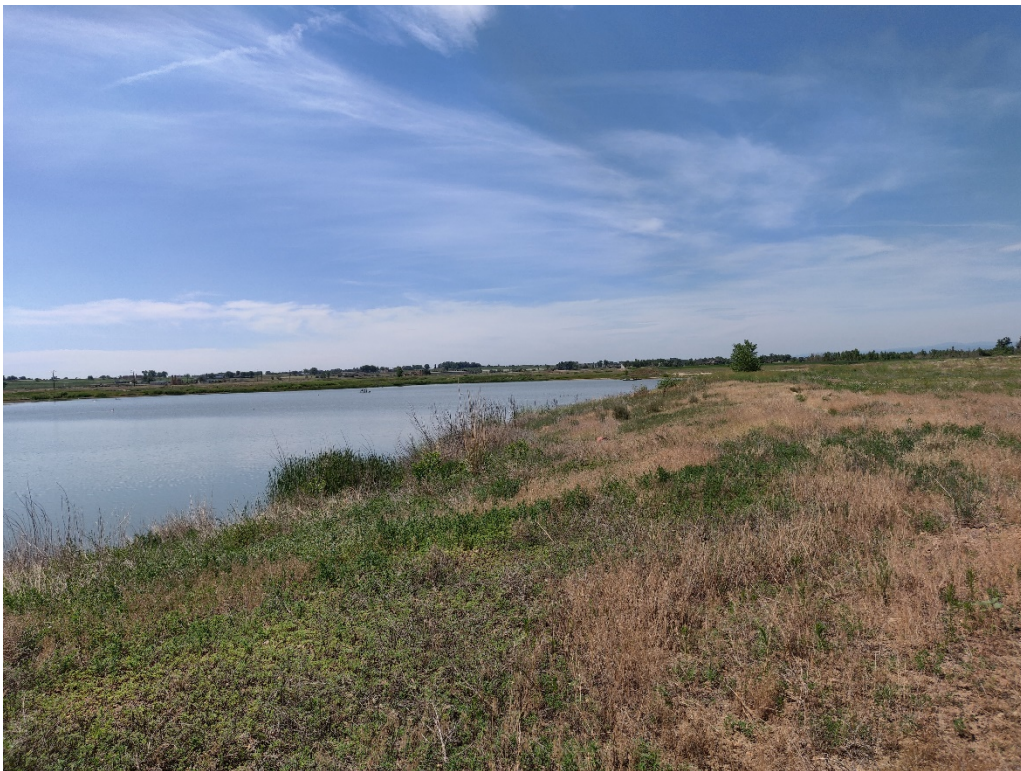
The approved post-mining land use for the site is general agriculture. Portions of mining areas CW1, CW2, CW3 and CW4 were observed to evaluate the reclamation progress. The vegetation in the areas consisted of reclamation grasses with patches of cheat grass and kochia. The Operator must implement the approved weed management plan to control the spread of the weed species. The Operator stated the reclaimed areas would be mowed soon to control the annual and noxious weeds.

View of the west shoreline of CW4 looking south

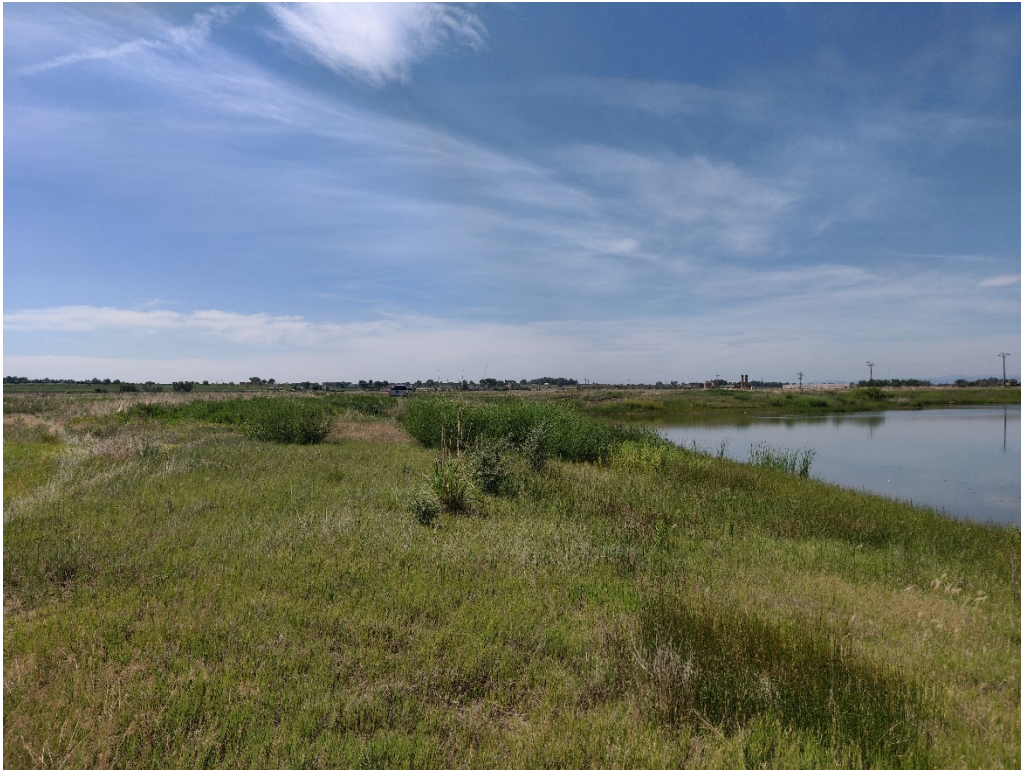
View of the east shoreline of CW4 looking south

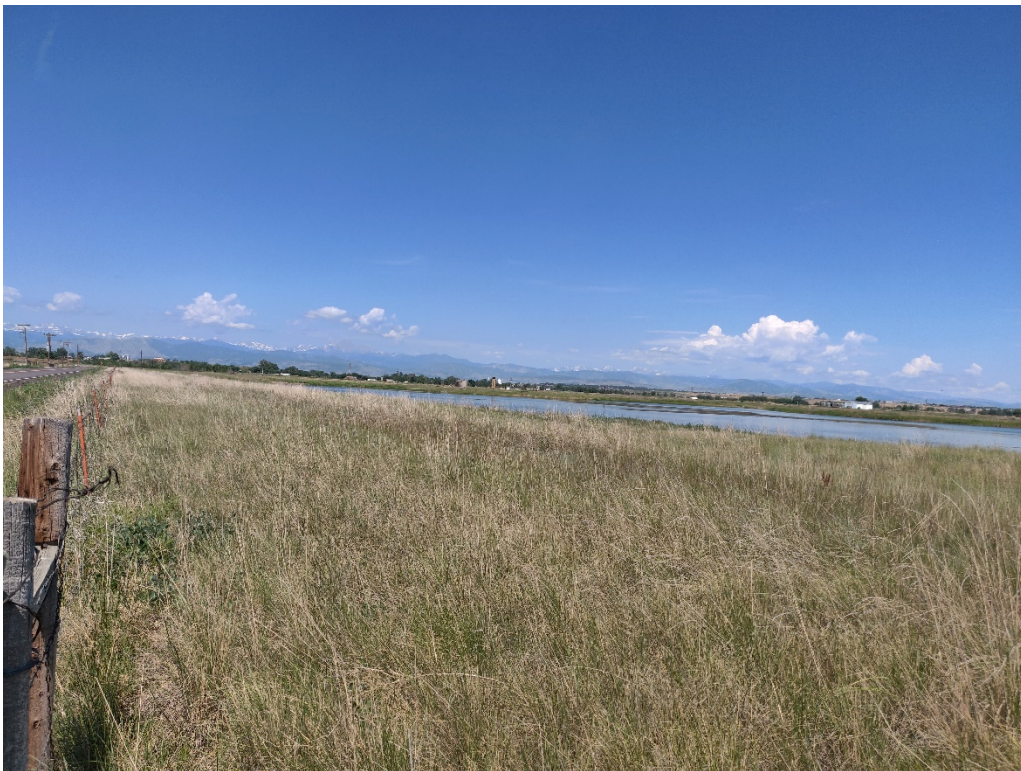
View of the south shoreline of CW3 looking west

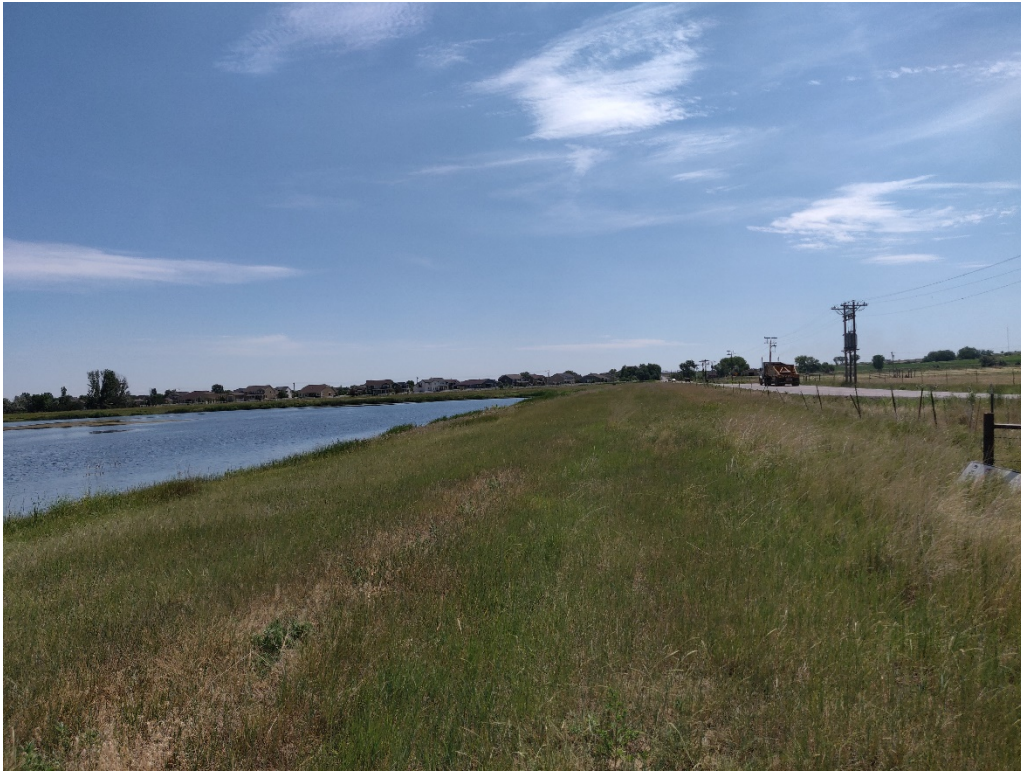
View of the south shoreline of CW3 looking east

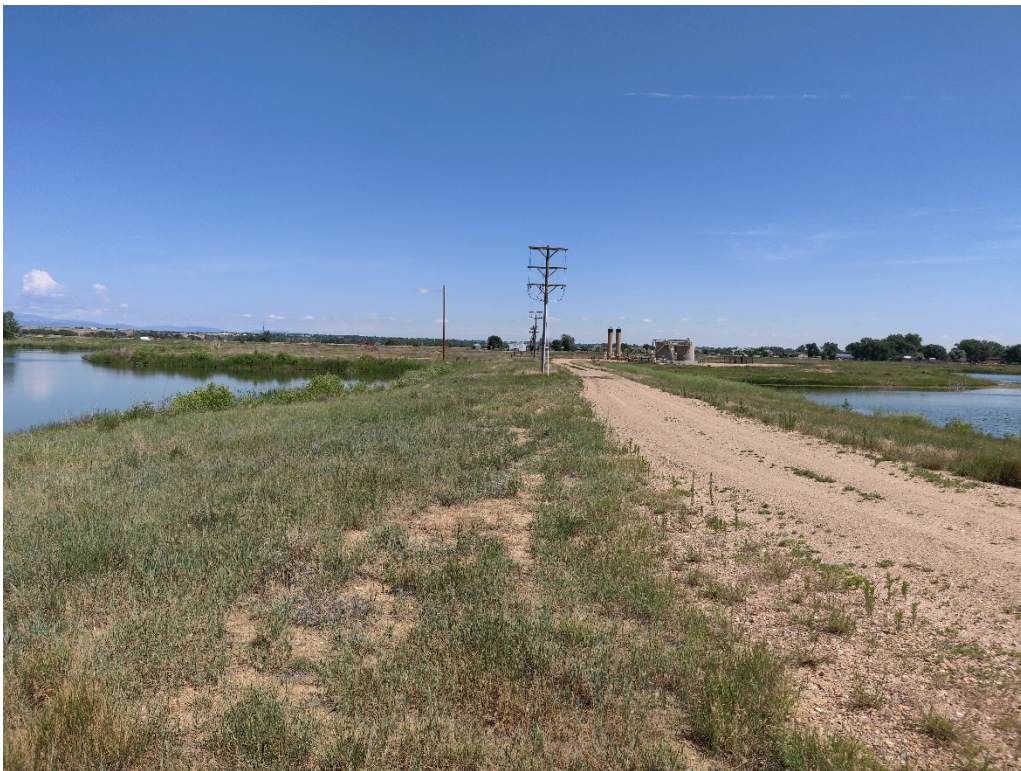
View of the east shoreline of CW2 looking north

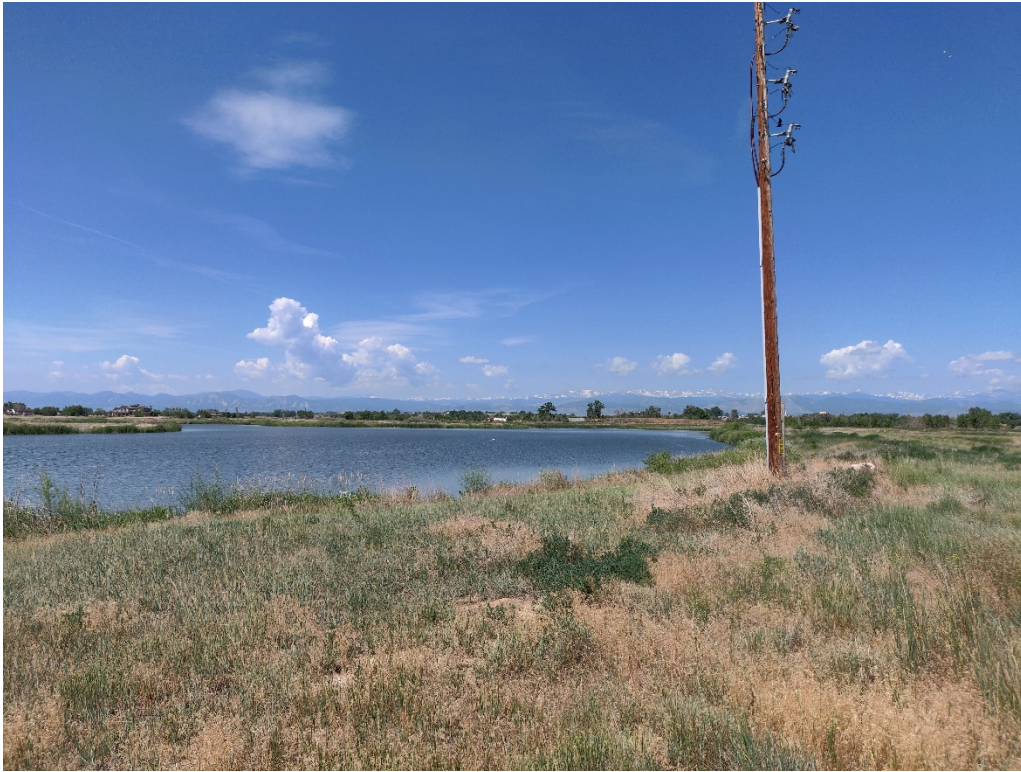
View of the north shoreline of CW1 looking west
