**MINERALS PROGRAM INSPECTION REPORT**  
**PHONE: (303) 866-3567**

<b>MINE NAME:</b> Duckworth Pit	<b>MINE/PROSPECTING ID#:</b> M-2003-091	<b>MINERAL:</b> Sand and gravel	<b>COUNTY:</b> Weld
<b>INSPECTION TYPE:</b> Monitoring	<b>INSPECTOR(S):</b> Peter Hays	<b>INSP. DATE:</b> June 26, 2020	<b>INSP. TIME:</b> 10:30
<b>OPERATOR:</b> Martin Marietta Materials, Inc.	<b>OPERATOR REPRESENTATIVE:</b> Julie Mikulas	<b>TYPE OF OPERATION:</b> 112c - Construction Regular Operation	
<b>REASON FOR INSPECTION:</b> Normal I&E Program	<b>BOND CALCULATION TYPE:</b> Complete Bond	<b>BOND AMOUNT:</b> \$60,900.00	
<b>DATE OF COMPLAINT:</b> NA	<b>POST INSP. CONTACTS:</b> None	<b>JOINT INSP. AGENCY:</b> None	
<b>WEATHER:</b> Clear	<b>INSPECTOR'S SIGNATURE:</b>

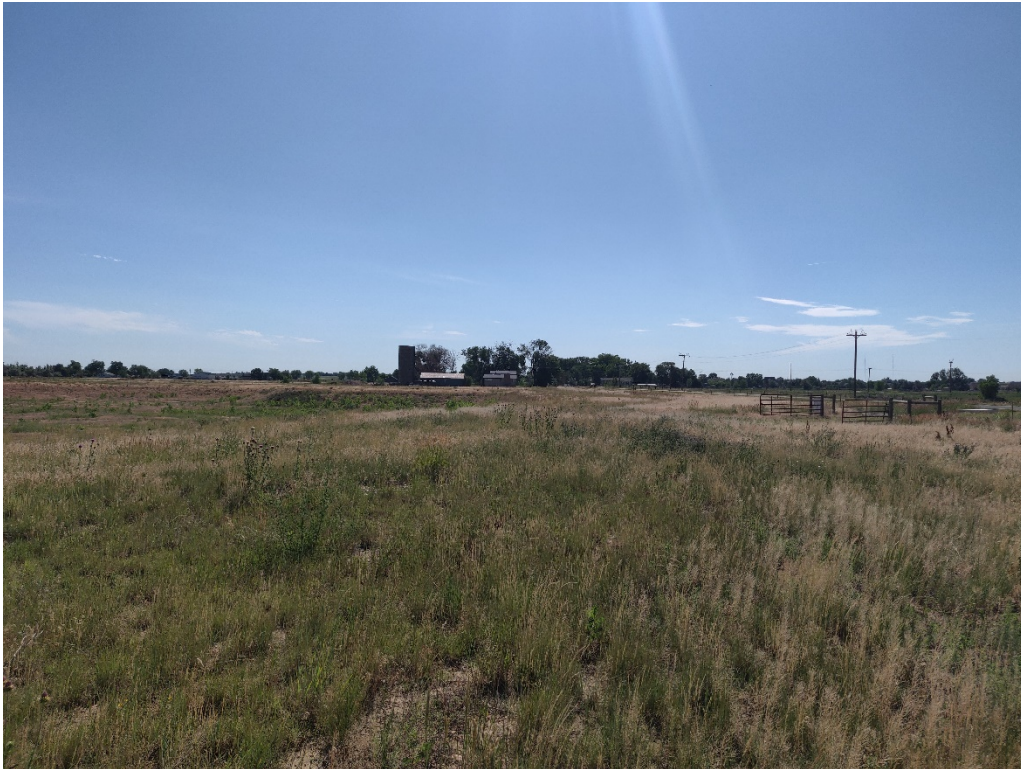
View of the site from the southwest corner of Lake 2 looking east

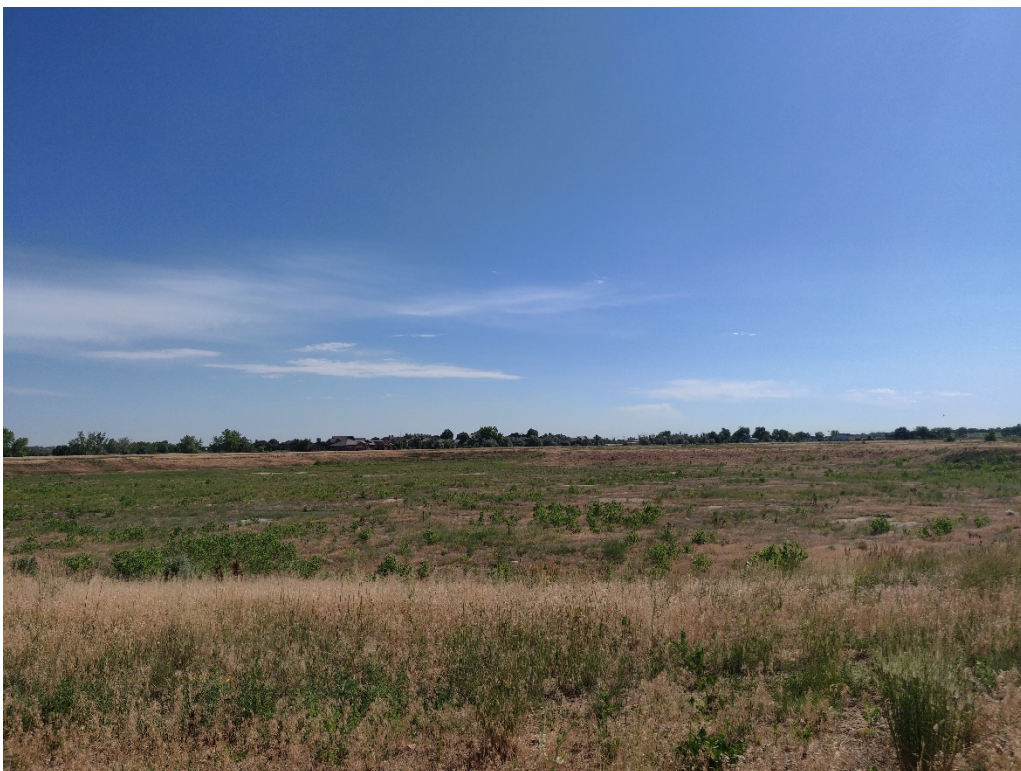
View of the site from the southwest corner of Lake 2 looking northeast

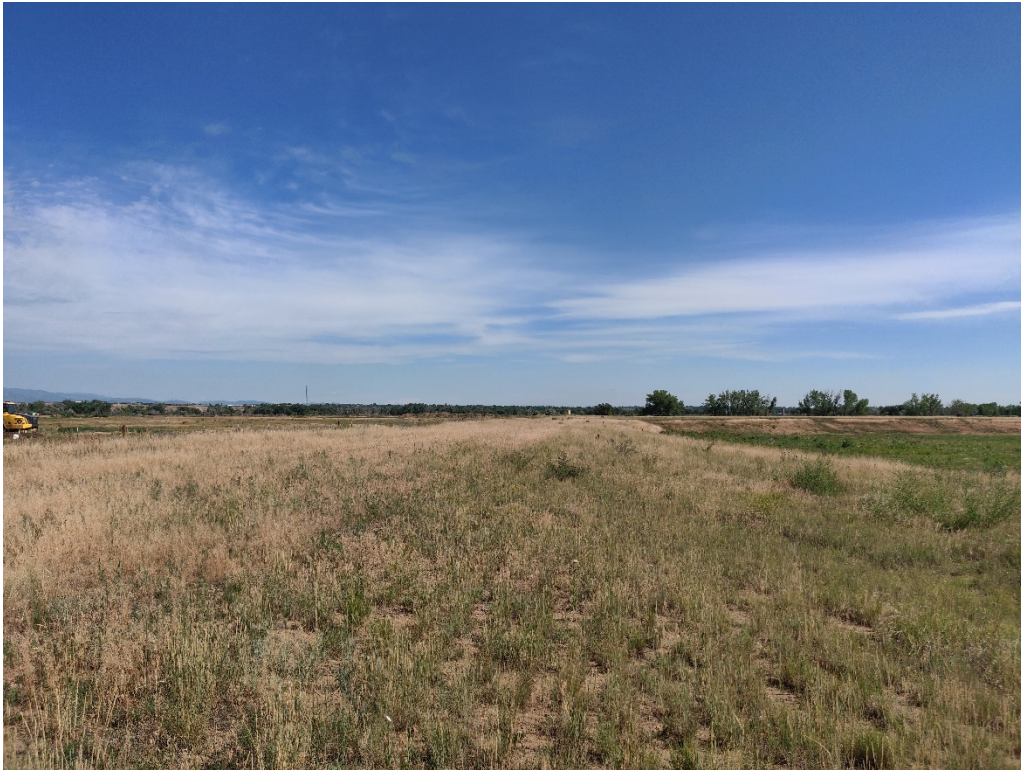
View of the site from the southwest corner of Lake 2 looking north

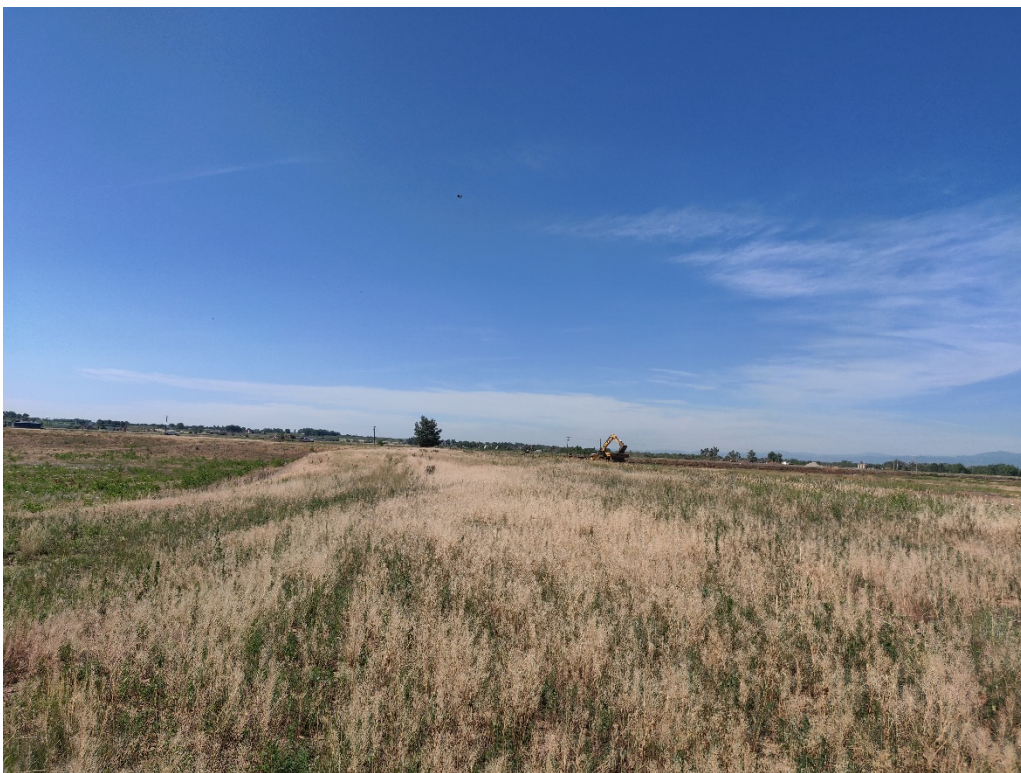
View of the site from the northwest corner of Lake 2 looking south

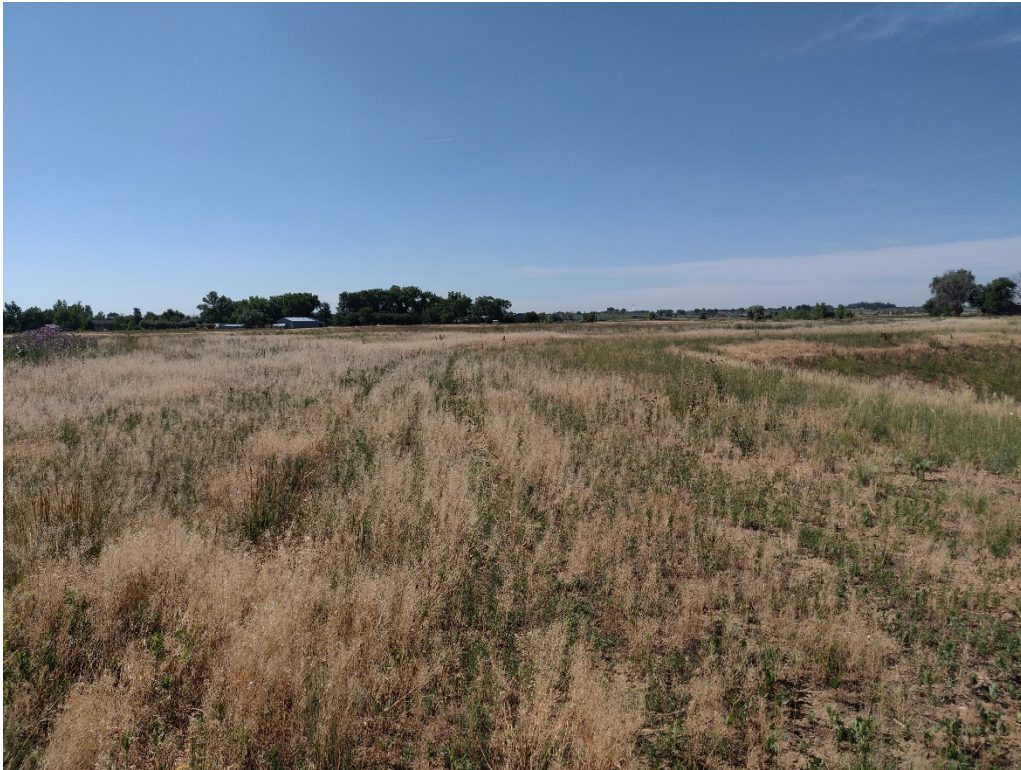
View of the site from the northwest corner of Lake 2 looking east

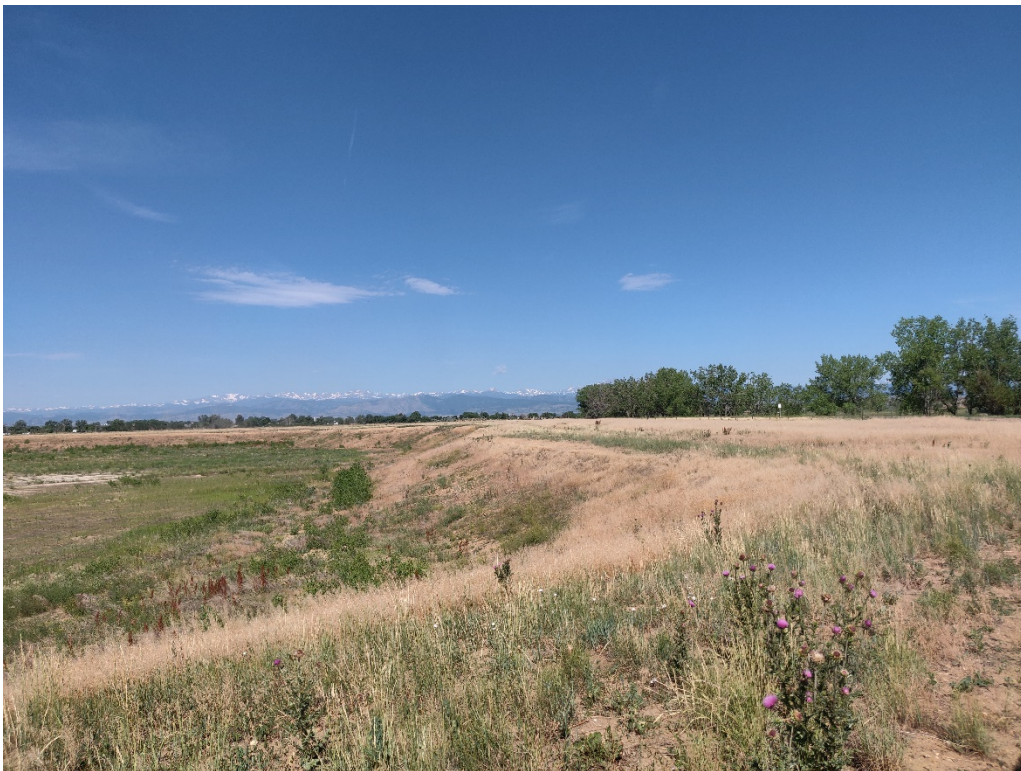
View of the site from the northeast corner of Lake 2 looking east

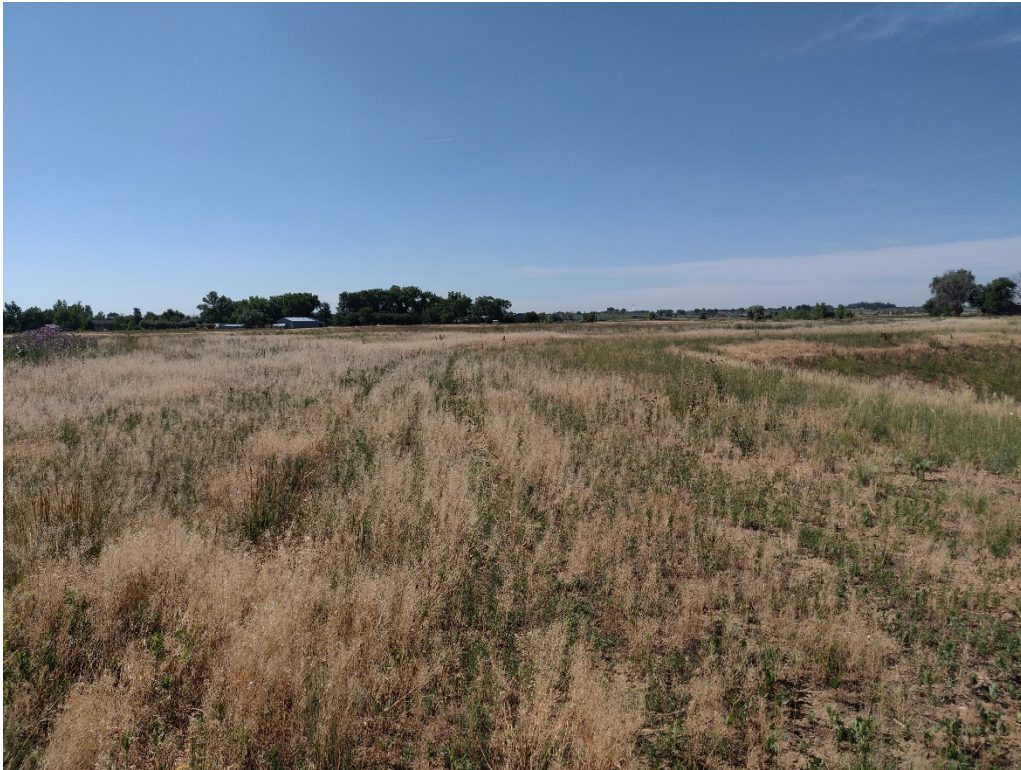
View of the site from the northeast corner of Lake 2 looking south

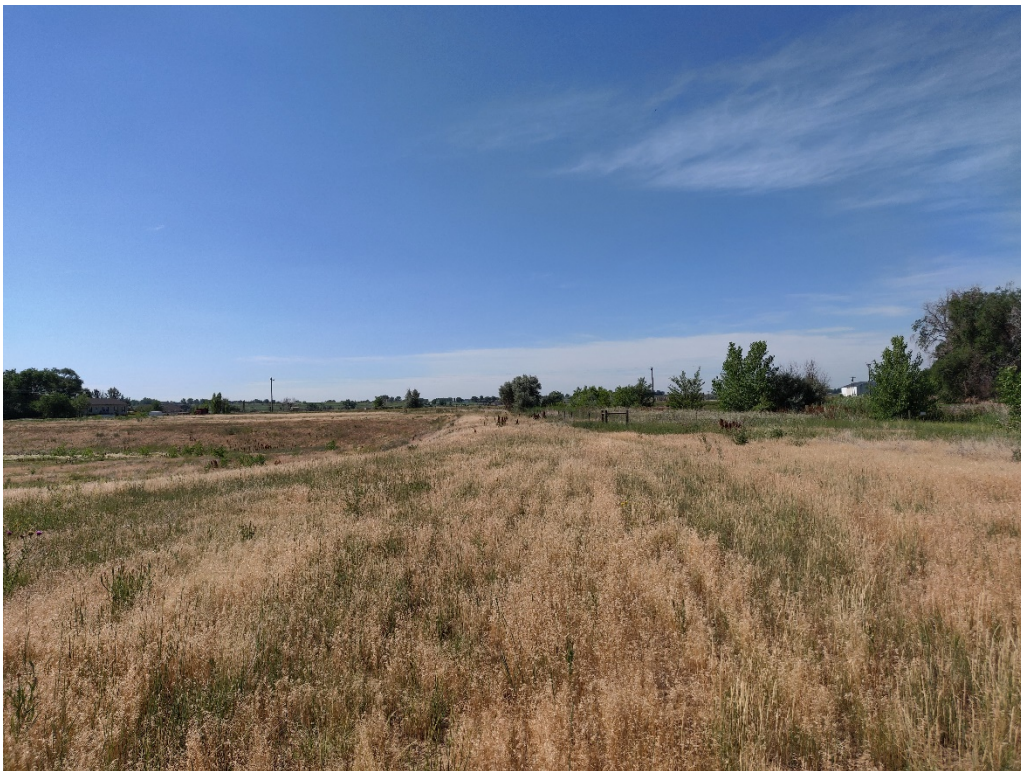
View of the site from the southwest corner of Lake 1 looking east

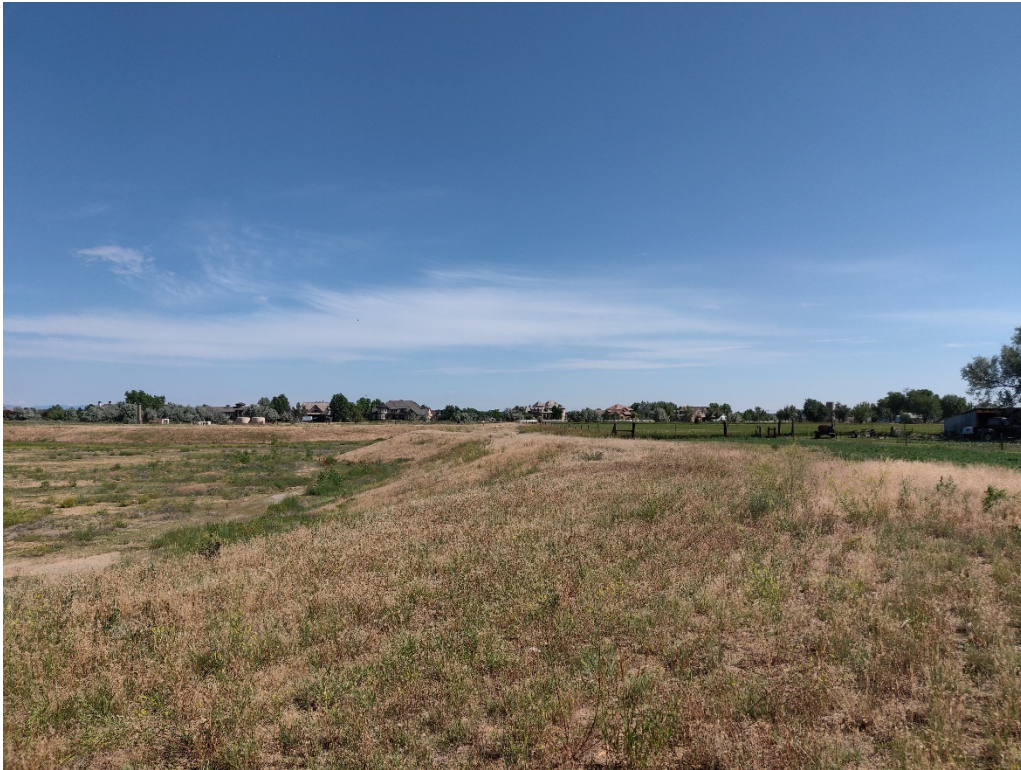
View of the site from the southeast corner of Lake 1 looking north

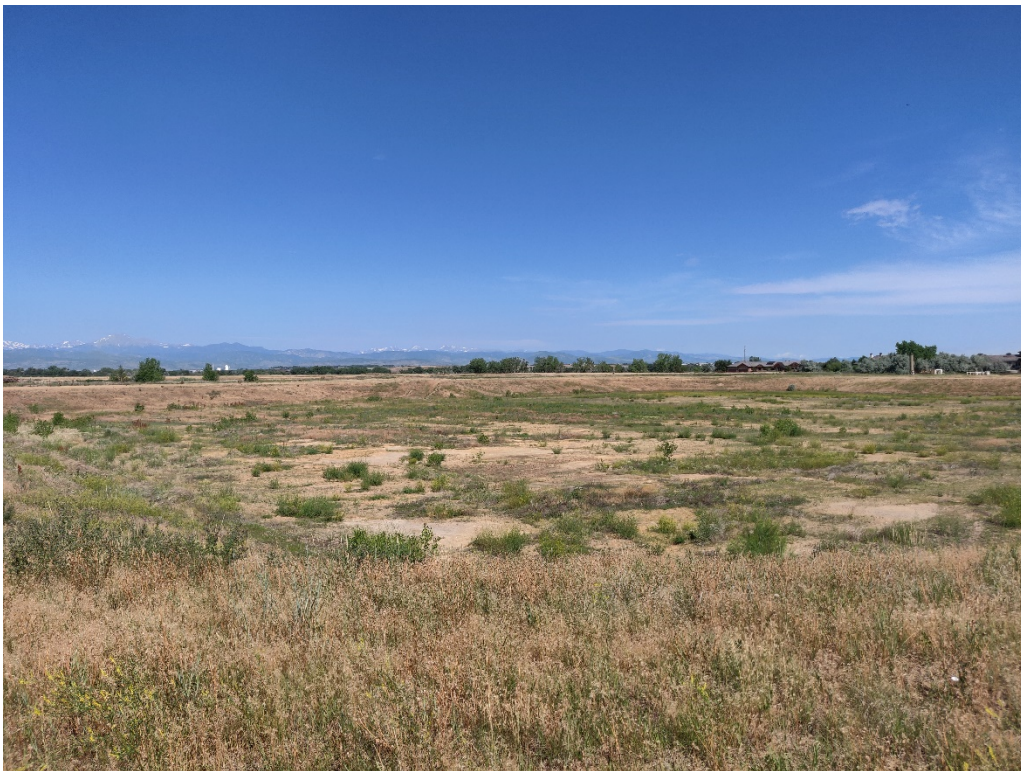
View of the site from the southeast corner of Lake 1 looking northwest

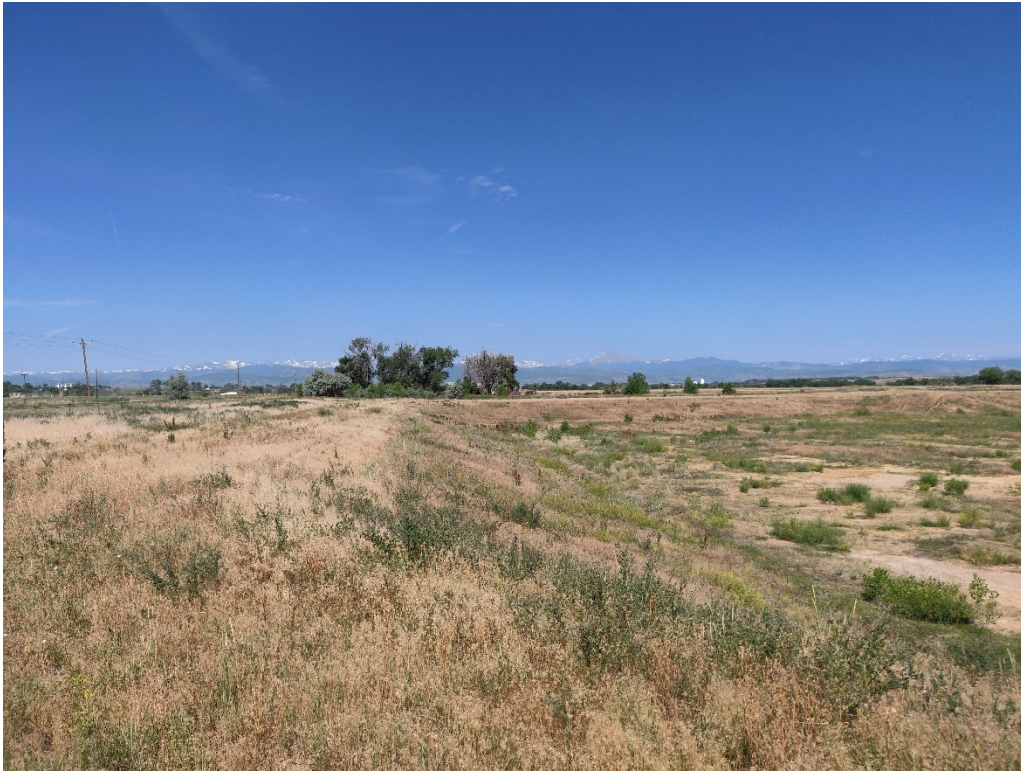
View of the site from the southeast corner of Lake 1 looking west

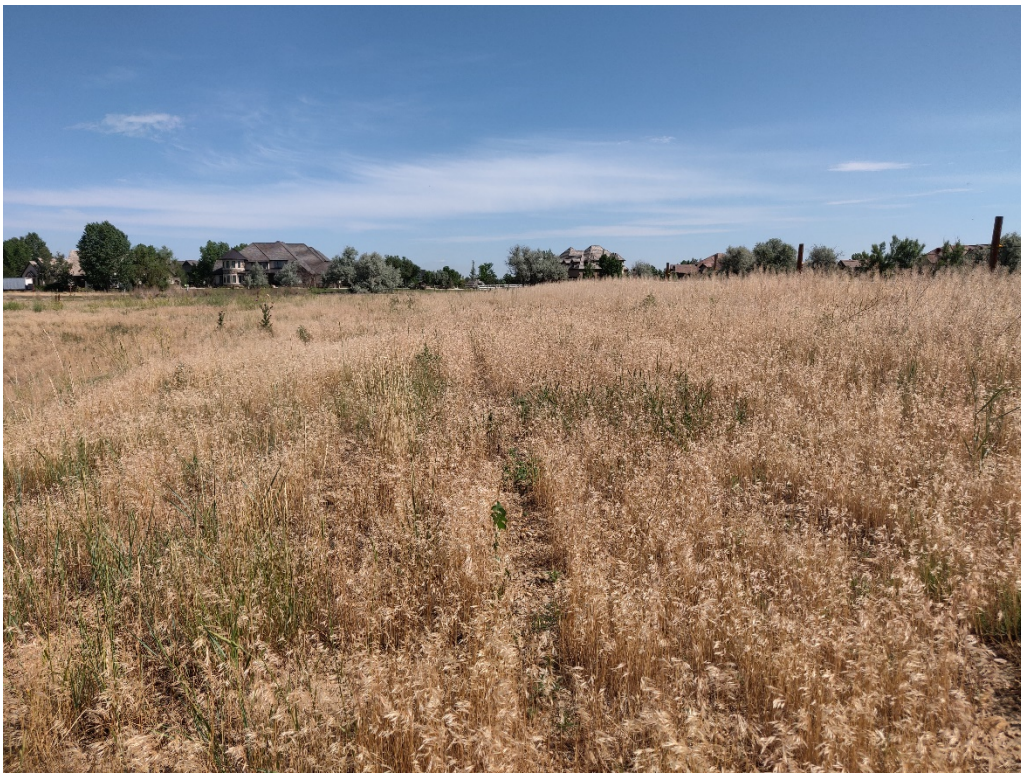
The site vegetation consisted primarily of noxious and annual weeds including; downy brome (cheat grass), kochia, field bindweed, yellow sweet clover, Canada thistle, Scotch thistle and an annual mustard species. The Operator will be required to implement the approved weed management plan for the site to control the annual and noxious weeds while revegetation grasses are established at the site. Large patches of cheat grass and kochia were observed in the upland areas. The Division recommends the Operator consult with a revegetation company to develop a plan to establish reclamation grasses at the site. The Division recommends the downy brome is treated with Esplanade to control the downy brome for several years to allow the reclamation grass to out compete the downy brome. Cottonwood trees have volunteered on the pit slopes and pit floor. The presence of the trees could compromise the integrity of the clay liners. The Operator stated they would investigate filling the reservoirs with water during the next free river period to inundate the trees. A survey of the pit slopes to verify the required 3H:1V grade was provided by the Operator during AM-01. The reservoir slopes were stable and no erosion features were observed during the inspection.

View of large patch of cheat grass along the east shoreline of Lake 1
