**MINERALS PROGRAM INSPECTION REPORT**  
**PHONE: (303) 866-3567**

<b>MINE NAME:</b> Riverbend Operation	<b>MINE/PROSPECTING ID#:</b> M-2000-016	<b>MINERAL:</b> Sand and gravel	<b>COUNTY:</b> Weld
<b>INSPECTION TYPE:</b> Monitoring	<b>INSPECTOR(S):</b> Peter Hays	<b>INSP. DATE:</b> June 26, 2020	<b>INSP. TIME:</b> 12:00
<b>OPERATOR:</b> Martin Marietta Materials, Inc.	<b>OPERATOR REPRESENTATIVE:</b> Julie Mikulas	<b>TYPE OF OPERATION:</b> 112c - Construction Regular Operation	
<b>REASON FOR INSPECTION:</b> Normal I&E Program	<b>BOND CALCULATION TYPE:</b> Partial Bond	<b>BOND AMOUNT:</b> \$3,530,500.00	
<b>DATE OF COMPLAINT:</b> NA	<b>POST INSP. CONTACTS:</b> None	<b>JOINT INSP. AGENCY:</b> None	
<b>WEATHER:</b> Clear	<b>INSPECTOR'S SIGNATURE:</b>

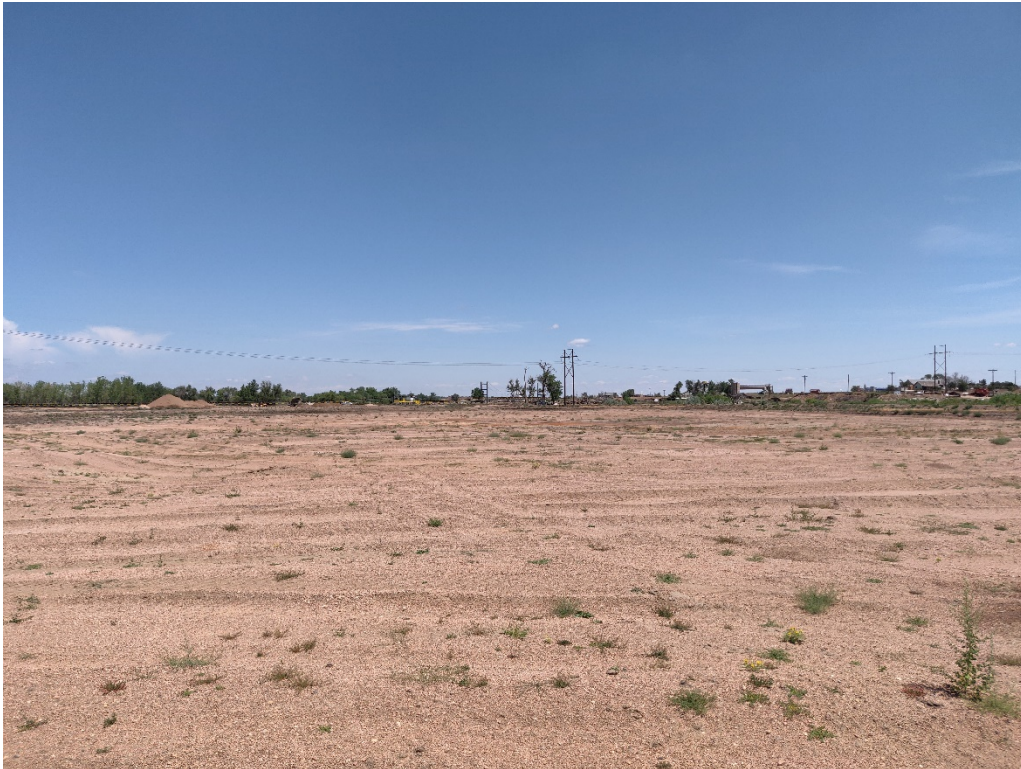
View of the stripped southern half of Cell 1 from the south side looking north

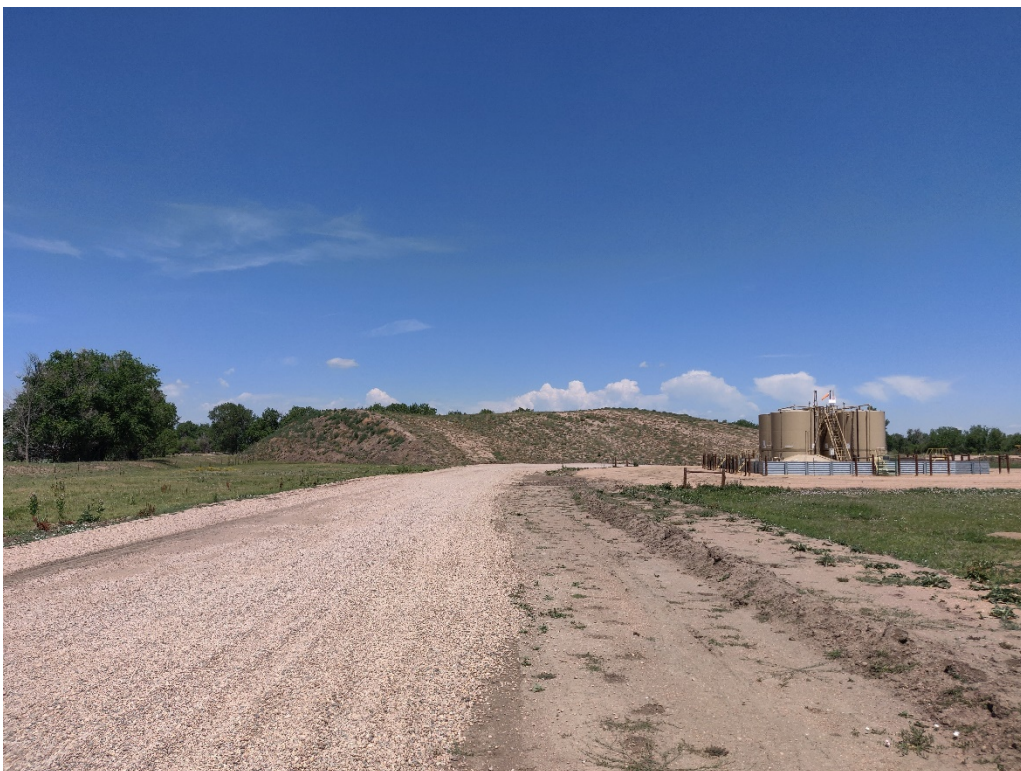
View of the stockpiled overburden and topsoil from Cell 1

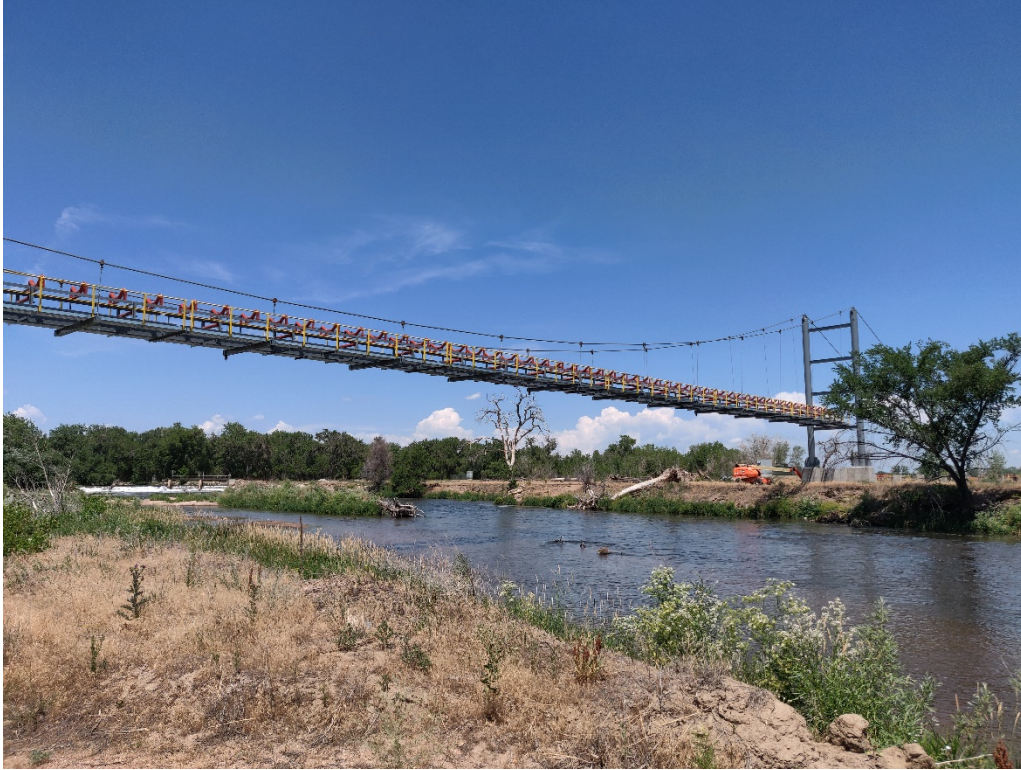
View of conveyor bridge from Cell 1 to Cell 1, Phase 4 over the South Platte River

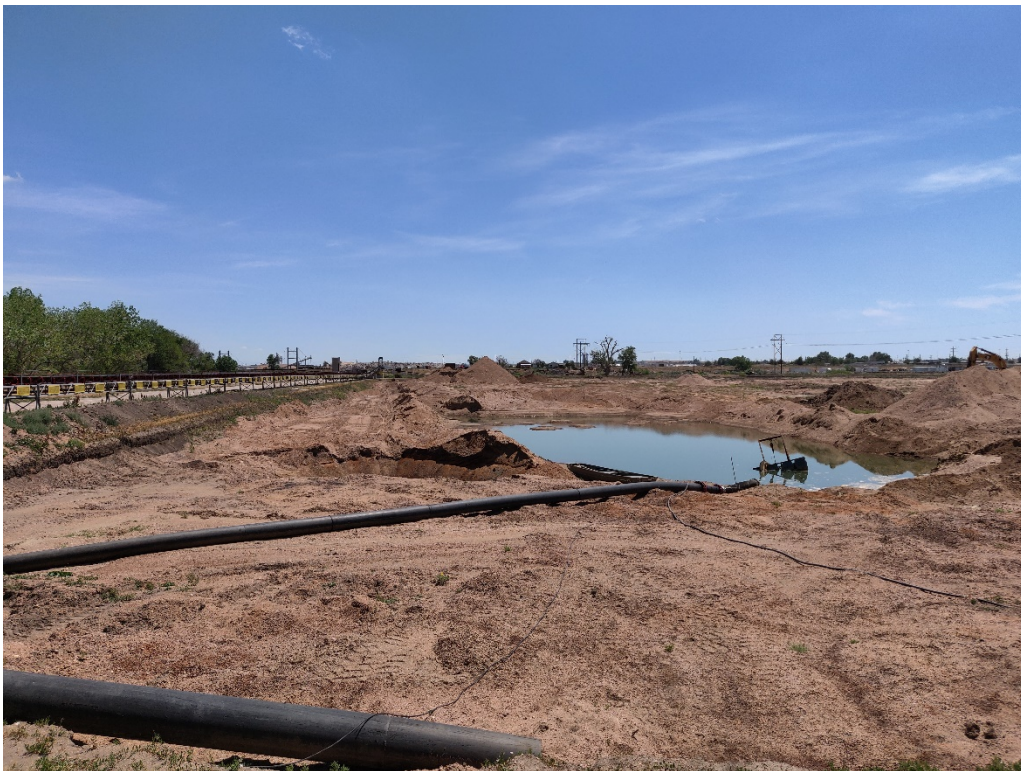
View of the dewatering pond in the northwest corner of Cell 1

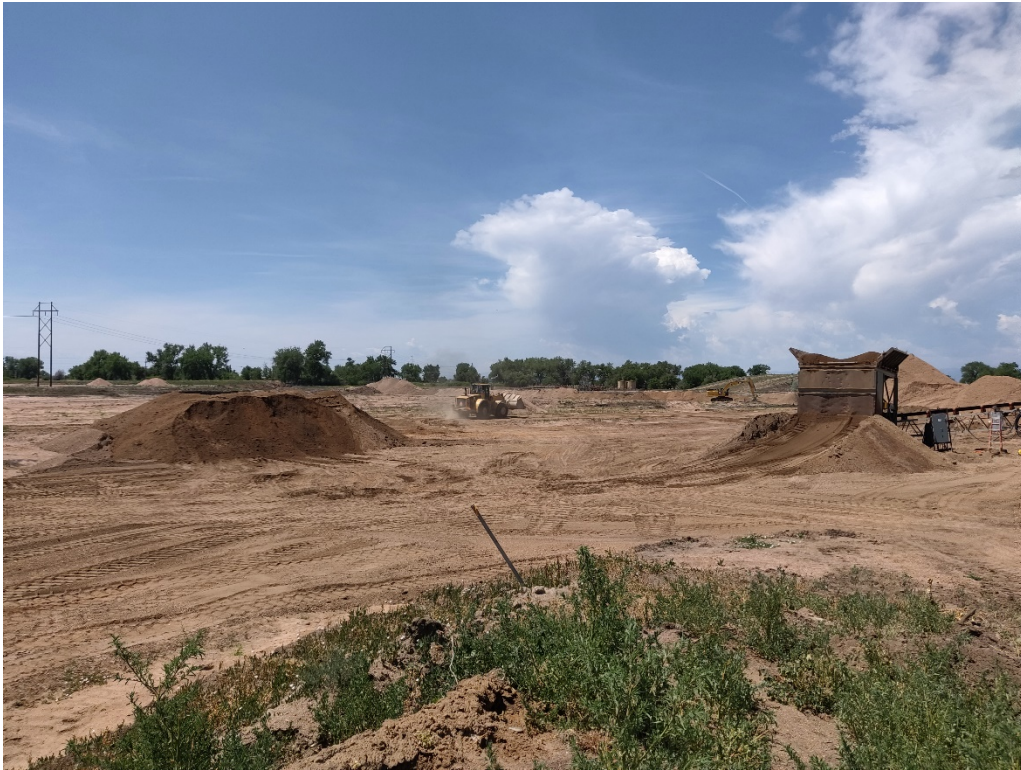
View of the mining activities in Cell 1 from the northeast corner looking southwest

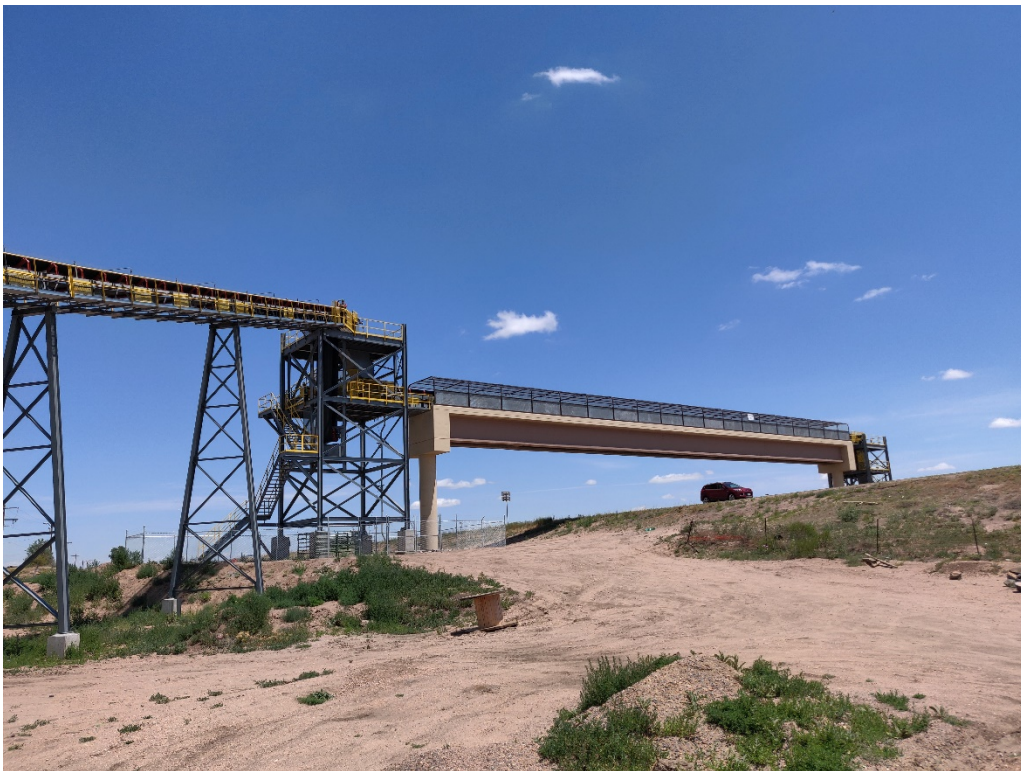
View of the conveyor bridge over Hwy 85
