## **MINERALS PROGRAM COMPLIANCE REPORT**

<b>MINE NAME:</b> Deep Creek Placer	<b>MINE/PROSPECTING ID#:</b> M-1986-102	<b>MINERAL:</b> Limestone (general)	<b>COUNTY:</b> San Miguel
<b>INSPECTION TYPE:</b> Monitoring	<b>INSPECTOR(S):</b> Lucas West	<b>INSP. DATE:</b> June 11, 2020	<b>INSP. TIME:</b> 10:30
<b>OPERATOR:</b> Collins Morehead, LLC	<b>OPERATOR REPRESENTATIVE:</b> None	<b>TYPE OF OPERATION:</b> 110c - Construction Limited Impact

**PHOTOGRAPHS – BEFORE and AFTER**

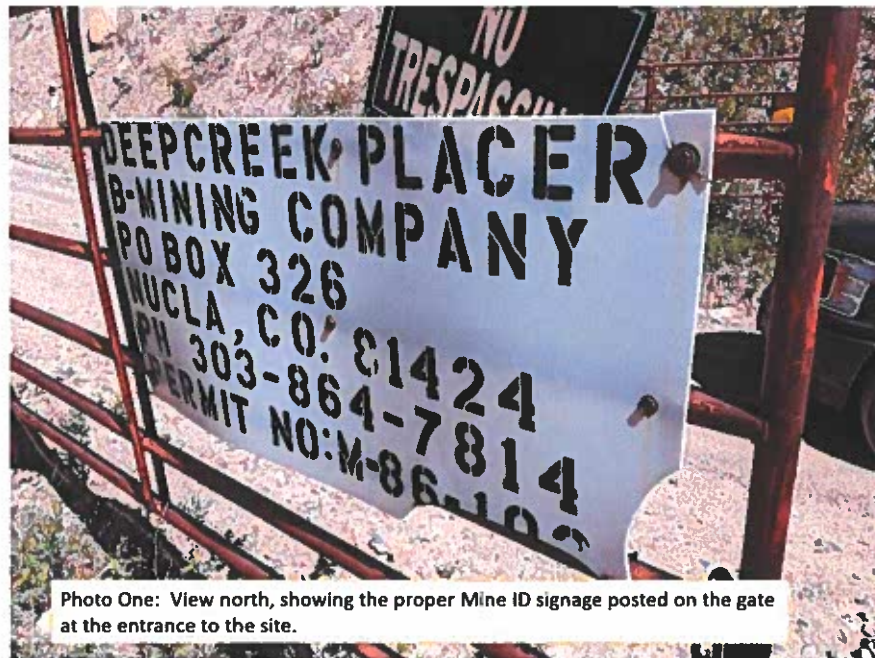
**Photo 1a (Original Inspection – Lucas West)**

The proper Mine Identification sign was posted on the gate at the bottom of the access road that can be seen in Photo One. The access road leading up to the equipment apron and portal areas is in good condition. No signs of significant erosion were noted and all storm water control features associated with the access road appeared to be functioning as designed at the time of the inspection. The access road can be seen in Photo Two.

No change.

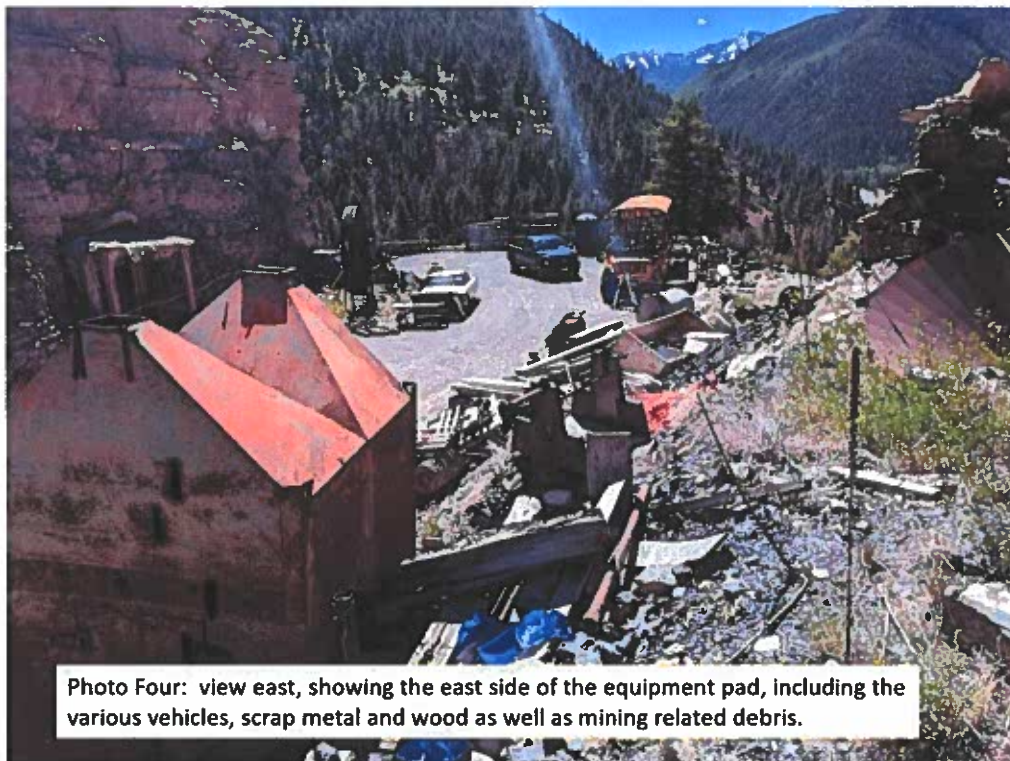
**Photo 4a (Original Inspection – Lucas West)**

**PROBLEM/POSSIBLE VIOLATION:** Problem: Trash and refuse was noticed on the site. This is a problem at this time for failure to dispose of refuse in a manner that controls unsightliness or deleterious effects of such refuse pursuant to C.R.S. 34-32.5-116(4)(e).

Photo Four: view east, showing the east side of the equipment pad, including the various vehicles, scrap metal and wood as well as mining related debris.

**CORRECTIVE ACTIONS:** The operator shall submit a written notice to the Division with photo documentation, that the trash has been removed from the site by the corrective action date.

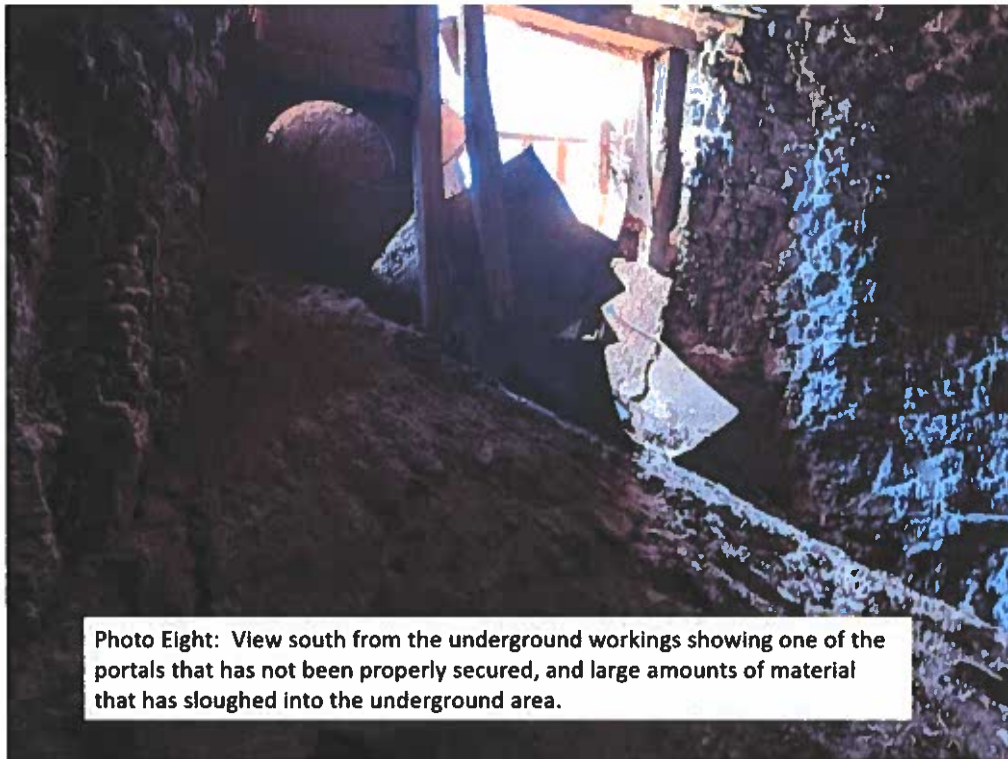
**Photo 8a (*Original Inspection – Lucas West*)**

The portals located on site leading to the underground workings appeared to be in good condition. All portals used for access to the workings were equipped with lockable steel gates, which were un-secured at the time to allow for inspection. The portals were in good condition and appeared to be stable at the time of the inspection. One portal that is secured and covered with a light density plastic to allow light to filter to the underground workings had evidence of material sloughing into the underground workings. The amended reclamation plan states that the remaining portals will either be sealed with concrete block or with a lockable steel gates, this portal appeared have to neither closure method installed. The portal can be seen in Photo Eight from the underground workings. The material that has sloughed off should be cleared of the opening, and one of the approved closure methods should be installed. This task must be completed in accordance with the approved Reclamation Plan before a full reclamation permit release can be completed.

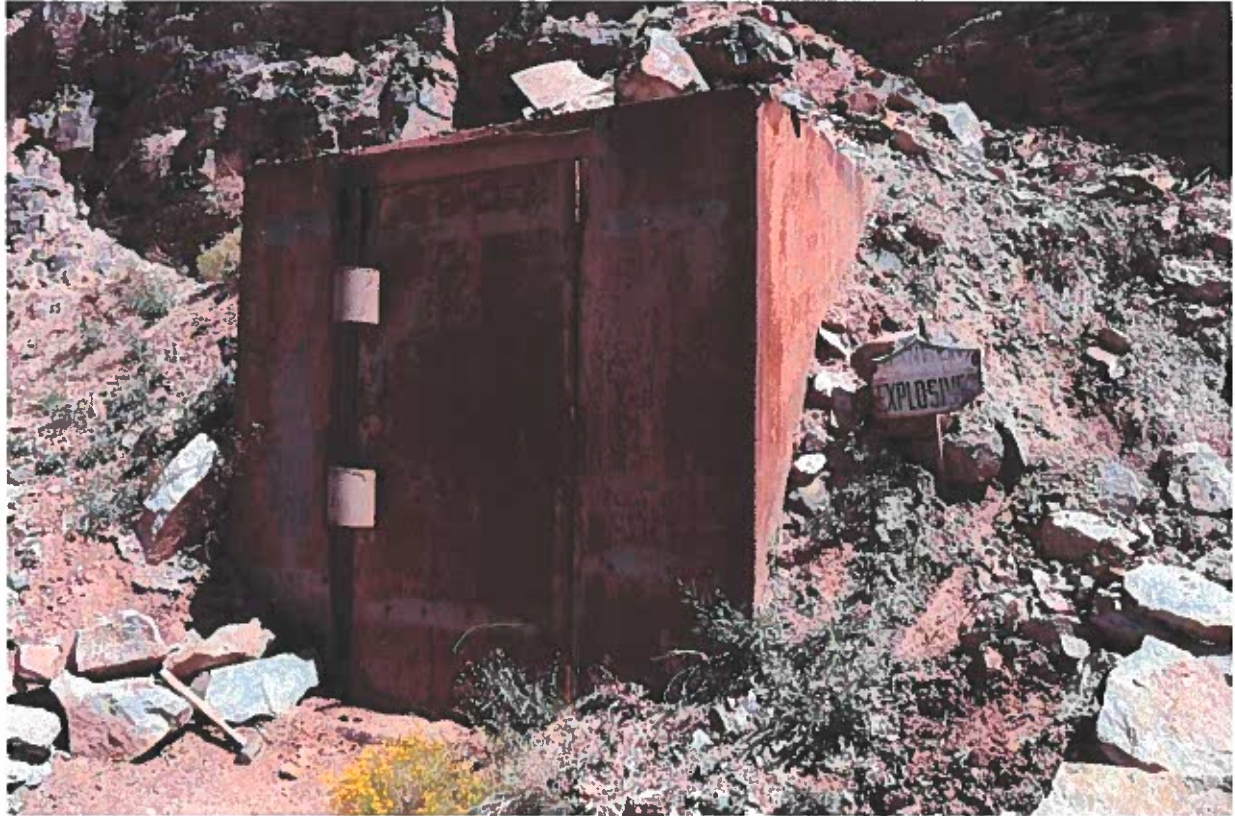
The historic explosives magazine located on site was observed and was unsecured at the time of the inspection. Materials stored inside the magazine include propane tanks, various fuel and oil containers and other flammable items. This is not considered a problem at this time however the magazine should be secured. No evidence of settling, slumping or erosion were noted during the inspection and no state listed noxious weeds were observed.

Photo 9. Door hinge repaired on Explosives magazine such that door can now be secured.  
Note: This steel structure only used for fuels, not explosives.
