**MINERALS PROGRAM INSPECTION REPORT**  
**PHONE: (303) 866-3567**

<b>MINE NAME:</b> PVRE Pit #1	<b>MINE/PROSPECTING ID#:</b> M-2017-009	<b>MINERAL:</b> Sand and gravel	<b>COUNTY:</b> Logan
<b>INSPECTION TYPE:</b> Monitoring	<b>INSPECTOR(S):</b> Brock Bowles	<b>INSP. DATE:</b> July 15, 2020	<b>INSP. TIME:</b> 10:00
<b>OPERATOR:</b> Platte Valley Real Estate, LLC	<b>OPERATOR REPRESENTATIVE:</b> Dan Long and Tyler Chamberlain	<b>TYPE OF OPERATION:</b> 110c - Construction Limited Impact

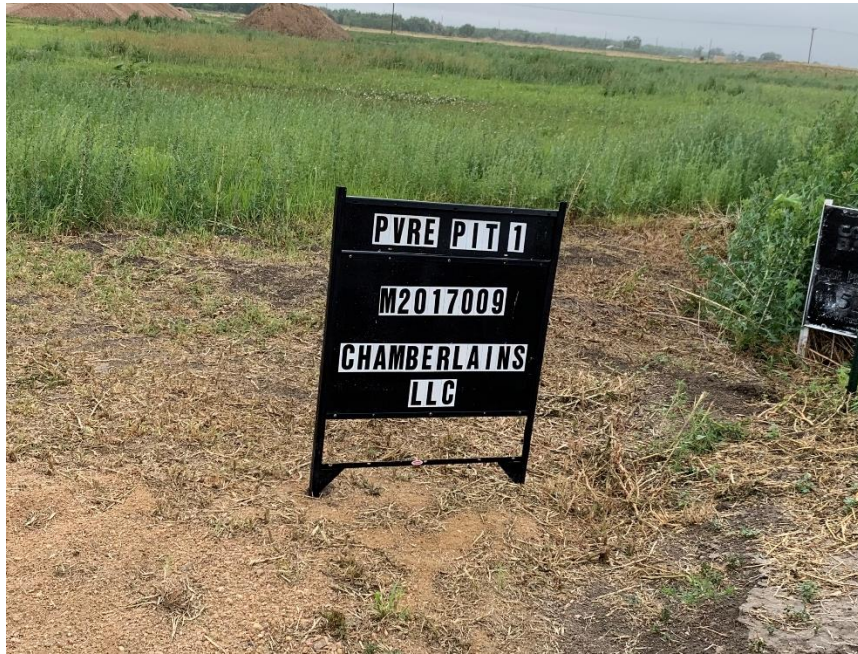
The mine identification sign was in place and had information required by Rule 3.1.12. The permit boundary markers were in place. No mining was taking place at the time of this inspection but sand processing equipment was on site.

Mine entrance sign along Jack's Lane on the northwest corner of the permit area.

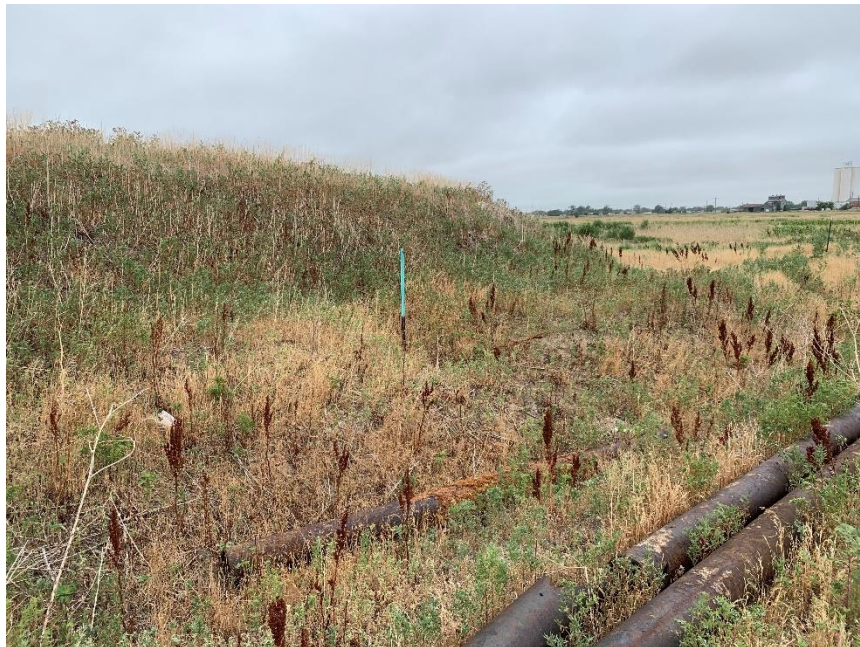
Permit marker on southeast corner. The pile in background is off-permit and belongs to City of Sterling.

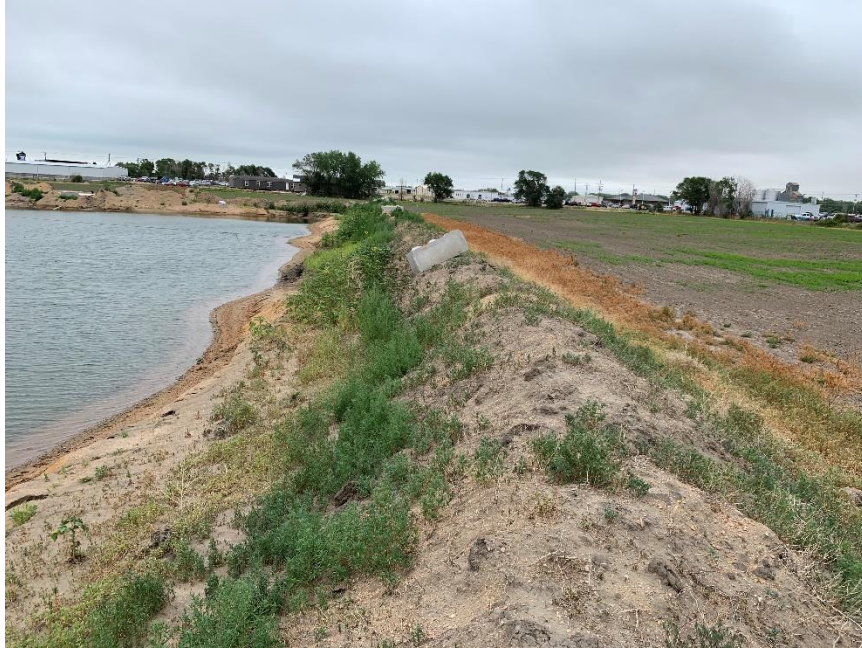
**PROBLEM/POSSIBLE VIOLATION:** Problem: The topsoil stockpile is staged on the east bank of the pit. Wave action from the water in the pit will erode the eastern bank, just below the topsoil stockpiles. This situation fails to protect topsoil from erosion pursuant to C.R.S. 34-32.5-116(4)(g).

**PROBLEM/POSSIBLE VIOLATION:** Problem: The topsoil stockpiles do not have established vegetation on them and are therefore susceptible to erosion. Rule 3.1.9(1) states if topsoil is not replaced into the backfill area within a time short enough to avoid deterioration of the topsoil, vegetative cover or other means shall be employed so that the topsoil is protected from erosion.

The topsoil stockpile is staged on the east bank of the pit, which contains water. Wave action from the water in the pit will erode the eastern bank, just below the topsoil stockpiles. A technical revision needs to be submitted with a plan to protect the shoreline and the topsoil piles from wave action erosion. A single technical revision can be submitted to address both items listed in this report.

Topsoil was stockpiled on the east side of the pit between the pit and the permit boundary. The topsoil pile does not have an adequate vegetative cover to provide stabilization as required by Rule 6.3.3(b). The vegetation is mostly comprised of annuals which do not have the same erosion control qualities as perennial vegetation. A vegetative cover needs to be established on the topsoil piles. The currently approved reclamation seed mix can be applied to the topsoil piles. The due date for this action was set for October 30 because the best time to seed is usually the fall.

Topsoil stockpile between the eastern permit boundary and the mine pit, looking north.

**CORRECTIVE ACTIONS:** A technical revision needs to be submitted with a plan to protect the eastern

shoreline and the topsoil stockpiles from wave action erosion.

**CORRECTIVE ACTIONS:** The operator shall seed the stockpiles with the seed mix that was submitted as part of the approved reclamation plan. The Operator shall demonstrate compliance by submitting seed tags, a bill of sale or photographs of seeding activities.

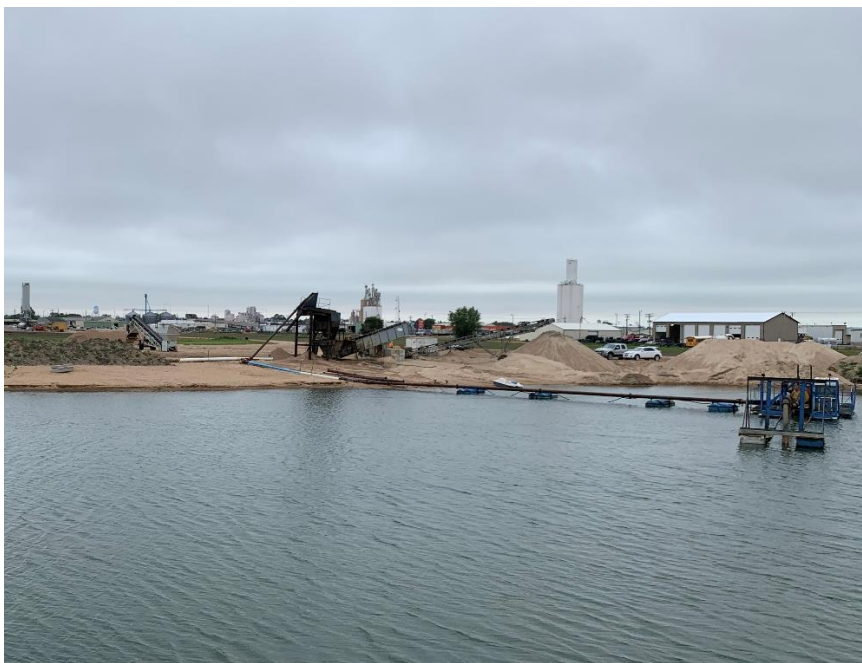
Sand processing equipment on west side of pit, looking west.
