MINERALS PROGRAM INSPECTION REPORT
PHONE: (303) 866-3567

MINE NAME: Climax Mine	MINE/PROSPECTING ID#: M-1977-493	MINERAL: Molybdenum	COUNTY: Lake, Summit
INSPECTION TYPE: Monitoring	INSPECTOR(S): Lucas West	INSP. DATE: July 23, 2020	INSP. TIME: 10:05
OPERATOR: Climax Molybdenum Company	OPERATOR REPRESENTATIVE: Diana Kelts	TYPE OF OPERATION: 112d-3 - Designated Mining Operation	
REASON FOR INSPECTION: Normal I&E Program	BOND CALCULATION TYPE: None	BOND AMOUNT: \$91,011,850.00	
DATE OF COMPLAINT: NA	POST INSP. CONTACTS: None	JOINT INSP. AGENCY: None	
WEATHER: Clear	INSPECTOR'S SIGNATURE:

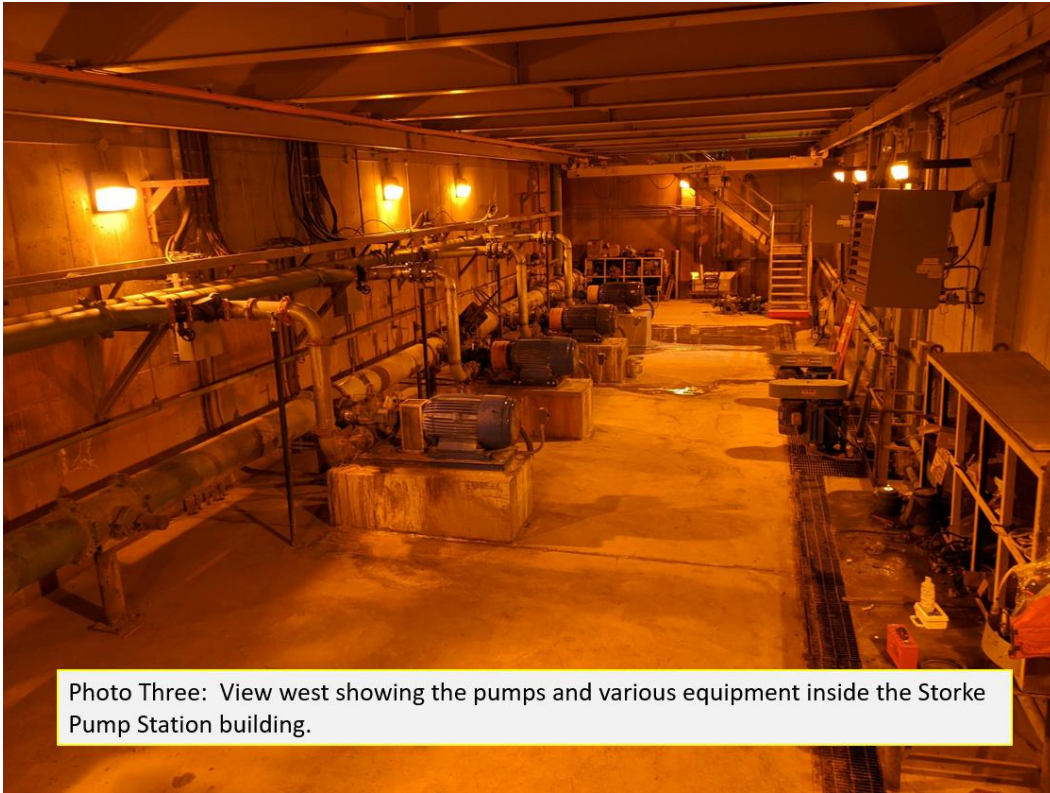
The Storke Interceptor and wastewater pump station are located just south of the main pit area, adjacent to the 5 shaft area in the Arkansas Basin. The Storke Interceptor collects water from the out slopes of one of the main pit haul roads and reports it to the Storke Wastewater Pump Station. The interceptor ditch was observed and appeared to be functioning as designed. Free from trash, debris and large boulders, the interceptor can be seen in Photo One. The interceptor, as well as other inputs, reports to the Storke Wastewater pump station. The pump station consists of two lined ponds, seen in Photo Two that are pumped by a series of pumps to the East Tailings Delivery Line (ETDL) and ultimately report to the Sludge Densification Plant (SDP) for the first stage of treatment. The pump house building was secure at the time of the inspection. All lines, pumps and equipment located within the pump house were in good condition and functioning as designed at the time of the inspection. The pumps can be seen in Photo Three. No problems or possible violations were noted in this area.

Photo Three: View west showing the pumps and various equipment inside the Storke Pump Station building.

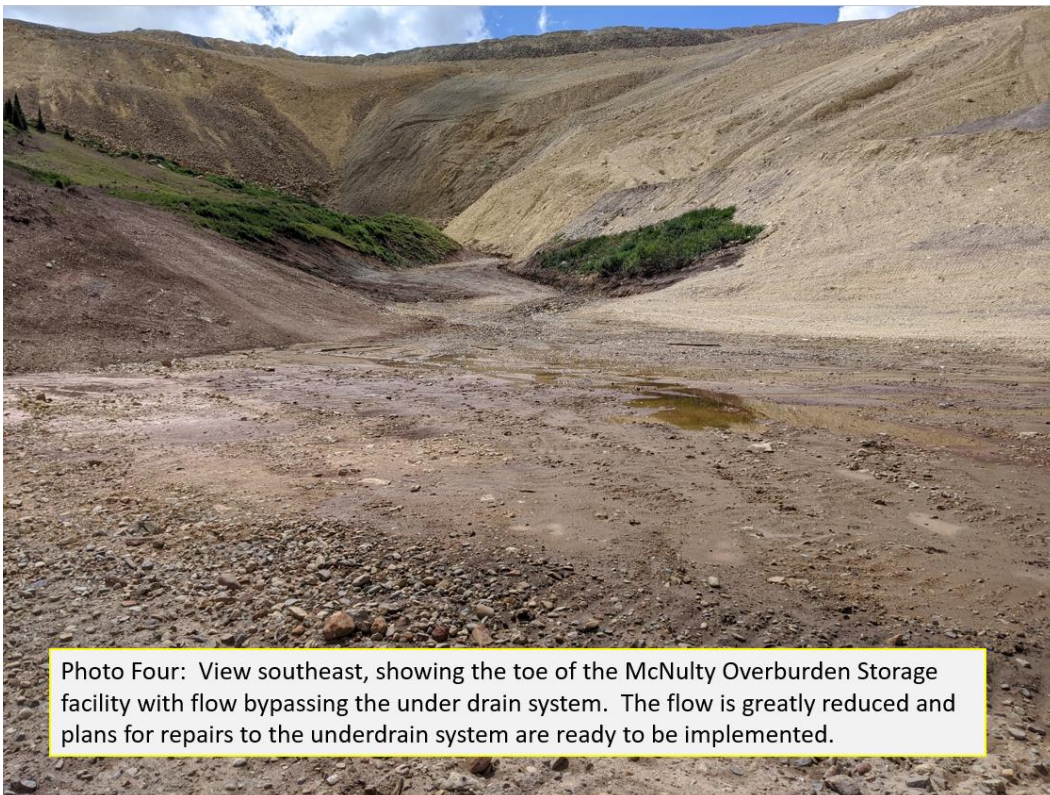
On June 23 the Operator reported a failure of the underdrain system that had been installed in the McNulty OSF. The underdrain system failed to convey water as it was intended due to high flows. The flow, however was controlled and reported to the McNulty ditch and ultimately to the SDP therefore no loss of containment occurred. The underdrain system was installed under the OSF and was intended to catch surface water as it infiltrated through the overburden. Recent downturns in activity caused less overburden to be deposited on top of the drains, creating a shorter residence time for surface water to infiltrate and report to the drains. Repairs have been designed and will be implemented during the month of August. At this time, a small amount of water can be seen flowing from the toe of the slope. Photo Four shows the flow as it exits the toe of the overburden pile. The flow that is bypassing the system is reporting to McNulty Ditch and flowing to the SDP. Flow was also observed discharging from the underdrain outfall structure, Seen in Photo Five, suggesting that the underdrain is functioning, however some flow is still bypassing the drain. At it's peak the flow that

Photo Four: View southeast, showing the toe of the McNulty Overburden Storage facility with flow bypassing the under drain system. The flow is greatly reduced and plans for repairs to the underdrain system are ready to be implemented.

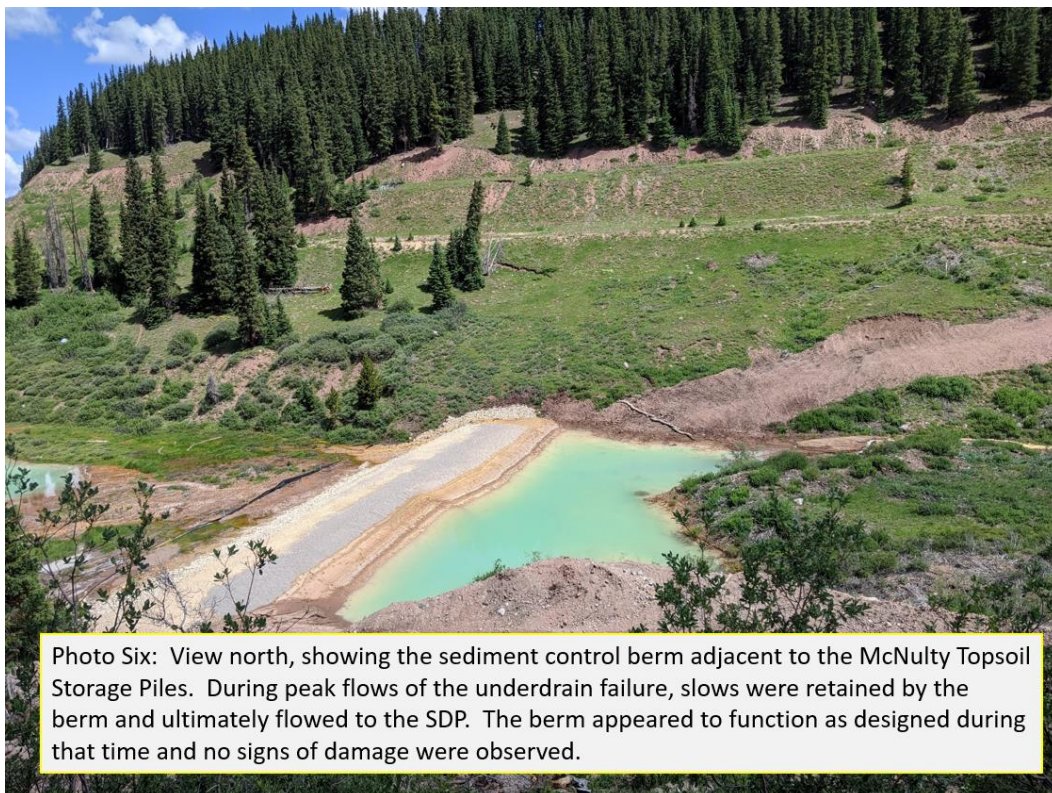
was bypassing the underdrain system flowed to a sediment control berm adjacent to the Topsoil Stockpile area. The holding pond and sediment control berm appeared to be functioning as designed and showed no damage from the increased flows. The sediment control berm can be seen in Photo Six.

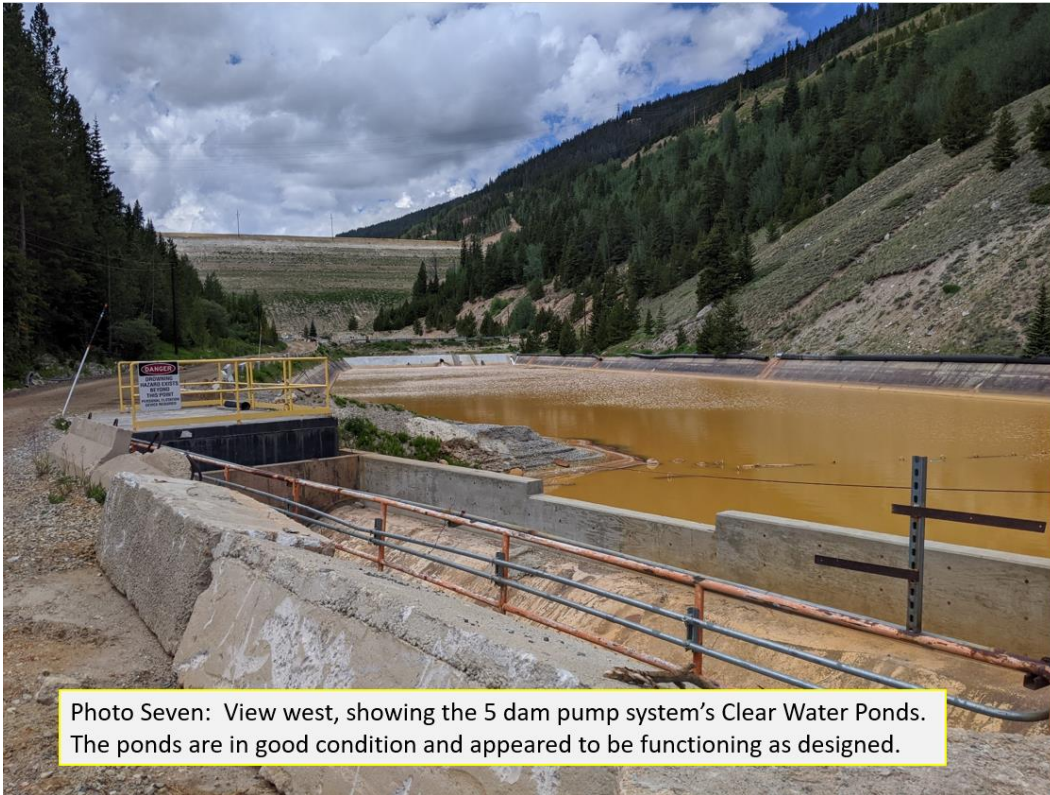
The 5 dam Clear Water Ponds were observed and appeared to be functioning as designed. The ponds, as seen in Photo Seven appeared to possess adequate free board as they report to the 5 dam pump system. The pump system and building were in good condition at the time of the inspection. The interior of the pump building can be seen in Photo Eight. Everything within the pump building is being stored in a neat and orderly fashion and no items of concern were observed in the area.

Photo Seven: View west, showing the 5 dam pump system's Clear Water Ponds. The ponds are in good condition and appeared to be functioning as designed.

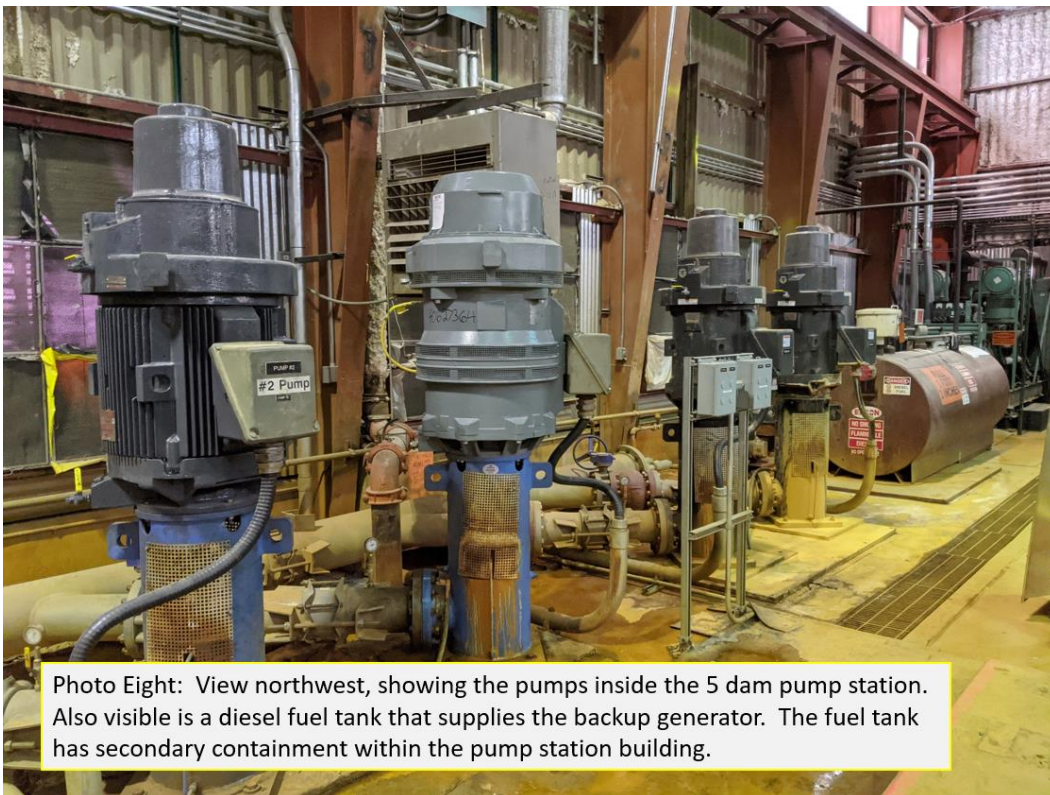
Photo Eight: View northwest, showing the pumps inside the 5 dam pump station. Also visible is a diesel fuel tank that supplies the backup generator. The fuel tank has secondary containment within the pump station building.

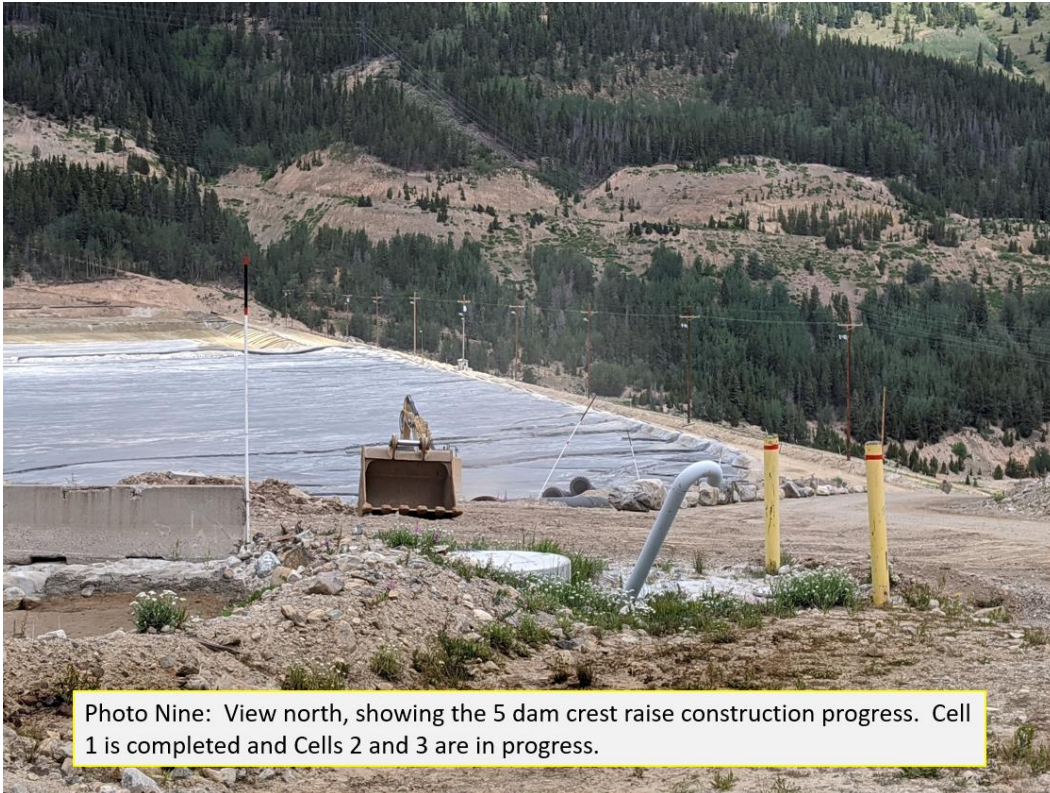
At the time of the inspection a crest raise of the 5 dam was in progress. The crest raise has been completed in Cell 1, where tailings are currently being deposited. Cells 2 and 3 are in construction and will be operational within the coming weeks. A photo of the crest raise construction can be seen in Photo Nine. No tailings were actively being deposited at the time of the inspection. The crest raise construction appears to be in compliance with the approved plans and no problems were observed at this time.

Photo Nine: View north, showing the 5 dam crest raise construction progress. Cell 1 is completed and Cells 2 and 3 are in progress.

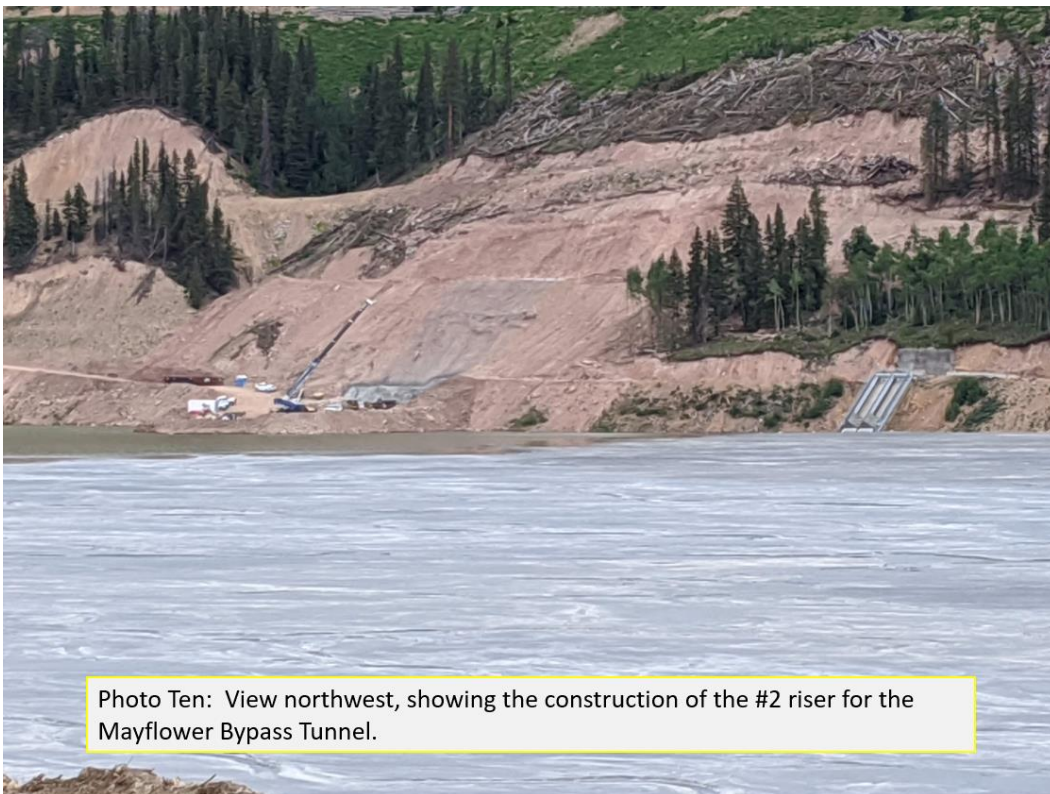
Adjacent to the Mayflower Tailings Storage Facility the #2 riser is being constructed as it ties into the Mayflower Bypass Tunnel. Discussions with the contractor on site indicate that construction re-bar has been placed and inspected and the anchor bolts were in process of being tested. The first of several concrete pours is expected to happen the week of July 27, with subsequent pours to follow. A photo of the construction area can be seen in Photo Ten.

Photo Ten: View northwest, showing the construction of the #2 riser for the Mayflower Bypass Tunnel.
