FIELD WEEKLY PROGRESS REPORT

PROJECT: VALLEY LEACH FACILITY (VLF2) PHASE 2 CQA
SITE: CRIPPLE CREEK & VICTOR GOLD MINE (COLORADO)
CONTRACTOR: TEZAK HEAVY EQUIPMENT
WEEK ENDING: SATURDAY, MAY 16, 2020

REPORTING PERIOD: 05.10.2020 THROUGH 05.16.2020

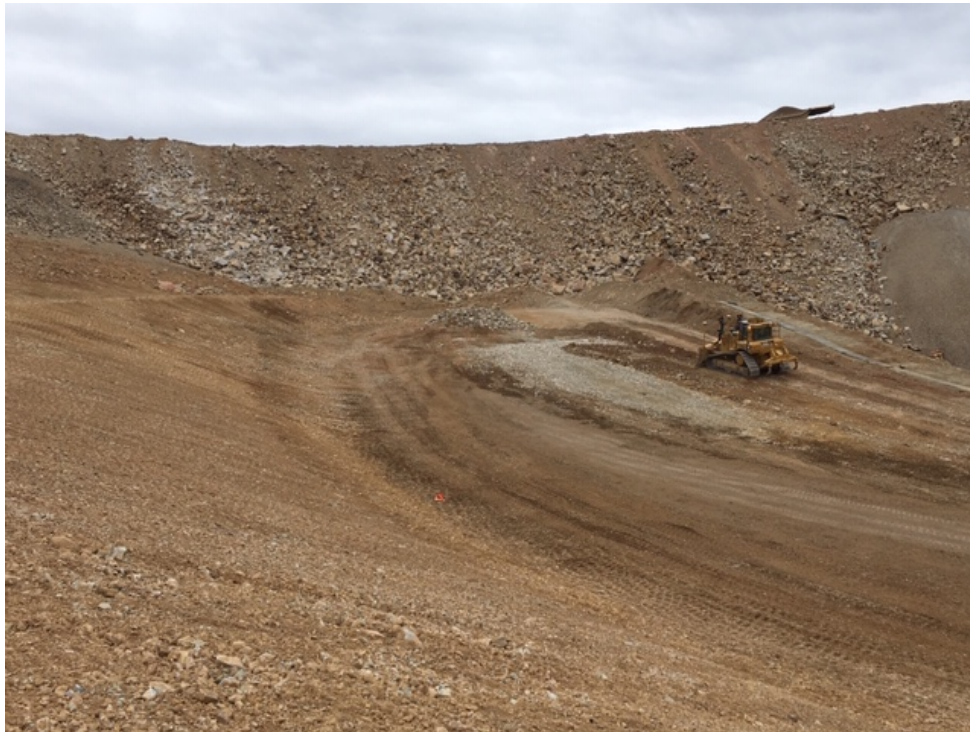
Unsuitable structural fill was hauled off of the 10,050' and 10,150' benches as well as off the flat areas at the toes of the slopes and stockpiled outside the Phase 2B limits.

May 11, 2020 – Removing stockpiled structural fill from the area below the 10,050' bench (JP)

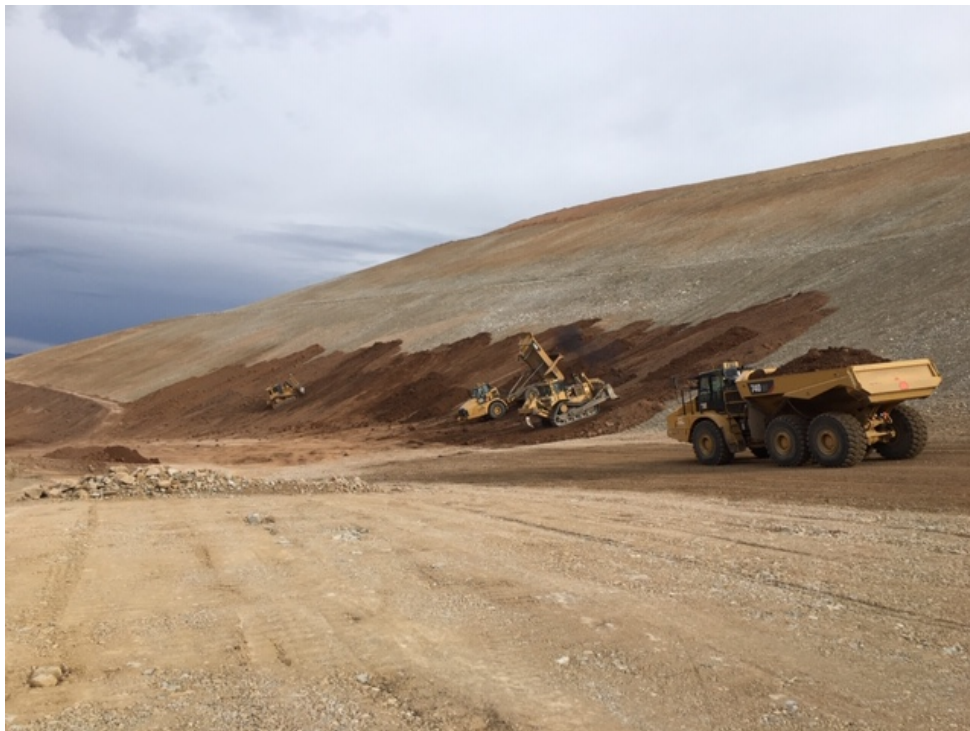
May 1, 2020 – SLF placement progress (JP)

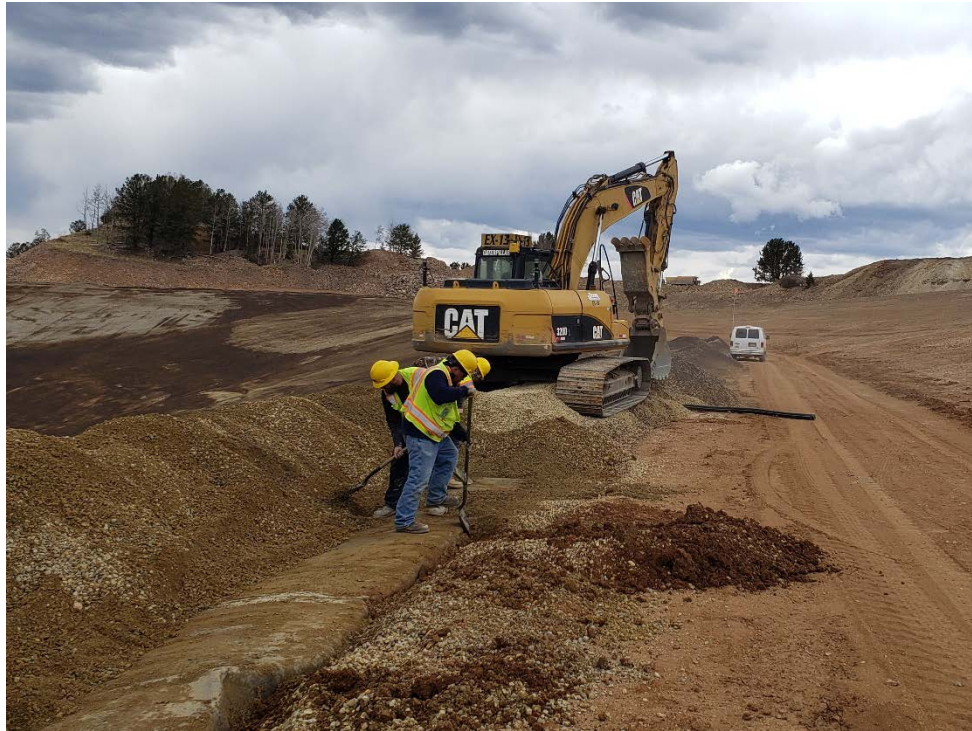
Geomembrane along the Phase 2A crest on the north side of Phase 2B was exposed during this reporting period. The Phase 1/Phase 2B geomembrane interface on the south end of Phase 2B was also cleaned off to prepare for proper tie-in.

May 12, 2020 –Exposing Phase 2A geomembrane (BM)

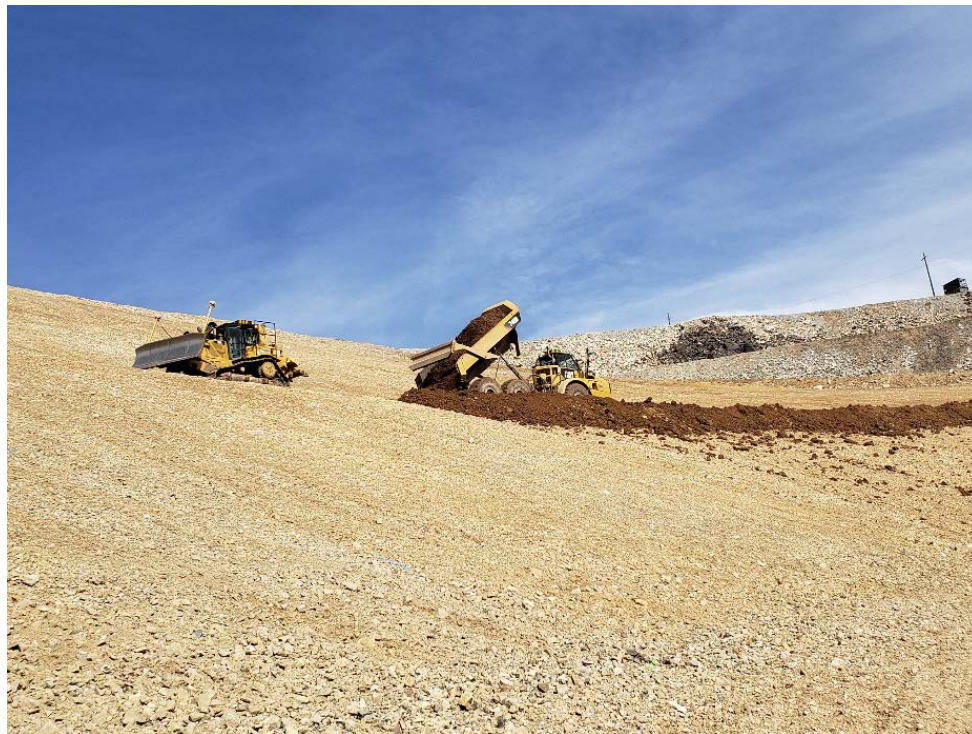
May 12, 2020 – Creating a SLF berm along the 10,050' bench (BM)

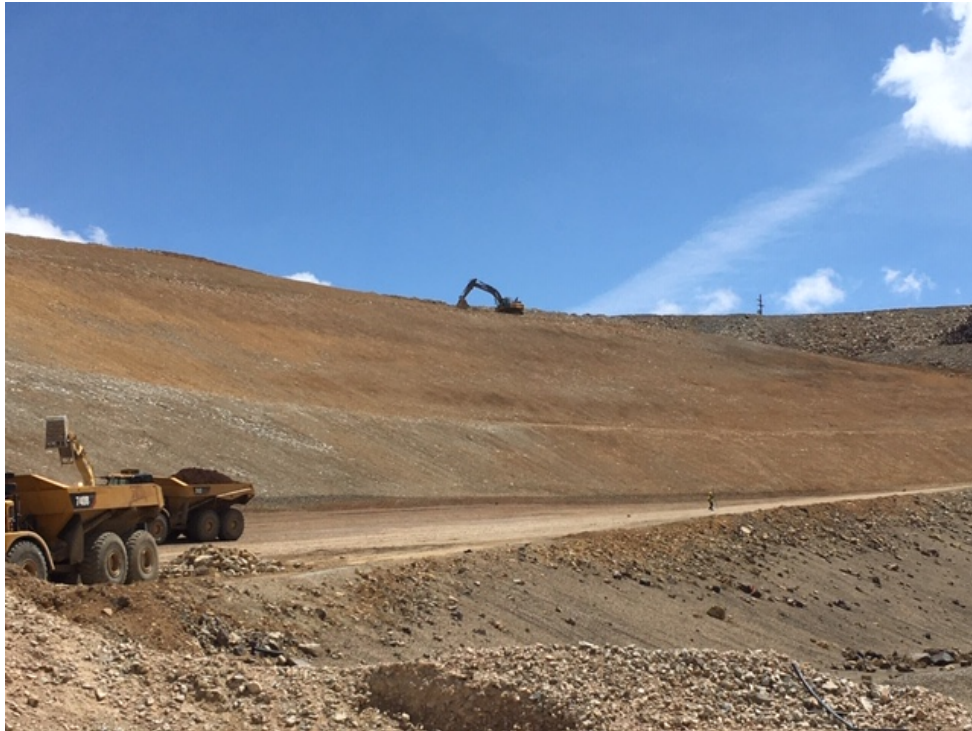
May 12, 2020 – Excavator grading the 10,150' bench (JP)

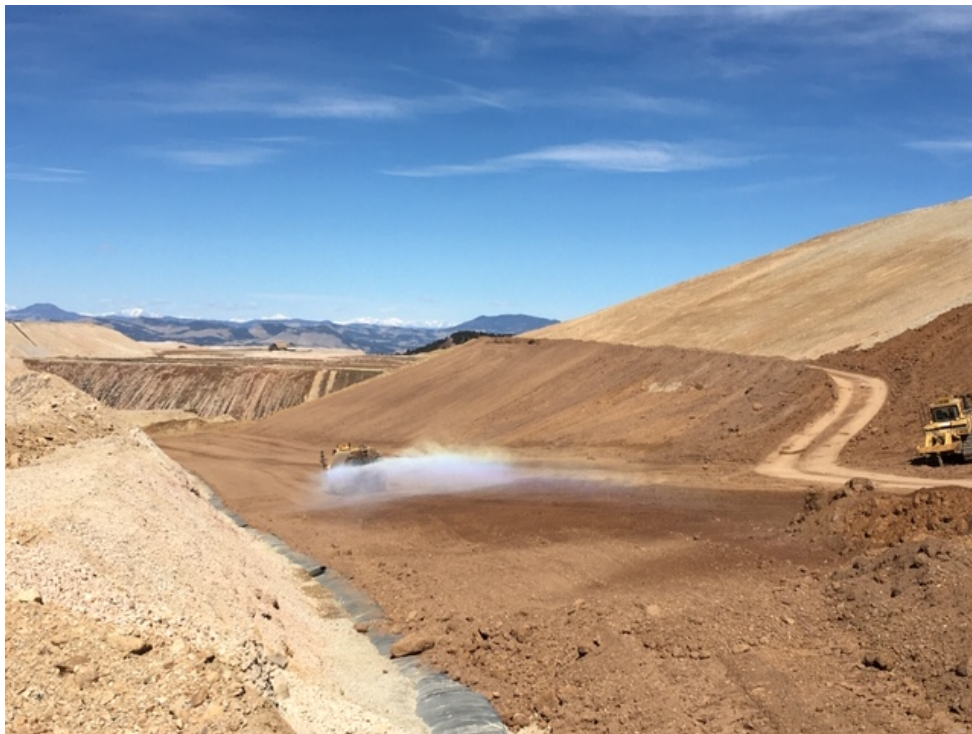
May 13, 2020 – Moisture conditioning the SLF (JP)

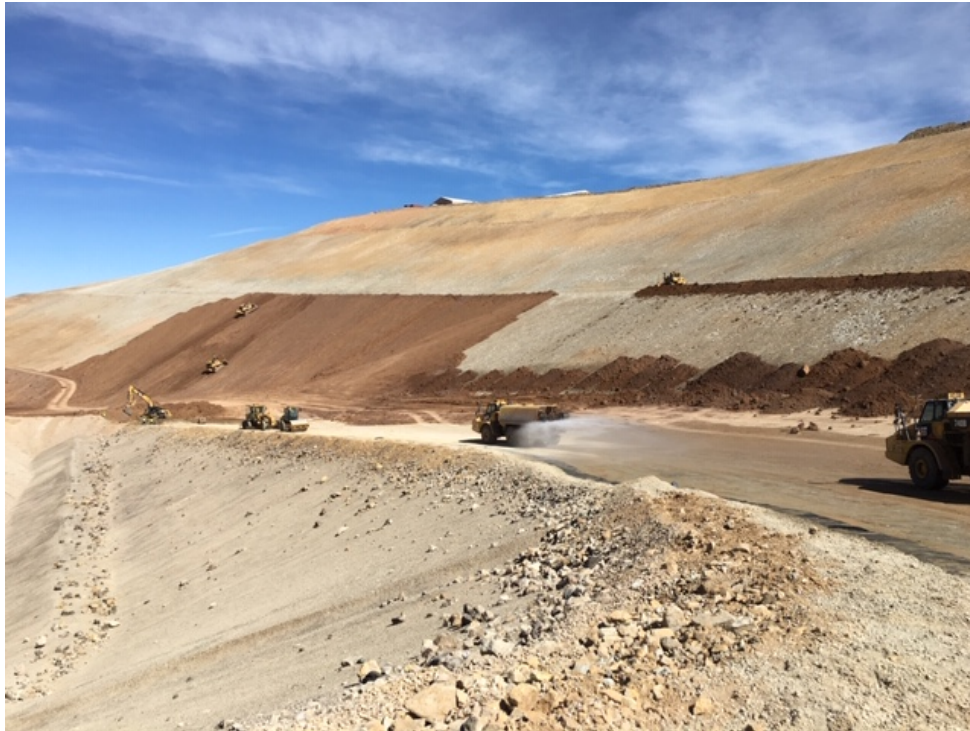
May 13, 2020 – Overview of work activities (JP)

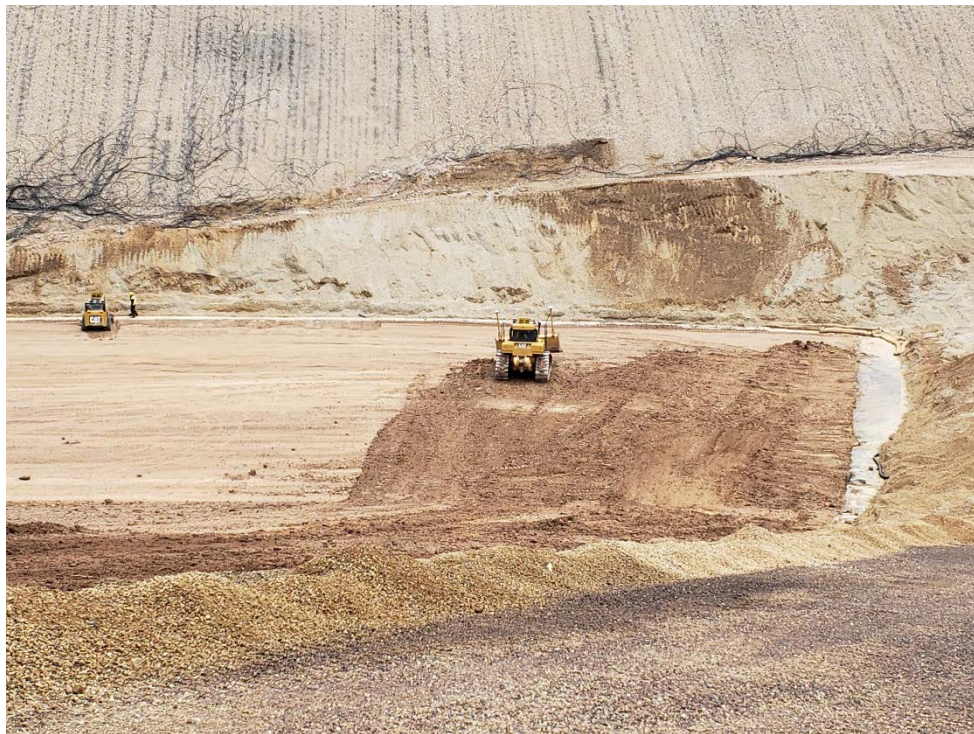
May 14, 2020 – Finish grading the SLF along the Phase 2A and Phase 1 tie-in (BM)

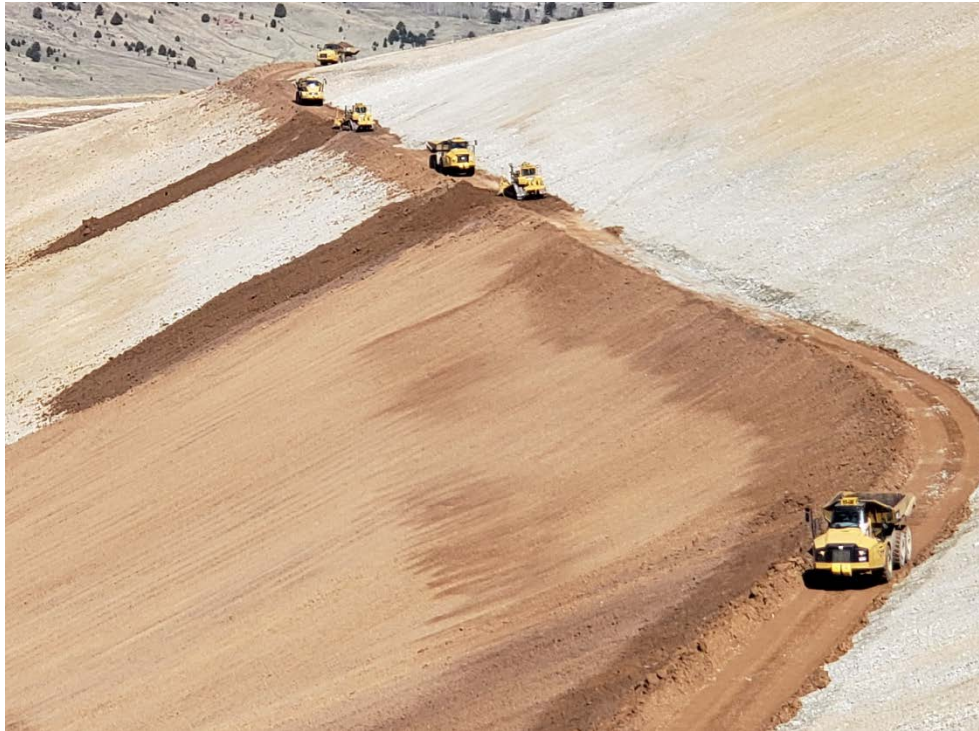
May 15, 2020 – SLF placement progress along 10,050' bench (BM)

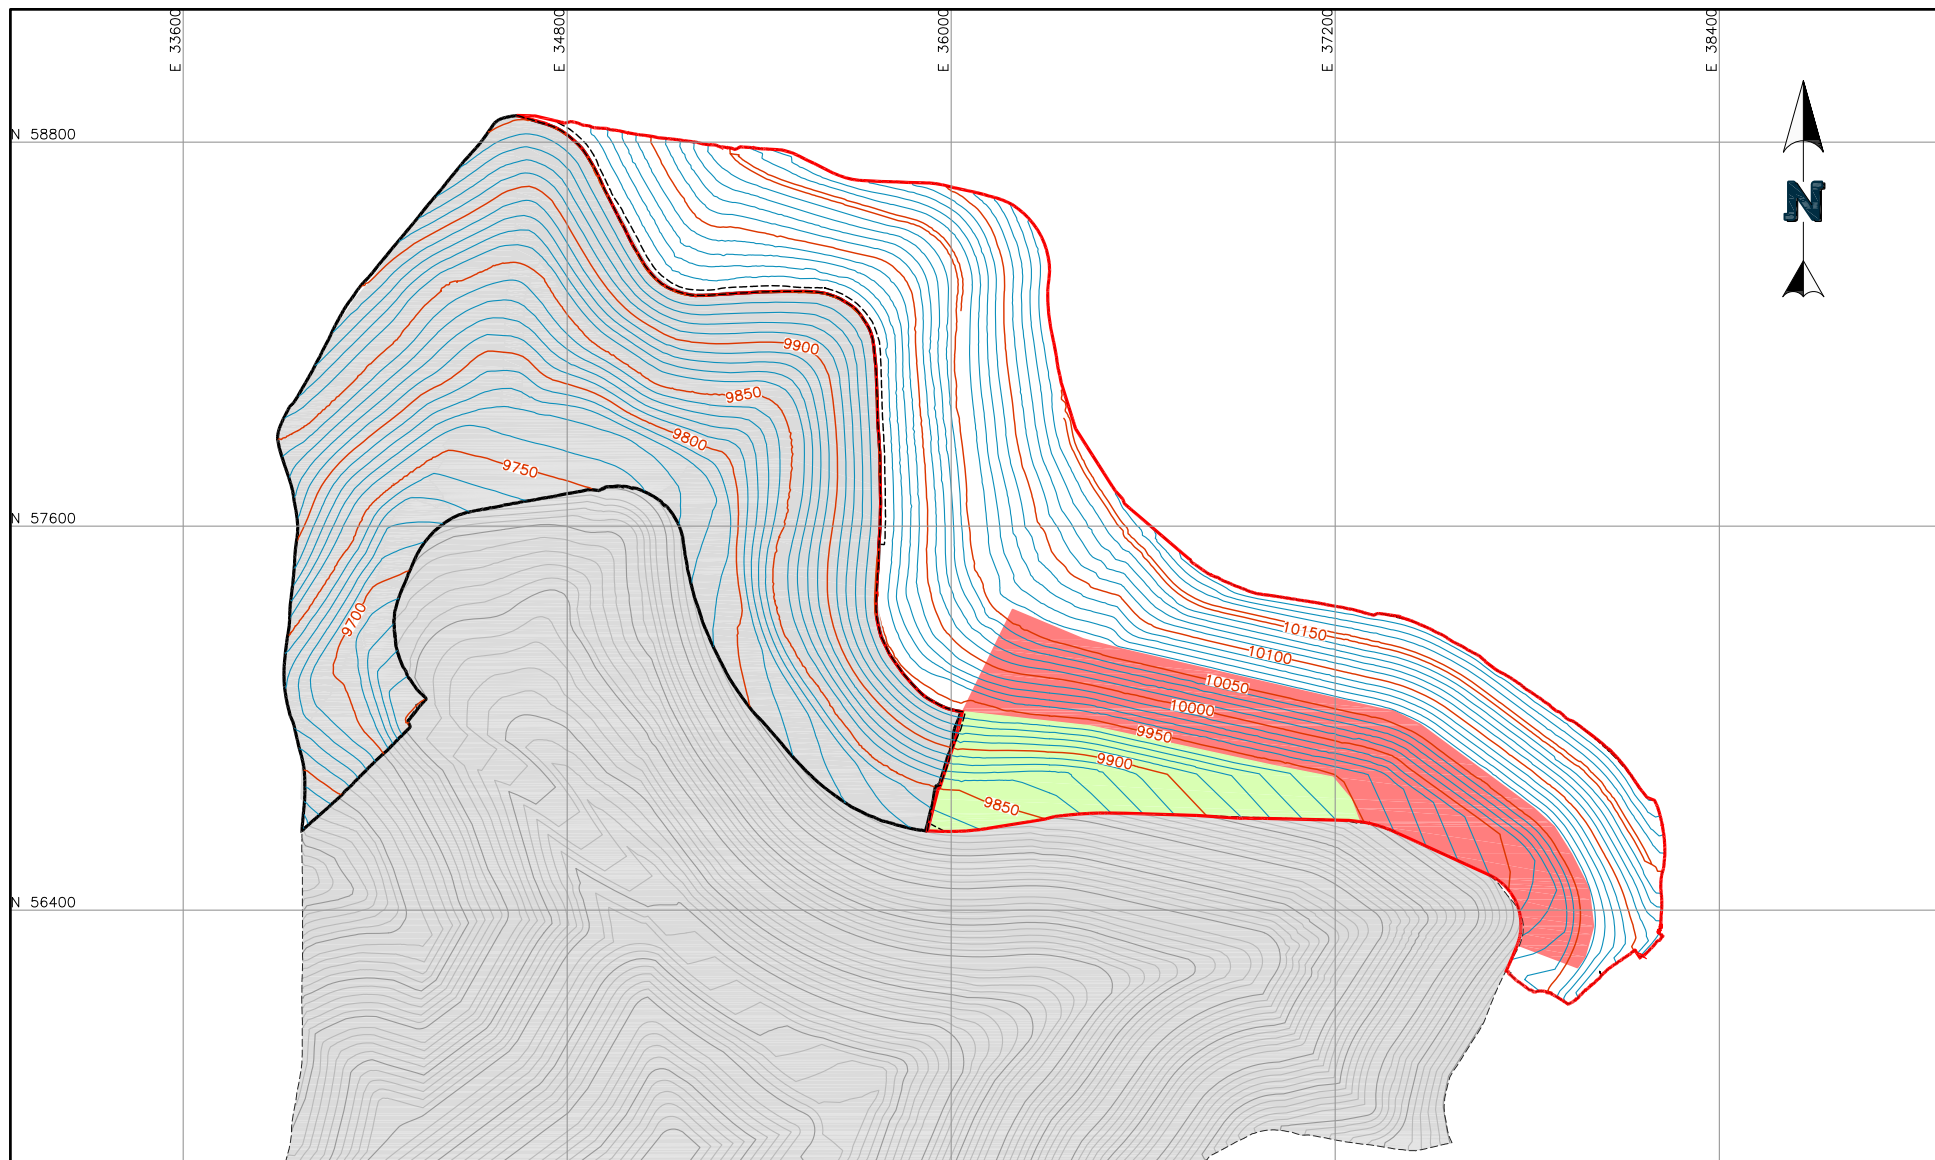
TITLE **WEEKLY SUBGRADE ACCEPTANCE
WEEK ENDING 05-16-20**

Two areas of subgrade were accepted during this reporting period. Figure 1 shows the current area of subgrade acceptance.

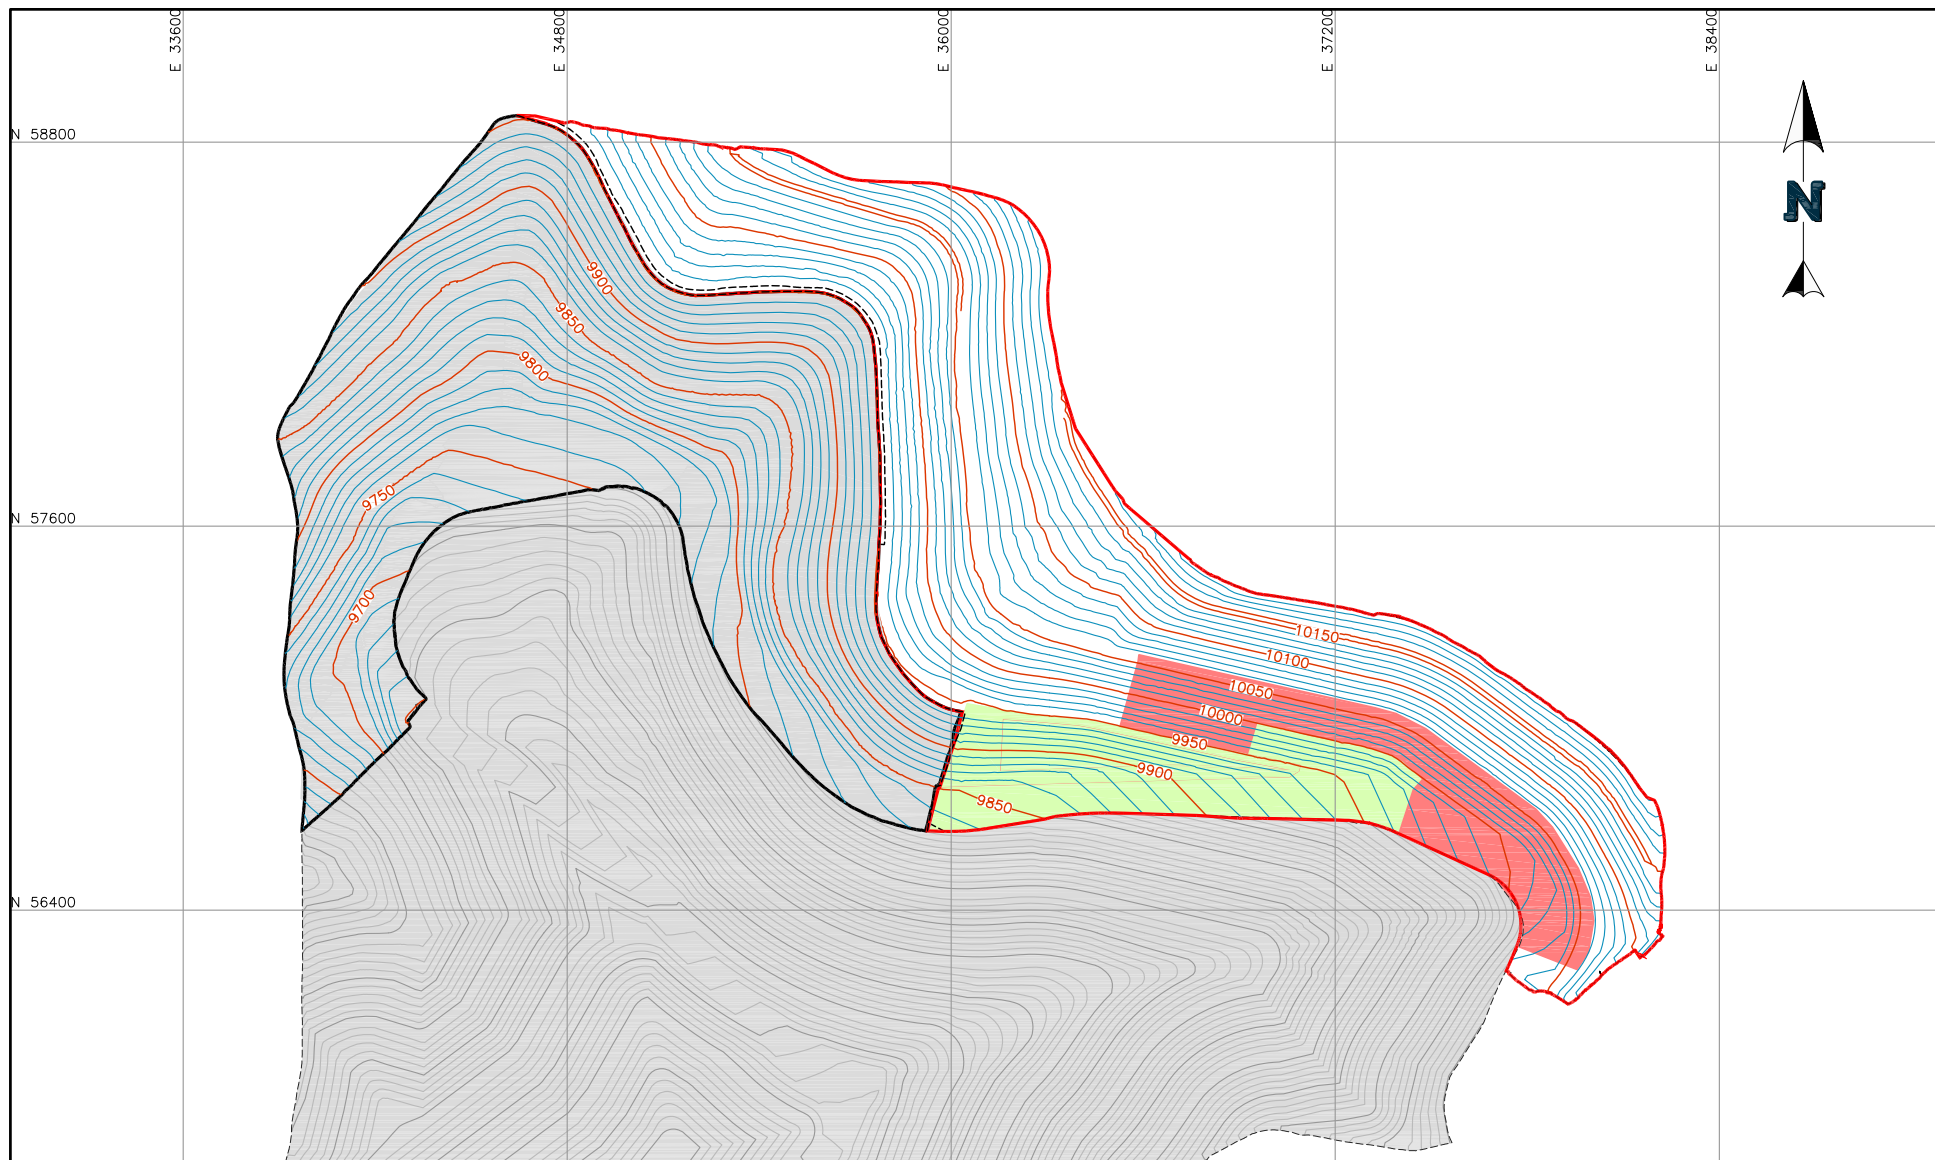
TITLE **WEEKLY SLF PLACEMENT
WEEK ENDING 05-16-20**

Soil Liner Fill (SLF) placement continued in the southwest portion of Phase 2B around the toes and slopes below the 9,950' and 10,050' benches. SLF material was hauled from the Dump 1 stockpile using articulating haul trucks. The material was then spread with low ground pressure CAT dozers equipped with GPS. Moisture conditioning of SLF material was performed in place using a water truck, and compaction was done using a vibratory smooth drum compactor. Figure 2 shows the area of SLF placement during this reporting period.
