## FIELD WEEKLY PROGRESS REPORT

**PROJECT:** VALLEY LEACH FACILITY (VLF2) PHASE 2 CQA  
**SITE:** CRIPPLE CREEK & VICTOR GOLD MINE (COLORADO)  
**CONTRACTOR:** TEZAK HEAVY EQUIPMENT  
**WEEK ENDING:** SATURDAY, JUNE 13, 2020

**REPORTING PERIOD: 06.07.2020 THROUGH 06.13.2020**

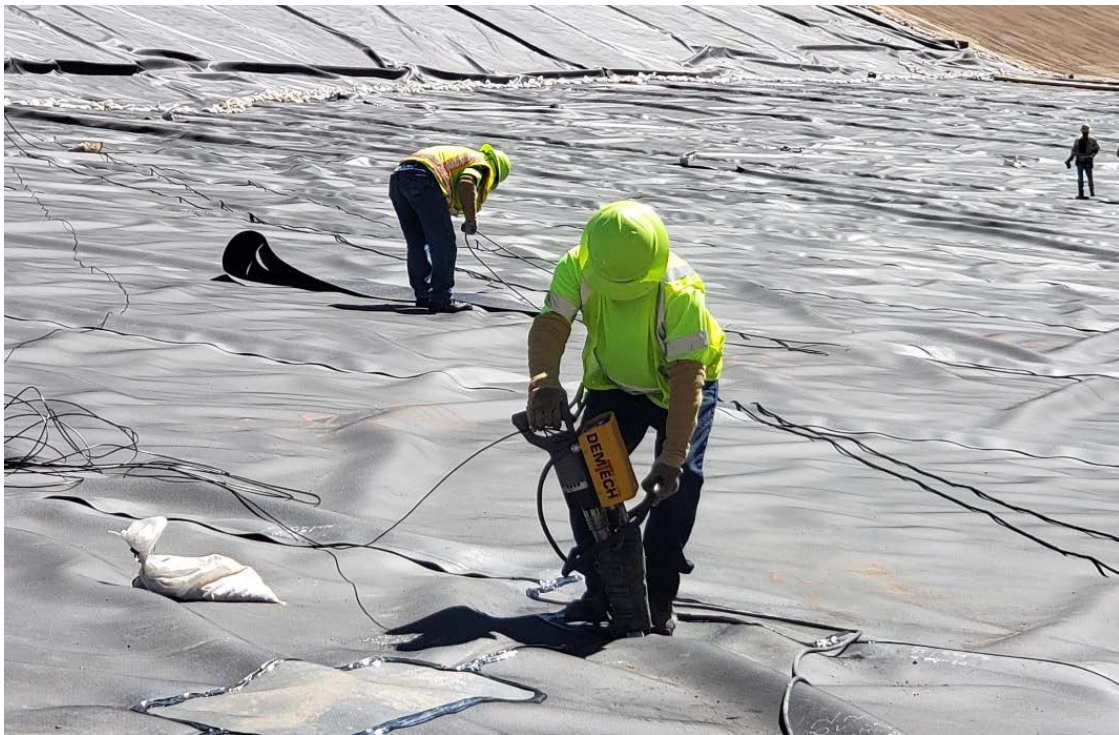
**June 8, 2020 – Extrusion welding a repair (BM)**

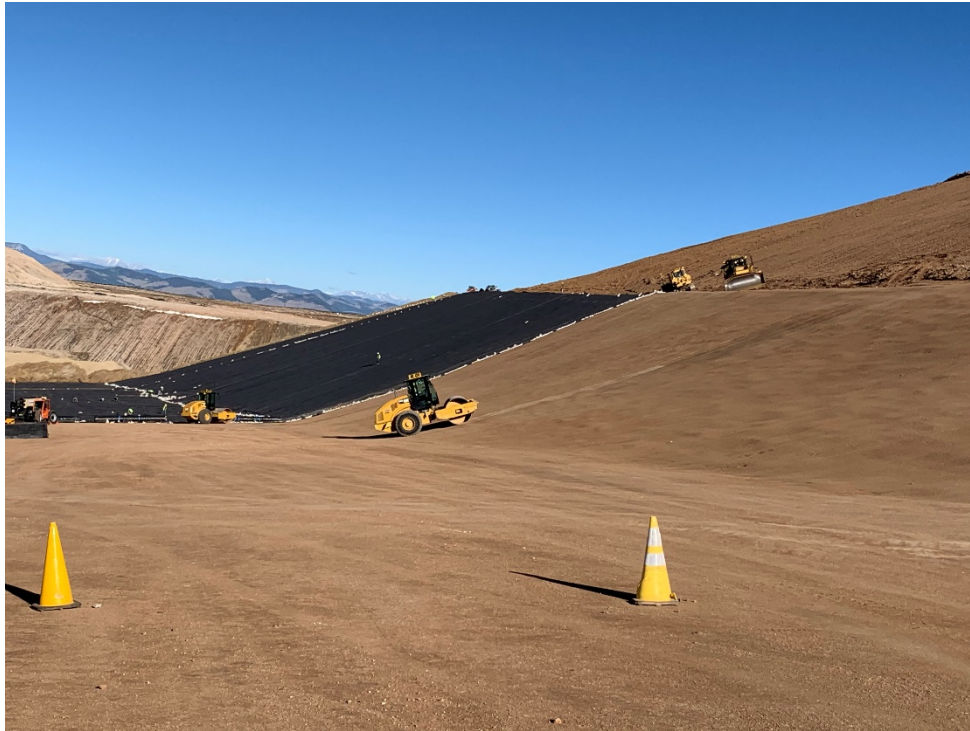
**June 10, 2020 – SLF compaction below the 9,950' bench (JP)**

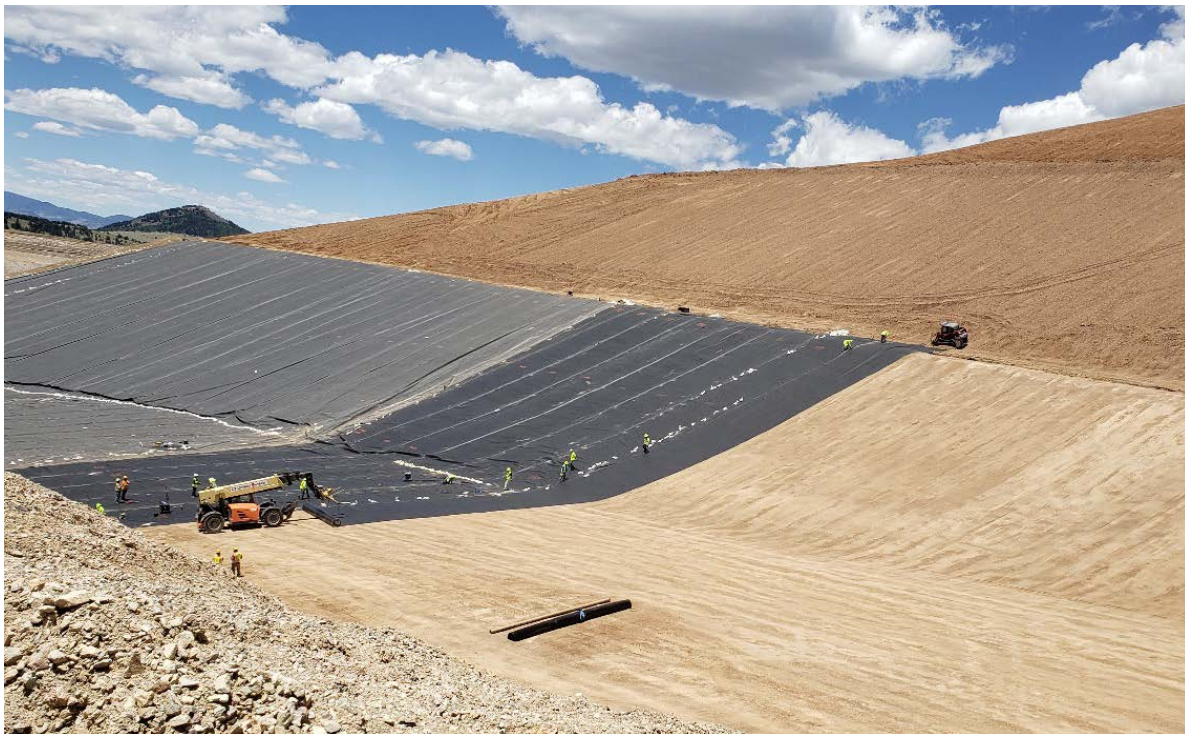
**June 11, 2020 –Geomembrane deployment (BM)**

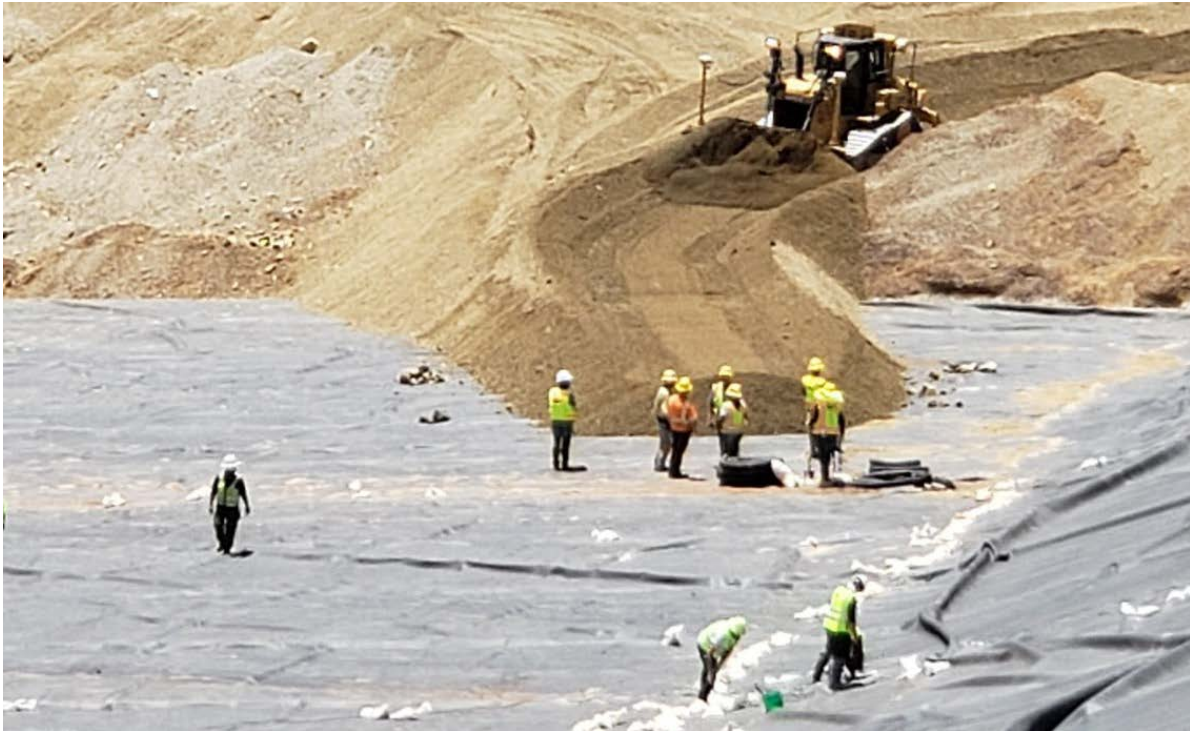
**June 11, 2020 – Spreading drain cover fill (BM)**

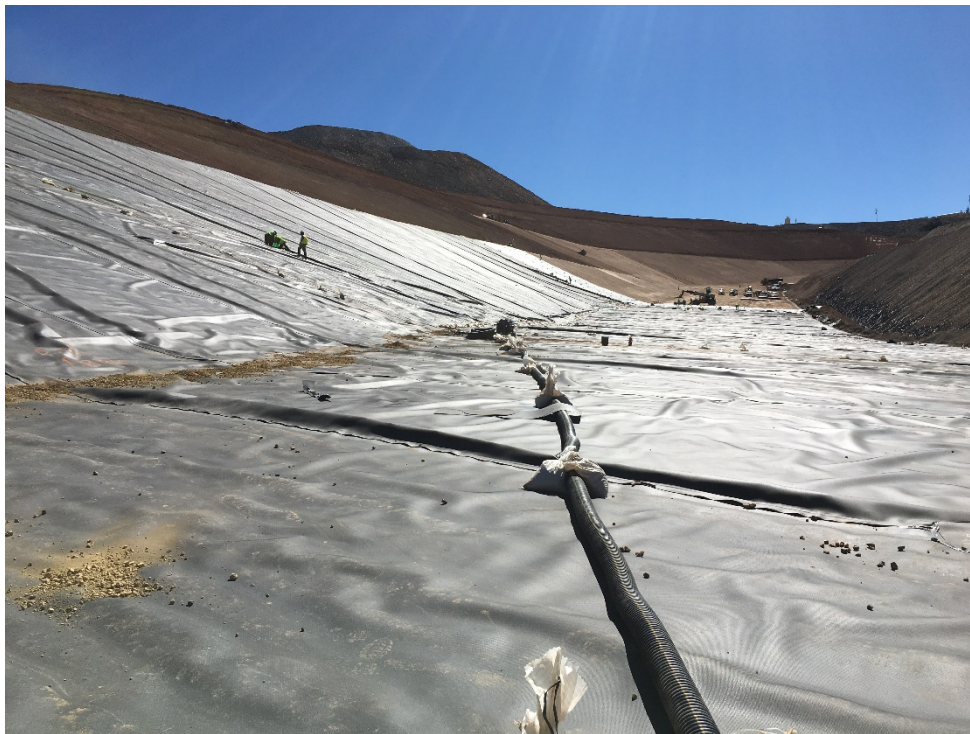
**June 11, 2020 – HVSC piping laid out on geomembrane (JP)**

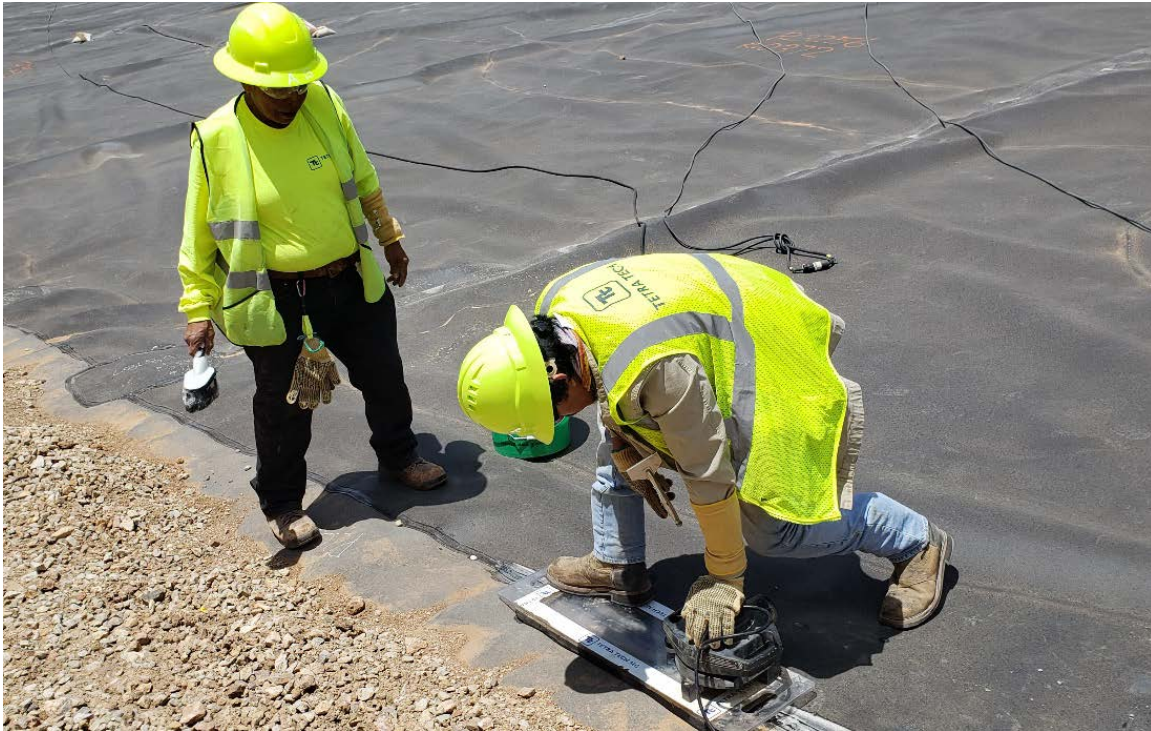
June 13, 2020 – Vacuum testing extrusion welds (BM)

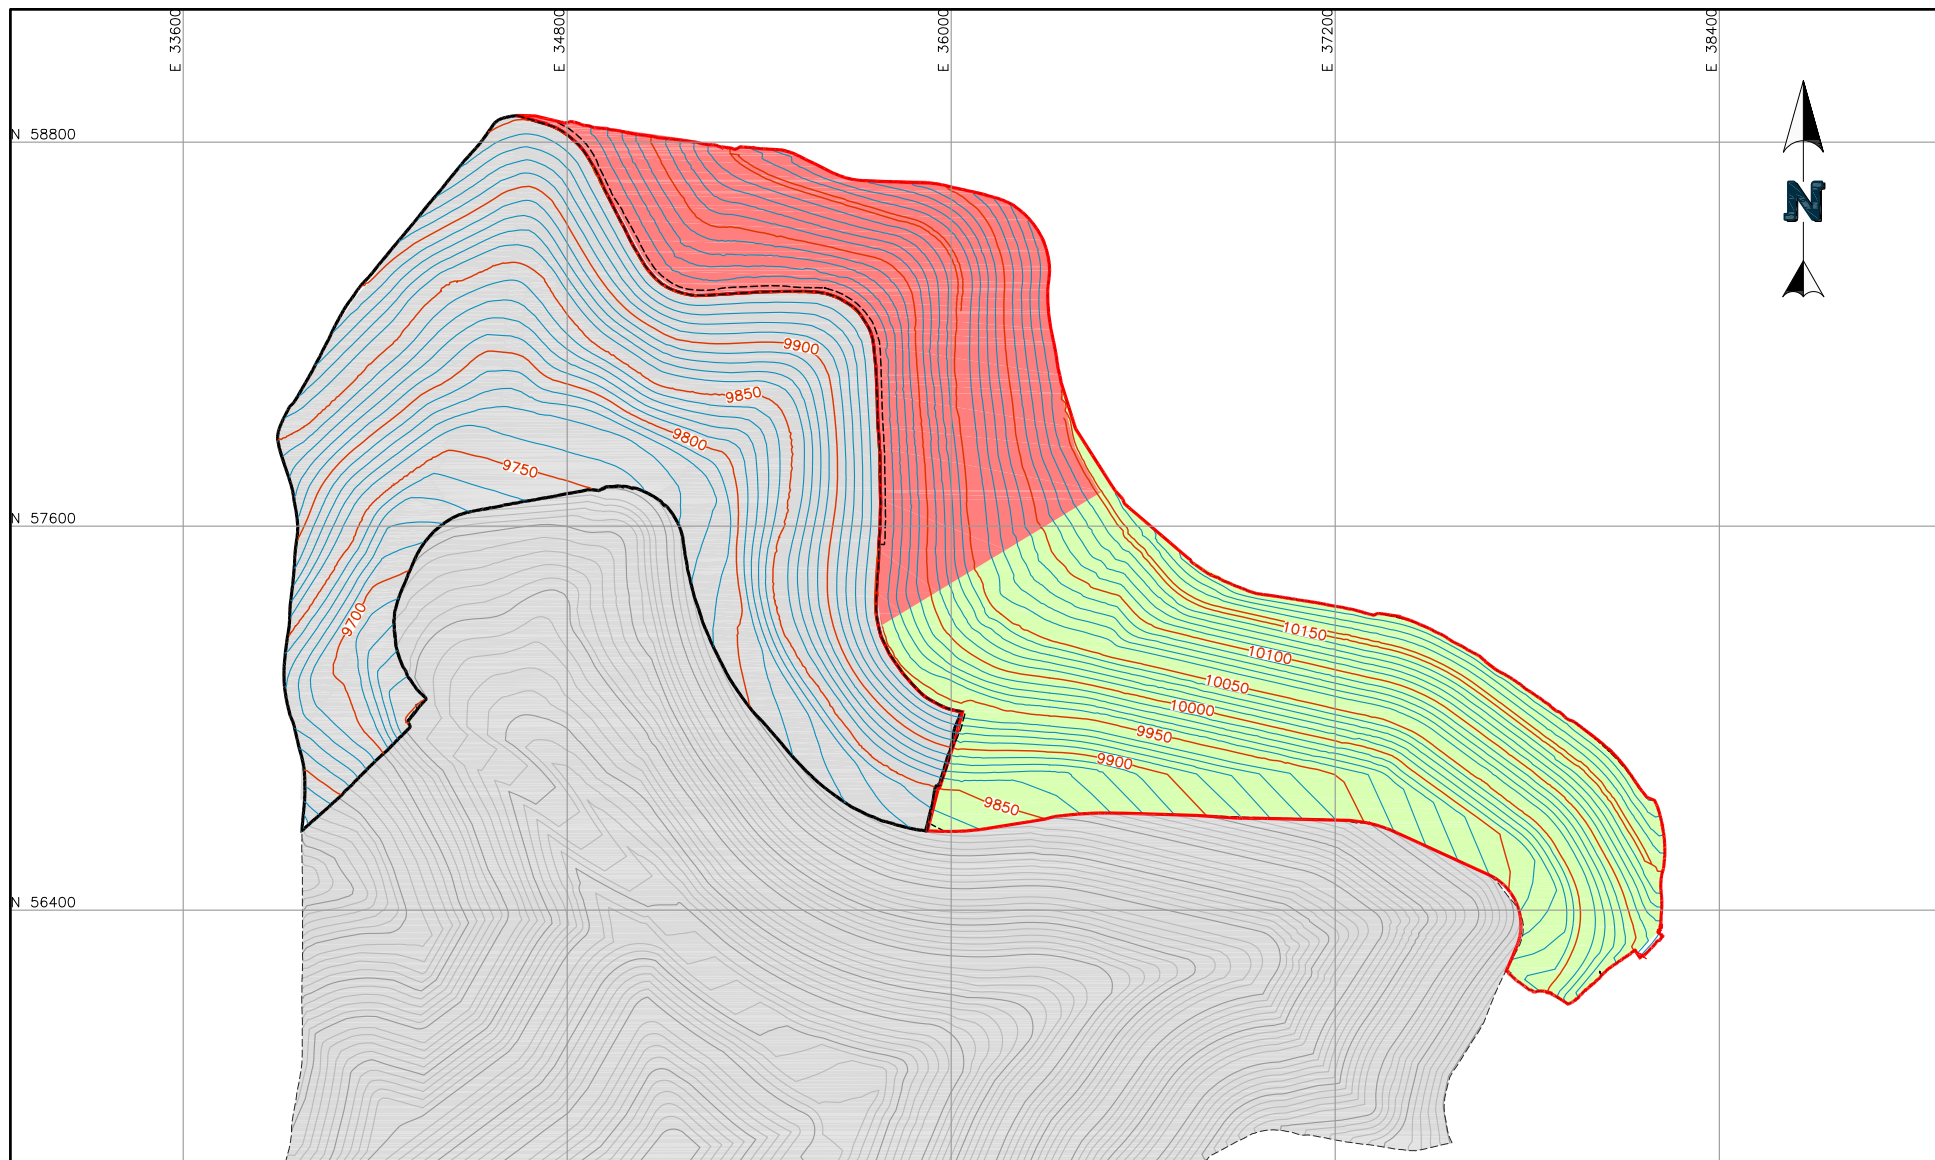
TITLE **WEEKLY SUBGRADE ACCEPTANCE  
WEEK ENDING 06-13-20**

One additional area of subgrade was accepted during this reporting period. All subgrade has been approved for 2020 construction. Figure 1 shows the current area of subgrade acceptance.

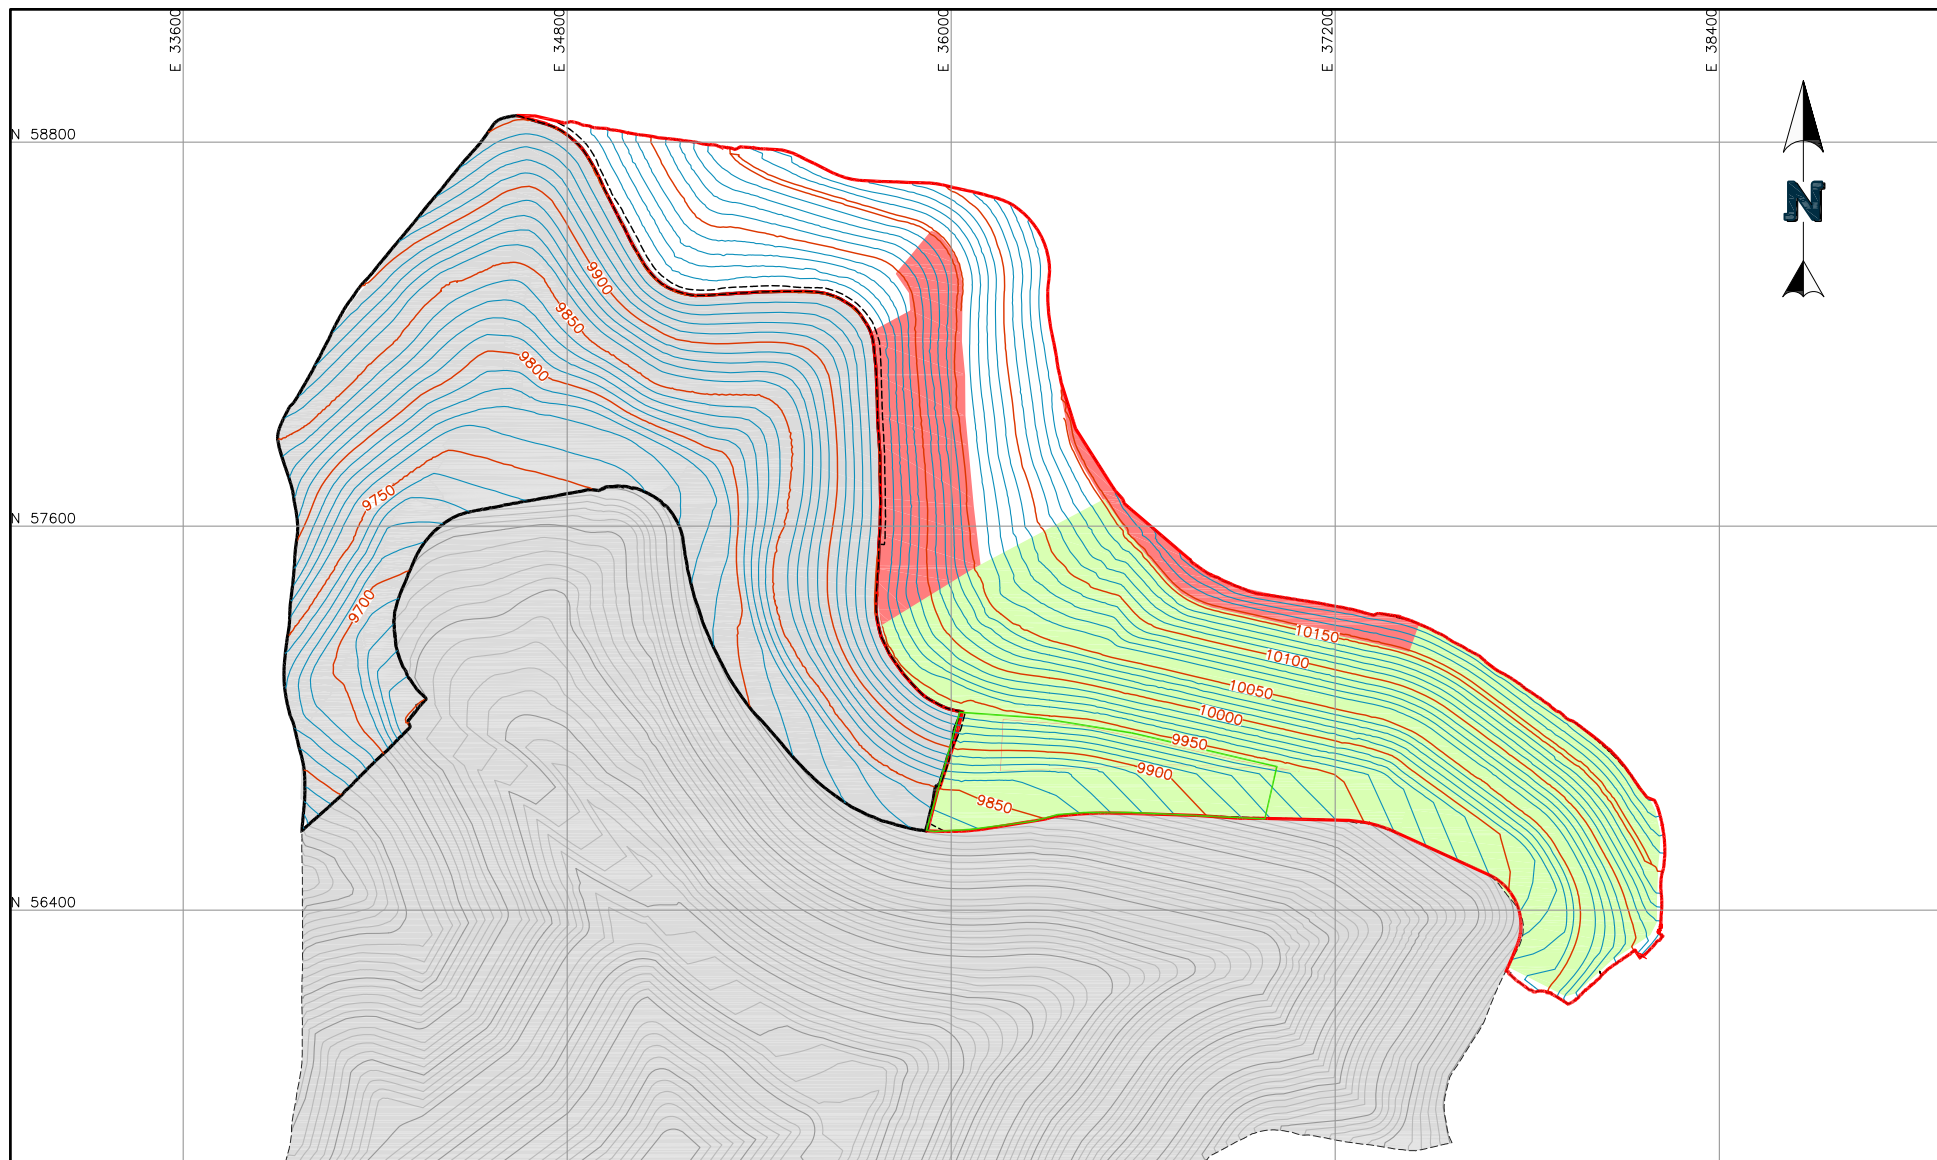
TITLE **WEEKLY SLF PLACEMENT  
WEEK ENDING 06-13-20**

Soil Liner Fill (SLF) placement continued in the southwest portion of Phase 2B between the 10,150' and 10,195' benches as well as in the northern portion of Phase 2B between the 9,950' and 10,050' benches. SLF material was hauled from the Dump 1 stockpile using articulating haul trucks. The material was then spread with low ground pressure CAT dozers equipped with GPS. Moisture conditioning of SLF material was performed in place using a water truck, and compaction was done using a vibratory smooth drum compactor. Figure 2 shows the area of SLF placement during this reporting period.

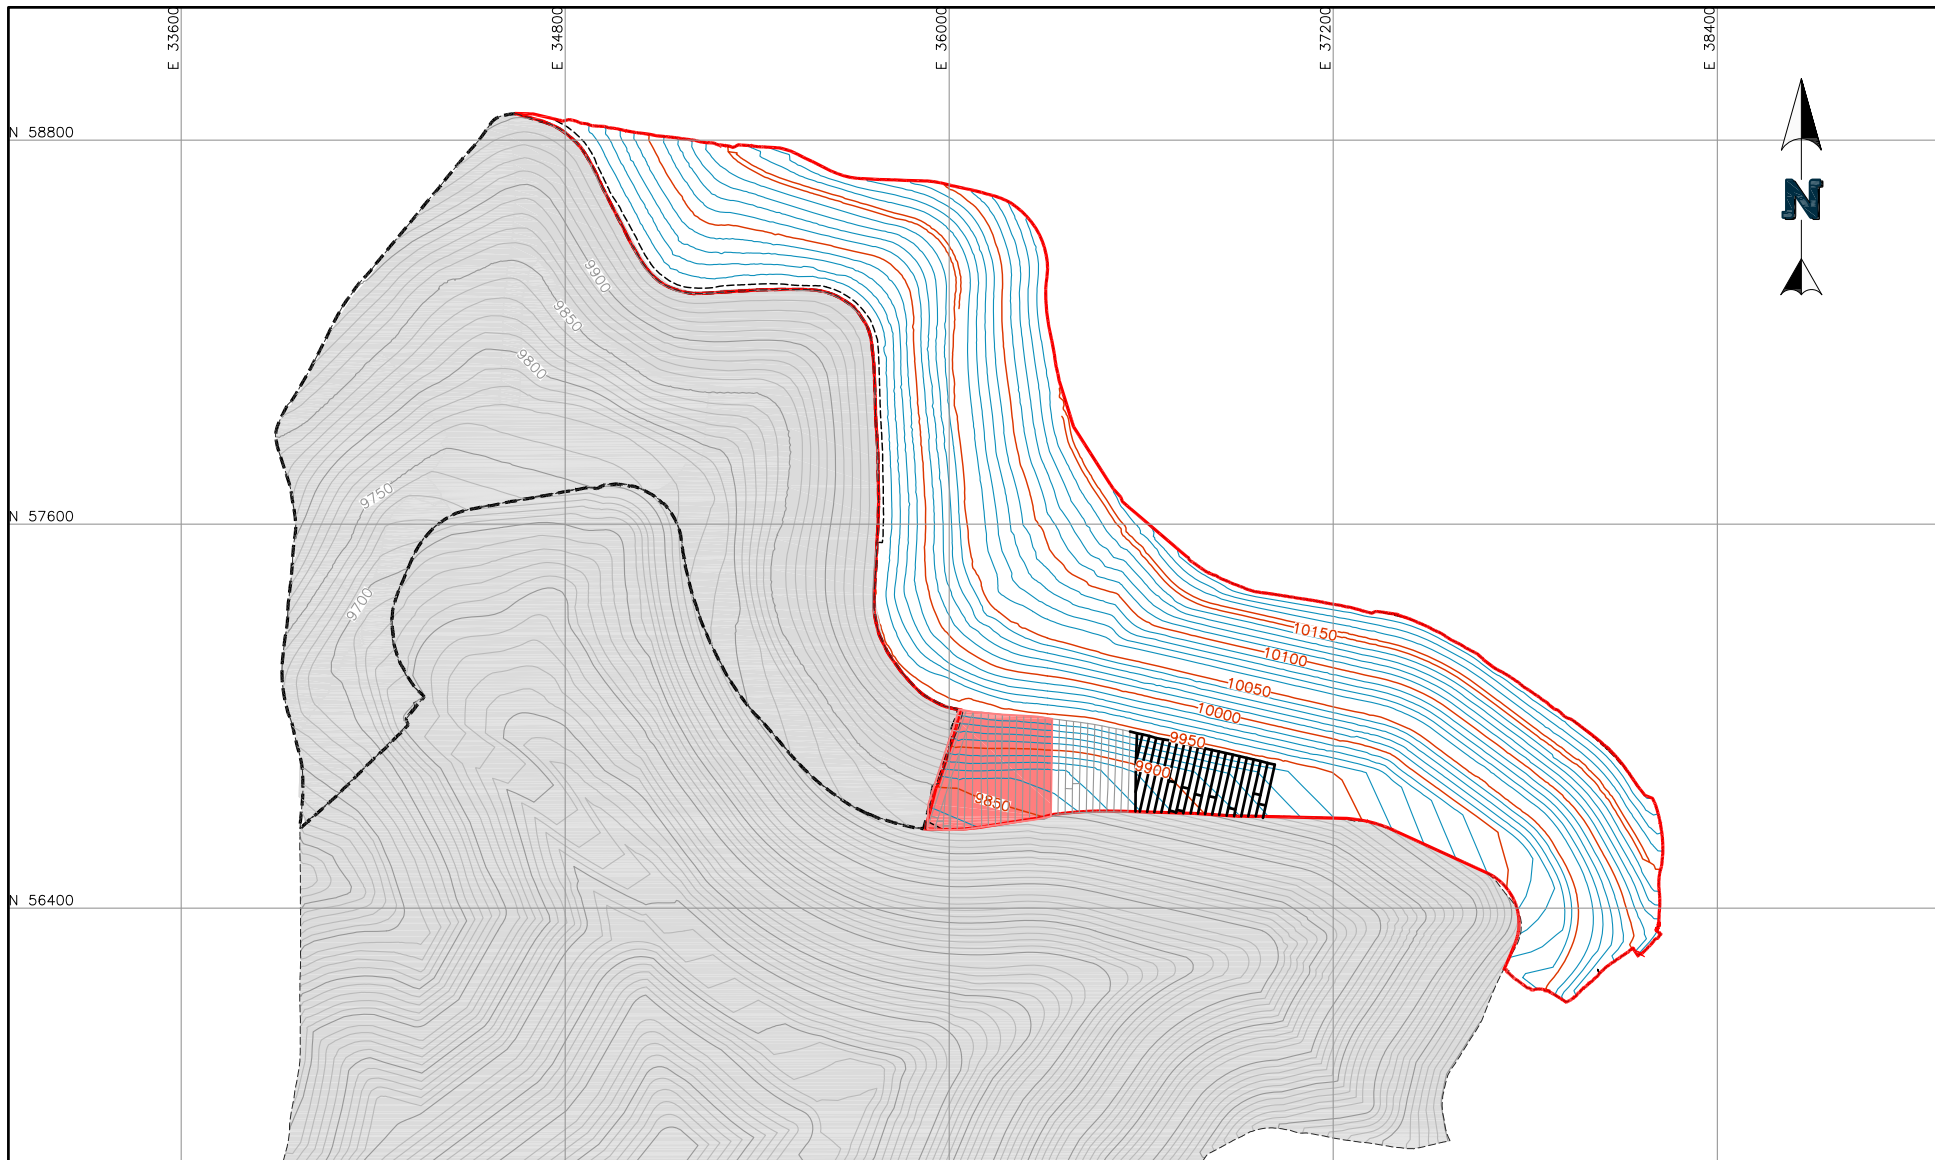
TITLE **WEEKLY GEOMEMBRANE PLACEMENT & ACCEPTANCE  
WEEK ENDING 06-13-20**

Geomembrane installation continued within the Phase 2A-5 limits as shown on Figure 3. Approximately **92,022** square feet (P-3232 to P-3260) of 80-mil LLDPE (double sided textured) was deployed. Subgrade was inspected and approved by NewFields, Tezak, Newmont and AEG representatives prior to geomembrane deployment. Approximately **4,472** linear feet of seam was fusion welded using two fusion welding machine/operator combinations. **Eleven** destructive testing samples were marked during fusion seaming. Approximately **977** linear feet of seam was extrusion welded using two extrusion welding machine/operator combinations. **Ten** destructive testing samples were marked during extrusion seaming. Non-destructive testing was performed for fusion welded seams. Repairs were performed using the extrusion welding method for some marked defects.

Panels P-3193 through P-3216 were accepted for drain cover fill placement. The attached Figure 3 shows the acceptance areas.

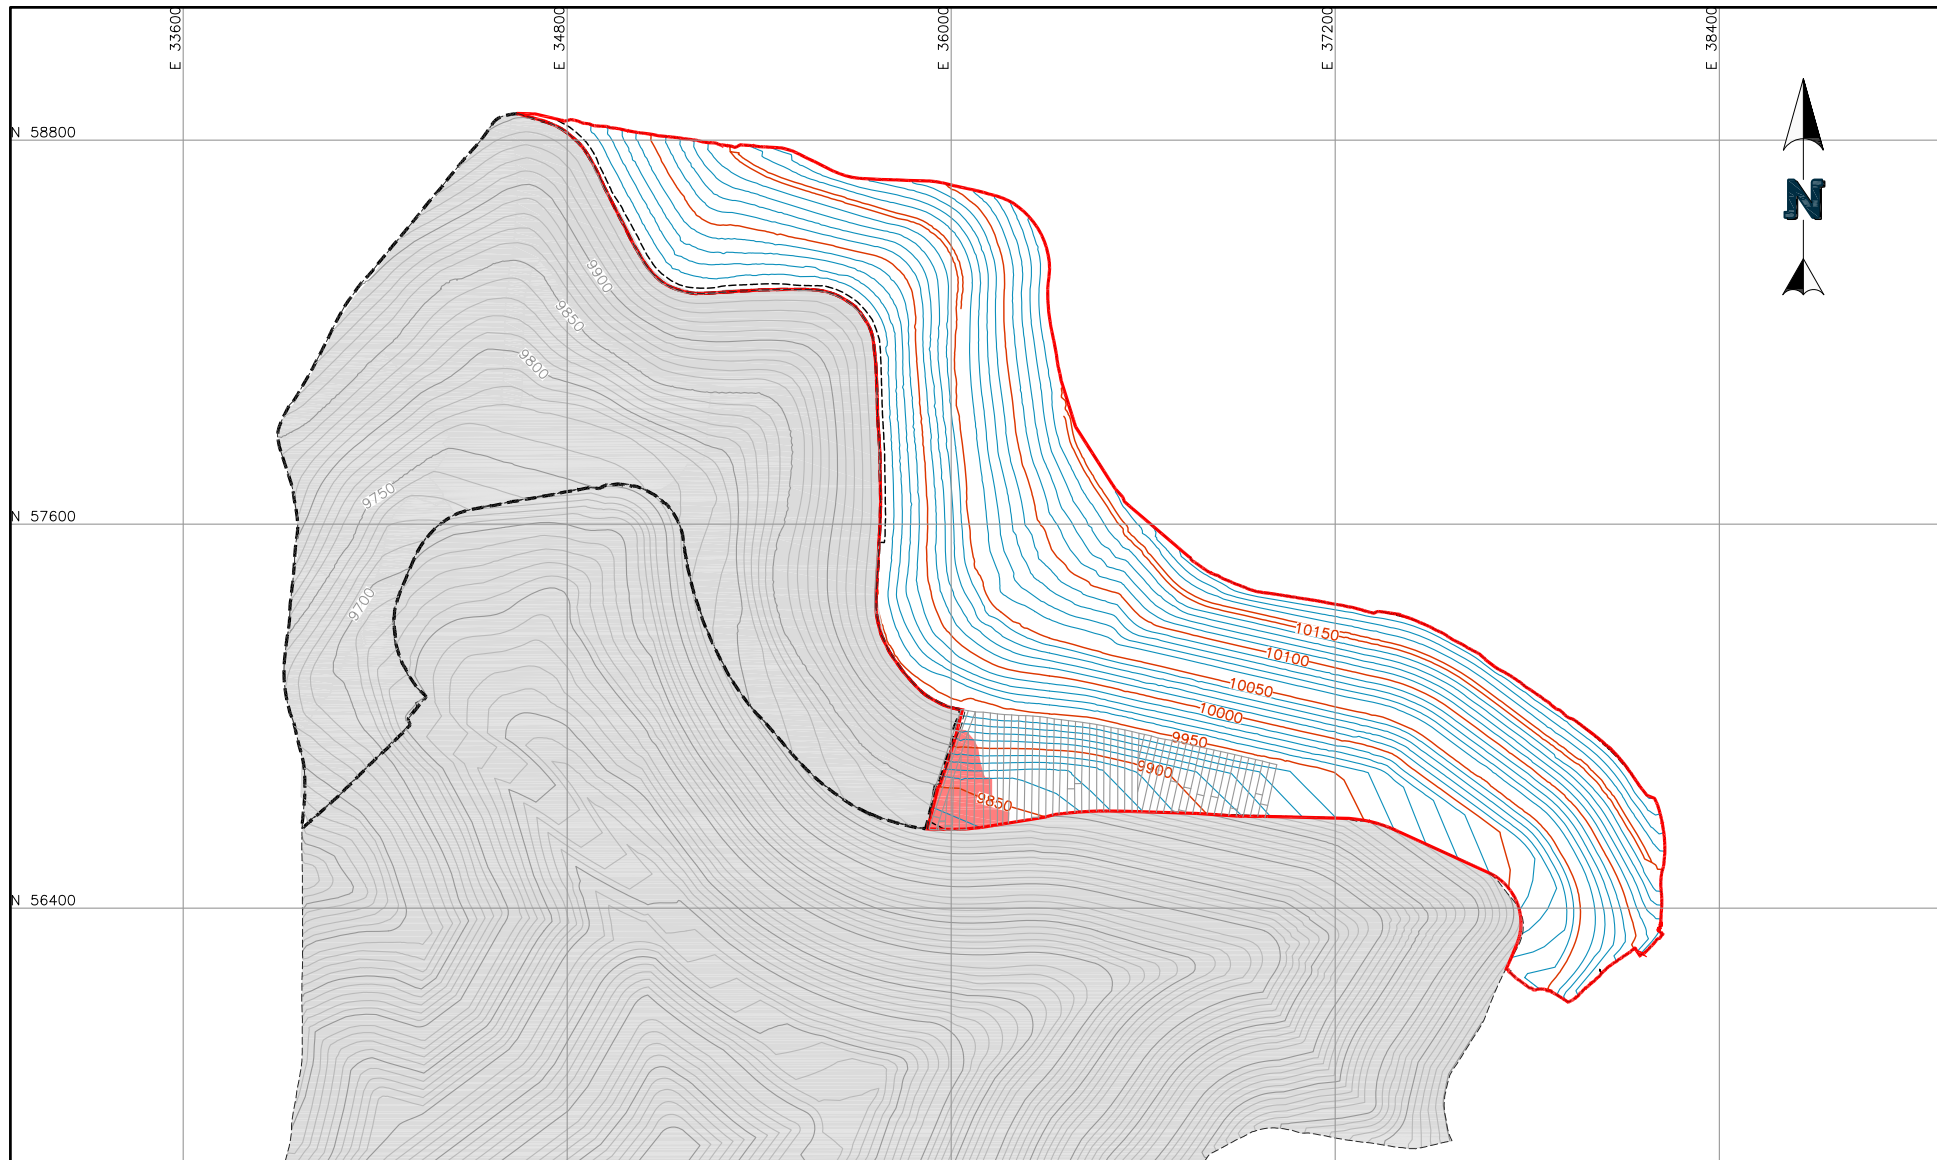
TITLE **WEEKLY DRAIN COVER FILL PLACEMENT  
WEEK ENDING 06-13-20**

Drain Cover Fill (DCF) placement was performed in the areas shown on Figure 4. Some DCF was spread from the stockpiles in previously constructed Phase 2A and some was hauled from the mine's approved crushed ore stockpiles. The DCF was placed in a 2-foot lift on previously approved geomembrane by low ground pressure CAT dozers. Haul routes consisted of 4-foot lifts that will be spread into 2-foot lifts at a later date. Tezak laborers were present during placement to assist in removing debris/sandbags/large rocks, installing high volume solution collection piping, and ensuring that the lift thickness was correct. A NewFields' representative constantly monitored the DCF placement.
