## MINERALS PROGRAM INSPECTION REPORT

<b>MINE NAME:</b> Schwartzwalder Mine	<b>MINE/PROSPECTING ID#:</b> M-1977-300	<b>MINERAL:</b> Uranium	<b>COUNTY:</b> Jefferson
<b>INSPECTION TYPE:</b> Monitoring	<b>INSPECTOR(S):</b> Amy Eschberger, Tim Cazier	<b>INSP. DATE:</b> August 4, 2020	<b>INSP. TIME:</b> 09:30
<b>OPERATOR:</b> Colorado Legacy Land, LLC	<b>OPERATOR REPRESENTATIVE:</b> Billy Ray, Sam Lowe	<b>TYPE OF OPERATION:</b> 112d-2 - Designated Mining Operation	
<b>REASON FOR INSPECTION:</b> Normal I&E Program	<b>BOND CALCULATION TYPE:</b> None	<b>BOND AMOUNT:</b> \$8,900,000.00	
<b>DATE OF COMPLAINT:</b> NA	<b>POST INSP. CONTACTS:</b> None	<b>JOINT INSP. AGENCY:</b> None	
<b>WEATHER:</b> Clear	<b>INSPECTOR'S SIGNATURE:</b>

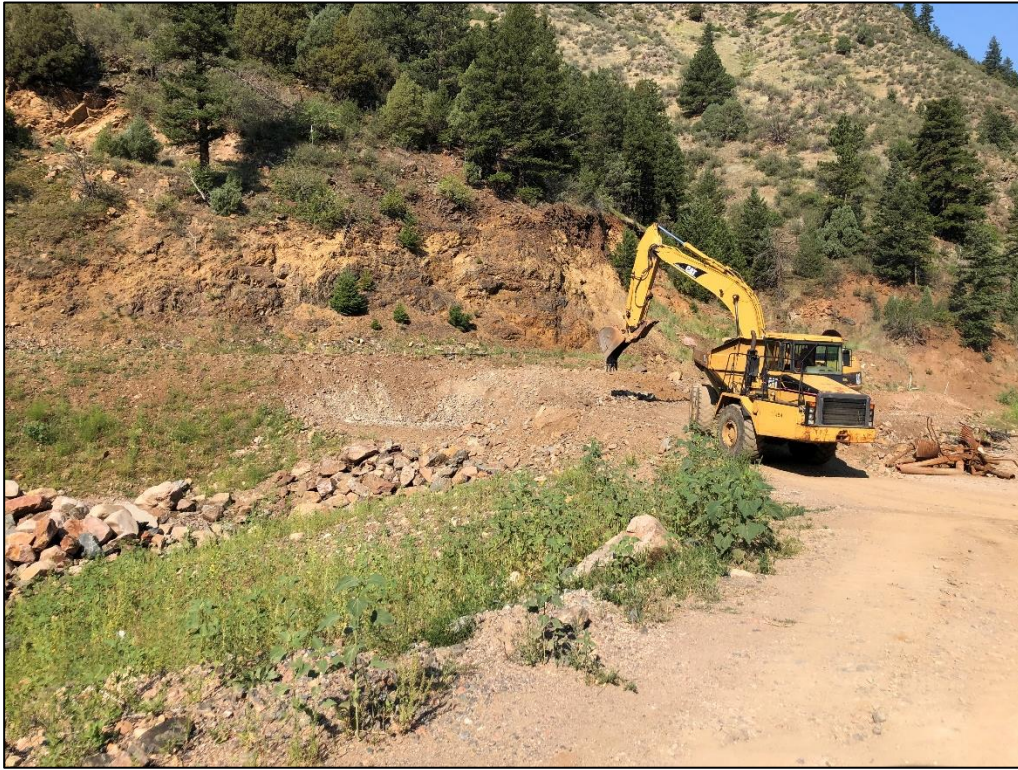
The alluvial excavation project was underway during the inspection. Current excavation activities are in the stretch of the valley between the Black Forest Mine portal and the sump # 4 location (beneath the mesa with the water treatment plant). The operation is still on track to complete the excavation project by the end of this year. It should be noted, an Amendment application (AM-05) was submitted by the operator on July 24, 2020 to increase the permit area by 3.98 acres (to accommodate anticipated reclamation activities in the Black Forest Mine and NWRP) and to include disposal of contaminated alluvial soils into the Black Forest Mine. The AM-05 application was called incomplete. The Division will begin a technical review of AM-05 once all items required for the application to be considered complete for filing purposes have been submitted.

**Photo 1.** View looking northwest across area where excavation activities are currently underway (near Black Forest Mine portal).

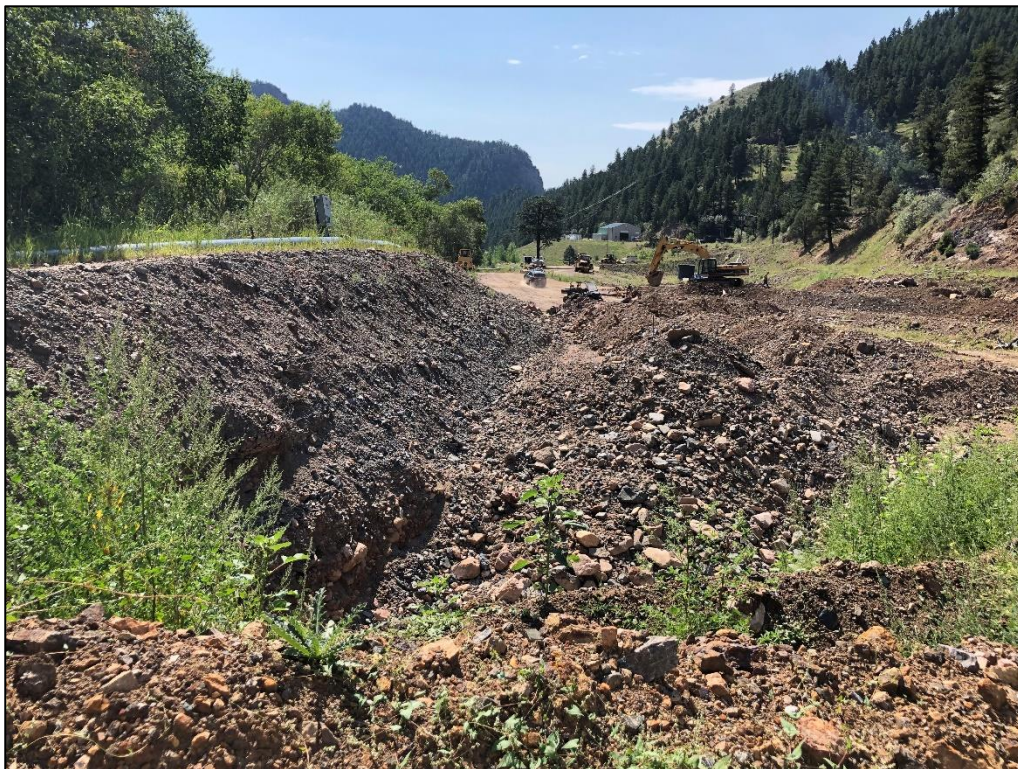
**Photo 2.** View looking southeast across area where excavation activities are currently underway (near Black Forest Mine portal).

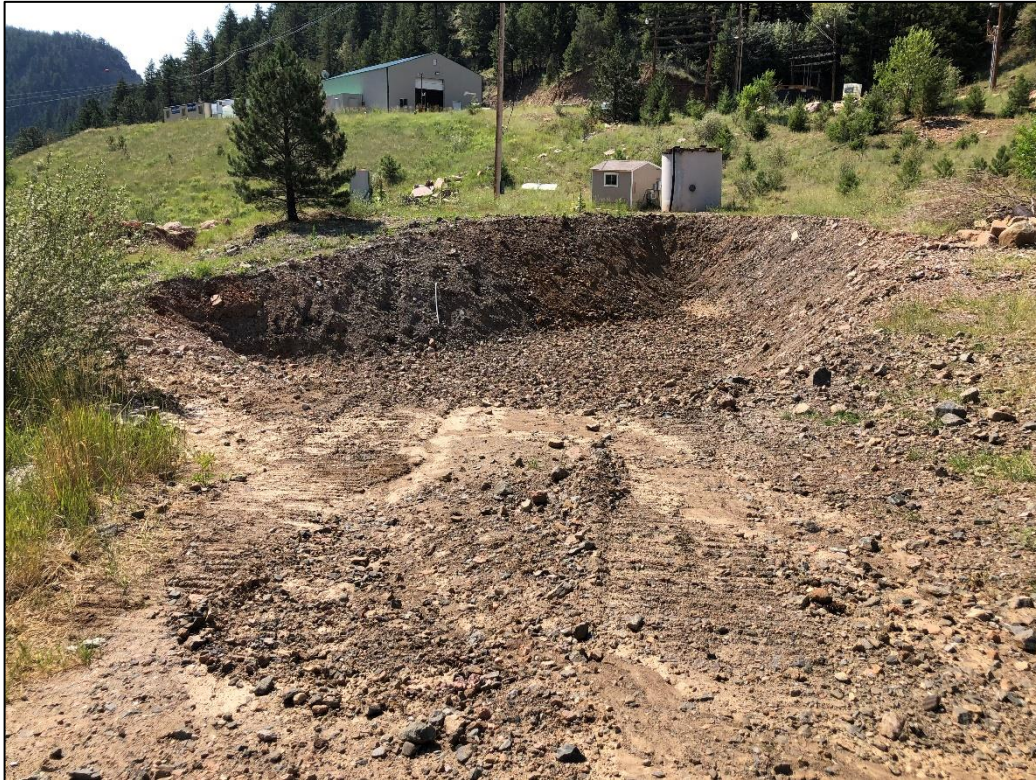
**Photo 3.** View looking southeast across excavation area near sump #4 (beneath mesa with water treatment plant).

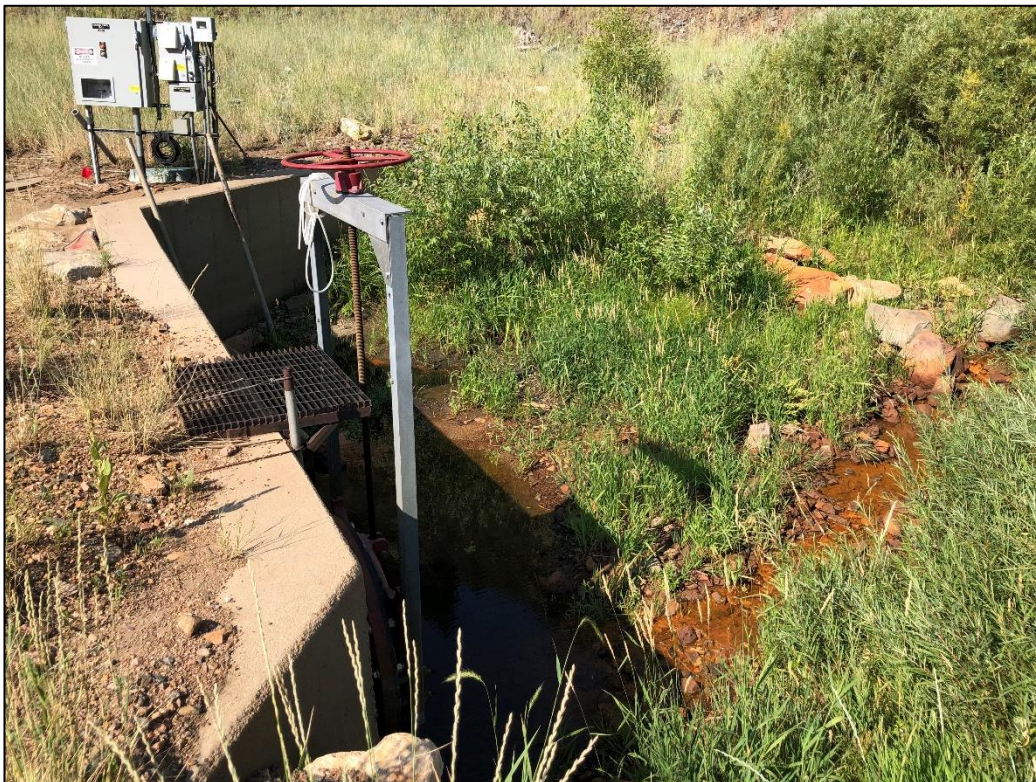
The Division observed the "seep areas" near the toe of the NWRP (between Glencoe Valley Road and Ralston Creek), and found these areas to be dry. The creek was flowing above the upgradient cutoff wall and these flows were being routed through the bypass pipeline. The water treatment plant was online during the inspection. The mine pool was at 206 feet below the Steve Level, which is 56 feet below the required 150 foot depth. The operator has plans to dewater the mine pool further during the operating season in 2020 to enable a 6-month shutdown of the plant (anticipated for November 2020 to May 2021). The operator will monitor the recharge response from these seasonal pumping and shutdown periods. The last in-situ injection treatment of the mine pool was completed in the 1<sup>st</sup> quarter of 2020, which included two tracers. The operator is currently monitoring the effect of this in-situ treatment on the chemistry of the mine pool as they dewater and treat the

**Photo 4.** View looking at upgradient cutoff wall/headgate in Ralston Creek, showing creek flowing (at low flows) upstream of cutoff wall during inspection.

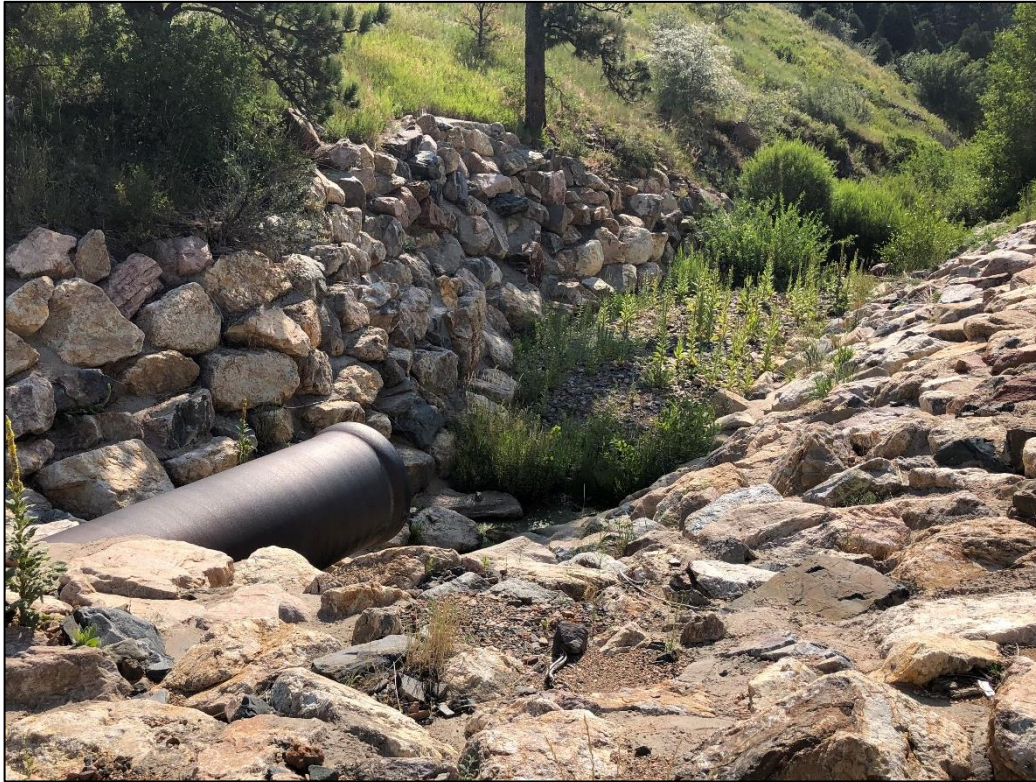
**Photo 5.** View looking downstream from upgradient cutoff wall/headgate in Ralston Creek, showing creek channel dry downstream of cutoff wall during inspection.

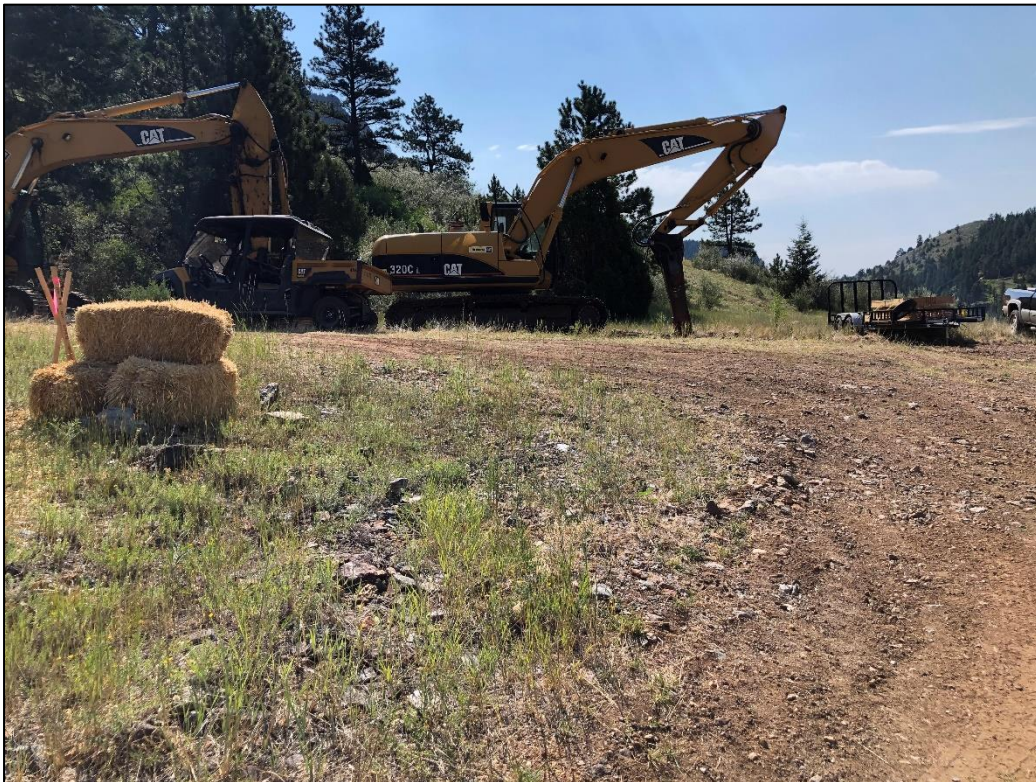
**Photo 6.** View looking south across top of NWRP. Note temporary stockpiles of material excavated from trench have been removed from this area.

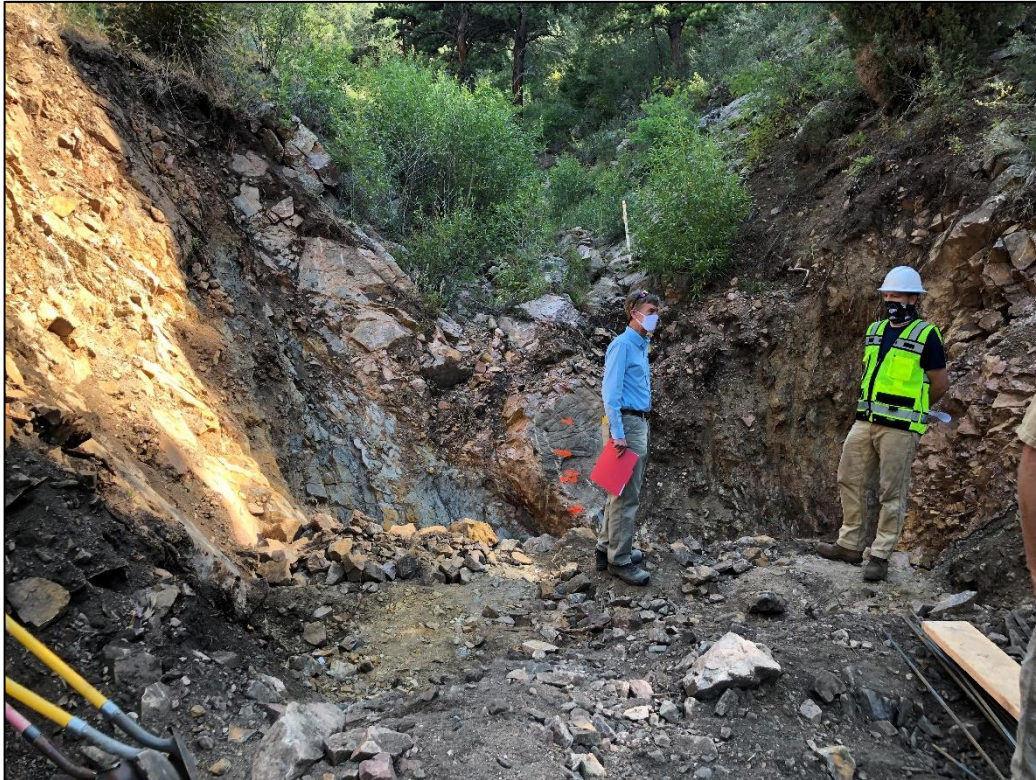
**Photo 7.** View looking northeast across excavation area at top of NWRP where concrete seal wall will be installed in accordance with TR-28.

Subsequent to the inspection, informal discussions with the operator (via email and telephone) clarified the intent to complete the seal wall in two separate concrete pours. Two pours were deemed necessary due to the larger volume of concrete required to fill the deeper excavation. The post-inspection discussions focused on the method to be selected to ensure a watertight seal between the two pours. Discussions were continuing when this report was completed. Any deviations from the approved design will be incorporated into the final as-built construction drawings to be submitted to the Division after the project is completed. The Division approves the Phase 1 construction work completed for the NWRP diversion channel project, and hereby authorizes the operator to proceed with the next construction phase. The next inspection must be scheduled after the channel subgrade is completed and during installation of the Geoweb components, preferably while the manufacturer representative is present on site.

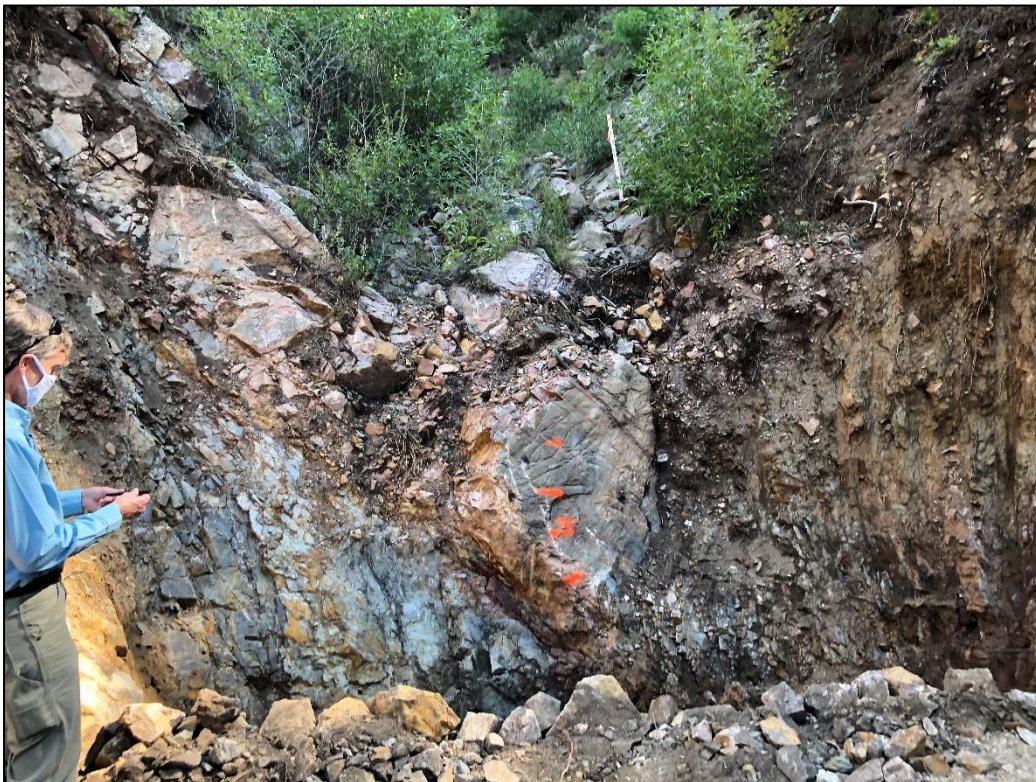
**Photo 8.** Closer view of excavation area at top of NWRP where concrete seal wall will be installed in accordance with TR-28.

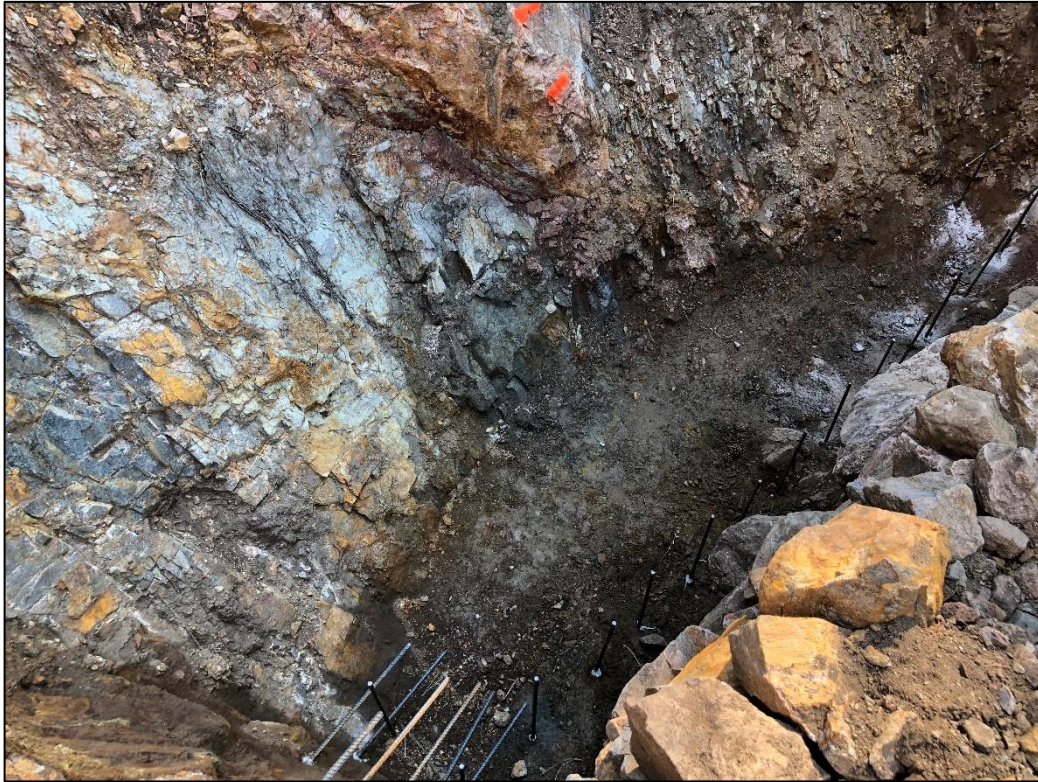
**Photo 9.** View looking down into excavated trench at top of NWRP. Note rebar tie-ins epoxied into bedrock.

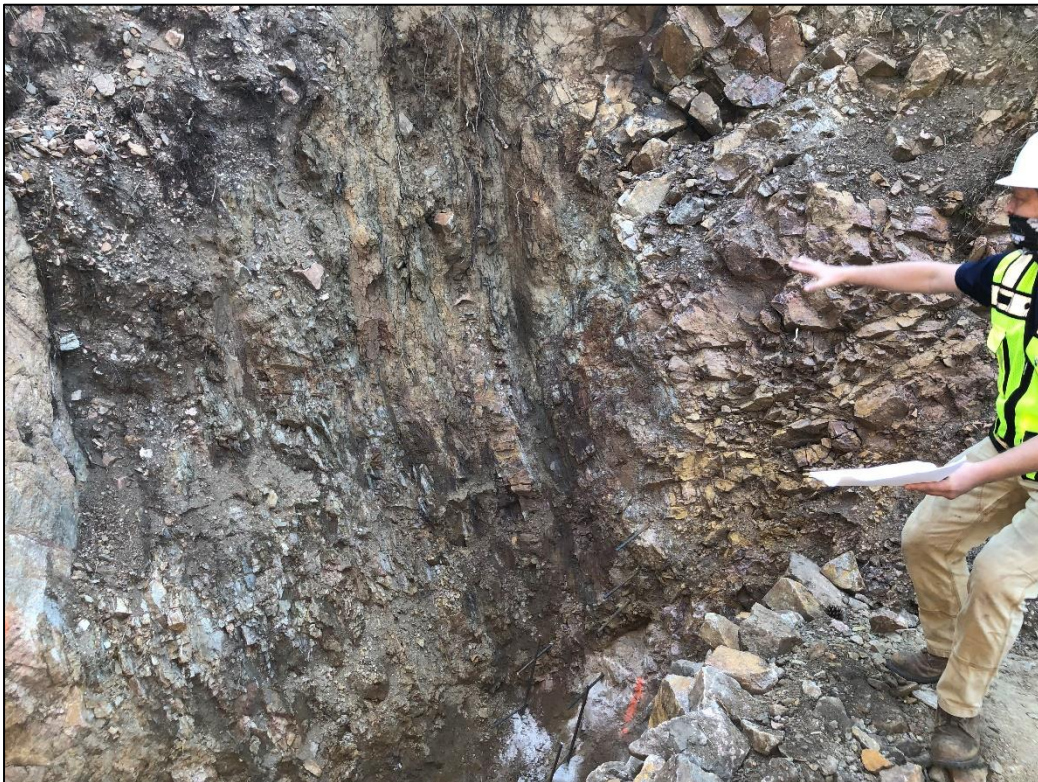
**Photo 10.** View of southeastern (lateral) sidewall of excavated trench at top of NWRP.

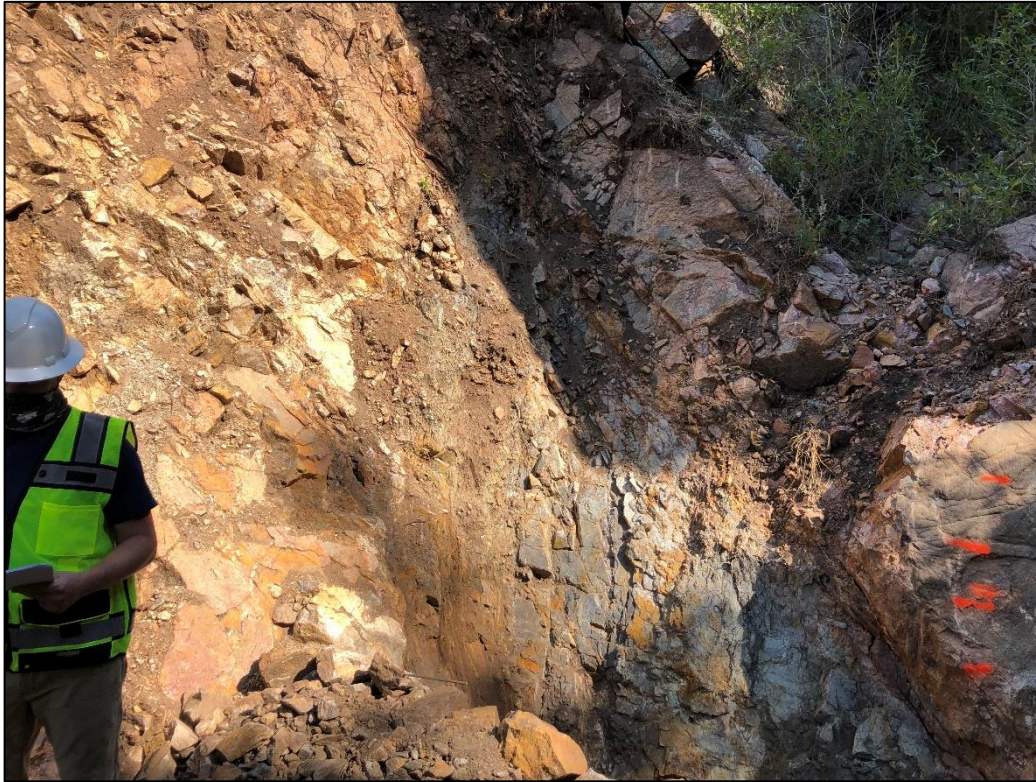
**Photo 11.** View of northwestern (lateral) sidewall of excavated trench at top of NWRP.

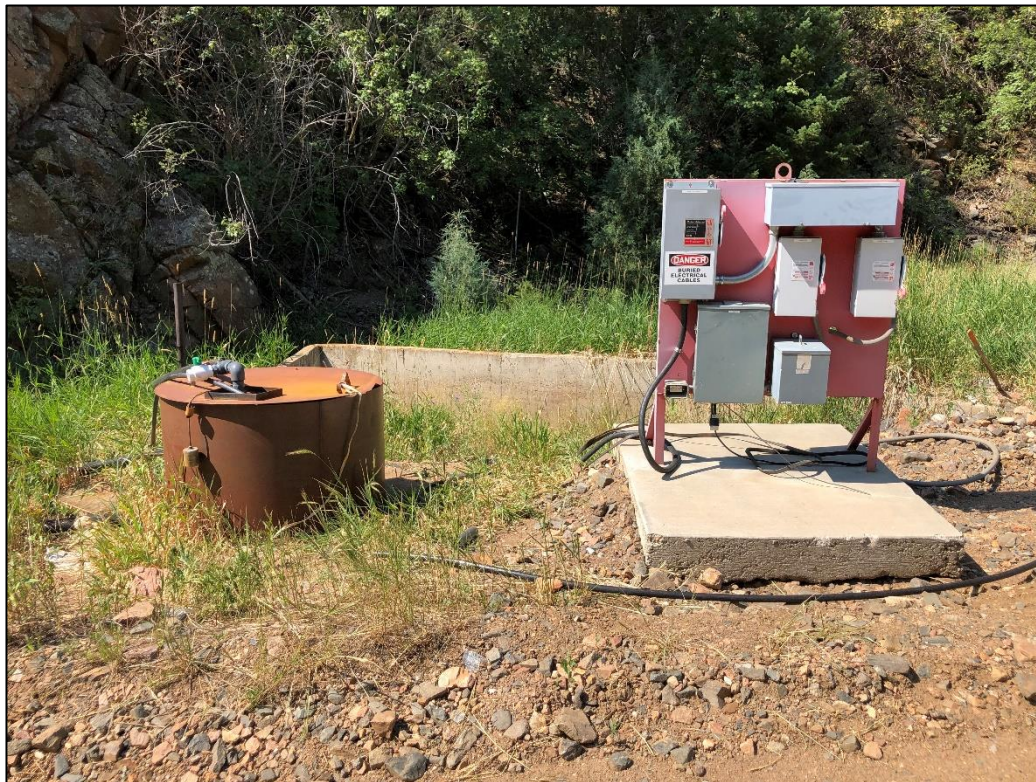
Since the Division's last inspection of the site, the operator completed re-routing the sump lines from sumps # 4, 5, 8, 9, and 10 (per the operator's July 17, 2020 notice) to create a master sump at sump #1. This will allow the operation to safely excavate these sump areas while removing the surrounding contaminated soils down to bedrock. According to Mr. Ray, all sumps have been dry in recent months. Sump #1 is located downgradient of the mine site, near the southern extent of the anticipated excavation area. The Division observed a small amount of water present in Sump #1 during the inspection (measurements were not obtained), which appeared to be coming from the wetland study effluent line that was recently re-routed to this sump from sump #5. As of Technical Revision No. 27 (approved on January 17, 2019), any water collected in the sumps was being routed to the water treatment plant where an aggregate sample was collected for water quality analysis. Now, only water collected in sump #1 will be sampled and the results submitted with the quarterly water monitoring report.

**Photo 12.** View of sump #1 located downgradient of mine site, which will be the only sump to remain after excavation activities in the valley are completed.

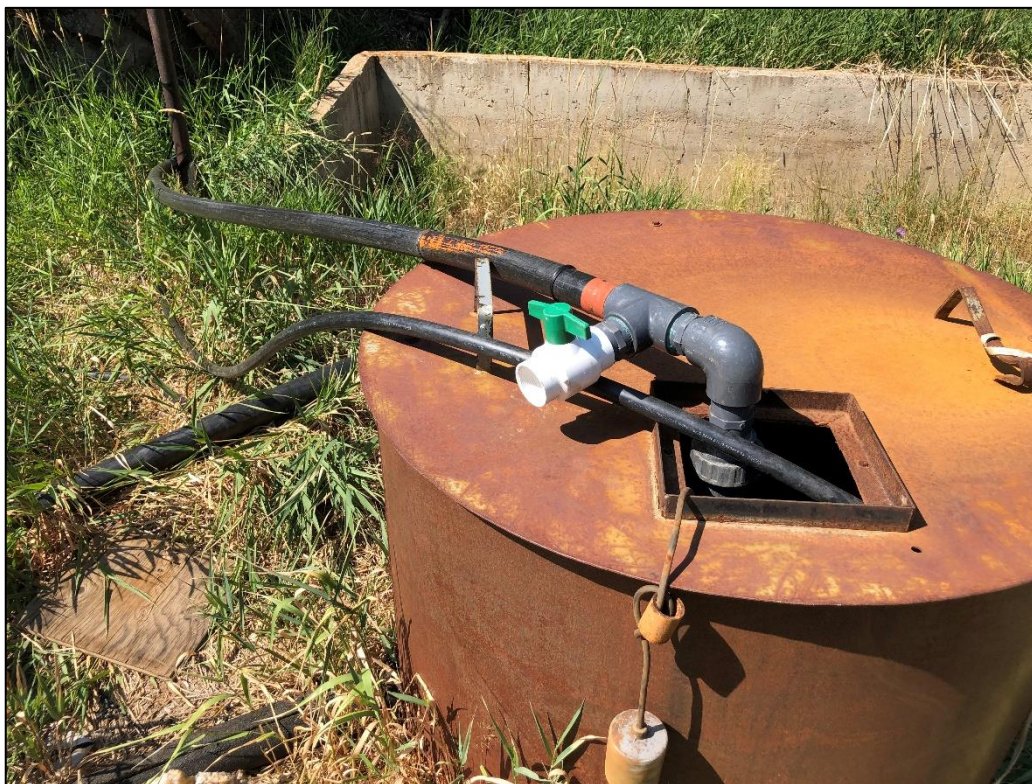
**Photo 13.** Closer view of sump #1 located downgradient of mine site. Note smaller wetland study effluent line installed in sump and larger line in which water from sump is pumped to water treatment plant for sampling prior to being discharged to the mine pool.
