COLORADO
Division of Reclamation,
Mining and Safety
Department of Natural Resources

Permit Number: C-1981-041 Mine Name: Roadside Portals Operator: Snowcap Coal Company, Inc. Operator Address: Ms. Tonya Hammond P.O. Box 1430 Palisade, CO 81526	County: Mesa Operation Type: Underground Permit Status: Active Ownership: Private
	Operator Representative Present: Tonya Hammond / Brett Fontanari
Operator Representative Signature: (Field Issuance Only)

Inspection Start Date: July 21, 2020 Inspection Start Time: 08:20 Inspection End Date: July 21, 2020 Inspection End Time: 09:40		Inspection Type: Coal Partial Inspection Inspection Reason: Normal I&E Program Weather: Clear	
Joint Inspection Agency: None		Joint Inspection Contacts: None	
Post Inspection Agency: None		Post Inspection Contacts: None	
Inspector(s): Clayton Wein Amy Yeldell	Inspector's Signature: <i>Clayton Wein</i>		Signature Date: 8/3/2020

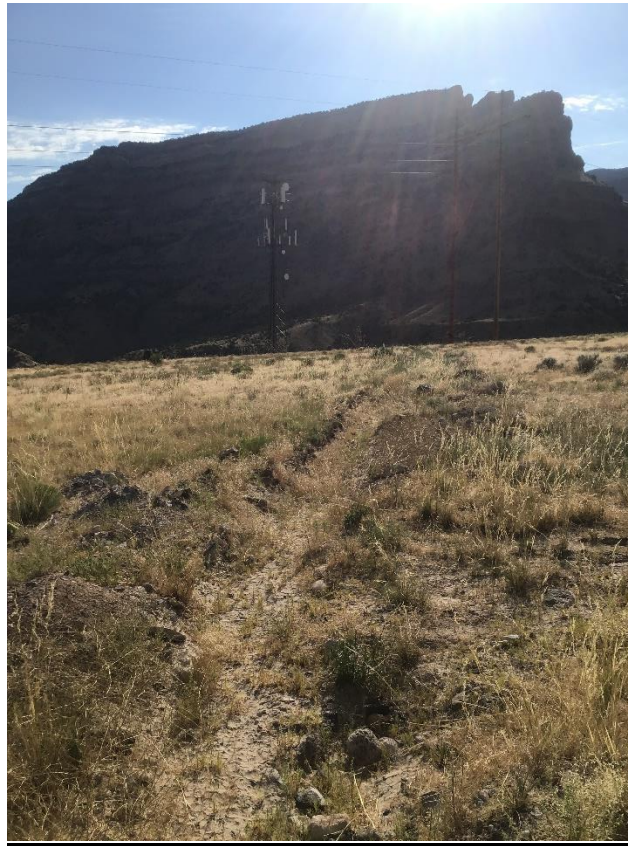
The trenches on top of the Tract 70 mesa were dry (Photo 1). There was no evidence of recent water application to the area. Several trenches trend west-east on the mesa and can be found all along the top of the mesa.

Photo 1: One of the dry trenches on top of the Tract 70 Mesa. The ditch trends west-east. Several ditches like the one in the photo can be found on top of the mesa.

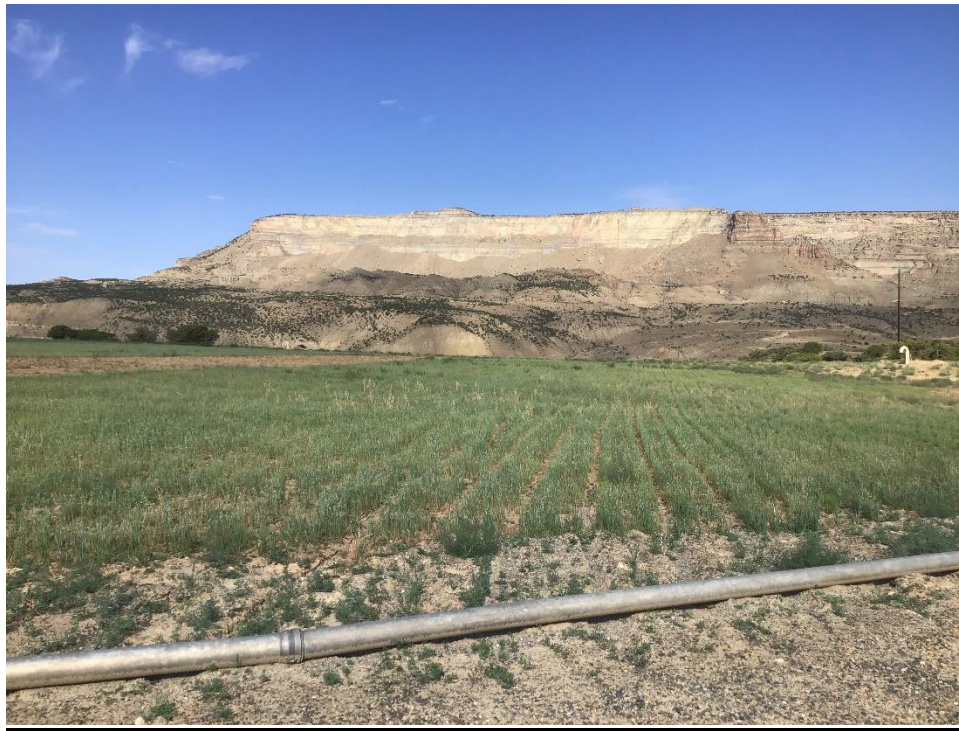
The irrigated field to the south of the Tract 70 Mesa had no water being applied to it (Photo 2 and 3). There was no evidence of recent flows.

Photo 2: The northwestern portion of the WSFQ irrigated field.

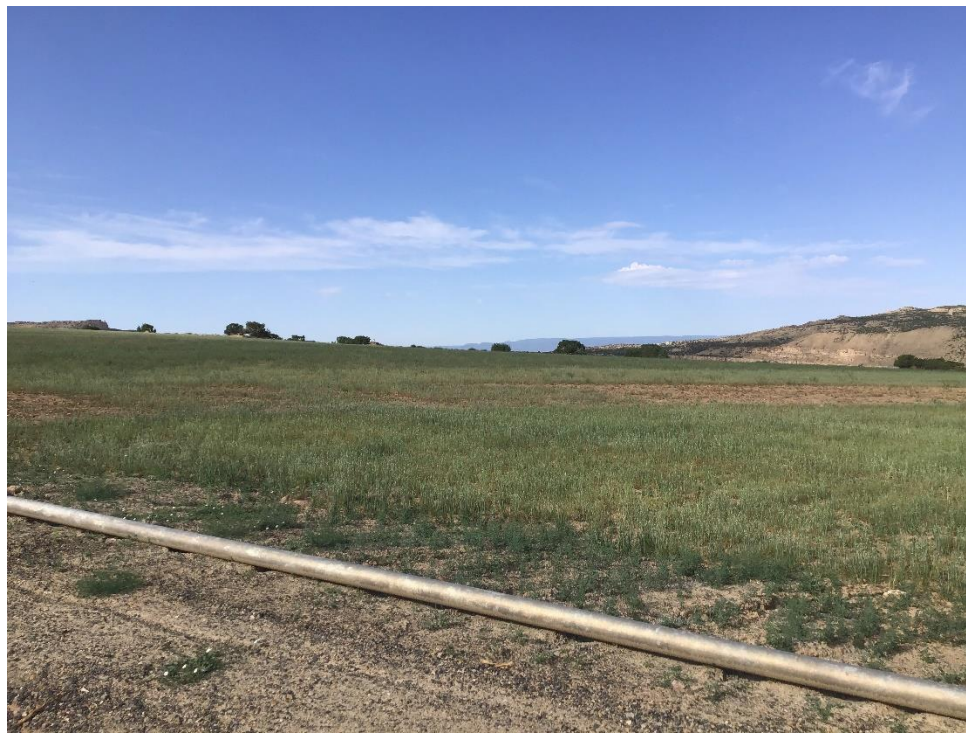
Photo 3: The southern portion of the WSFQ irrigated field.
