**MINERALS PROGRAM INSPECTION REPORT**  
**PHONE: (303) 866-3567**

| <b>MINE NAME:</b><br>Mineral Mountain Project | <b>MINE/PROSPECTING ID#:</b><br>M-2014-045 | <b>MINERAL:</b><br>Gold | <b>COUNTY:</b><br>Teller |
| <b>INSPECTION TYPE:</b><br>Monitoring | <b>INSPECTOR(S):</b><br>Elliott Russell & Jason Musick | <b>INSP. DATE:</b><br>July 15, 2020 | <b>INSP. TIME:</b><br>10:00 |
| <b>OPERATOR:</b><br>Mineral Mountain Gold, LLC | <b>OPERATOR REPRESENTATIVE:</b><br>Lance Barker | <b>TYPE OF OPERATION:</b><br>110d - Designated Limited Impact | |

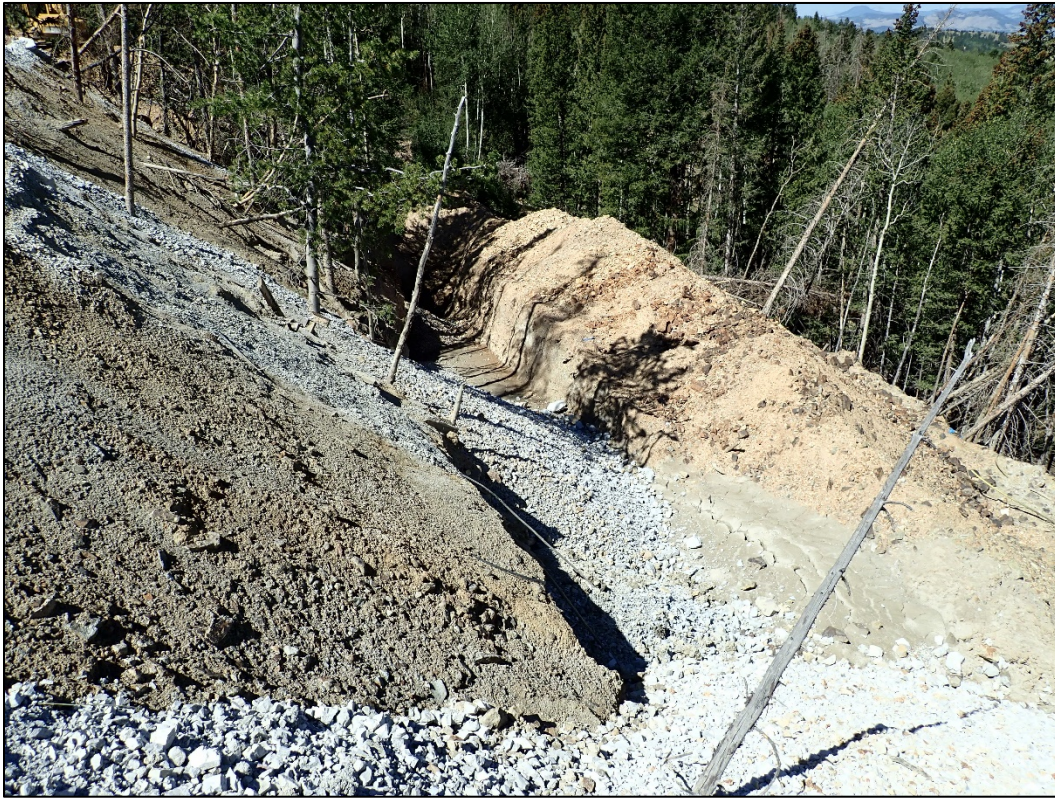
The Division observed the mill tailings trench located on the western portion of the mine site's waste rock dump. The trench is positioned approximately halfway down the estimated 50-foot dump face. Mill tailings are dumped from the crest of the waste rock dump and flow down into the trench. The Operator stated they usually mix the mill sand with more course development rock. The Operator stated they had been utilizing the tailings trench area for several years.

**Photo 1.** Tailings trench; looking west from the crest of the waste rock dump.

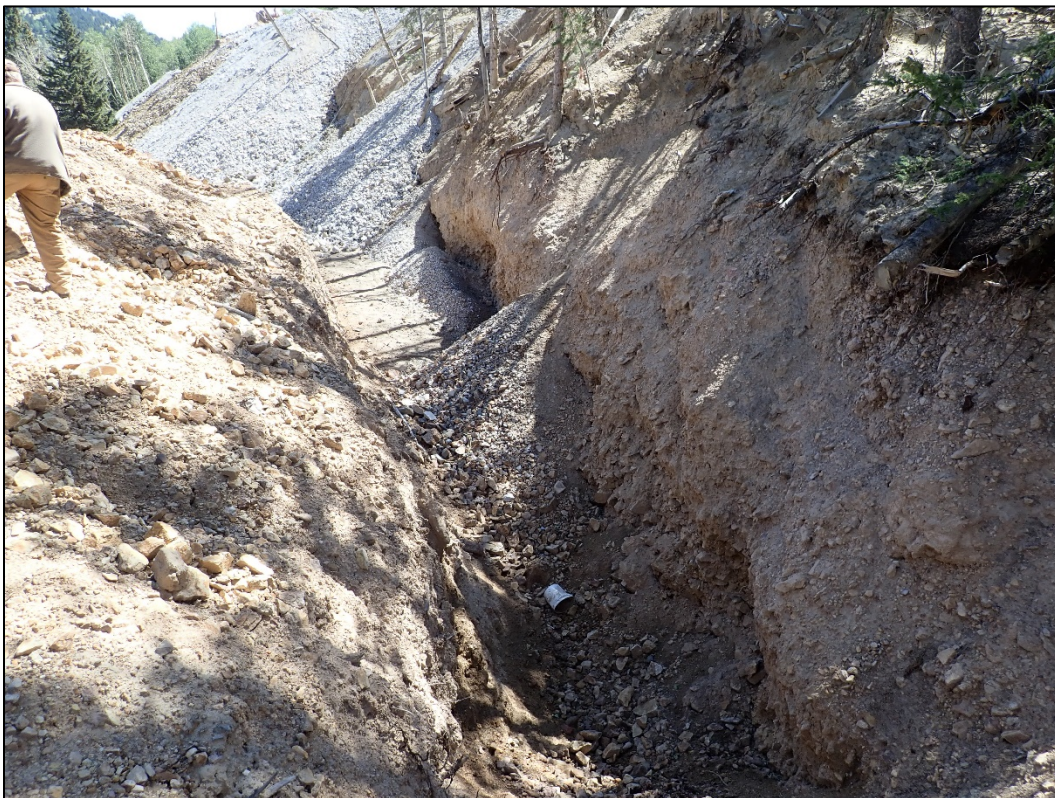
**Photo 2.** Tailings trench; looking east.

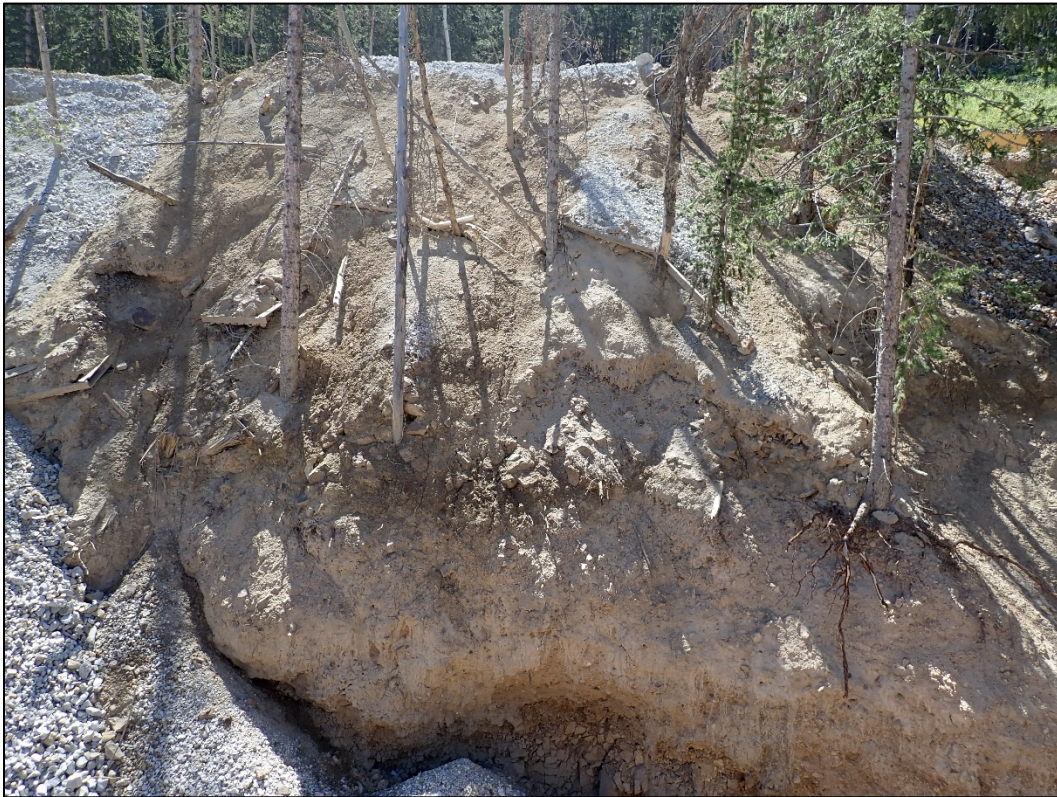
**Photo 3.** Face of waste rock dump from where tailings were placed into the trench; looking south.

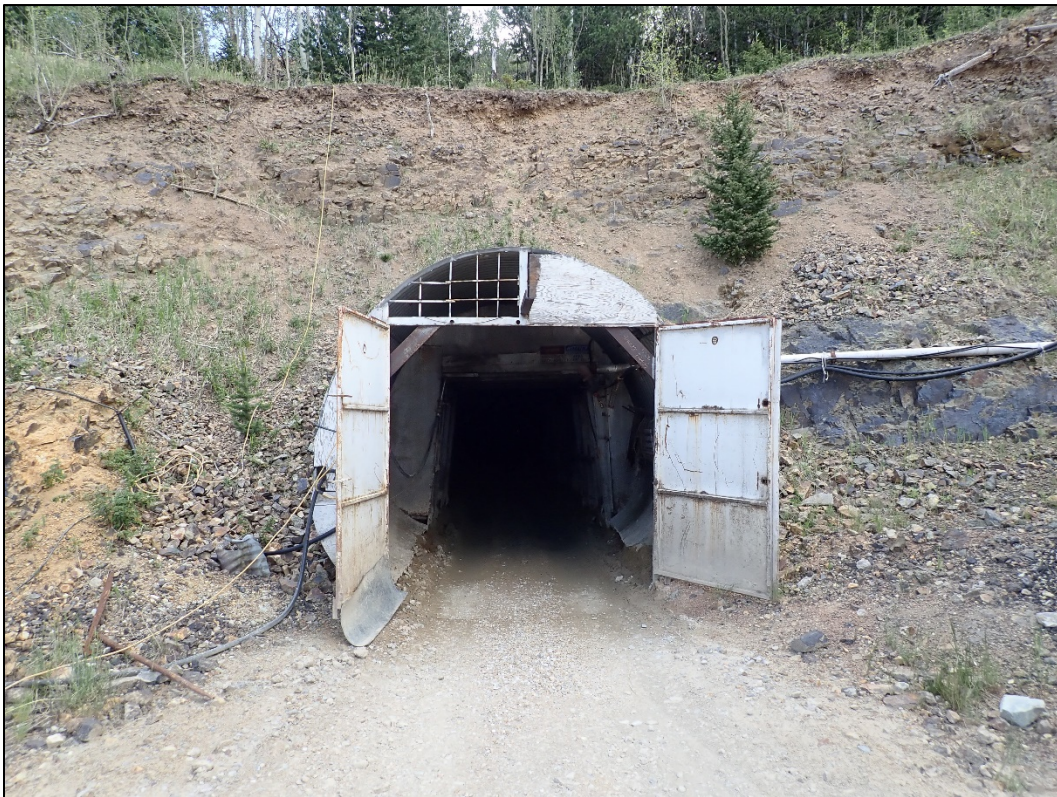
**Photo 4.** Portal entrance; looking southeast.

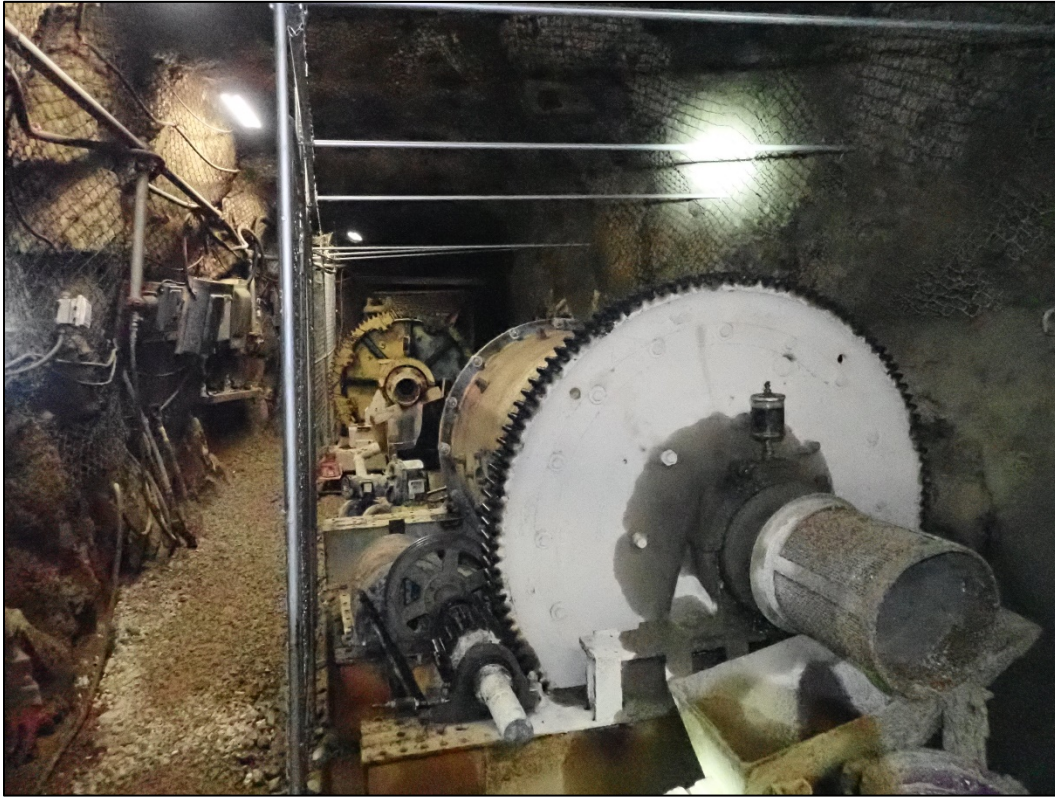
**Photo 5.** Two ball mills on upper level of mill.

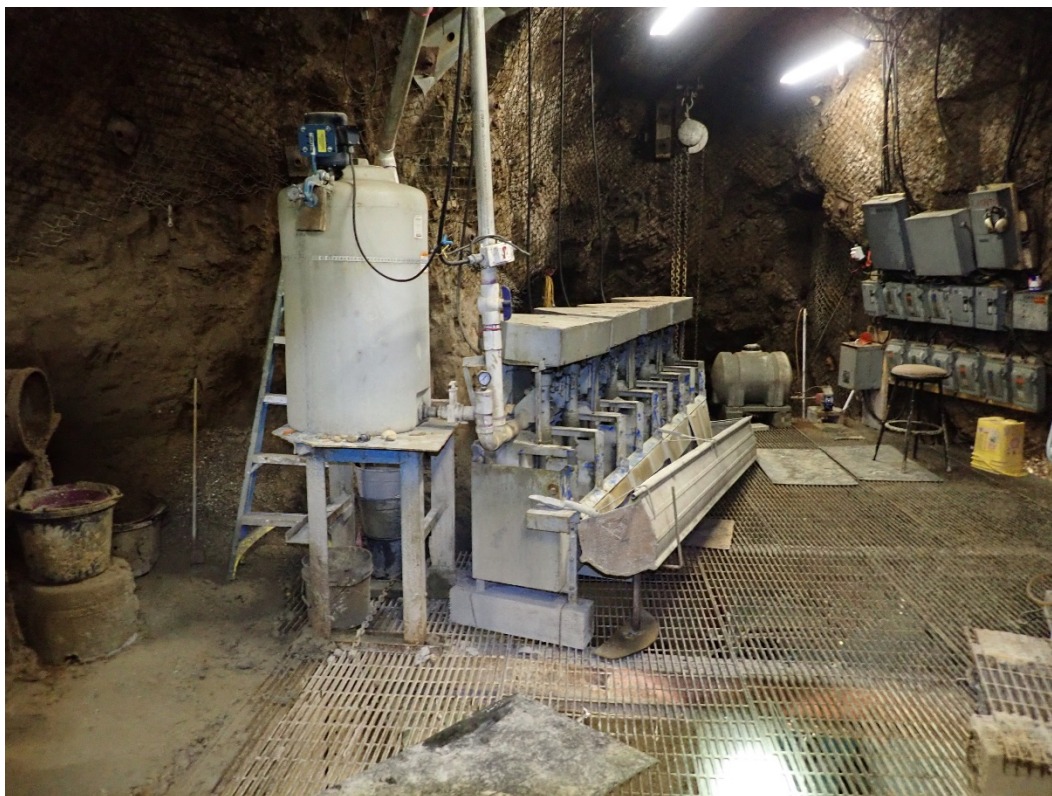
**Photo 6.** The second of two flotation machines on upper level of mill.

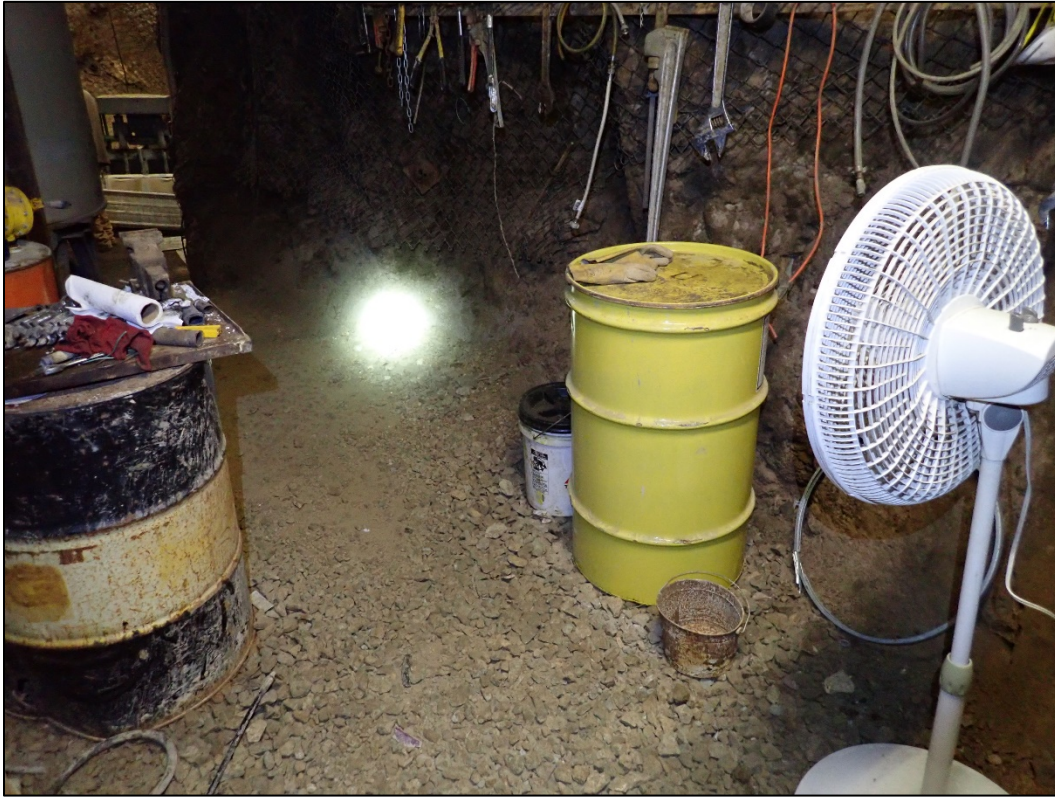
**Photo 7.** One of two 55 gallon drum of xanthate stored on upper level of mill.

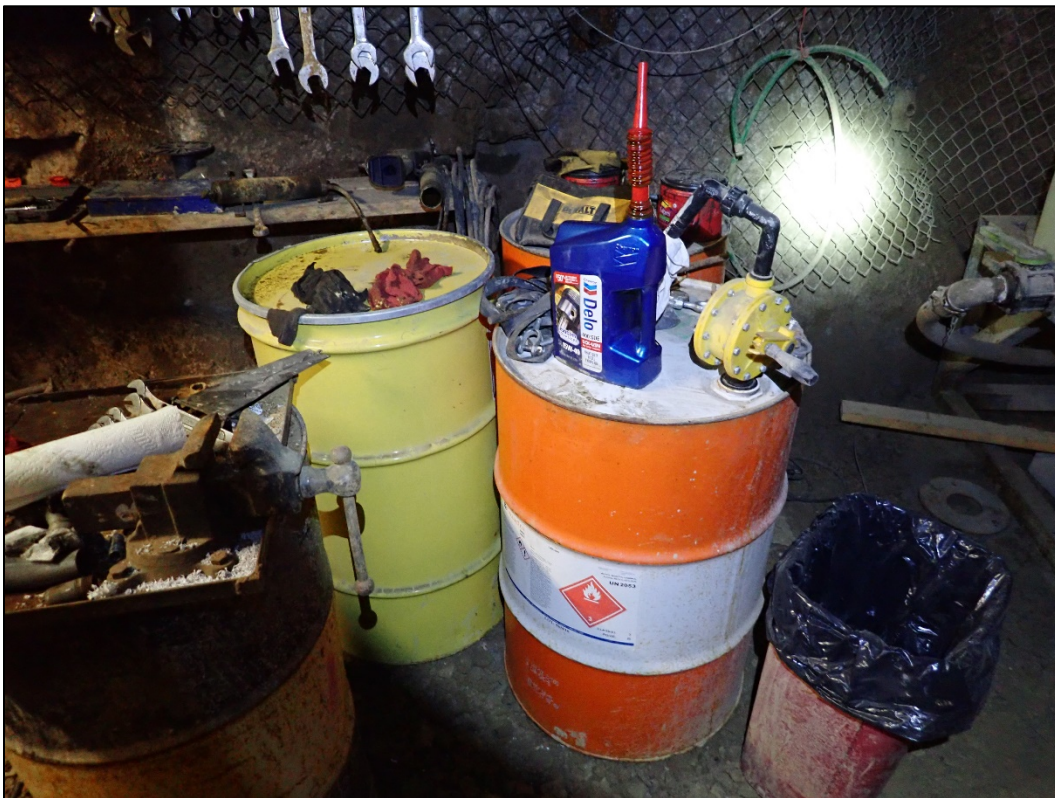
**Photo 8.** Second 55 gallon drum of xanthate and one of two 55 gallon drum of MIBC frother on upper level of mill.

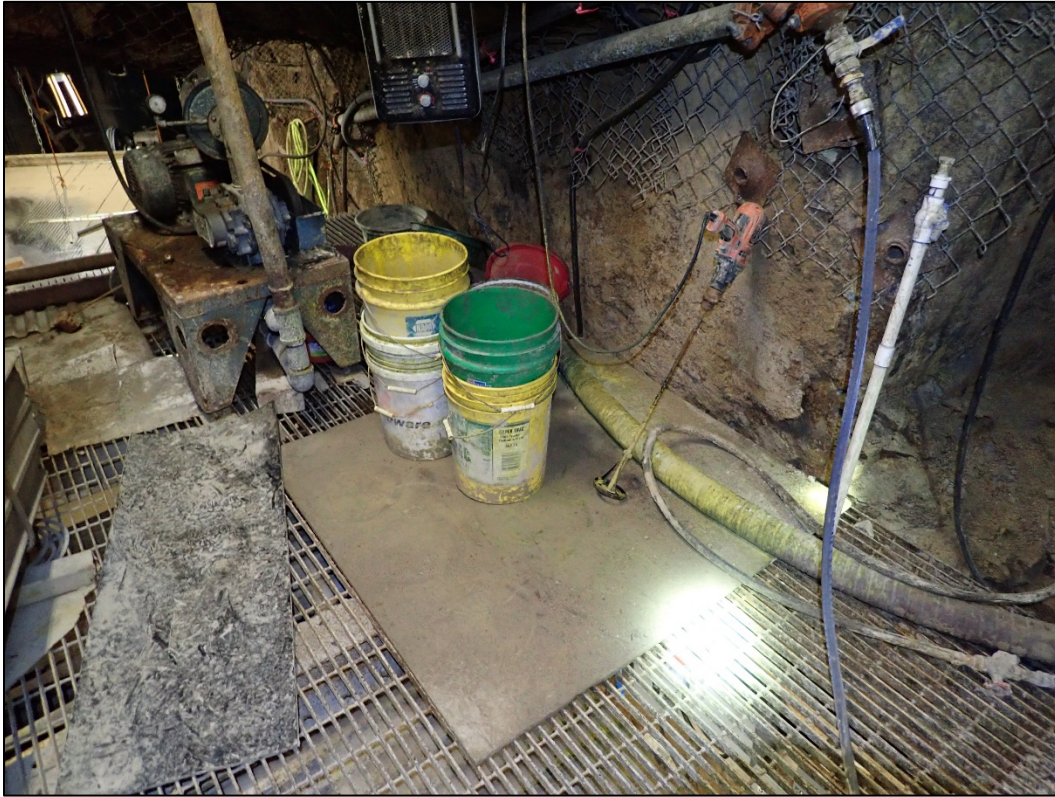
**Photo 9.** Xanthate mixing station on upper level of mill.

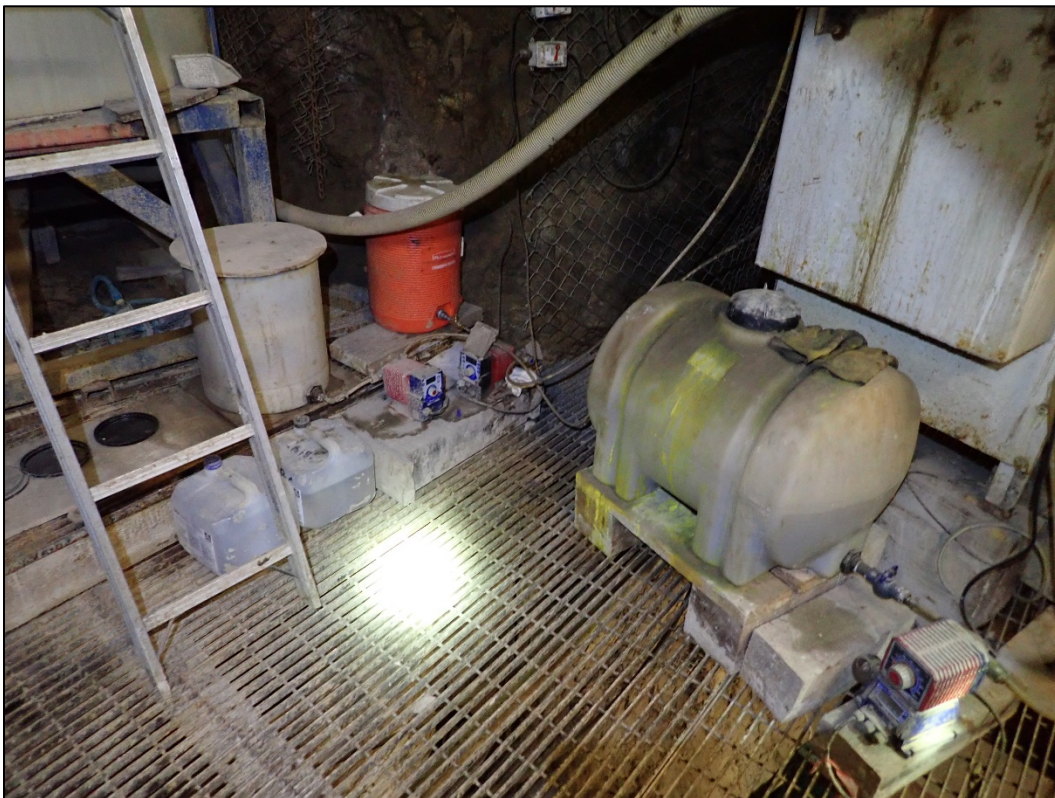
**Photo 8.** Mixed xanthate storage containers and pumps on upper level of mill.

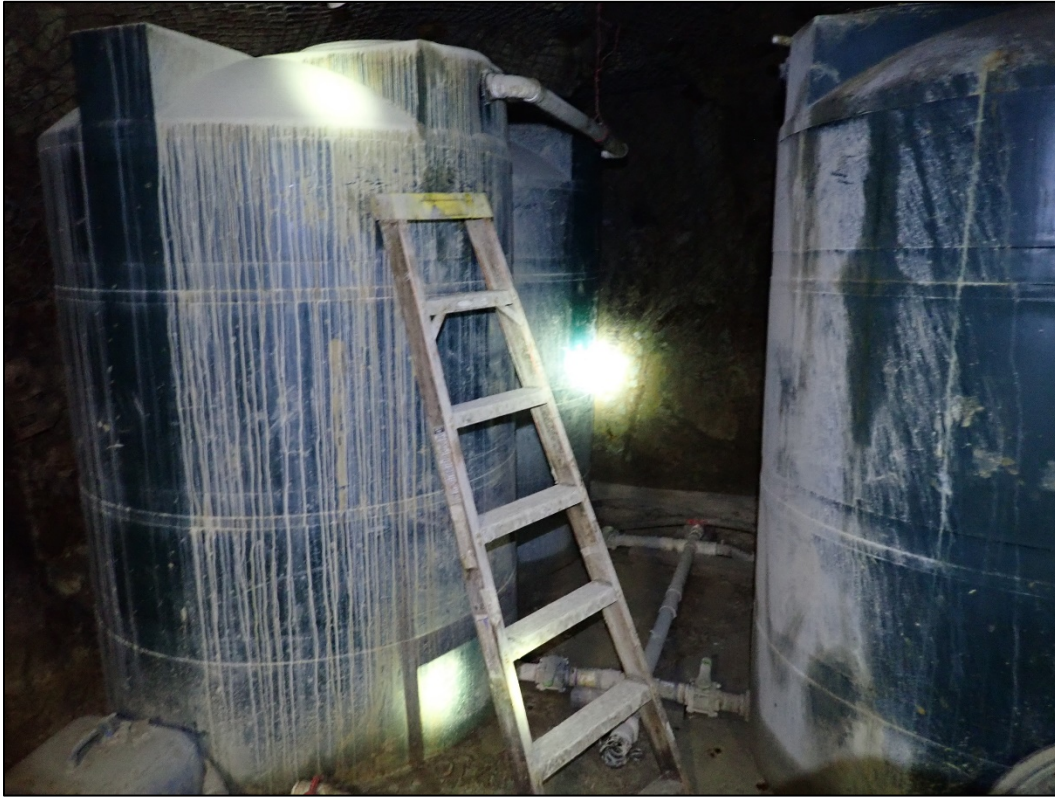
**Photo 9.** 5,000 gallon fresh water storage are on lower level of mill.

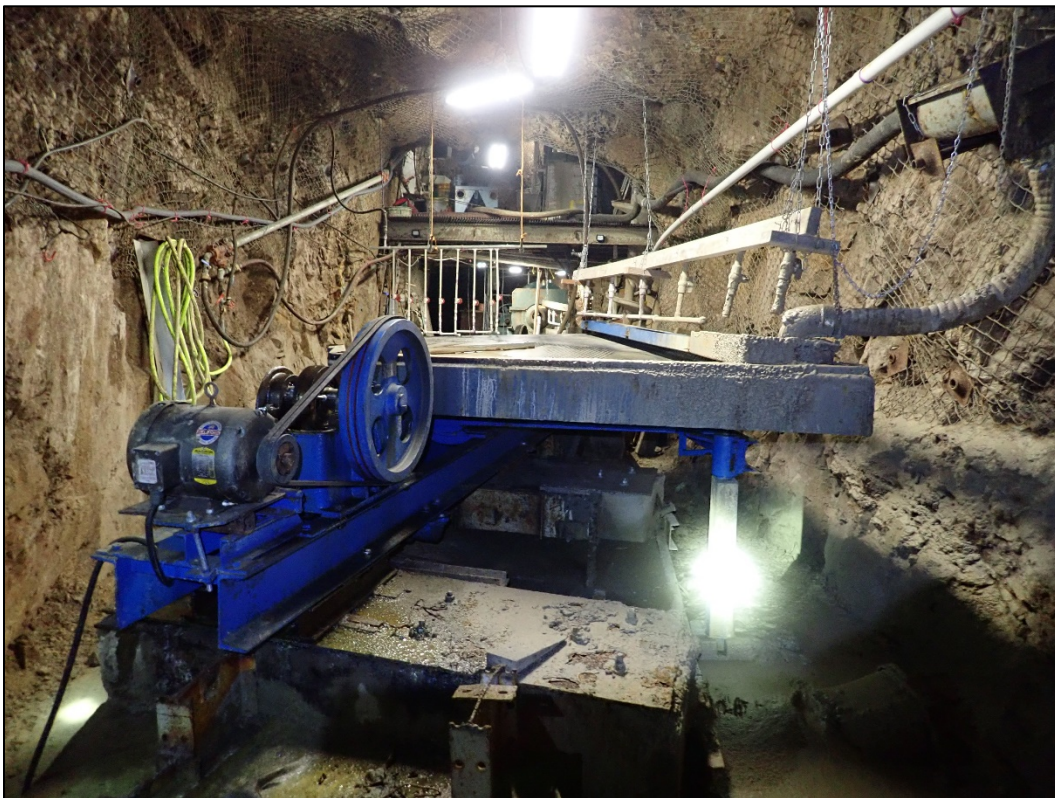
**Photo 10.** First of two gravity separation shaker tables on lower level of mill.

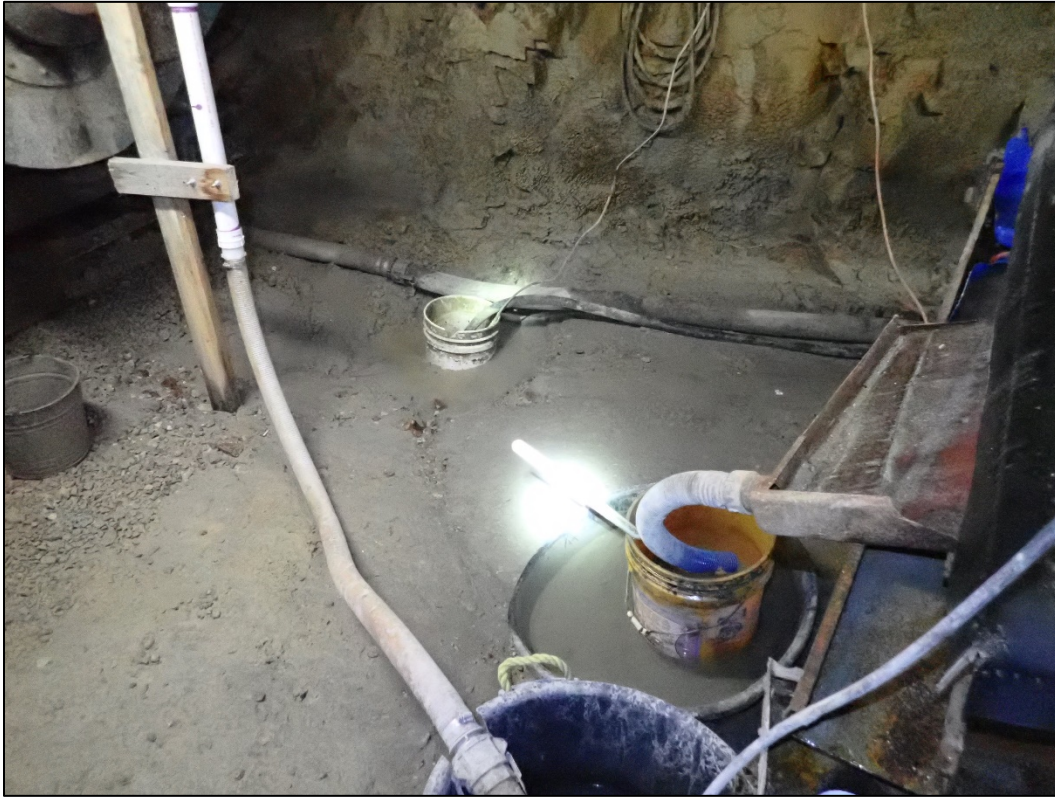
**Photo 11.** Gravity concentrate and gravity reject collection buckets after the second shaker table on lower level of mill.

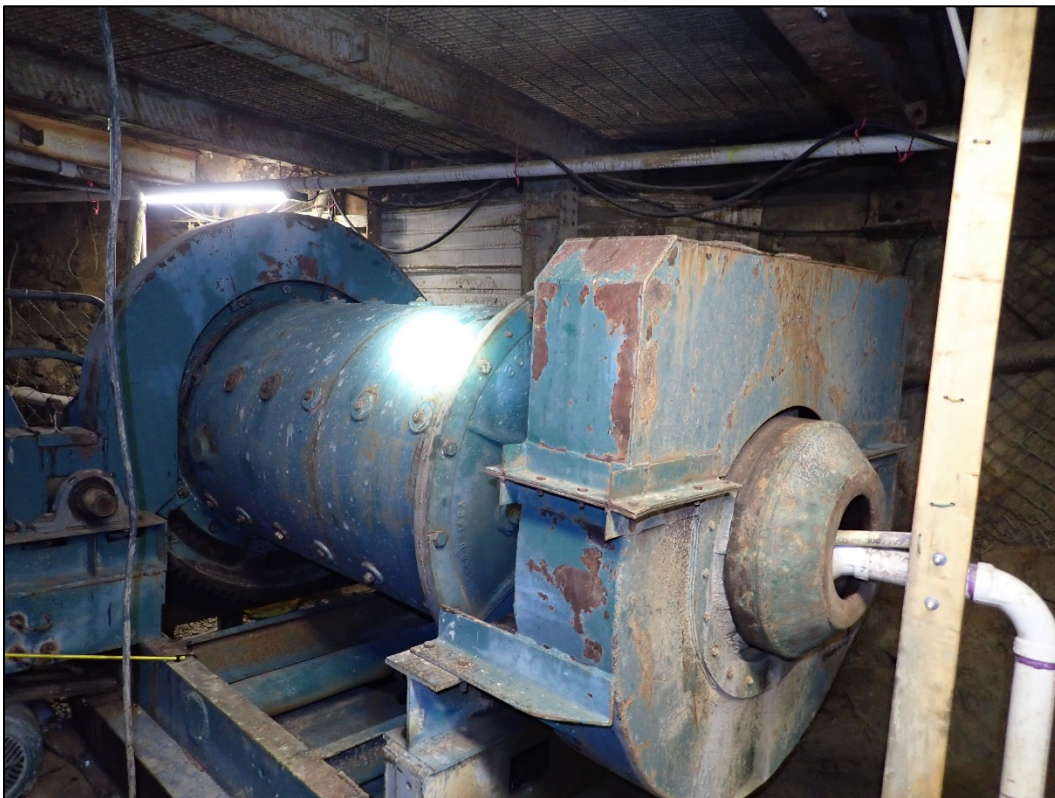
**Photo 12.** Regrind ball mill for gravity reject (start of the floatation circuit) on lower level of mill.

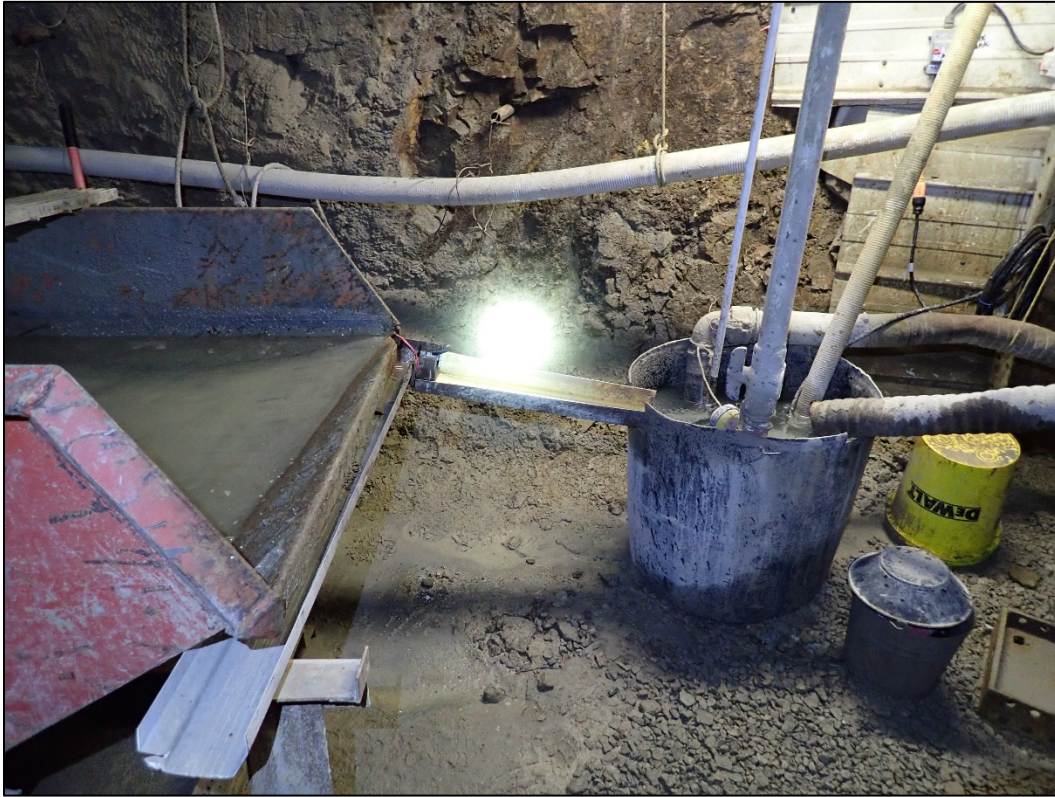
**Photo 13.** Regrind bucket collection and flotation concentrate settling bin on lower level of mill.

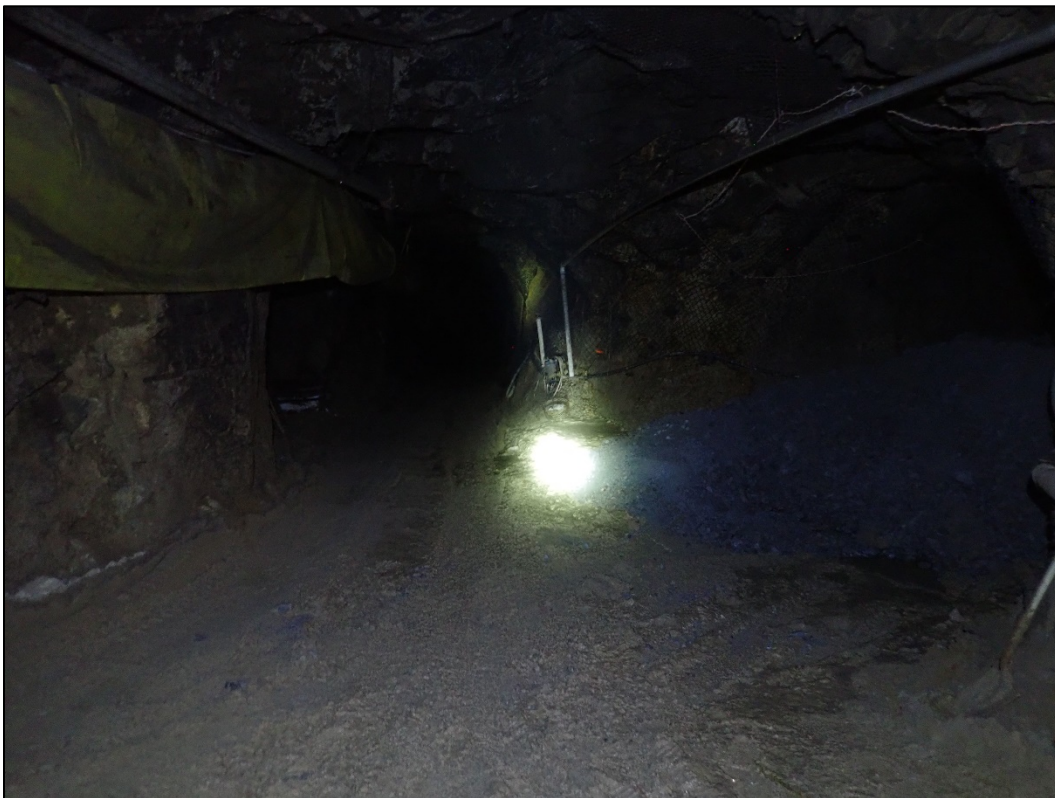
**Photo 14.** Y intersection adjacent to lower level of mill with decline tunnel (left) and milling tailings sump area (right).

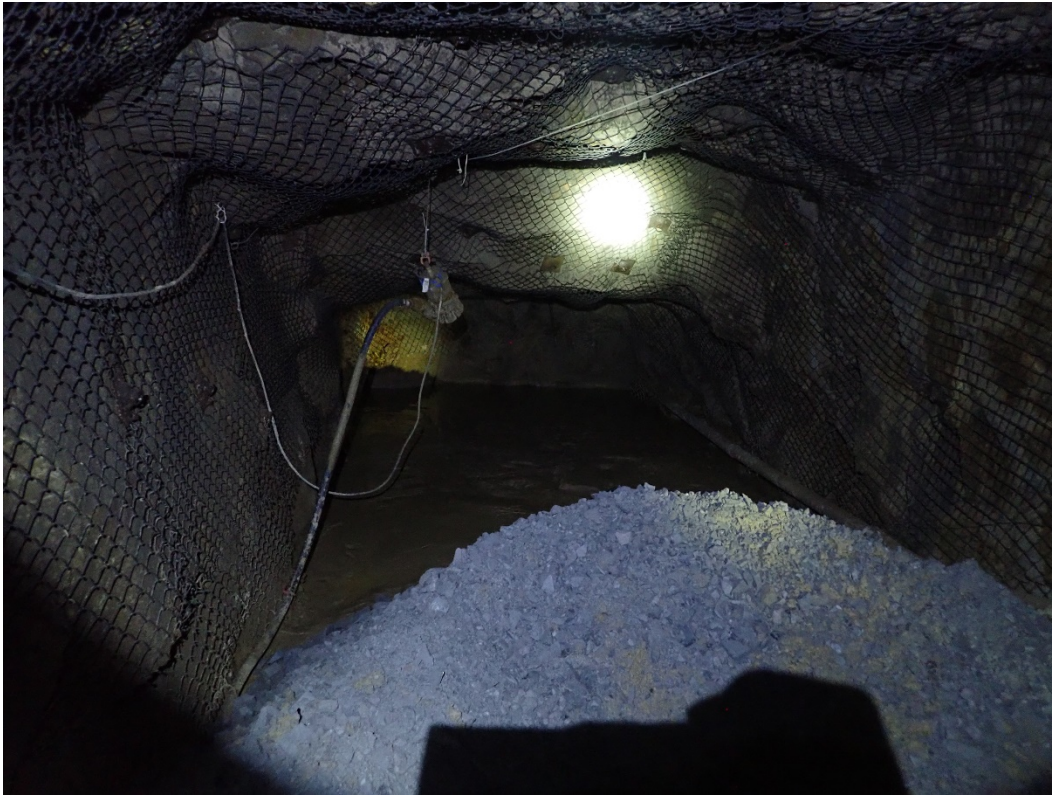
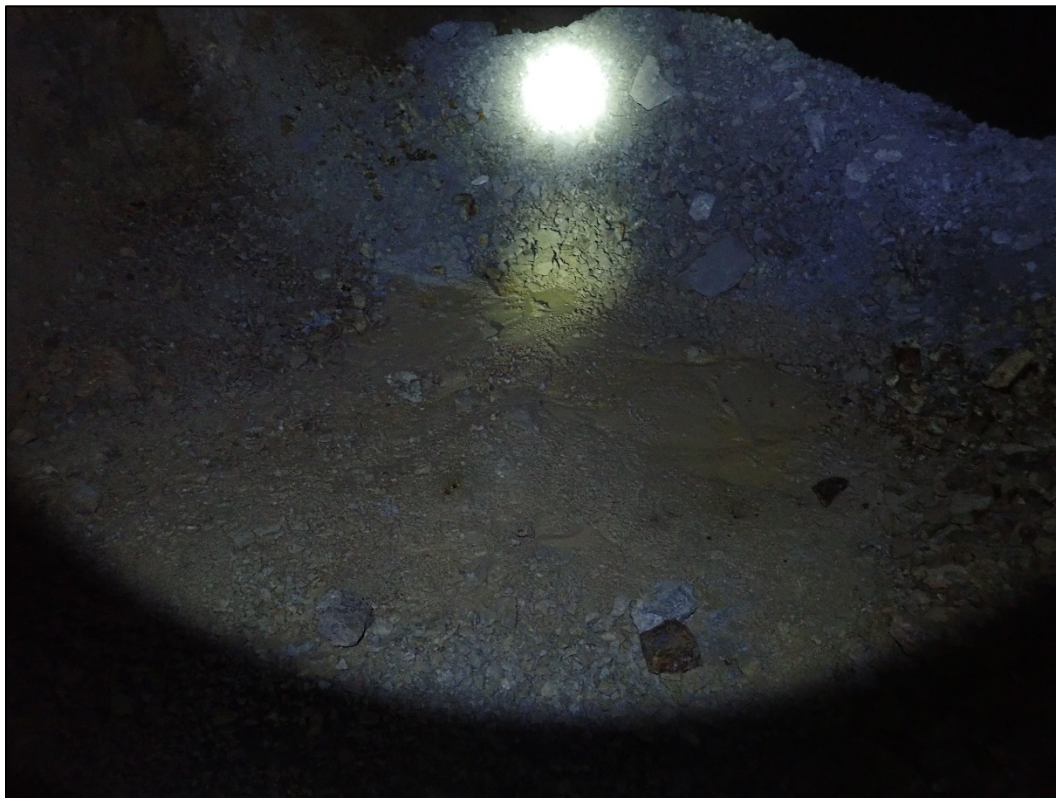
Just downgradient of the lower level of the mill is a Y intersection where a decline tunnel begins on one side and a small area used as a sump for mill tailings on the other side. The Operator stated they typically place 4 tons of development rock at the entrance to the tailings sump to serve as a containment dam for the tailings. The tailing is pumped to the back of the area where it can decant. The Operator estimated the tailings sump area and can hold roughly 20 tons of sand. Portions of the development rock and tailings sand is hauled to the surface and placed in the tailings trench when more capacity is needed in the sump. The permit describes the mine and its workings being dry and located well above the ground water table. The lower level of the mill and the decline tunnel past the tailings sump room had significantly wet ground conditions. The Division walked the decline all the way down to the face where a small pool of water was located. One exploratory drift was inspected off of the decline and it was dry. The Division believes the wet conditions are from the milling process and the tailings sump.

**Photo 15.** Mill tailings sump area.

**Photo 16.** Mill tailings sump area.

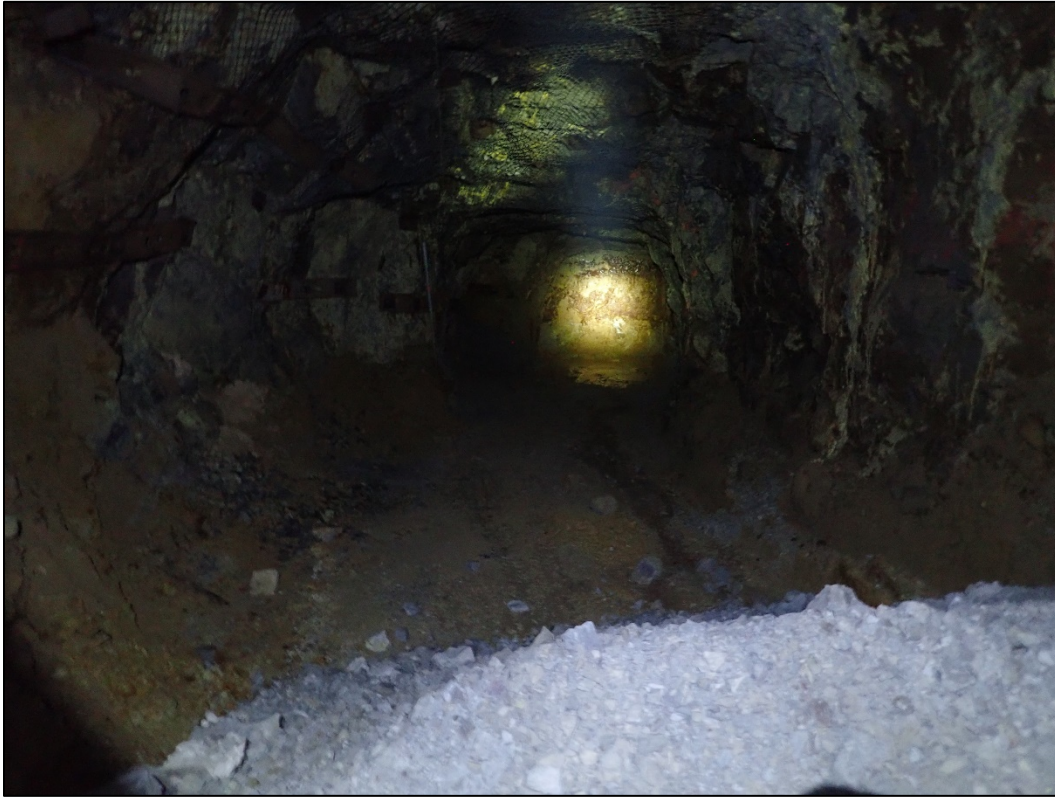
**Photo 17.** Bottom of decline tunnel.
