MINERALS PROGRAM INSPECTION REPORT
PHONE: (303) 866-3567

MINE NAME: Puzzler Group	MINE/PROSPECTING ID#: P-1987-043	MINERAL: Gold	COUNTY: Clear Creek
INSPECTION TYPE: Monitoring	INSPECTOR(S): Peter Hays	INSP. DATE: August 4, 2020	INSP. TIME: 13:00
OPERATOR: Climax Molybdenum Company	OPERATOR REPRESENTATIVE: Aaron Hilshorst	TYPE OF OPERATION: MP - Mineral Prospecting

The Puzzler Group NOI was inspected by Peter Hays with the Division of Reclamation, Mining and Safety (Division/DRMS) as part of the Division's monitoring inspection program. Mr. Aaron Hilshorst with Climax Molybdenum - Henderson Operations (Henderson) was present during the inspection.

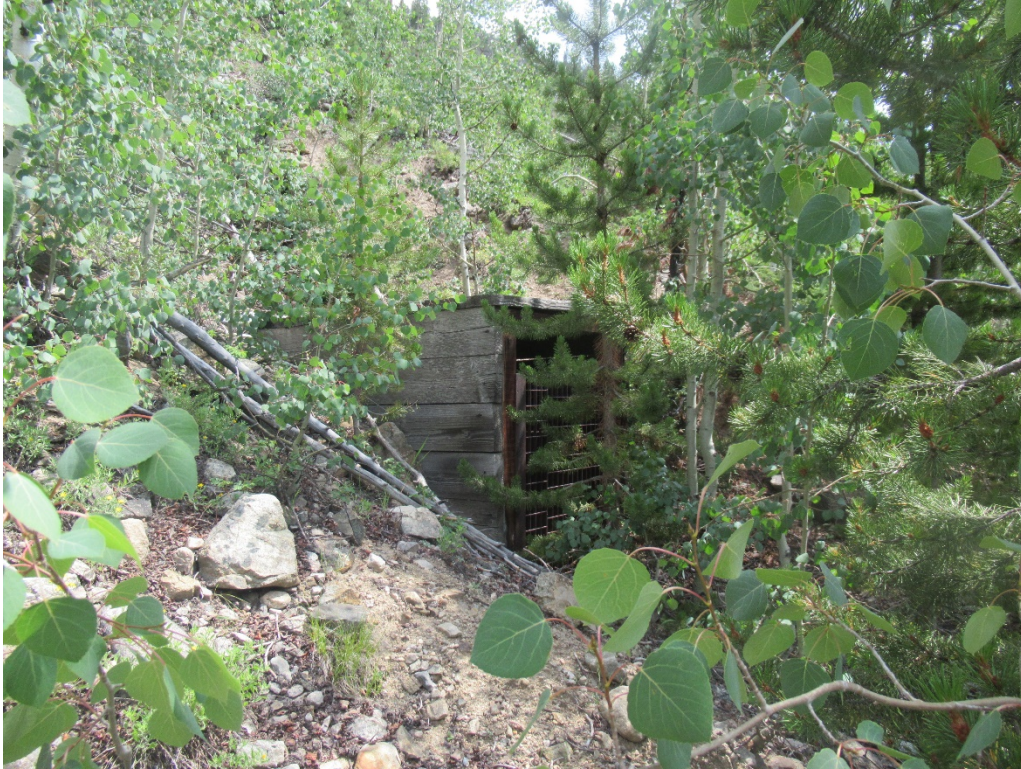
Two closures were observed during the inspection, an adit and the ventilation shaft. The adit appears to have been closed by the Prospector. The adit was collapsed behind the interior gate of the adit. The closure appeared stable and in good condition. The second closure was a shaft secured by the Inactive Mines Program within the Division under Project # 412 in 2010. The closure was stable and in good condition. A copy of the shaft closure report is attached for reference. No additional drill pads or access roads were observed during the inspection.

View of exterior adit closure

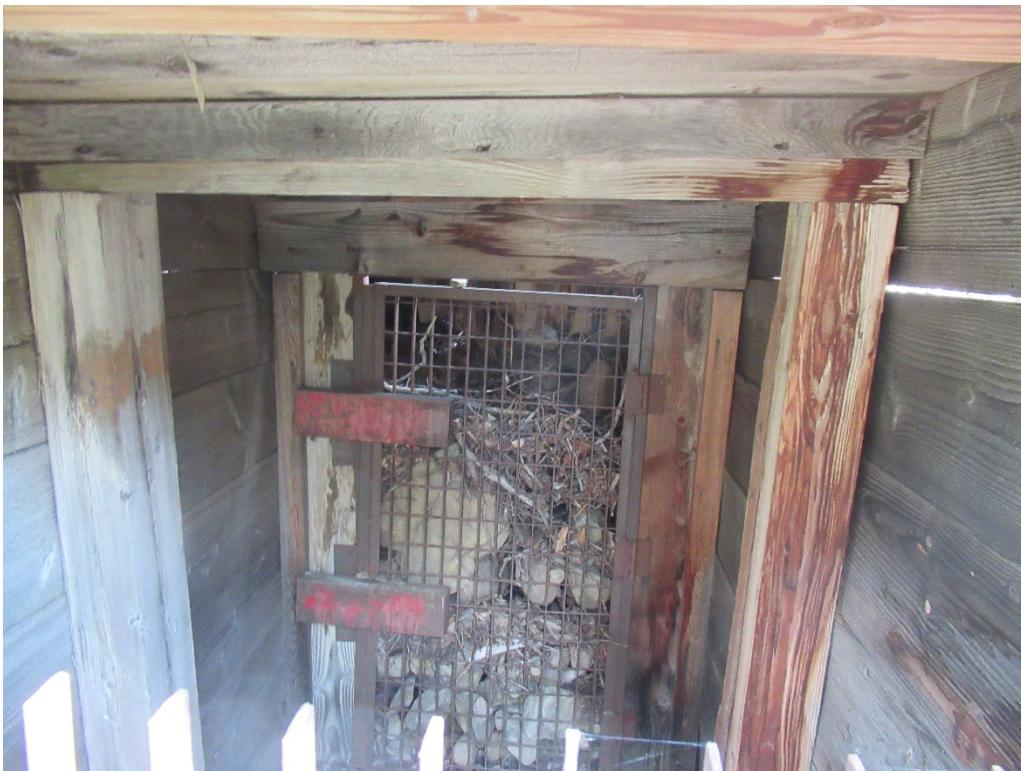
View of interior adit closure

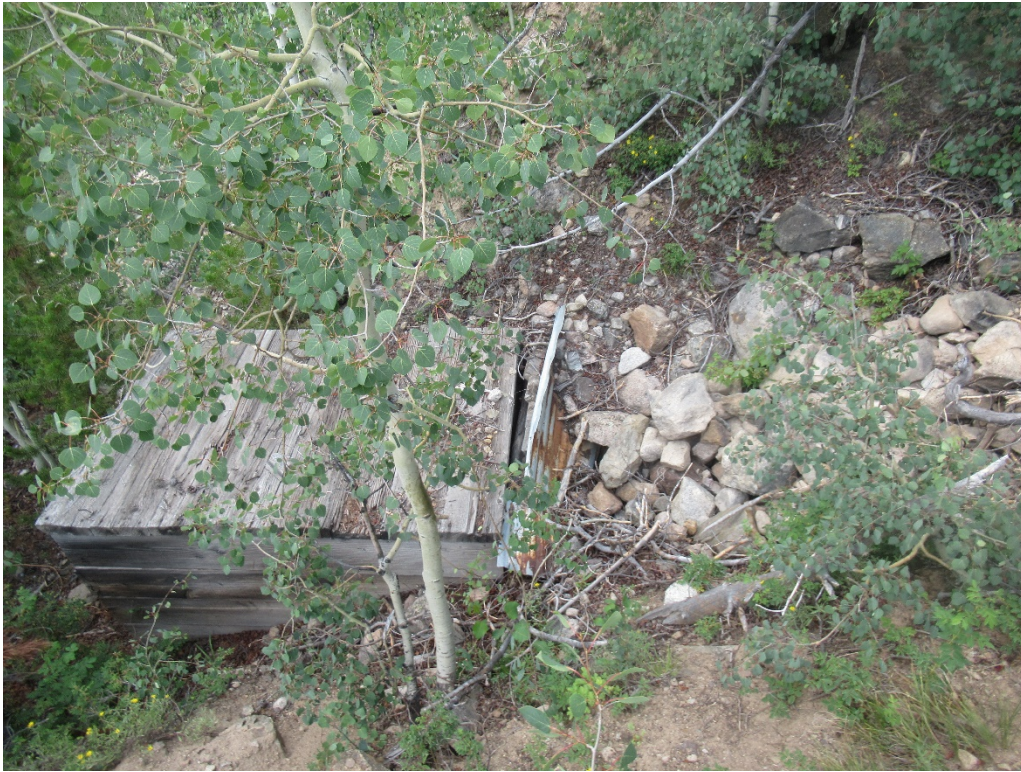
View of collapsed tunnel behind the adit

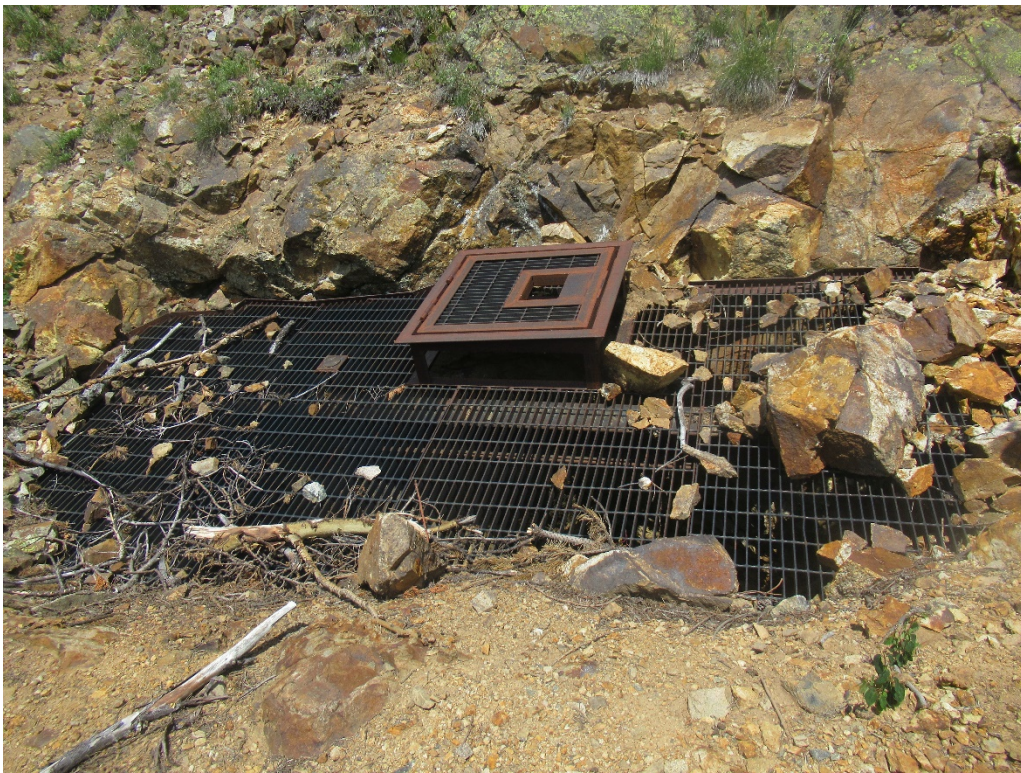
View of AML shaft closure grate

Work Description: Grate locked hatch, grate is set on beam and timbers and nailed down, not permanently, hatch shows signs of vandalism. Bat cupola added to grate.
