**MINERALS PROGRAM INSPECTION REPORT**  
**PHONE: (303) 866-3567**

<b>MINE NAME:</b> Henderson Mine	<b>MINE/PROSPECTING ID#:</b> M-1977-342	<b>MINERAL:</b> Molybdenum	<b>COUNTY:</b> Clear Creek, Grand
<b>INSPECTION TYPE:</b> Monitoring	<b>INSPECTOR(S):</b> Peter Hays	<b>INSP. DATE:</b> August 4, 2020	<b>INSP. TIME:</b> 10:00
<b>OPERATOR:</b> Climax Molybdenum Company	<b>OPERATOR REPRESENTATIVE:</b> Aaron Hilshorst	<b>TYPE OF OPERATION:</b> 112d-3 - Designated Mining Operation	
<b>REASON FOR INSPECTION:</b> Normal I&E Program	<b>BOND CALCULATION TYPE:</b>	<b>BOND AMOUNT:</b> \$37,993,785.00	
<b>DATE OF COMPLAINT:</b> NA	<b>POST INSP. CONTACTS:</b> None	<b>JOINT INSP. AGENCY:</b> None	
<b>WEATHER:</b> Clear	<b>INSPECTOR'S SIGNATURE:</b>

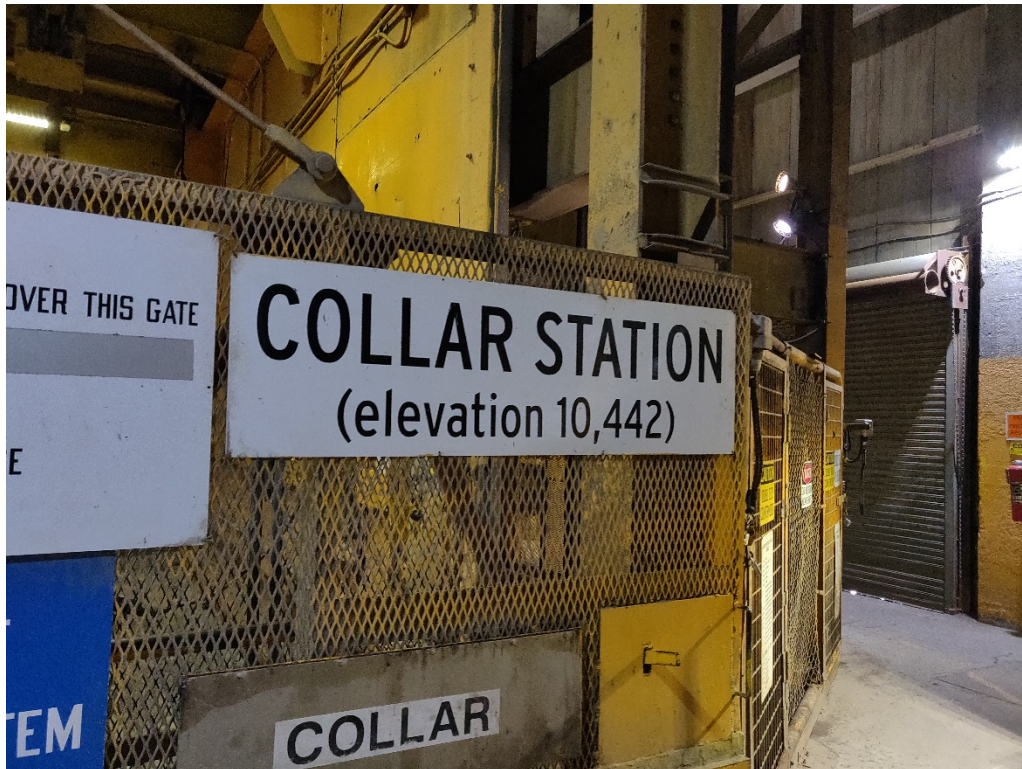
View of the Collar Station cage inside #2 Shaft

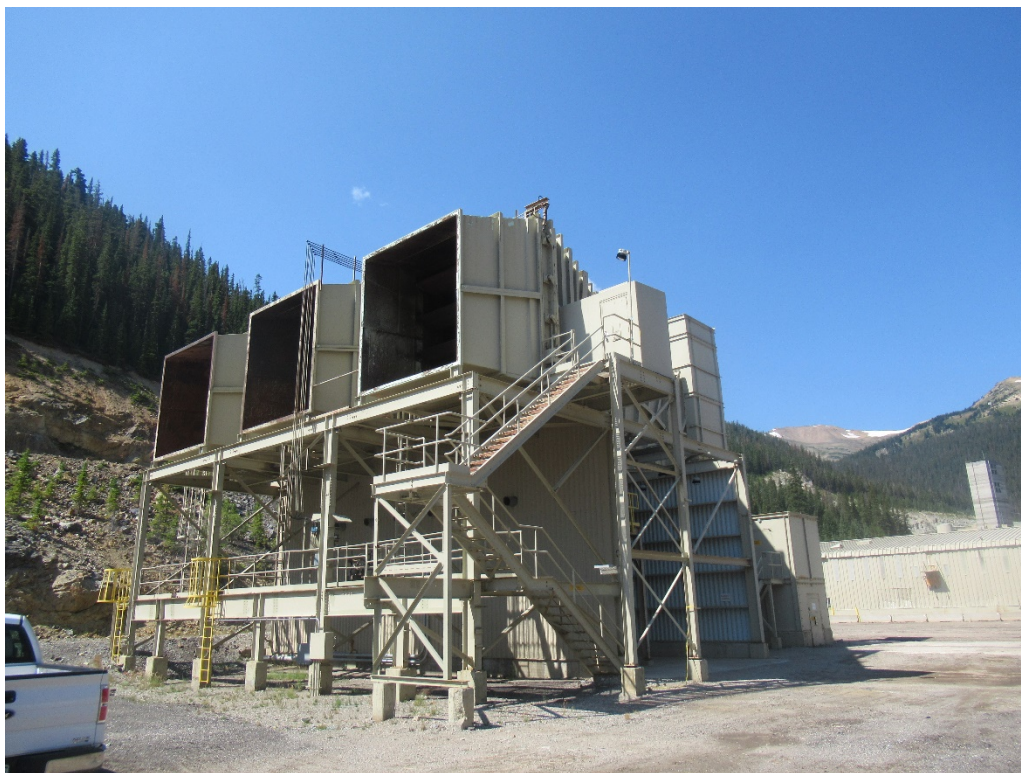
View of the surface structure for #1 Shaft

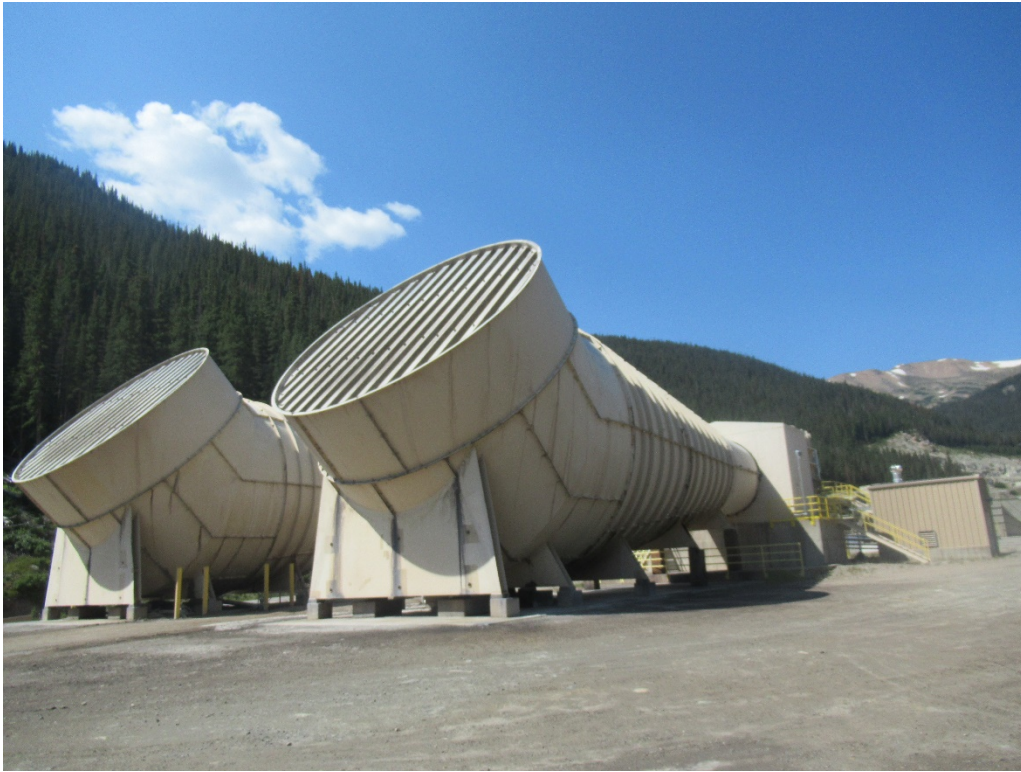
View of the surface structure for #5 Shaft

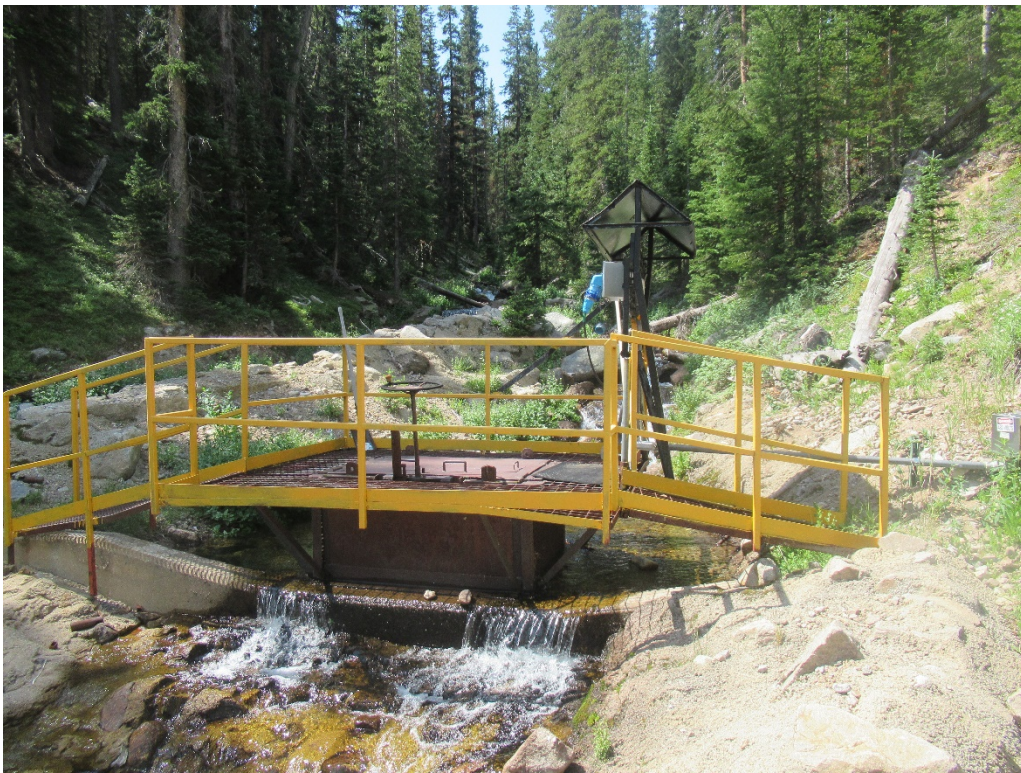
View of the Potable Water Intake
