**MINERALS PROGRAM INSPECTION REPORT**  
**PHONE: (303) 866-3567**

<b>MINE NAME:</b> Gold Hill Mill	<b>MINE/PROSPECTING ID#:</b> M-1994-117	<b>MINERAL:</b> Gold and silver	<b>COUNTY:</b> Boulder
<b>INSPECTION TYPE:</b> Monitoring	<b>INSPECTOR(S):</b> Amy Eschberger	<b>INSP. DATE:</b> July 14, 2020	<b>INSP. TIME:</b> 10:00
<b>OPERATOR:</b> Colorado Milling Company, LLC	<b>OPERATOR REPRESENTATIVE:</b> Avrom Howard and Lewis Perkins	<b>TYPE OF OPERATION:</b> 110(2) - Hard Rock Limited Impact

**M-1994-117 / Gold Hill Mill / Colorado Milling Company, LLC / 110(2) Hard Rock Permit**

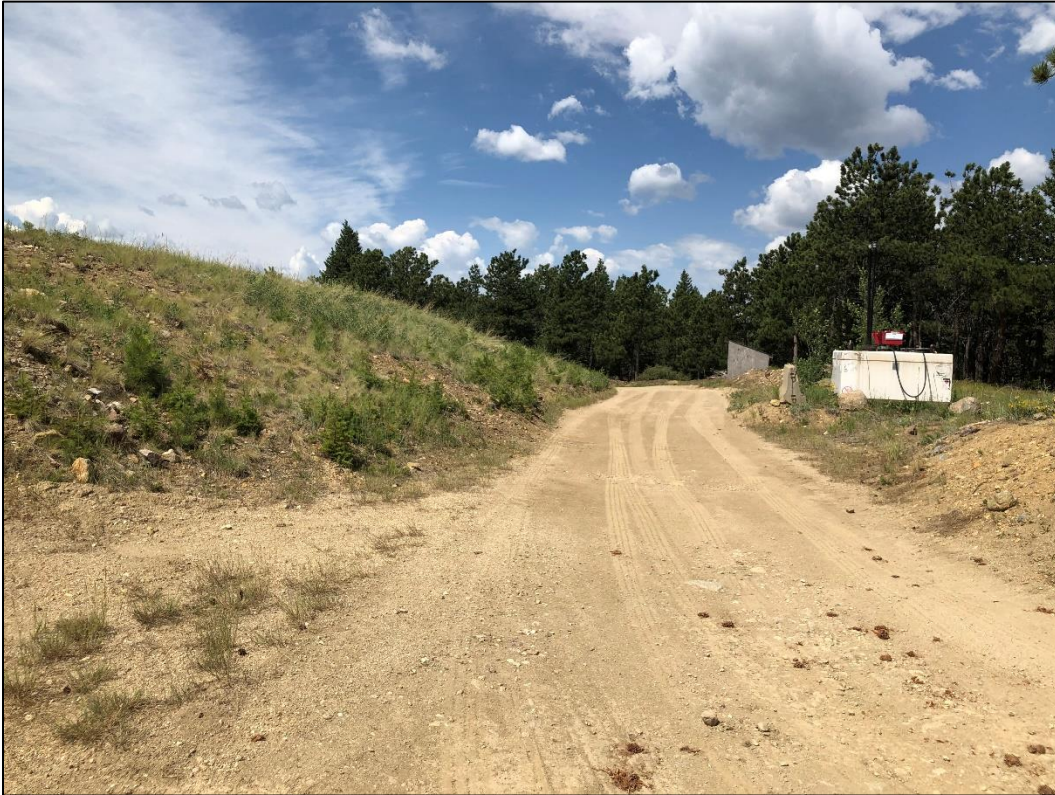
**Photo 1.** View looking west along access road, showing north side of ore stockpile (at left), stable with good vegetative cover.

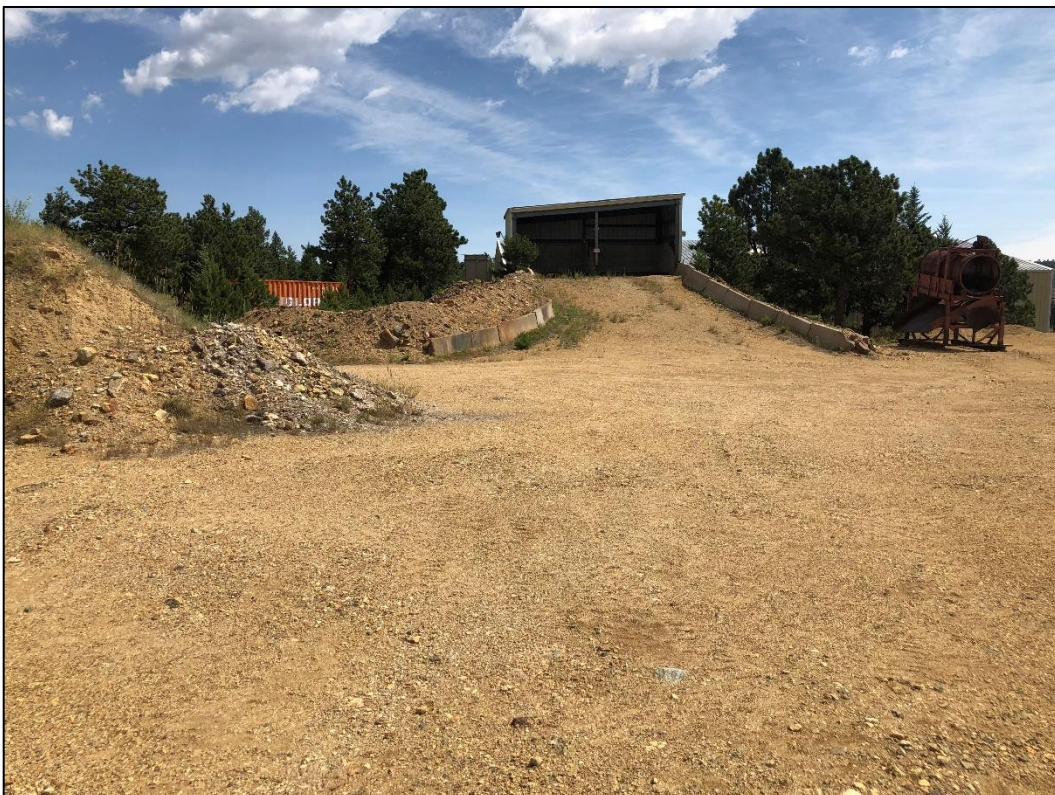
**Photo 2.** View looking northeast across top of ore stockpile, showing ramp (in background) connecting the stockpile to two coarse ore bins at southwestern edge of mill building.

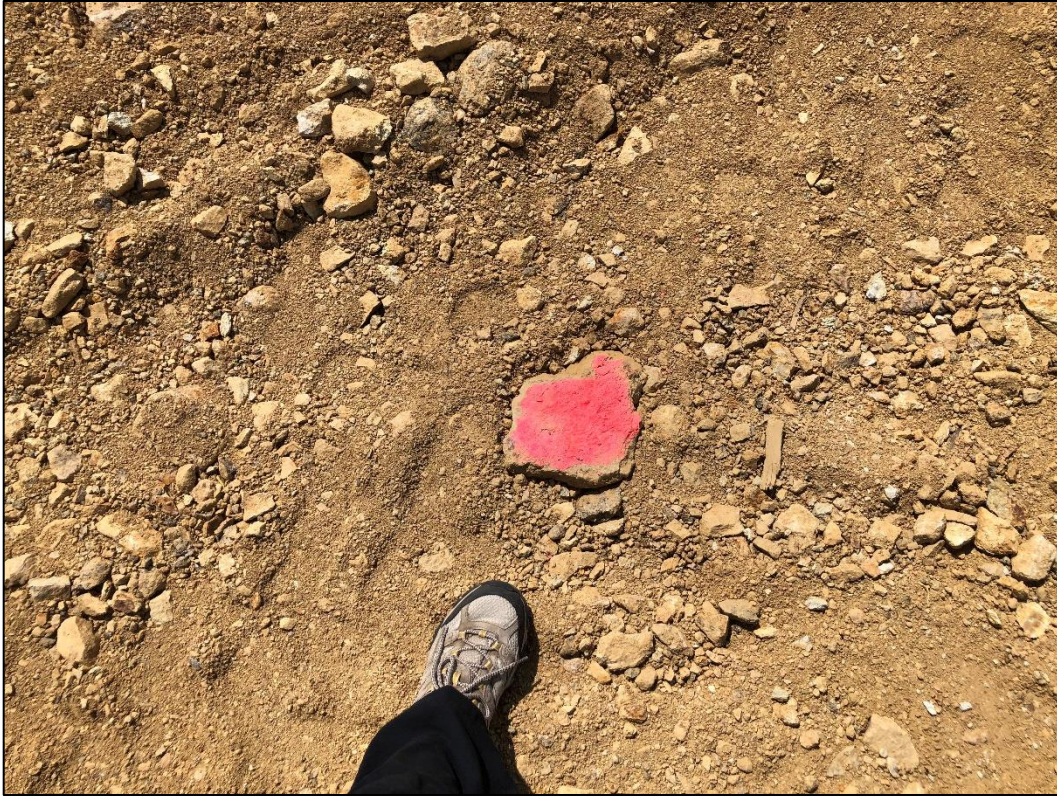
**Photo 3.** Closer view of top of ore stockpile, showing rock painted pink marking location where sample was recently collected for laboratory analysis.

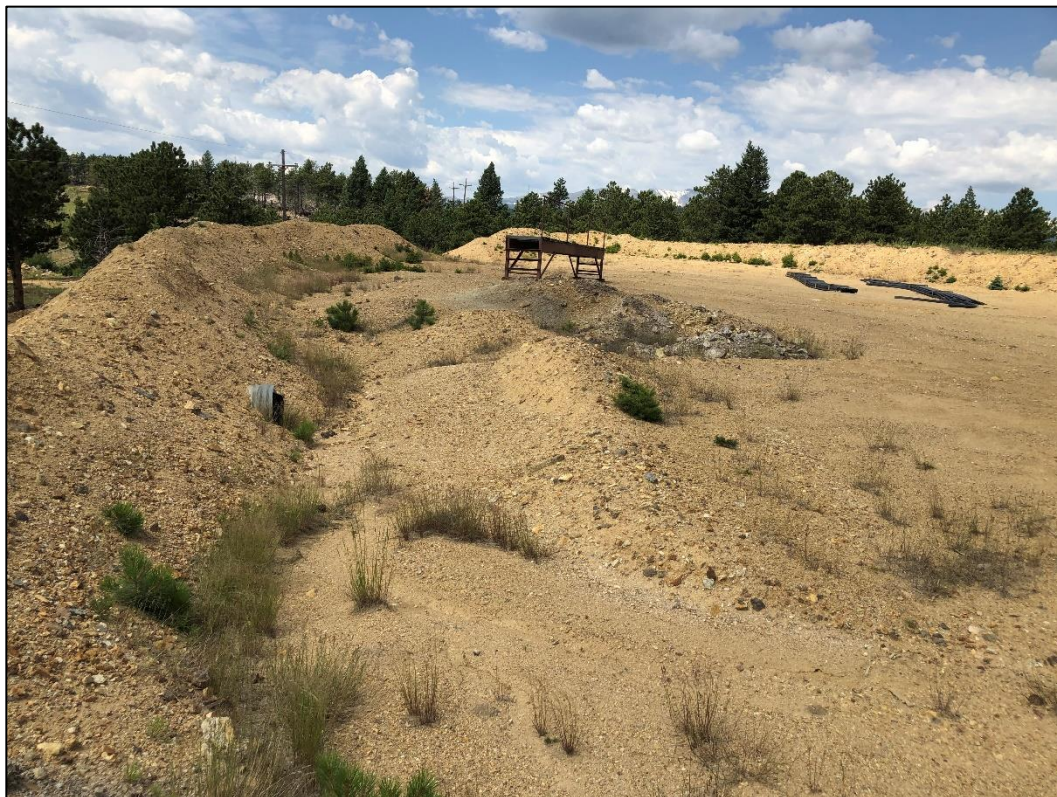
The Division inspected the large ore stockpile stored southwest of the mill facility. This ore was derived from the Cash Mine located just downhill from the mill site, which is part of the Cash & Who Do Mines permit. This stockpile is estimated to contain approximately 35,000-40,000 tons of material that could be processed in the mill. A ramp connects the top of the stockpile to the two coarse ore bins located at the southwestern edge of the mill building. The stockpile appeared to be stable. No signs of acid rock drainage from the stockpile were observed. Mr. Howard pointed out the rocks on top of the stockpile painted pink which mark the locations where samples had recently been collected for laboratory analysis. The Division does not consider small-scale sampling of the dump material and sending these samples off-site for analysis to be in conflict with the current restrictions on operations. However, the operator is not currently authorized to process material on site (as discussed above).

**Photo 4.** View looking southwest across top of ore stockpile stored southwest of mill facility.

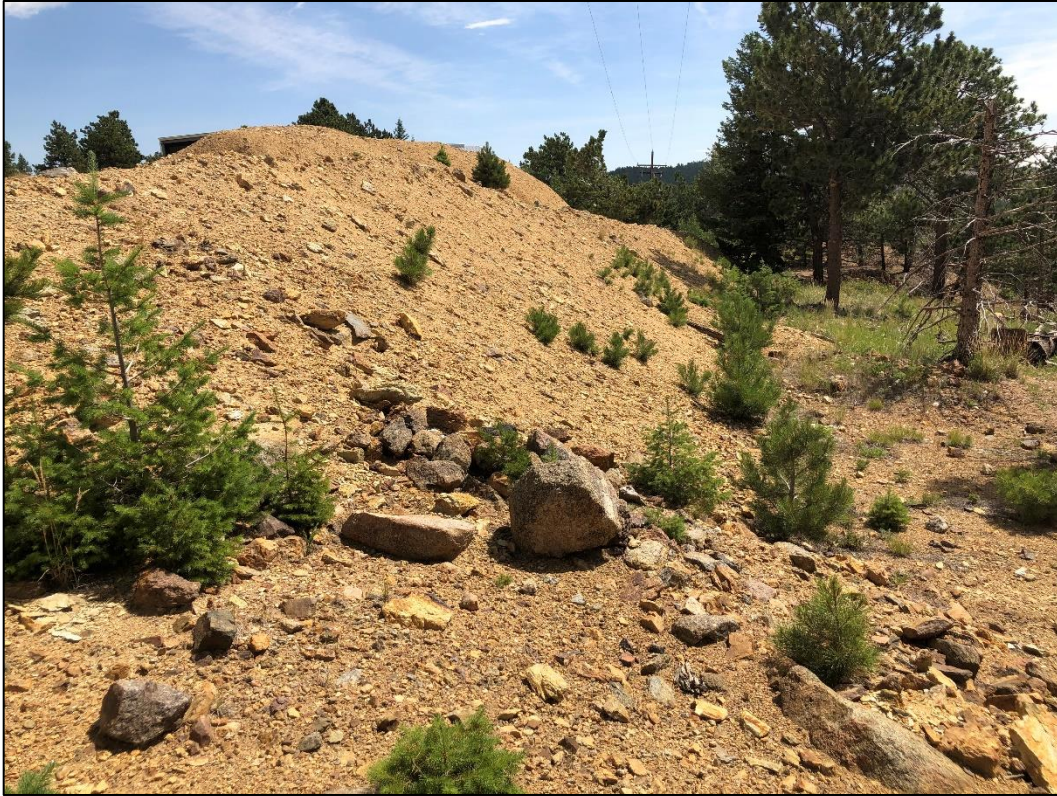
**Photo 5.** View looking northeast along south side of ore stockpile, which is stable with some volunteer pine trees growing on its slopes.

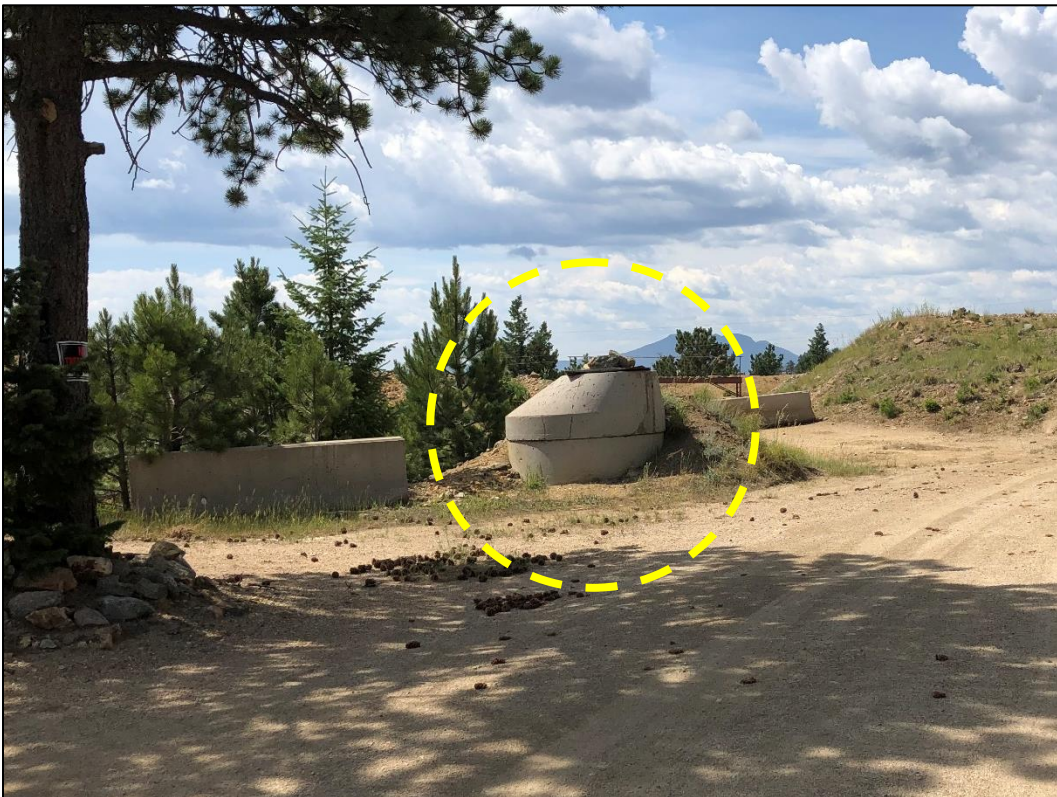
**Photo 6.** View looking southwest, showing Wynona Mine shaft well head (circled) located just southwest of mill facility.

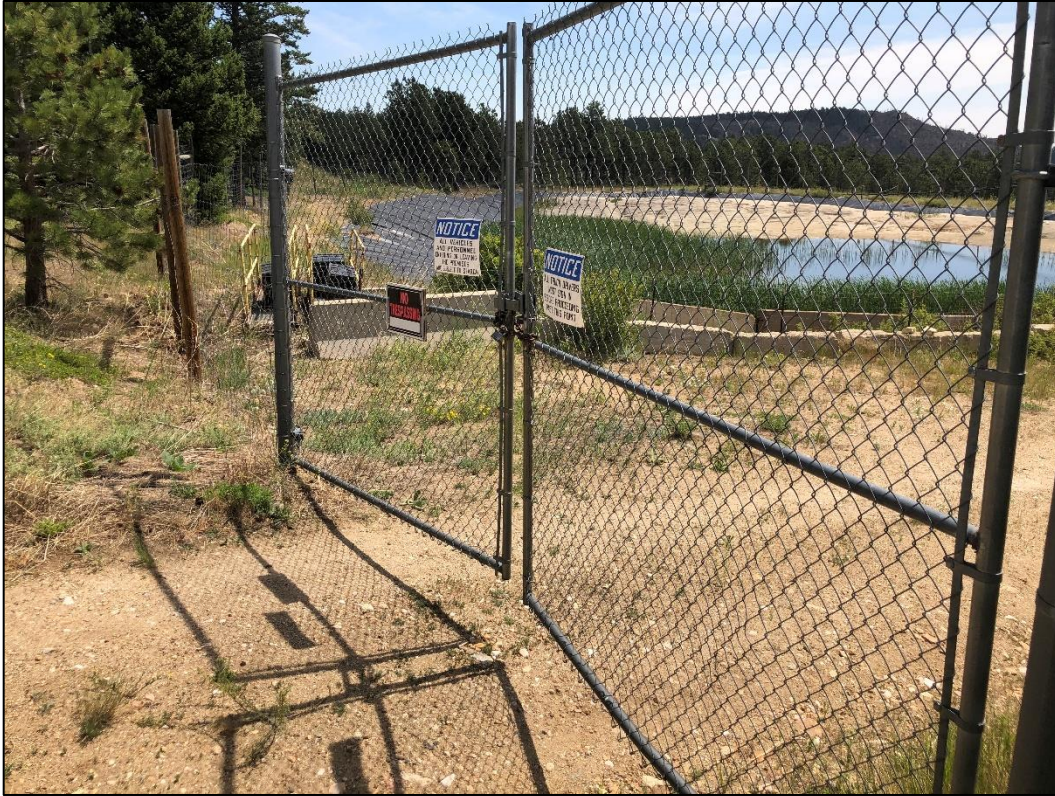
The tailings impoundment at the mill site is enclosed by wildlife (woven wire/mesh) fencing, with the entrance secured by a locked gate. Concrete barriers and an additional fence are installed along the western edge of the impoundment (within the perimeter fence). There was standing water present in the western portion of the impoundment from recent precipitation events. The water level was well below the required minimum two foot freeboard for the impoundment. The operator should be aware, the Division of Water Resources (DWR) requires any stormwater runoff intercepted by the operation, which is not diverted or captured in priority, to infiltrate into the ground and/or be released to the stream system within 72 hours. This may require a discharge permit from the CDPHE, WQCD. Otherwise, the operator will need to contact DWR to make replacements for evaporation. The required freeboard was maintained around the entire impoundment. However, along the (lower elevation) eastern edge of the impoundment, the tailings material was right at the two foot minimum. It has been documented in previous inspection reports that this area is subjected to intense crosswinds from the west which blow over the tailings pond. This has previously resulted in tailings material being dispersed off liner by the wind, typically to the east or southeast of the impoundment. The Division observed no evidence of tailings material deposited off liner. However, the impoundment should continue to be closely monitored, ensuring the minimum two foot freeboard is maintained and that no tailings material is being dispersed off liner.

**Photo 7.** View of entrance to tailings impoundment area secured by locked gate.

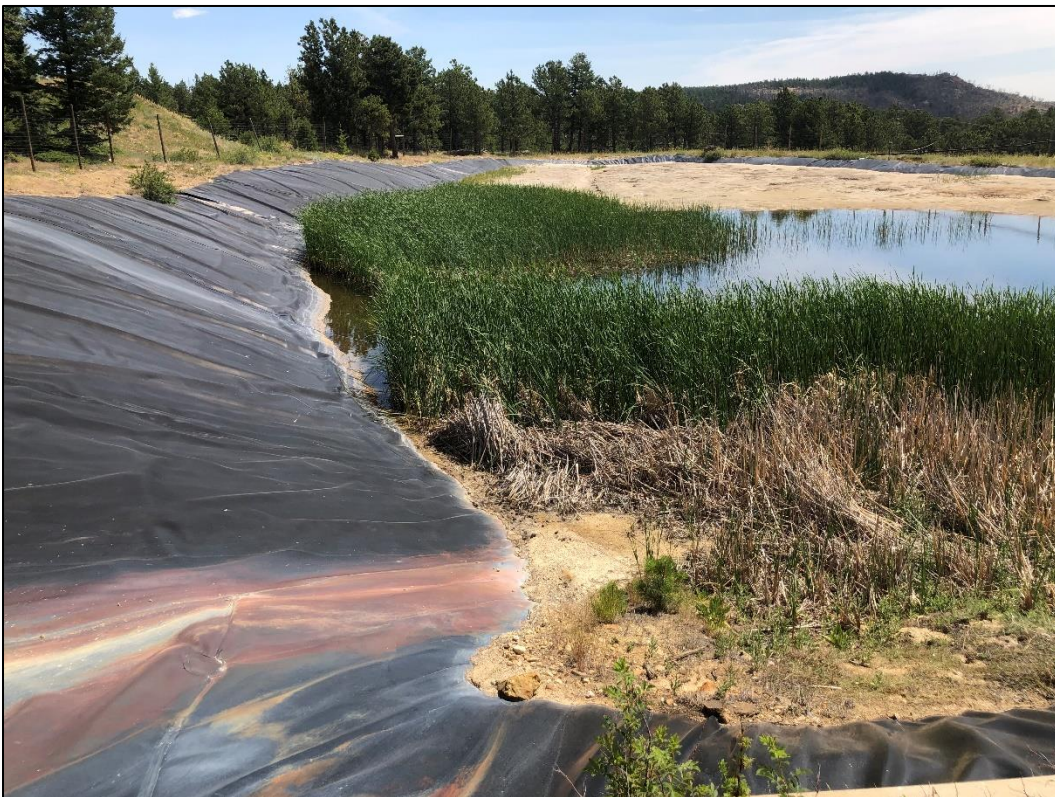
**Photo 8.** View looking northeast across northern edge of tailings impoundment, showing minimum freeboard of two feet is maintained. Note dense cluster of cattails which need to be removed prior to recommencing operations. Also note standing water present.

Prior to recommencing with mill operations, the operator will need to clean out the dense cluster of cattails and other vegetation growing on the tailings deposited in the western portion of the impoundment. Additionally, any volunteer trees or other woody vegetation growing in the lined area should be removed as soon as possible, as the roots of these plants could potentially compromise the integrity of the liner as the plants grow larger. The operator estimates the remaining capacity in the tailings impoundment could accommodate up to approximately 5,000 tons of additional tailings. Depending on the results of the current site evaluation, the operator may need to increase the tailings storage capacity at the site. If this proposal includes an increase in affected lands, it must be submitted to the Division through the Amendment process.

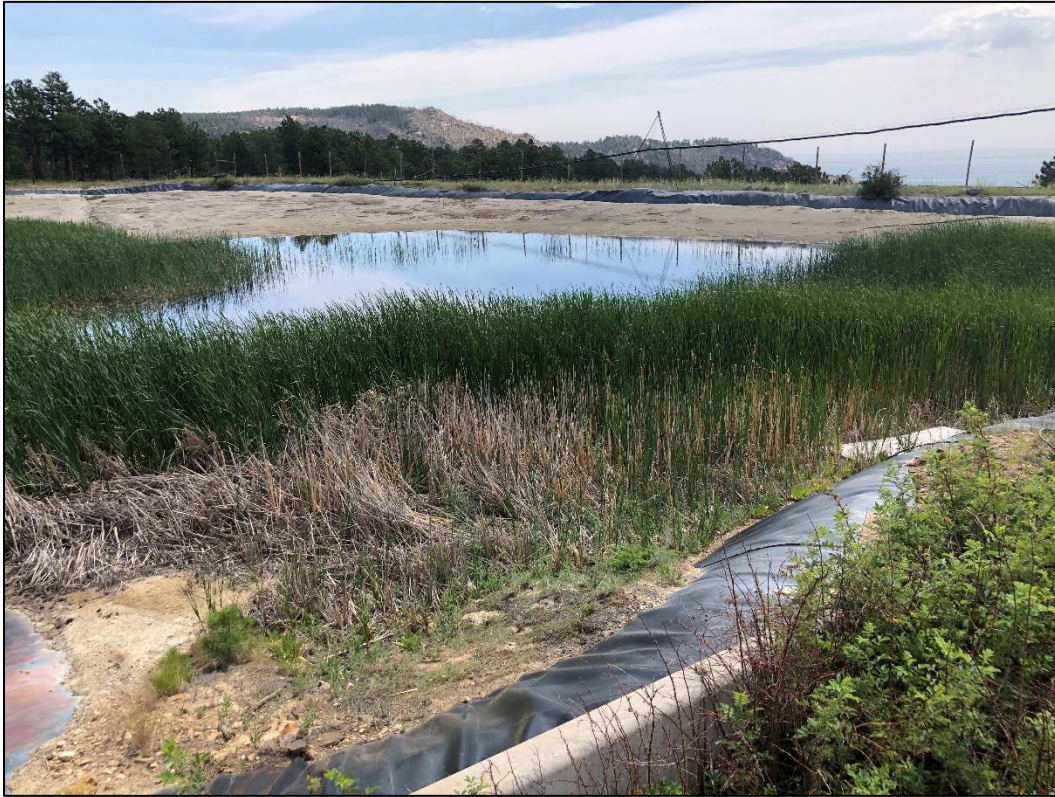
**Photo 9.** View looking northeast across tailings impoundment. Note dense cluster of cattails which need to be removed prior to recommencing operations. Also note standing water present.

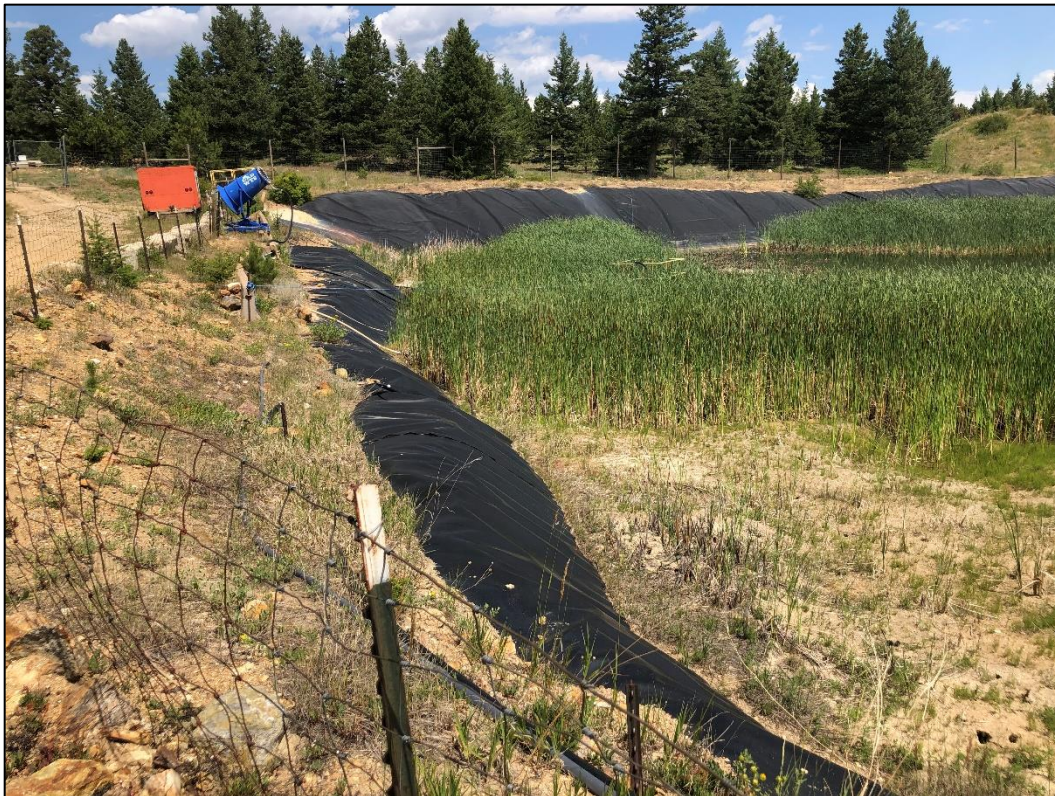
**Photo 10.** View looking northwest across western edge of tailings impoundment, showing minimum freeboard of two feet is maintained. Note dense cluster of cattails which need to be removed prior to recommencing operations. Also note fencing installed along western edge of impoundment.

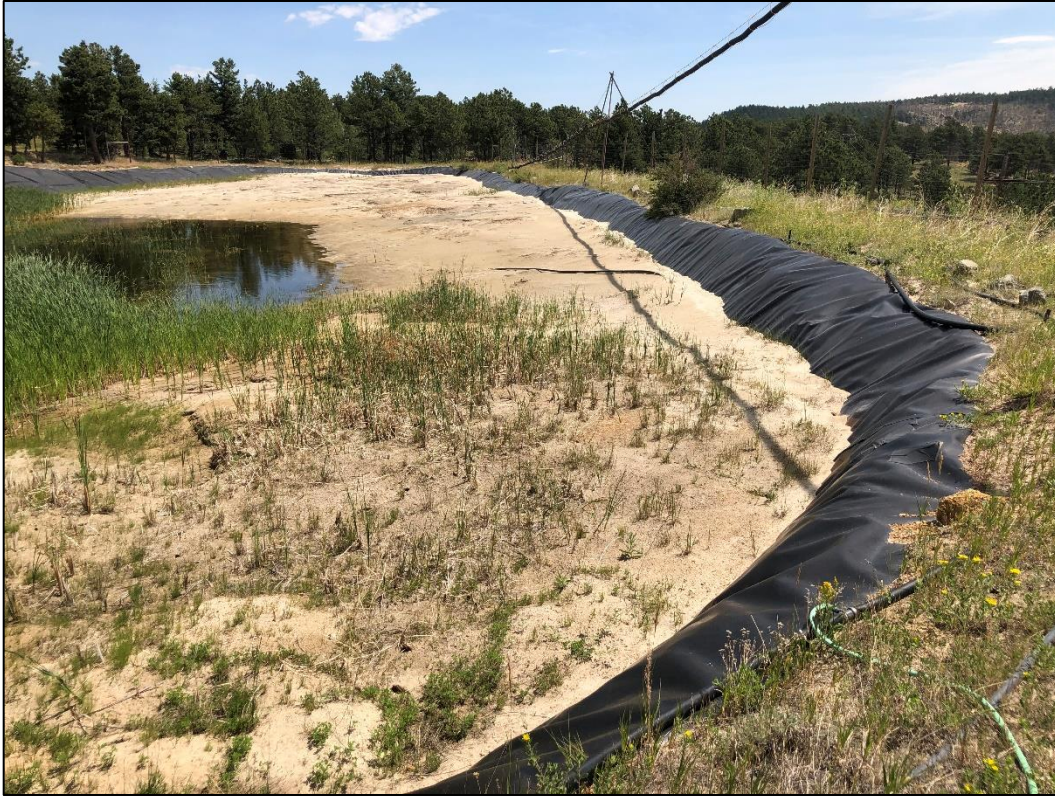
**Photo 11.** View looking northeast across southern edge of tailings impoundment, showing minimum freeboard of two feet is maintained. Note standing water present.

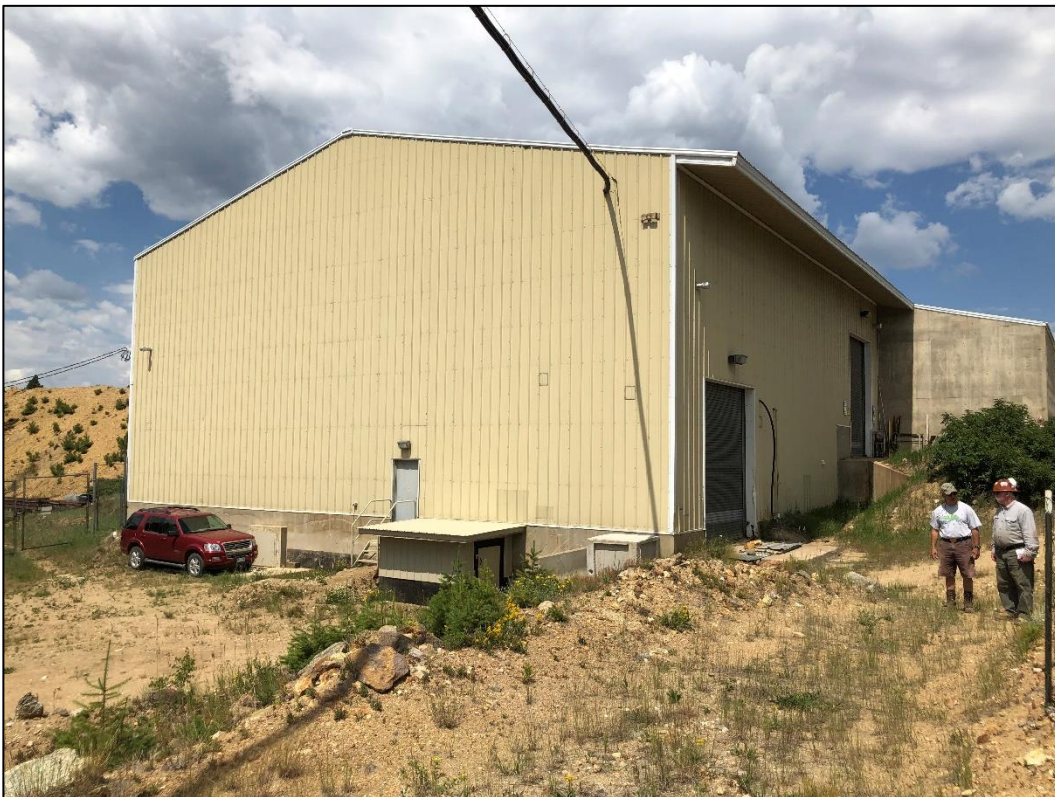
**Photo 12.** View looking west at back (southeastern) side of mill building (from within tailings impoundment enclosure).

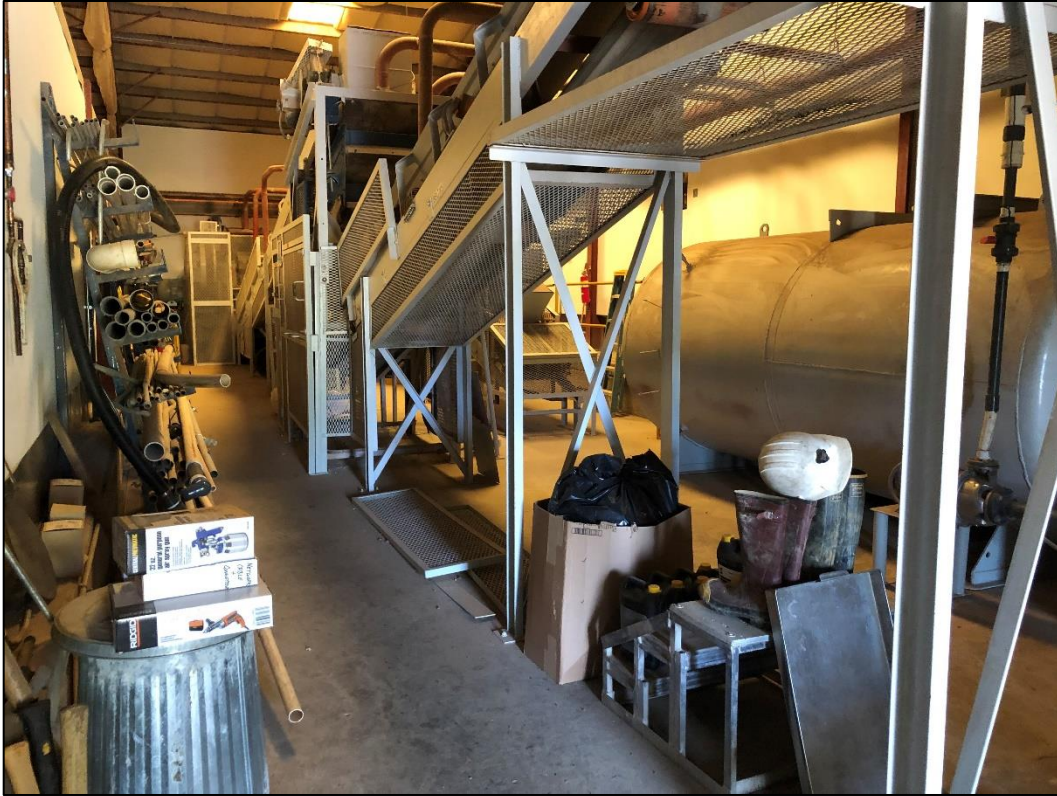
**Photo 13.** View inside mill building showing closed-circuit crushing plant. Mill remains offline in accordance with current DRMS and BLM restrictions.

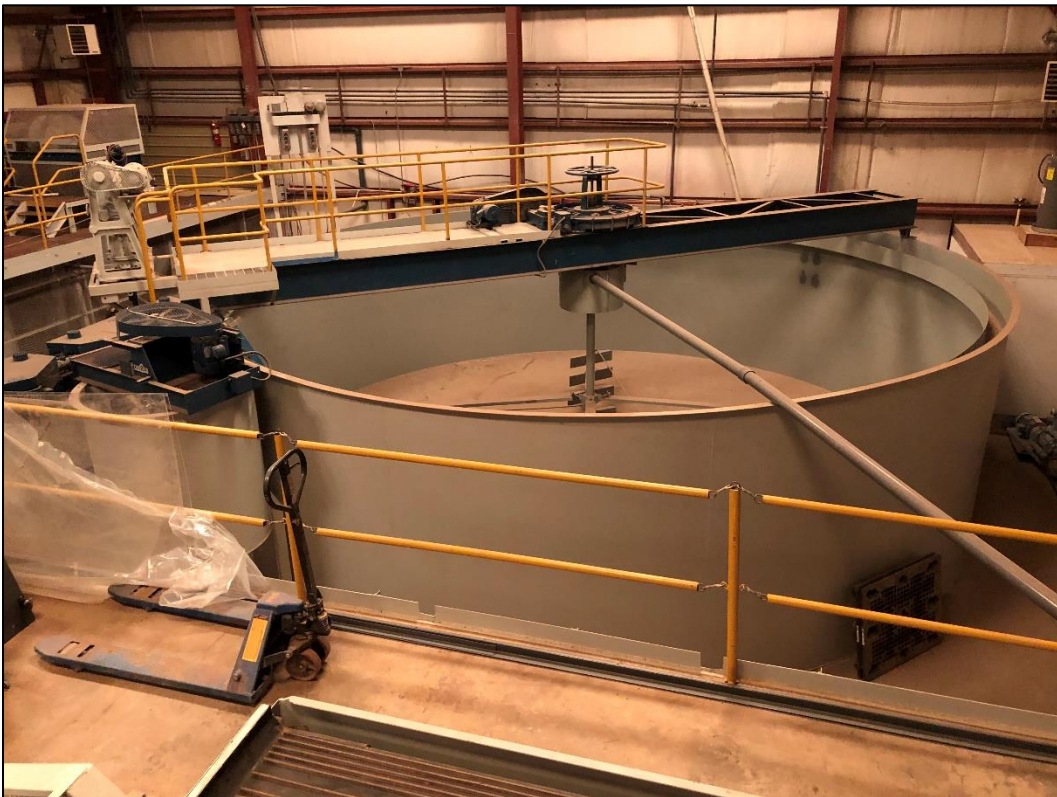
**Photo 14.** View inside mill building showing large thickener tank. Mill remains offline in accordance with current DRMS and BLM restrictions.

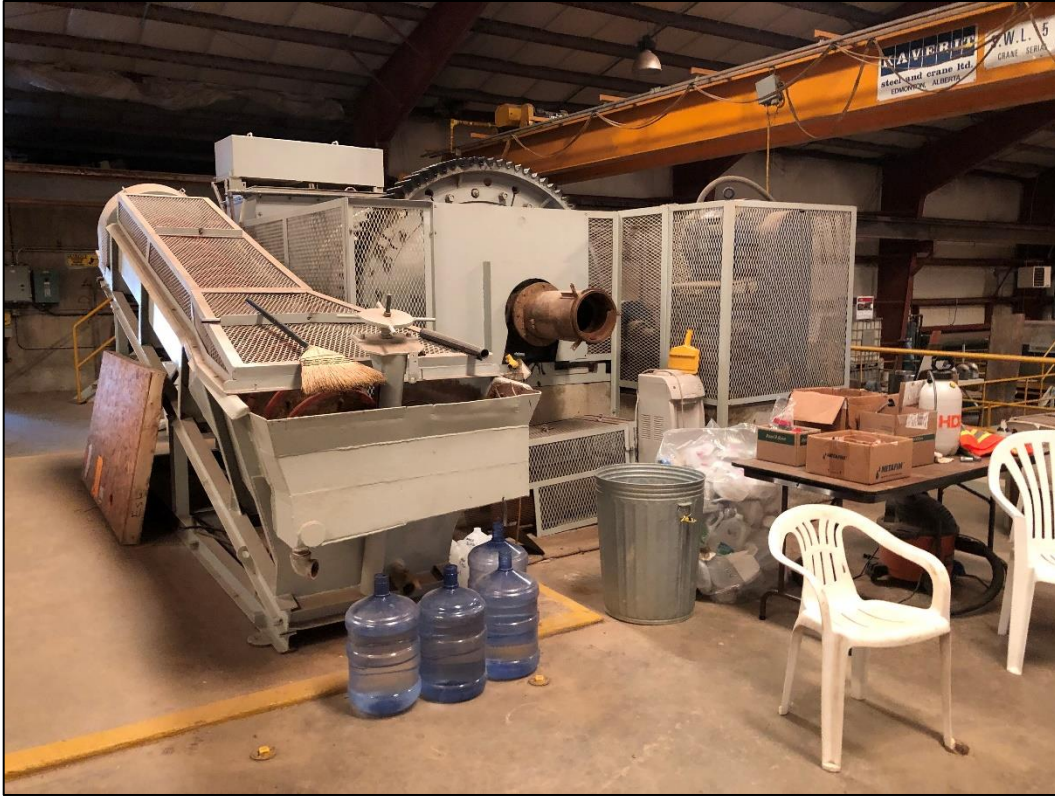
**Photo 15.** View inside mill building showing closed-circuit grinding plant. Mill remains offline in accordance with current DRMS and BLM restrictions.

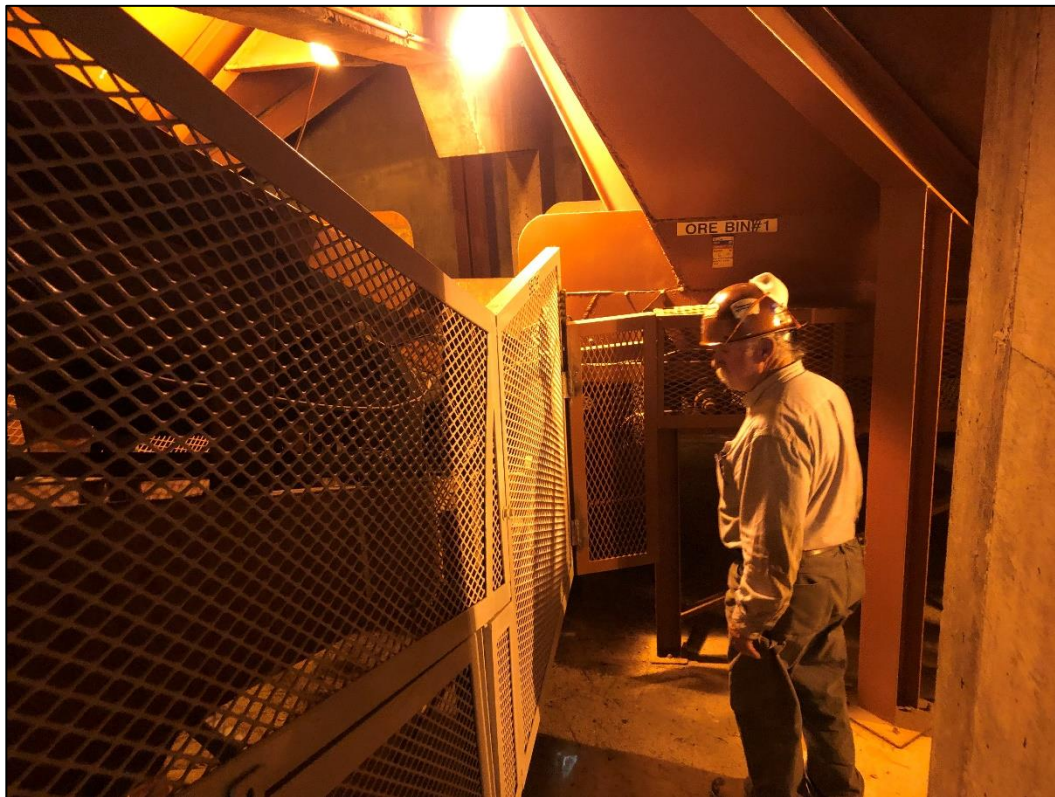
**Photo 16.** View inside mill building showing shoot from two outside coarse ore bins (at southwestern edge of mill building). Mill remains offline in accordance with current DRMS and BLM restrictions.

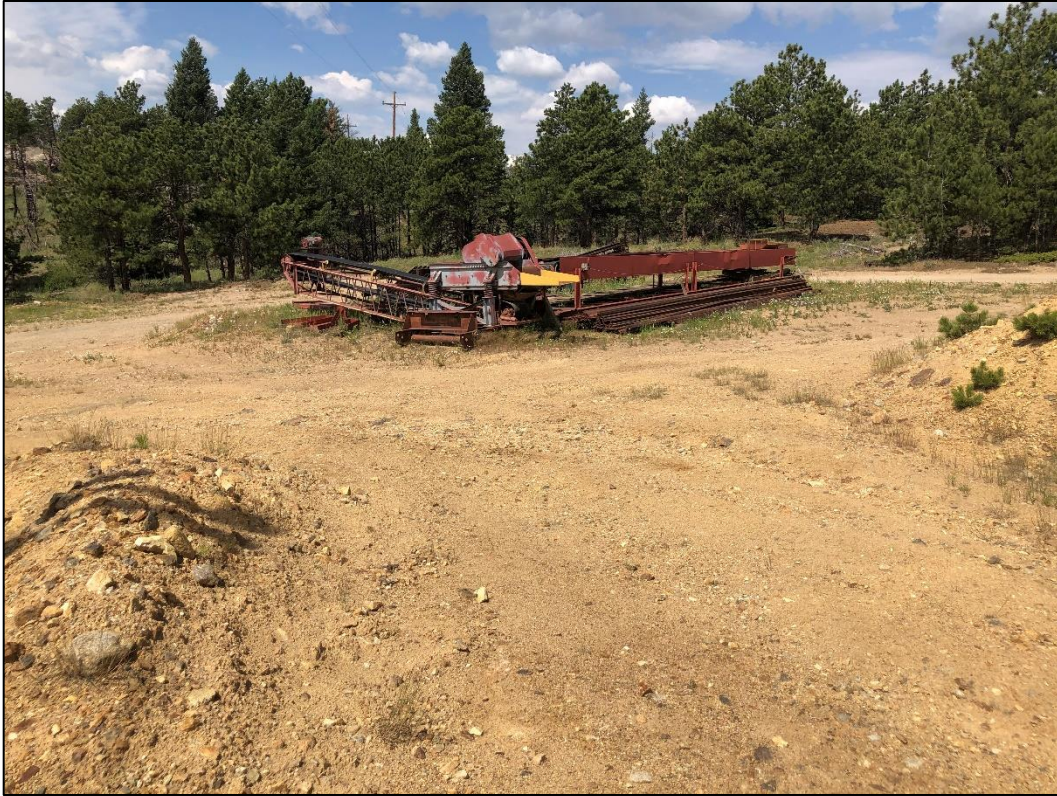
**Photo 17.** View looking west across small equipment storage area located west/southwest of ore stockpile. This area is within the approved permit area.

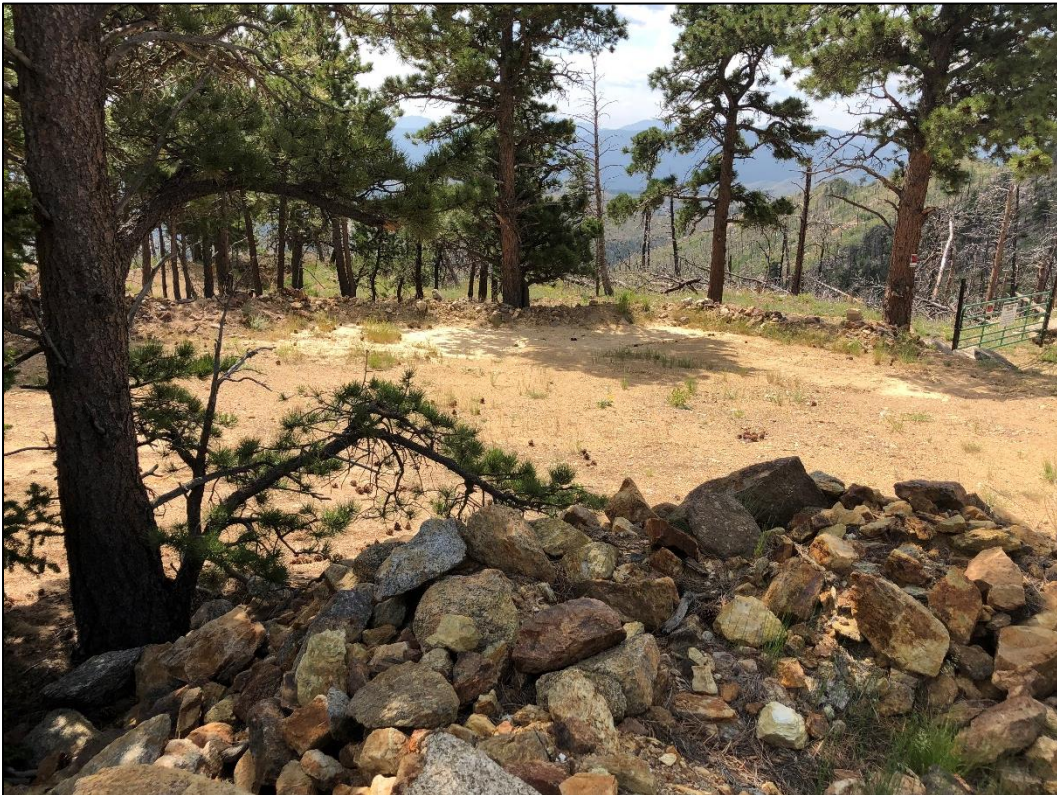
During the Division's last inspection of the site on August 9, 2018, there was equipment being stored in an area south/southwest of the ore stockpile, which was located partially outside of the approved permit area. In its inspection report, the Division informed the operator that any equipment storage areas for the mill operation are considered affected lands, and therefore, must be included within the approved permit area. Since that time, the operator has removed the equipment from the site and/or relocated it to within the permit area.

**Photo 18.** View looking south across area located south/southwest of ore stockpile (partially outside of approved permit area) where equipment has been removed.
