**MINERALS PROGRAM INSPECTION REPORT**  
**PHONE: (303) 866-3567**

<b>MINE NAME:</b> Motorcross Borrow Pit	<b>MINE/PROSPECTING ID#:</b> M-2019-041	<b>MINERAL:</b> Borrow material	<b>COUNTY:</b> Weld
<b>INSPECTION TYPE:</b> Monitoring	<b>INSPECTOR(S):</b> Peter Hays	<b>INSP. DATE:</b> August 5, 2020	<b>INSP. TIME:</b> 14:00
<b>OPERATOR:</b> SEMA Construction, Inc.	<b>OPERATOR REPRESENTATIVE:</b> None	<b>TYPE OF OPERATION:</b> 111 - Construction by Government Agency	
<b>REASON FOR INSPECTION:</b> Normal I&E Program	<b>BOND CALCULATION TYPE:</b> Partial Bond	<b>BOND AMOUNT:</b> \$70,750.00	
<b>DATE OF COMPLAINT:</b> NA	<b>POST INSP. CONTACTS:</b> None	<b>JOINT INSP. AGENCY:</b> None	
<b>WEATHER:</b> Clear	<b>INSPECTOR'S SIGNATURE:</b>

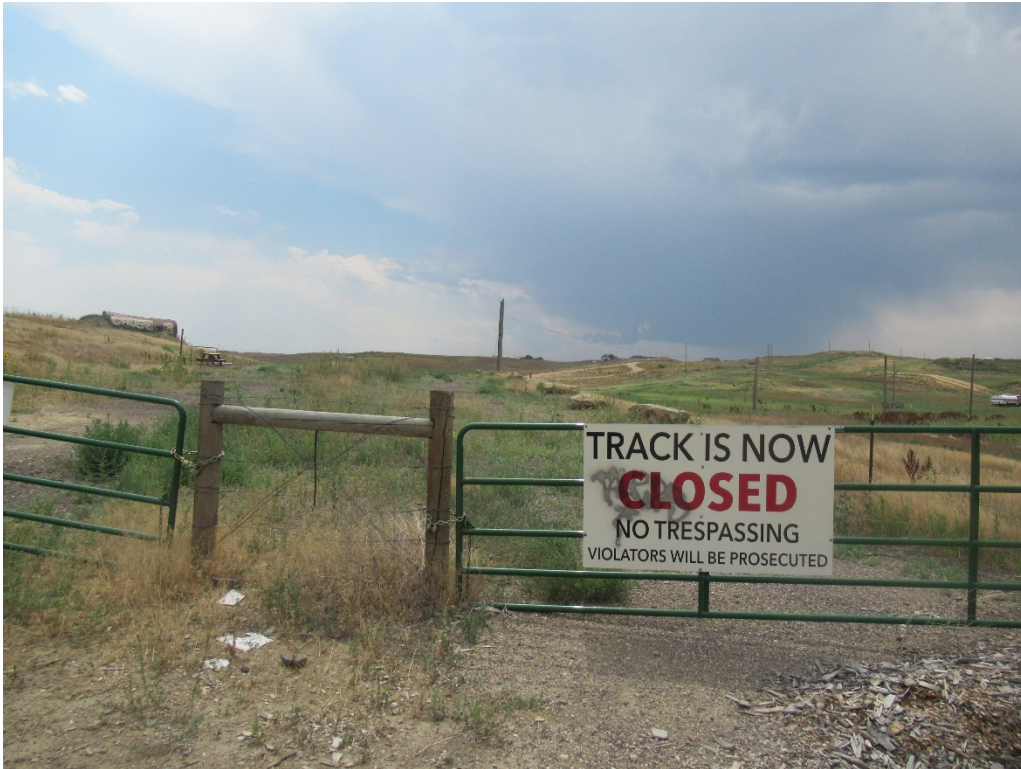
Mining operations have not commenced at the site according to the Operator. The mining and reclamation activities were originally proposed to be completed in the fourth quarter of 2020. The site will be mined from north to south with topsoil stockpiles along the north and east permit boundaries. The maximum mining depth will be 55 feet and 1,216,440 cubic yards of material is anticipated to be removed from the site. Groundwater will not be encountered by the mining operation. Site access was prevented by the locked former track entrance gates off of the I-25 Frontage Road.

View of the locked gate off of the I-25 Frontage Road

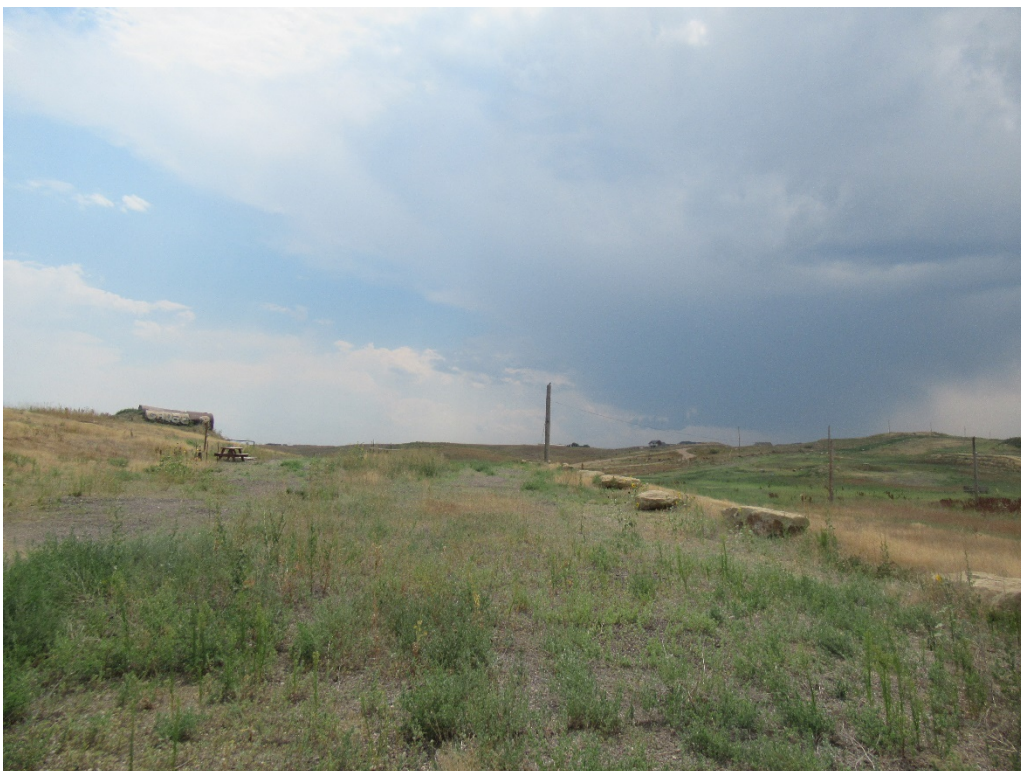
View of the site from the track gate looking west

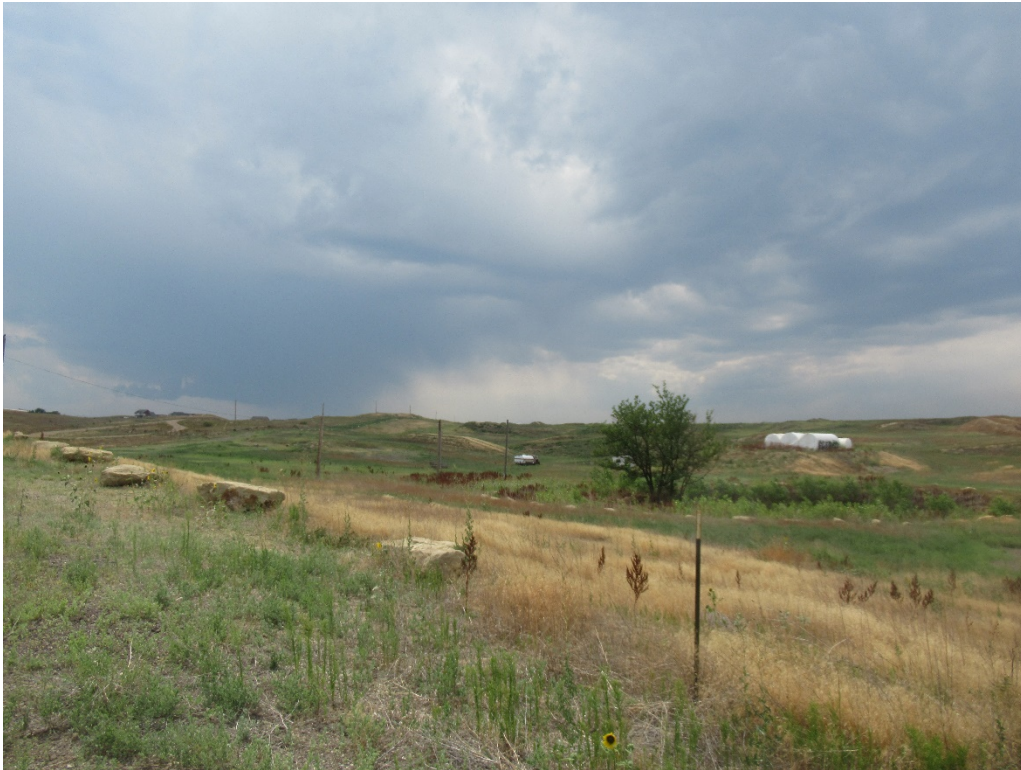
View of the site from the track gate looking northwest

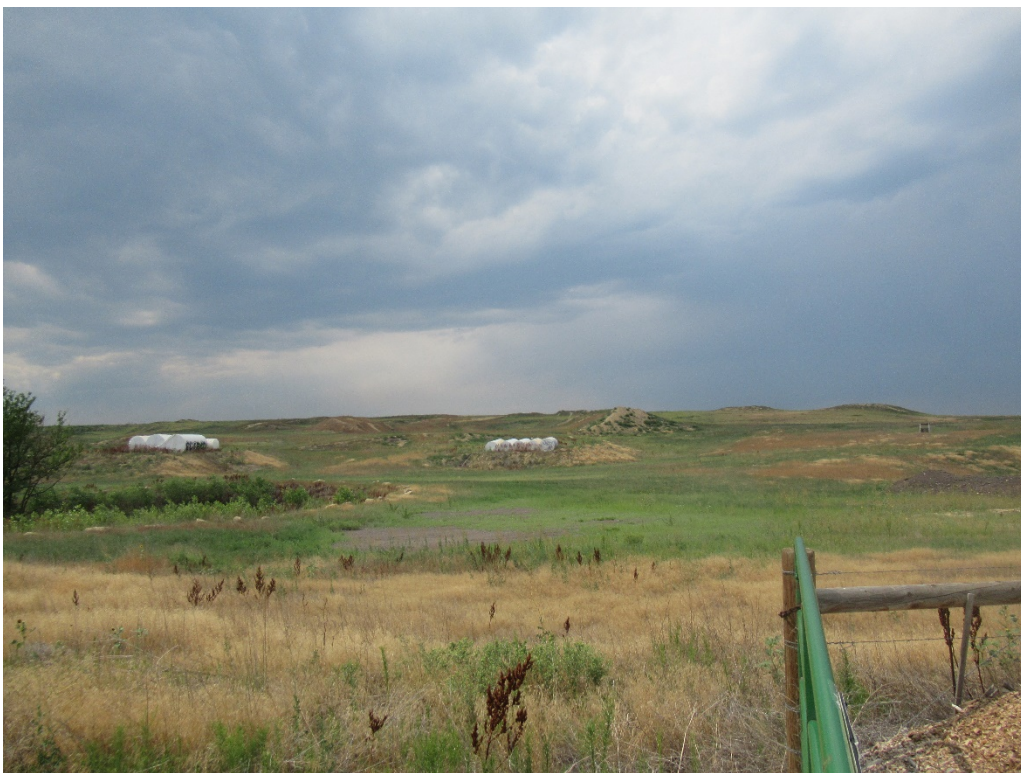
View of the site from the track gate looking north
