Bowie #2 inspection report

PERMIT INFORMATION

Permit Number: C-1996-083 Mine Name: Bowie No. 2 Mine Operator: Bowie Resources, LLC Operator Address: Mr. Basil Bear P.O. Box 1488 Paonia, CO 81428	County: Delta Operation Type: Underground Permit Status: Active Ownership: Private
	Operator Representative Present: Basil Bear
Operator Representative Signature: (Field Issuance Only)

Inspection Start Date: August 12, 2020 Inspection Start Time: 11:00 Inspection End Date: August 12, 2020 Inspection End Time: 15:50	Inspection Type: Coal Partial Inspection Inspection Reason: Normal I&E Program Weather: Clear
Joint Inspection Agency: None	Joint Inspection Contacts:
Post Inspection Agency: None	Post Inspection Contacts:
Inspector(s): Robert Zuber, P.E.	Inspector's Signature: <i>Robert D. Zuber</i> Signature Date: 8/14/2020

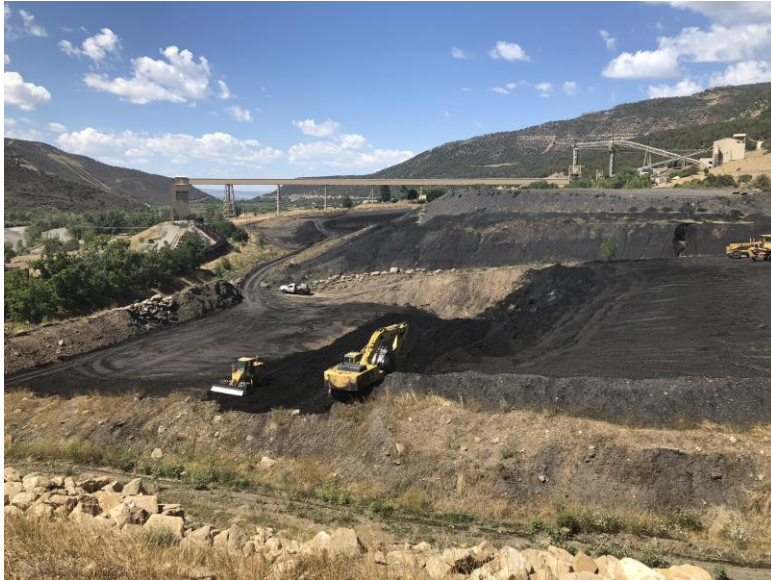
West end of Gob Pile #3

During the inspection, BRL's work on Gob Pile #3 was focused on the east side of this pile, the area that was used for drying material. They were spreading and compacting waste material, and Basil Bear was on top of the coverfill pile using survey equipment. Basil indicated that they plan to place and compact more than half of the remaining material during the remainder of 2020. Basil also indicated that in 2020 BRL plans to spread coverfill material on the west side of Gob Pile #3.

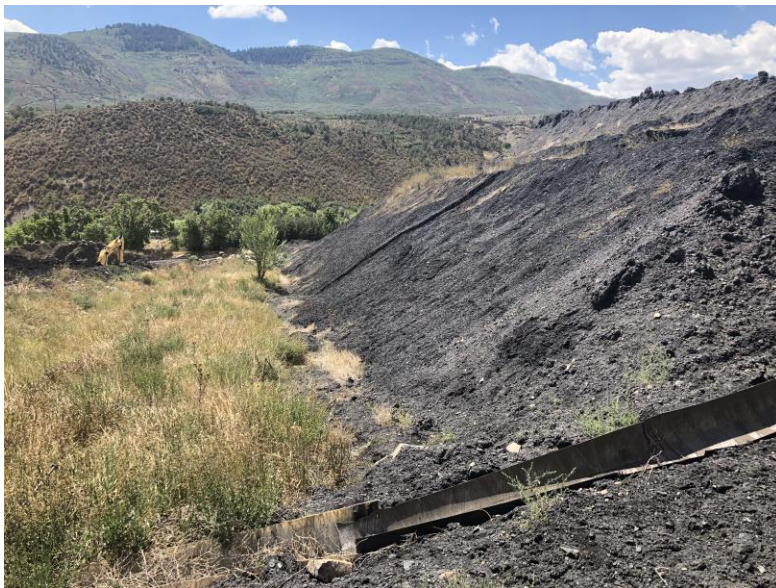
Steep portion of Gob Pile #3, where erosion BMPs are recommended

The steep portion of Gob Pile #3 appears stable, but the Division recommends the use of straw logs or other sediment BMP to prevent the waste material from leaving the pile (see PHOTOGRAPHS section).

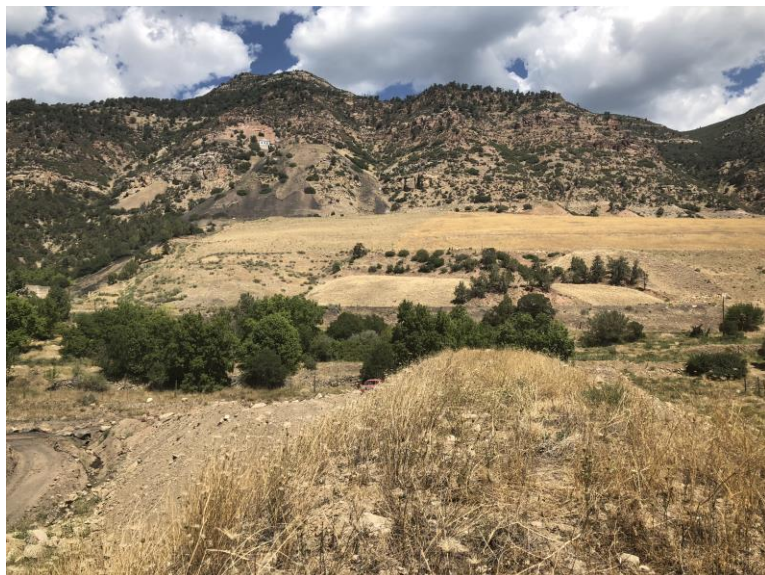
Gob Pile #1, Gob Pile #4, and surrounding area

No puddles, large amounts of erosion, or other significant problems were seen with gob piles. This includes Gob Piles 1 – 4.

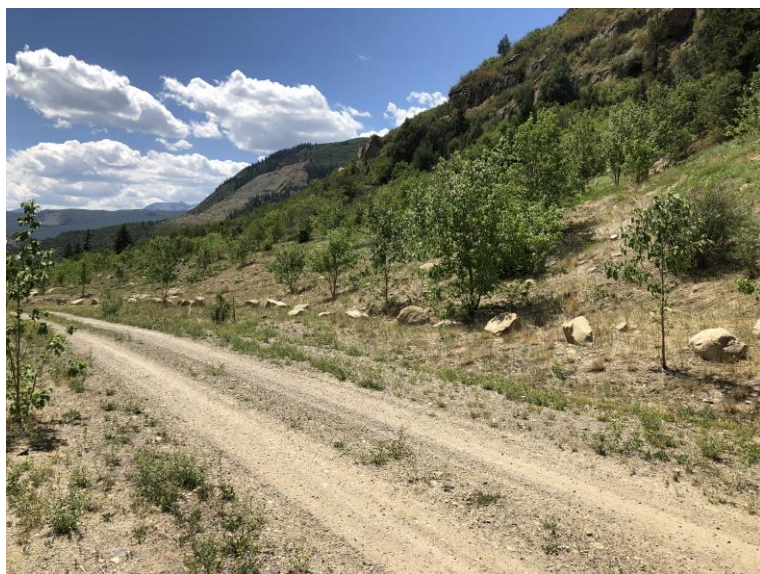
Reclaimed pad at Hubbard Creek Vent Shaft

The pad for the reclaimed Hubbard Creek Vent Shaft was inspected, and no erosion or other problems were identified. Mine ID signs were visible, and markers (boundary, stream buffer) were in place. Many healthy, small trees were growing at the site.

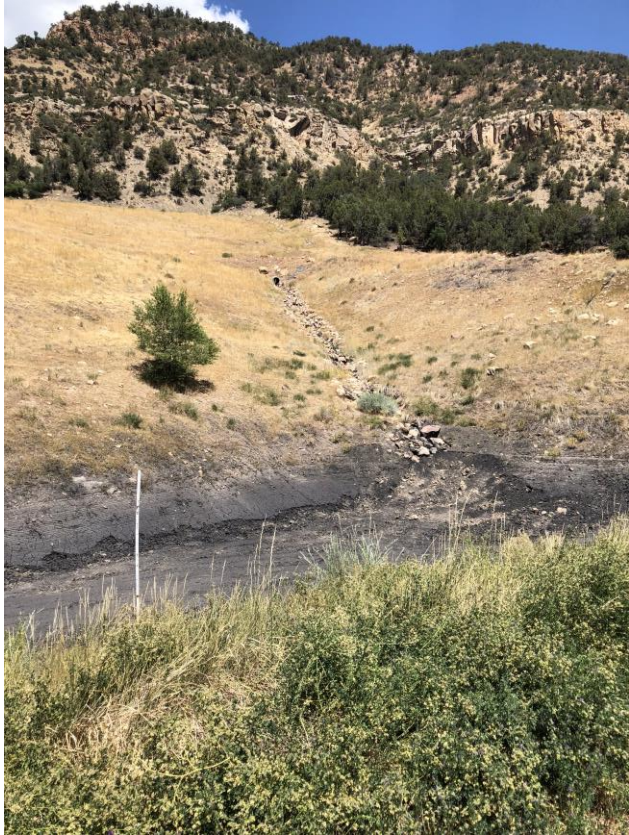
Pond F with inlet channel

Five ponds were inspected: B, C, D, F, and J. None of the ponds were discharging, and all but Pond J were dry or almost dry. Pond J held significant water, but it was well below the spillways. No problems were identified with embankments, spillways, or other features of the ponds.

Some weeds were seen during the inspection, including Russian knapweed by the Pond D discharge channel and possibly perennial pepperweed at the Utility Bench. Thistle above Pond F has apparently been sprayed to kill it.

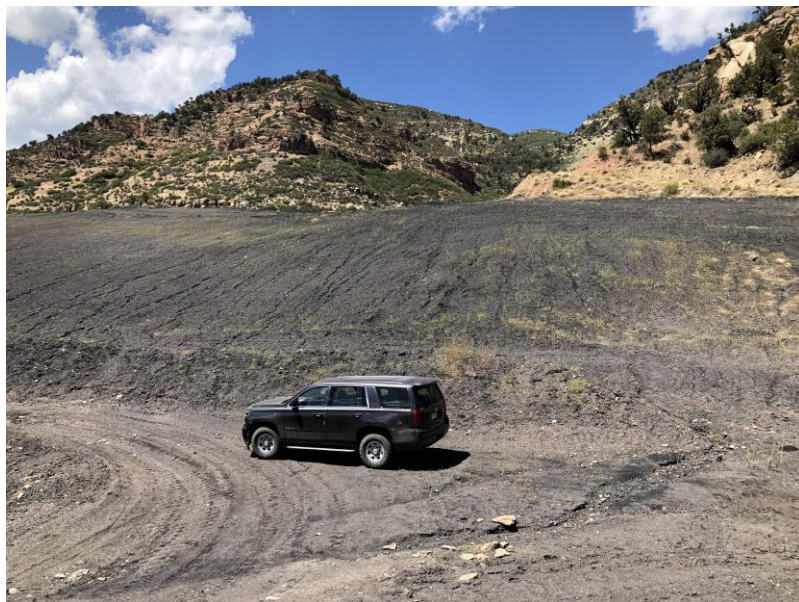
Erosion at Gob Pile #2

There remains some erosion on Gob Pile #2. As noted before, it is recommended that BRL address this erosion, per Rule 4.10.3(3). At the very least, this needs to be watched very closely. If the rills become larger, they should be addressed with erosion control BMPs. The sediment control BMPs below the upper part of Gob Pile #2 appeared to be functioning well. However, the sediment trap is too deep, and it should be kept at a smaller depth, preferably less than six inches, to reduce infiltration into the pile. The Division recommends that an additional row of straw bales or logs be placed in this area to offset the loss of sediment retention from the deeper sediment trap.

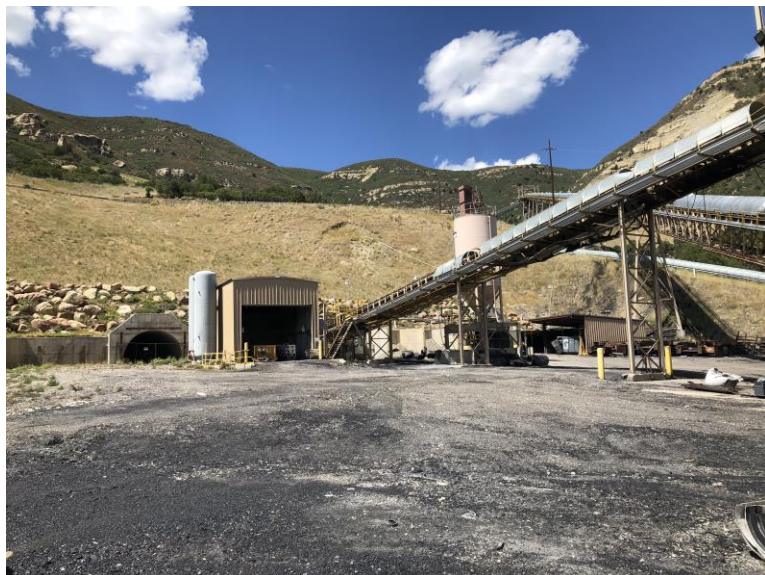
B Portal, looking northwest

It appears that slumps have not moved significantly in the recent past. These include slumps by the B Portal and by Curve Number 11 along the Haul Road.

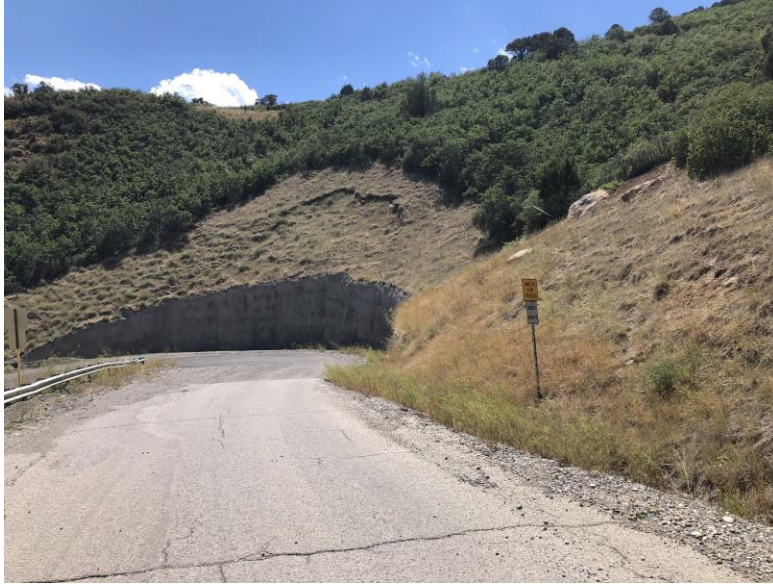
Slump at Curve 11

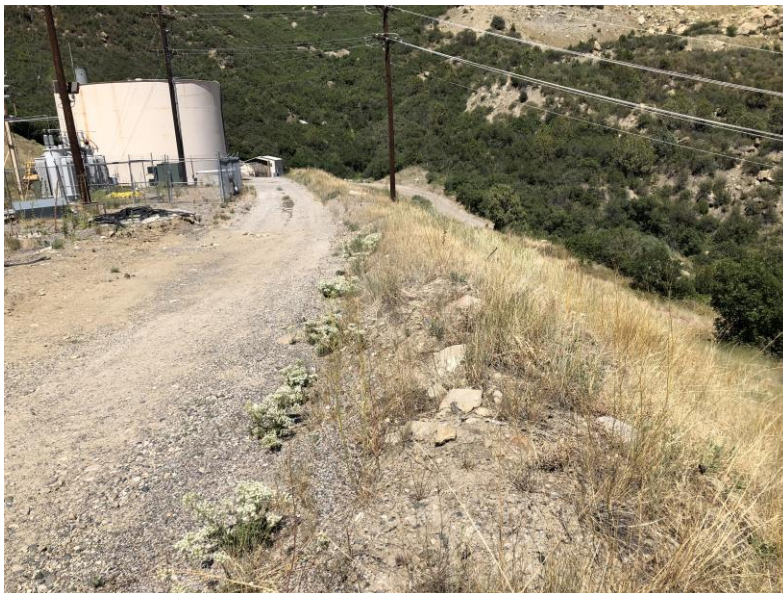
Utility Bench – white flowered plants are likely perennial pepperweed

Also, there are some weeds to spray. We already discussed the knapweed at Pond D, but I do not think that I mentioned the pepperweed at the Utility Bench. I needed to work on the identification.
