**MINERALS PROGRAM INSPECTION REPORT**  
**PHONE: (303) 866-3567**

<b>MINE NAME:</b> Betz Borrow Pit	<b>MINE/PROSPECTING ID#:</b> M-2018-048	<b>MINERAL:</b> Borrow material	<b>COUNTY:</b> Weld
<b>INSPECTION TYPE:</b> Monitoring	<b>INSPECTOR(S):</b> Peter Hays	<b>INSP. DATE:</b> August 5, 2020	<b>INSP. TIME:</b> 13:00
<b>OPERATOR:</b> SEMA Construction, Inc.	<b>OPERATOR REPRESENTATIVE:</b> None	<b>TYPE OF OPERATION:</b> 111 - Construction by Government Agency	
<b>REASON FOR INSPECTION:</b> Normal I&E Program		<b>BOND CALCULATION TYPE:</b> Partial Bond	
<b>DATE OF COMPLAINT:</b> NA		<b>BOND AMOUNT:</b> \$74,925.00	
<b>POST INSP. CONTACTS:</b> None		<b>JOINT INSP. AGENCY:</b> None	
<b>WEATHER:</b> Clear	<b>INSPECTOR'S SIGNATURE:</b>

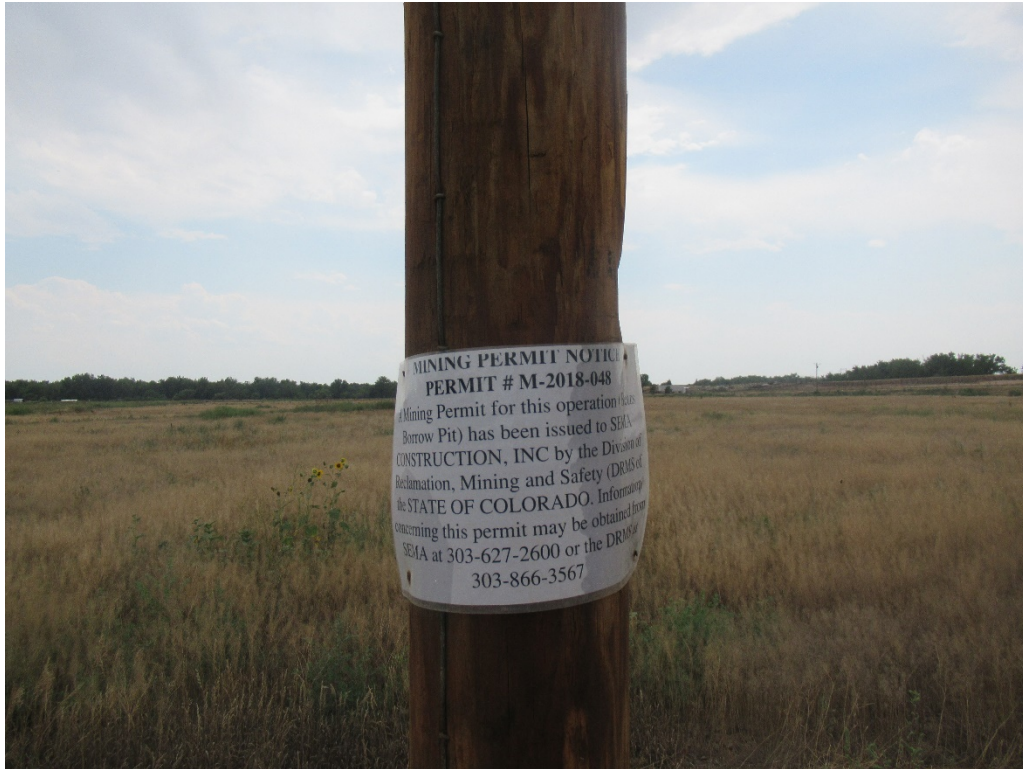
Betz Borrow 111 mine sign

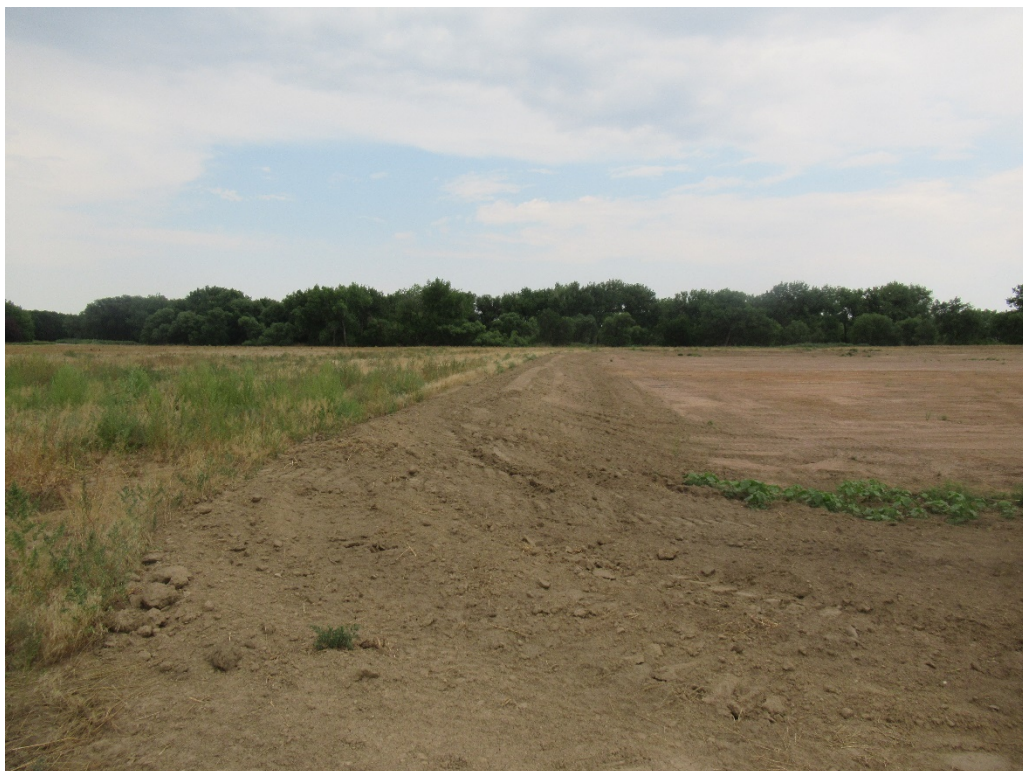
View of the current mining disturbance area from the northwest corner looking east

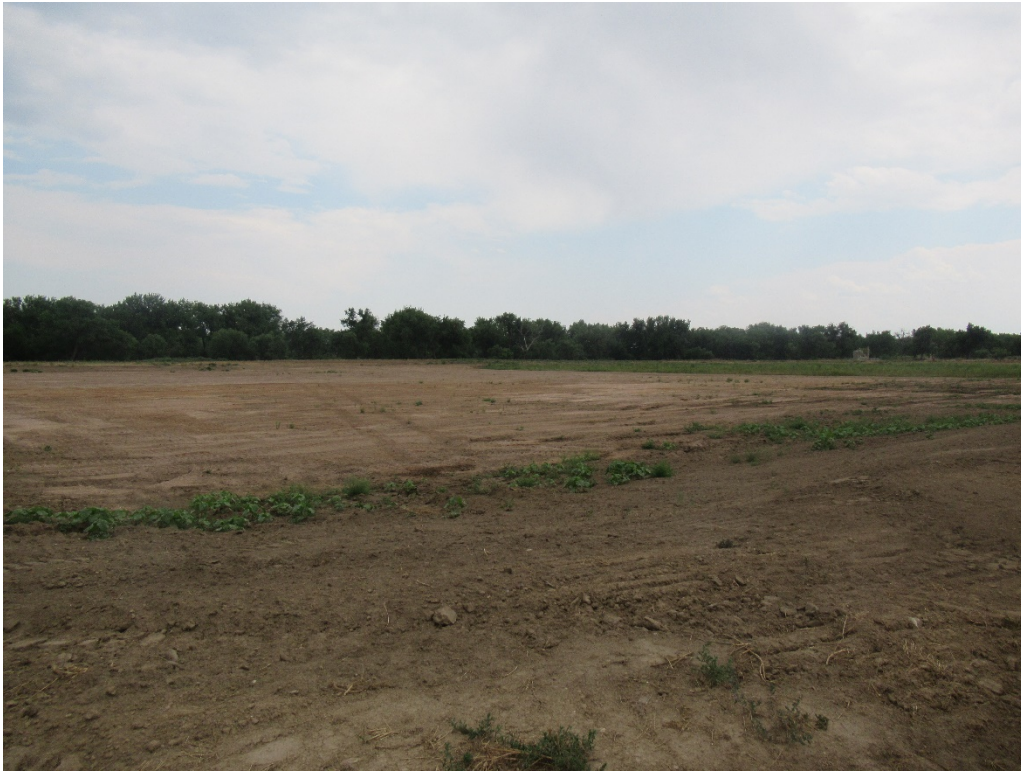
View of the current mining disturbance area from the northwest corner looking southeast

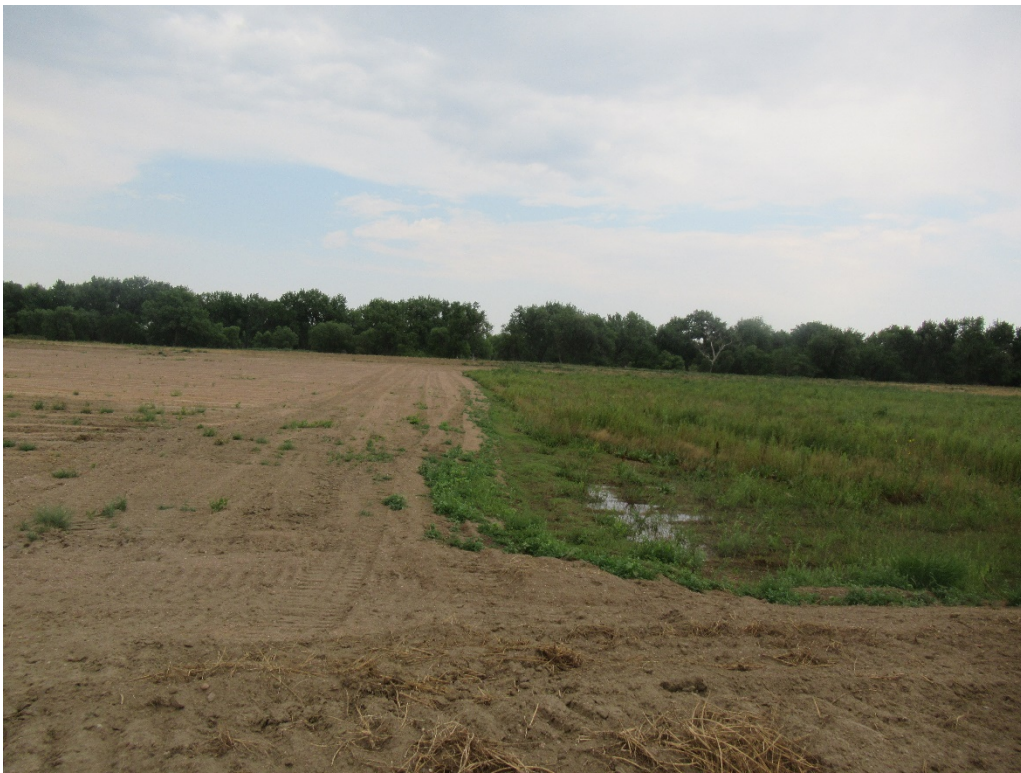
View of the boundary between the current mining area and the topsoiled mining area

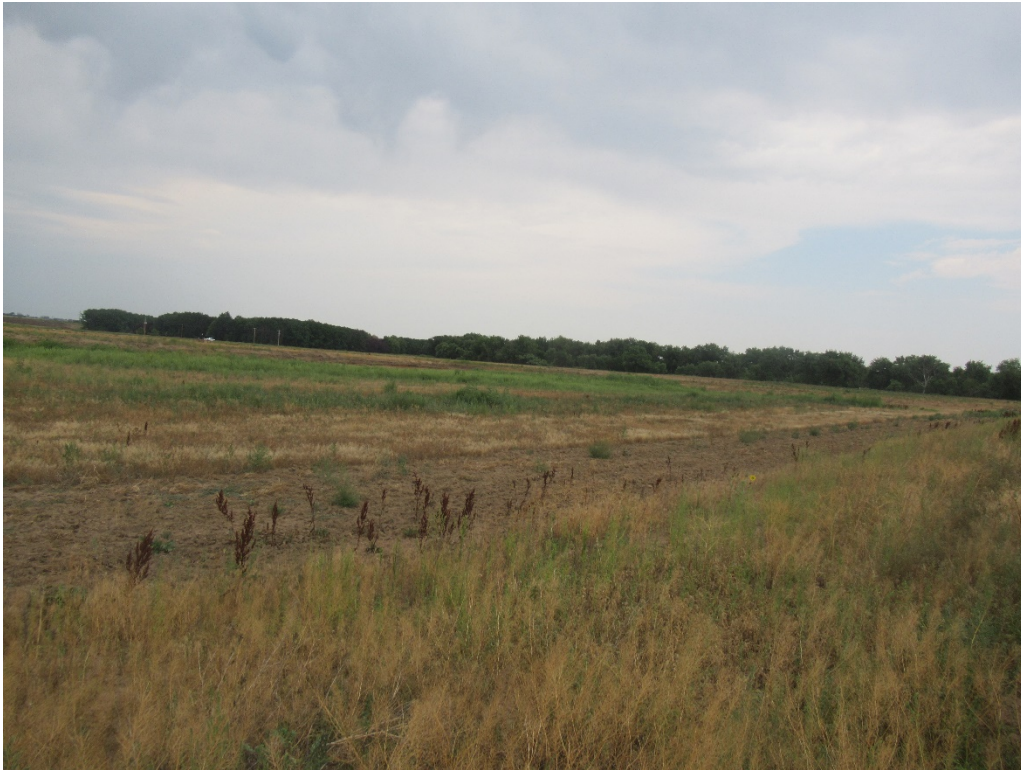
View of the site from the southwest corner looking northeast

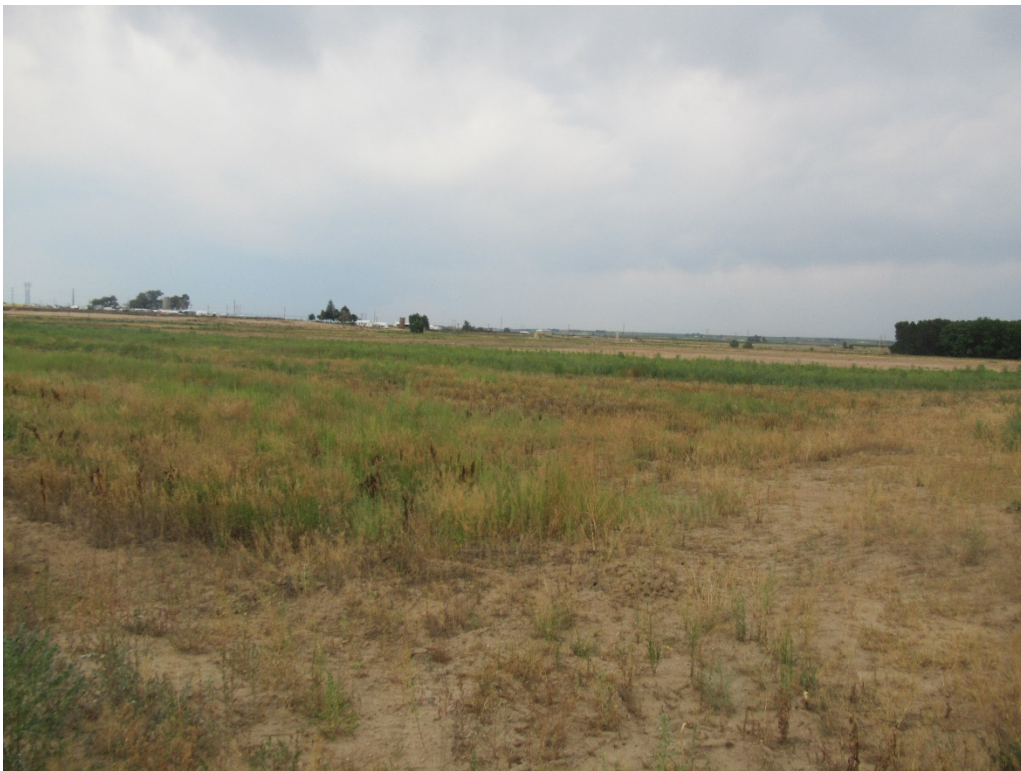
View of the site from the southeast corner looking northwest
