MINERALS PROGRAM INSPECTION REPORT
PHONE: (303) 866-3567

MINE NAME: Iverson Mine	MINE/PROSPECTING ID#: M-2011-001	MINERAL: Borrow material	COUNTY: Weld
INSPECTION TYPE: Monitoring	INSPECTOR(S): Peter Hays	INSP. DATE: August 5, 2020	INSP. TIME: 12:00
OPERATOR: Martin Marietta Materials, Inc.	OPERATOR REPRESENTATIVE: Julie Mikulas	TYPE OF OPERATION: 112c - Construction Regular Operation	
REASON FOR INSPECTION: Normal I&E Program	BOND CALCULATION TYPE: None	BOND AMOUNT: \$275,300.00	
DATE OF COMPLAINT: NA	POST INSP. CONTACTS: None	JOINT INSP. AGENCY: None	
WEATHER: Clear	INSPECTOR'S SIGNATURE:

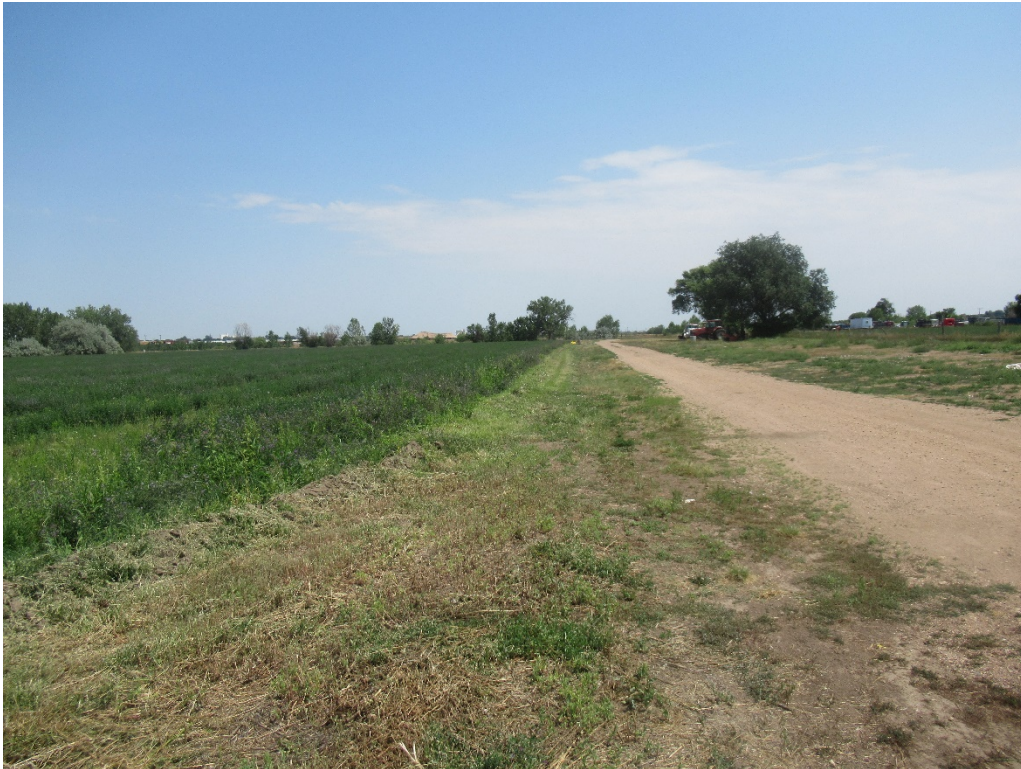
View of the former conveyor corridor from the southwest end looking east

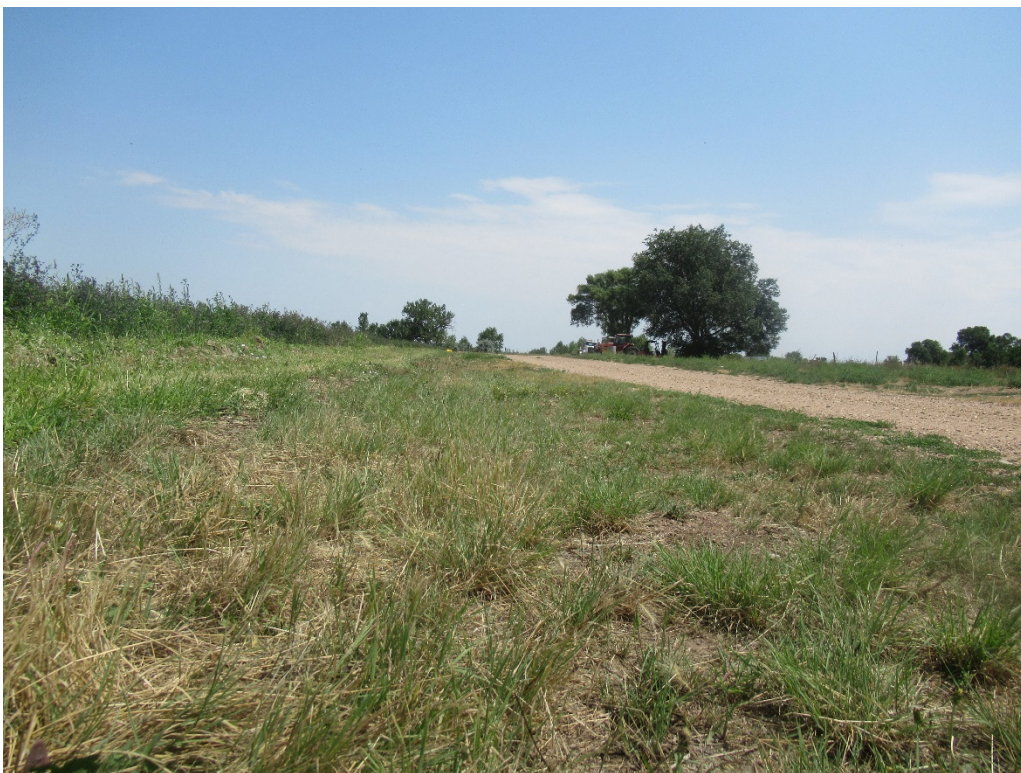
The release area consists of a 30 foot wide corridor along the perimeter of an agricultural field owned by the City of Greeley and under a railroad line owned by Great Western Railway of Colorado, LLC. The conveyor corridor was stable and vegetated with native grasses and annual weeds. The area was recently mowed by the Operator. The conveyor foundations consisted of portable concrete blocks, with no underground foundations. No foundations or equipment were observed during the inspection. The corridor was created by relocating the perimeter irrigation ditch for the field. It is anticipated the City of Greeley will relocate the ditch following the acreage release to allow for additional cropland. The field contained alfalfa at the time of the inspection. The conveyor tunnel under the railroad line was backfilled and reclaimed by the Operator. Great Western Railway installed two additional railroad lines on either side of the railroad line with the tunnel since the tunnel was backfilled preventing observation of the reclaimed tunnel. No comments were received from the landowners during the comment period. **The Division will approve the acreage release request for 1.5 acres based on the observations from this inspection.**

View of typical vegetation in the former conveyor corridor

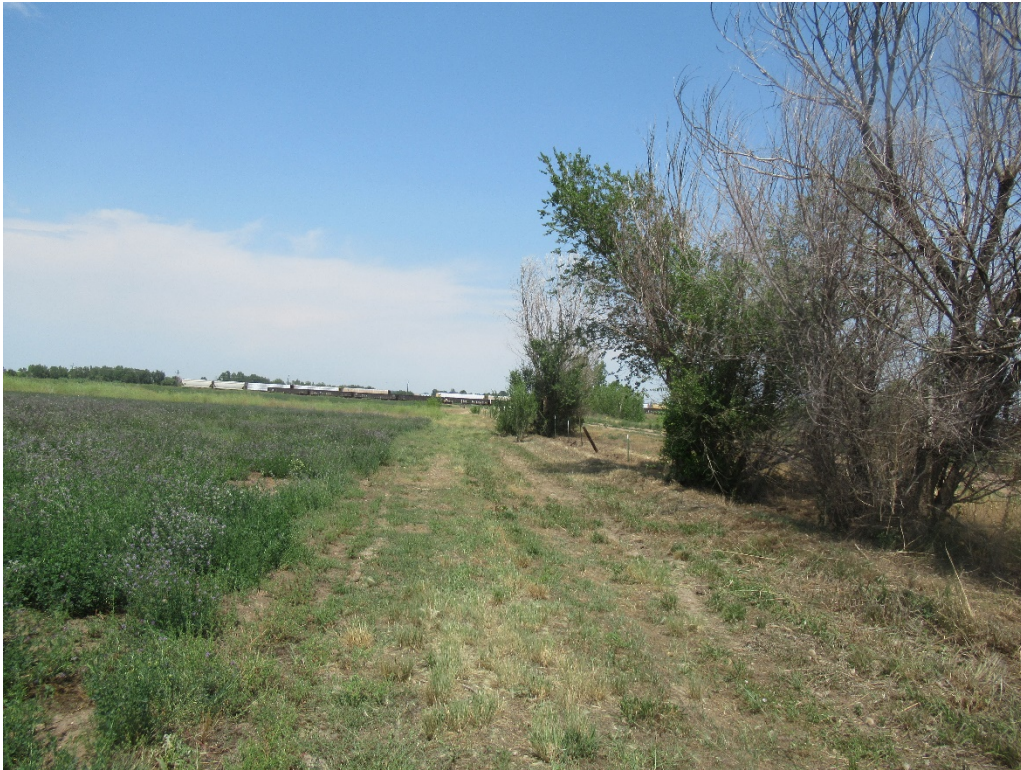
View of the former conveyor corridor from the southeast corner looking north

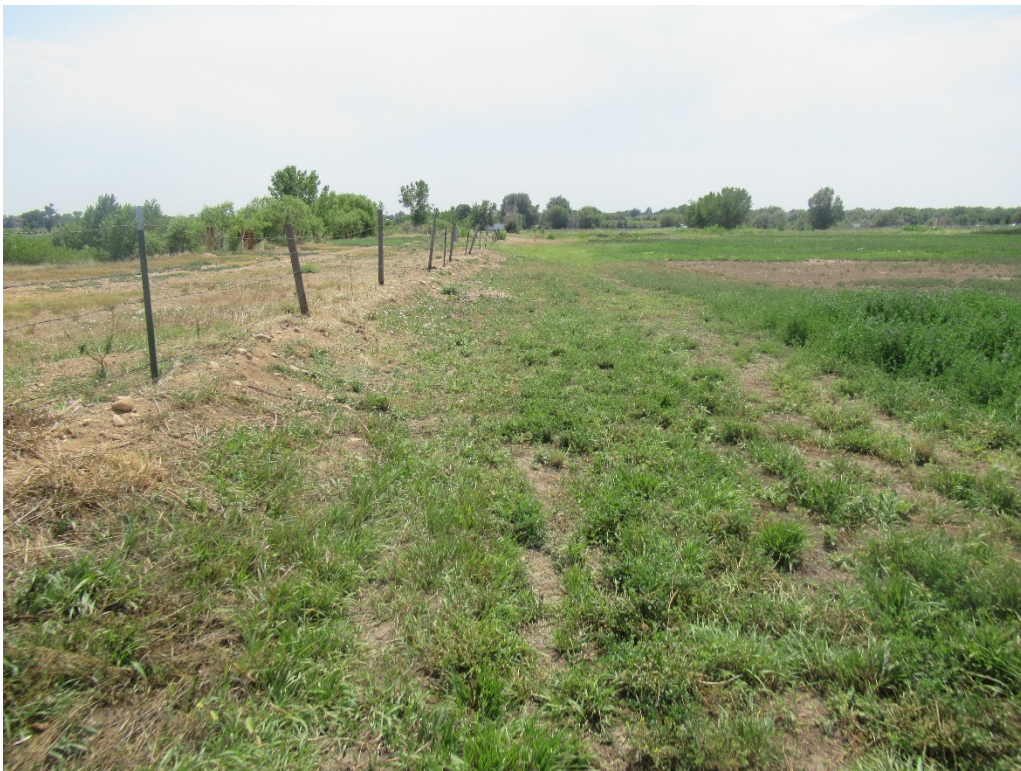
View of the former conveyor corridor from the north end looking south
