Minerals Exploration/Sampling/Testing Inspection U.S. Department of the Interior Bureau of Land Management Royal Gorge Field Office

Operation Type:	□ 3802 Pre-10/21/1976	 ✓ 	3802 Post-10/21/1976 □ 3809 included
Date: Aug 6, 2020 Time: 09:10 Weather: Sunny			Operation Name: Dawson-Green Mtn., El Plomo section Operator: Zephyr Case Number: N/A CDRMS Number: P-2020-002
PIM : S Cartor I Sk	<u>Attendees</u>		<u>General</u>

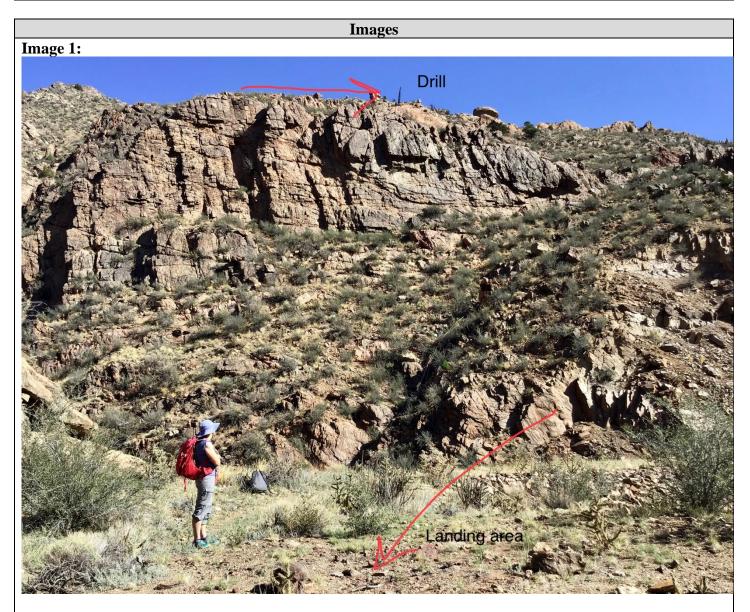
- i. The drilling structure for EP-20-01 was constructed onsite on 8/1/2020. Images 1 and 2.
 - The Deadman anchor and grounding rod for the rig were installed on 8/5/2020.

Comment: Overall EP-20-01 site and landing area

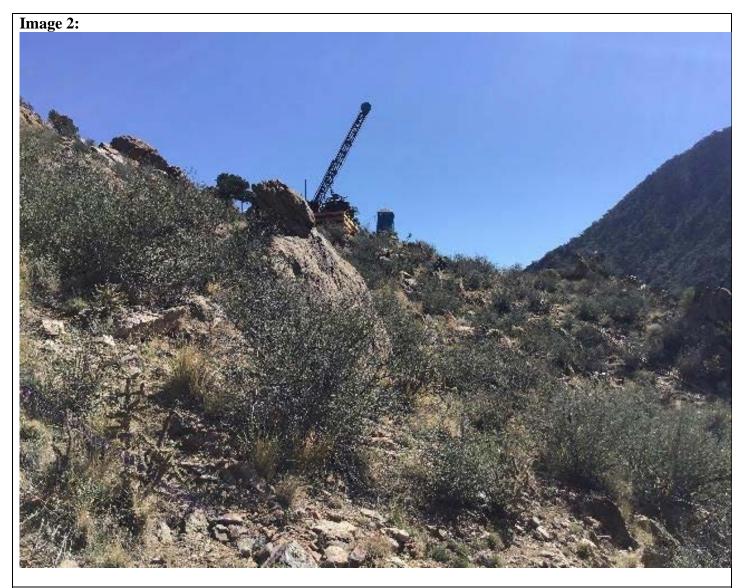
Comment: General overview of EP-20-01 drill site

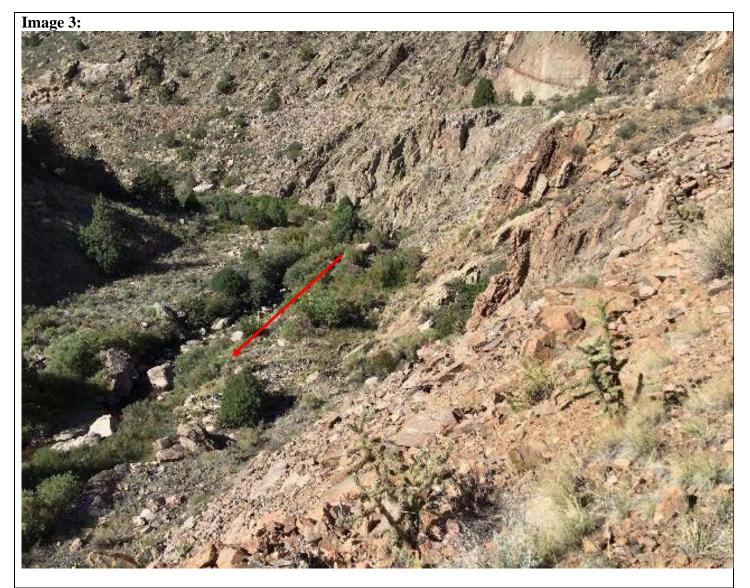
- The drill being used is an Atlas Copco CS-1000.
 - The entire hole is being cored. EP-20-01 started on 8/5/2020, with a total of 10' for that day.
 - The water pump is 8-9 hp (maximum of 10 gpm) in size and runs continually (Image 3).

Comment: Red arrow indicates water pump location along creek

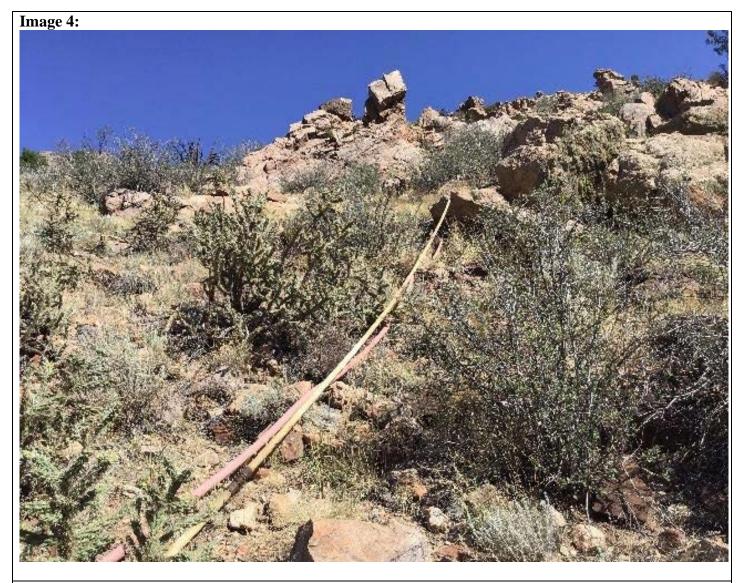
- There are two hoses, each with a diameter of <2", that extend from the water pump to the rig platform. These hoses displayed little movement vertically (none laterally) and were mostly extended across rocky areas and a small drainage. Image 4.

Comment: Water hoses

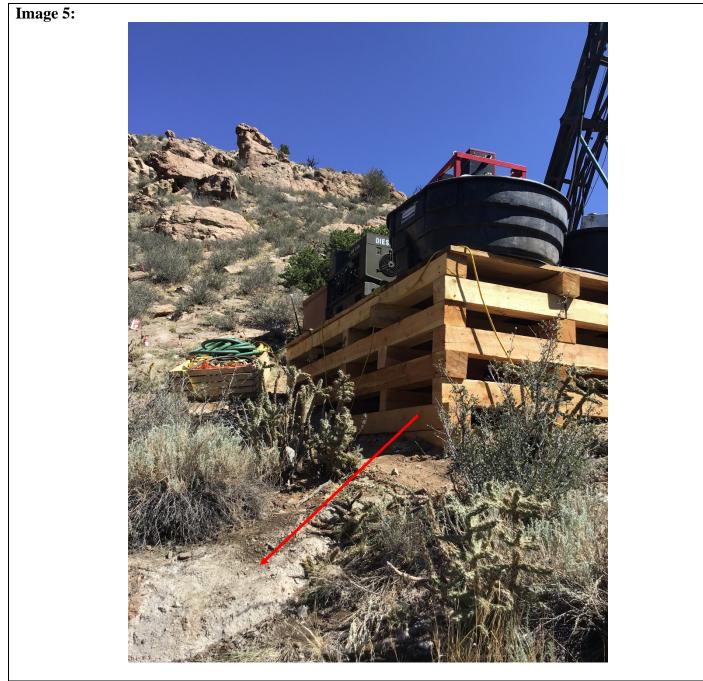
2.b. For the initial use of installing the Deadman anchor and surface casing, some water was expelled over the site of the platform, as the pump system was not yet set up. No erosional features were observed. Image 5.

Comment: Side of drill platform with expelled water from Deadman anchor and surface casing installation

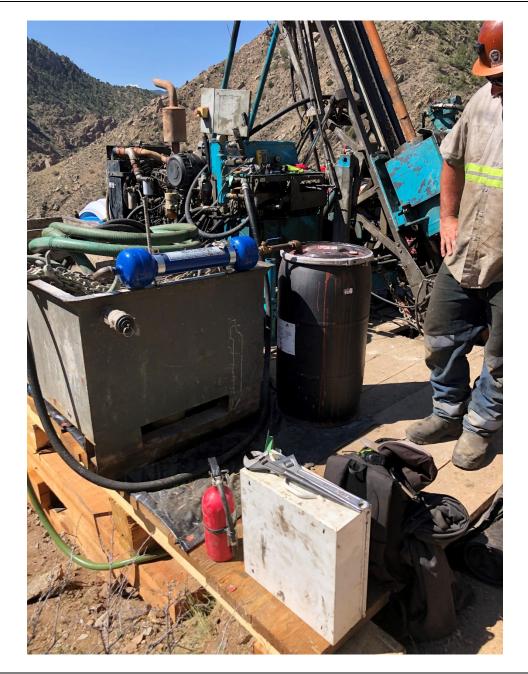
Image 6:

3.a. - The drum containing cuttings (after being filtered through the separator) is currently not labeled accurately, as the drum was used previously for other materials. The separated cuttings are stored in this drum until they are of sufficient quantity to be removed from the site. The drillers will fix the label to accurately reflect the contents. Image 6.

Comment: Separator and drum

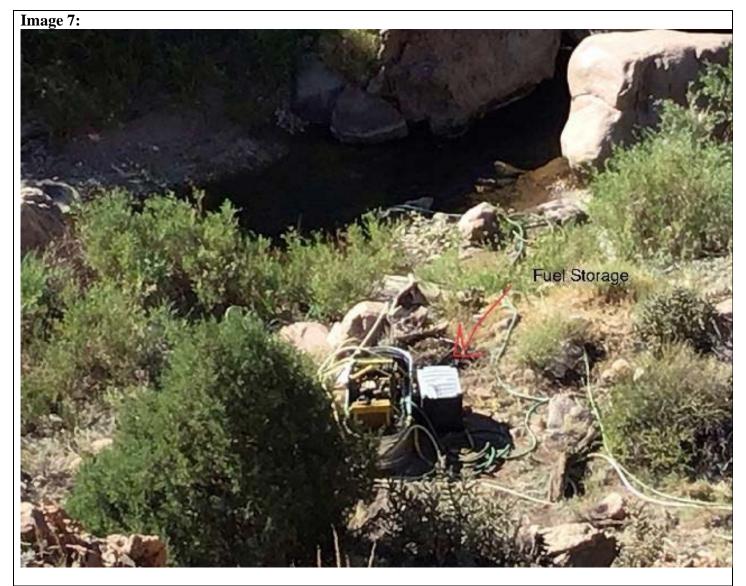
A stock tank is used for secondary containment of the water pump, which is located adjacent to the creek. If an oily-water mix accumulates in the trough, it is pumped and hauled out by helicopter.
Diesel fuel for the water pump is sourced from a 50-gallon, lined container adjacent to the pump (Image 7). All diesel fuel is flown in to refuel the pump.

Comment: Close-up of water pump along creek with fuel storage indicated by red arrow

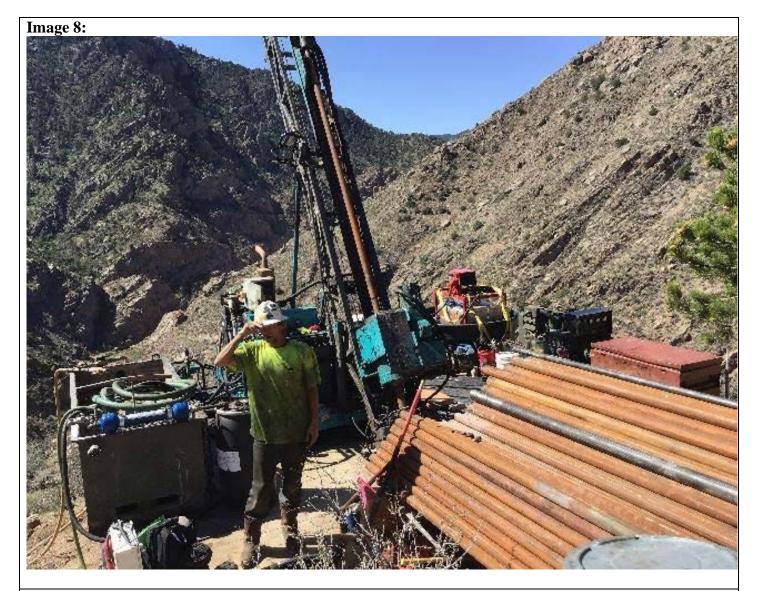
Comment: Rig platform area and pipe

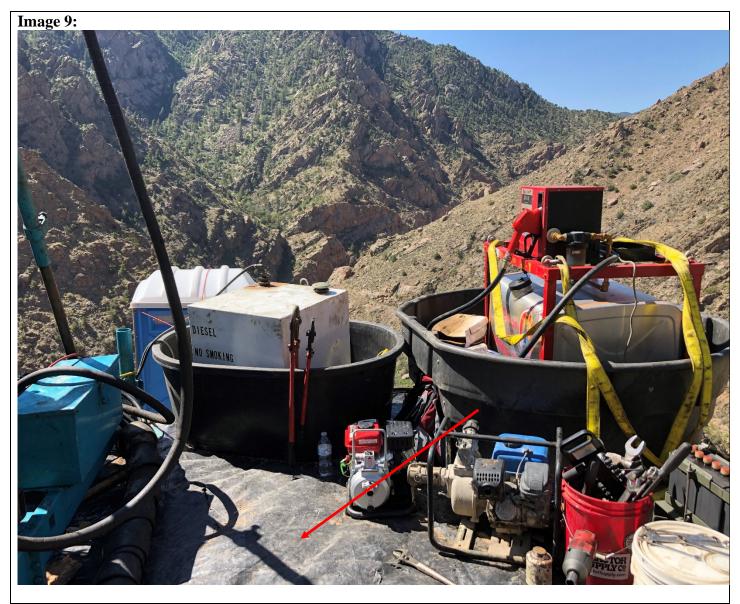
- Secondary containment/tubs used for equipment on platform (Image 9).

- Visqueen lines the top of the wooden platform, as a barrier from the working site to native ground below (Image 9).

Comment: Rig platform, red arrow indicates Visqueen barrier

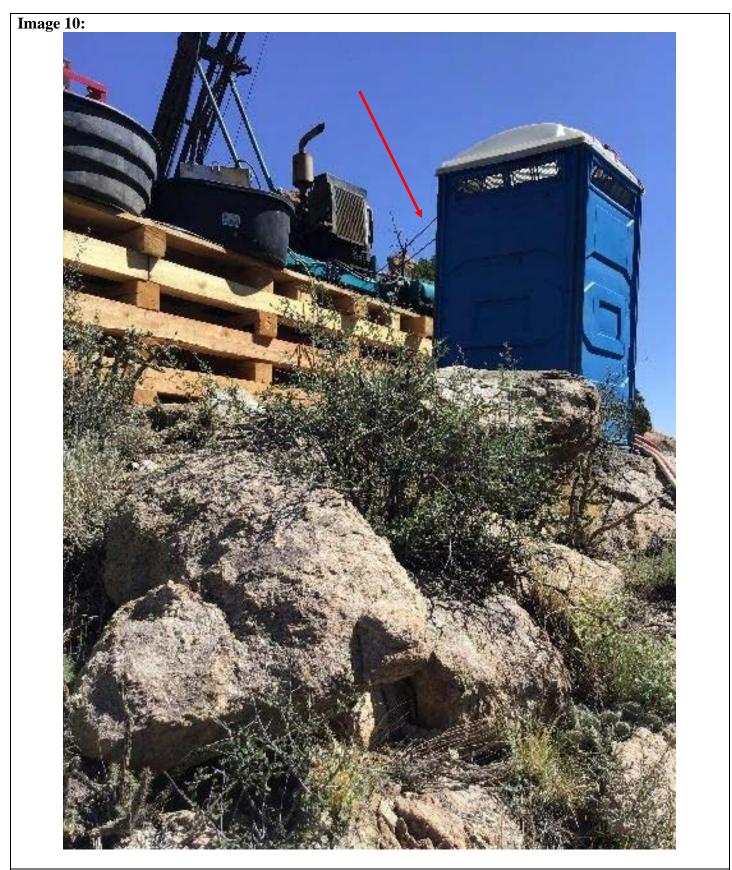
3.d. The porta potty is contained. Routine servicing is conducted by helicopter. The tank is removed and replaced with an empty one, as needed. No staining or discharge observed. Porta potty is tethered to the platform and appeared stable. Image 10.

Comment: Porta Potty and ground below, red arrow indicates tethers attached to the platform

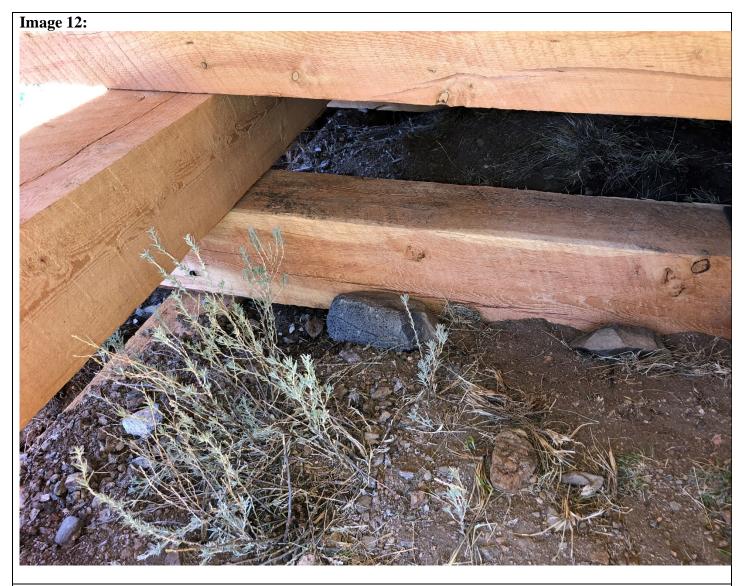
- The drilling platform was not solid on the bottom, which allows for vegetation to remain within the footprint of the drilling area (Image 12).
- Noise from the water pump is limited, due to the location and placement of it along the creek exhibiting steep canyon walls on both sides. A snapshot of the area along the trail where the pump could be heard is shown below in Images 15 and 16.

```
Comment: Vegetation visible underneath platform
```

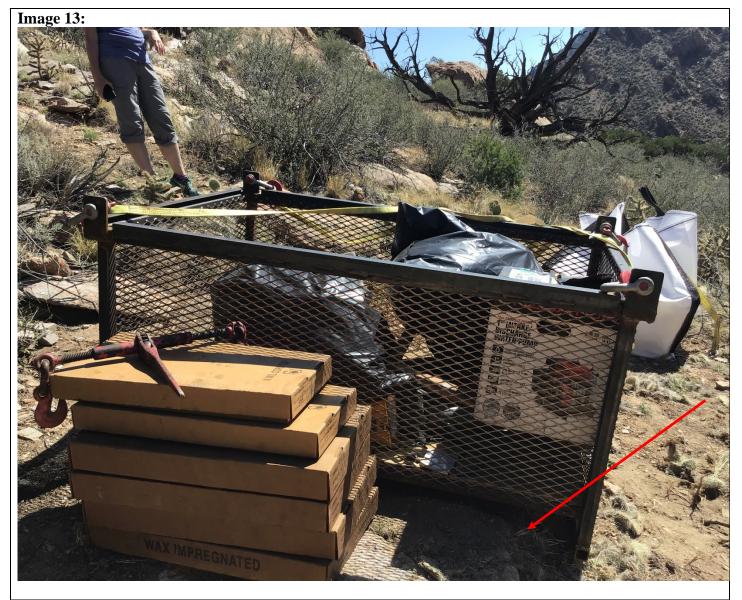
Comment: Storage area adjacent to rig, red arrow indicates storage box has space underneath

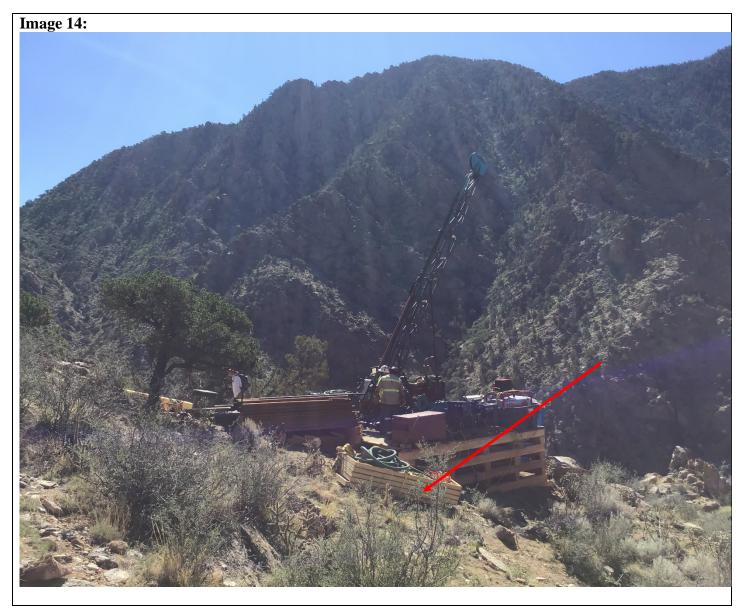
Comment: Additional storage area adjacent to rig, red arrow indicates storage box sitting flush on the ground
