MINERALS PROGRAM INSPECTION REPORT
PHONE: (303) 866-3567

MINE NAME: Stone Gravel Pit	MINE/PROSPECTING ID#: M-1997-089	MINERAL: Sand and gravel	COUNTY: Montezuma
INSPECTION TYPE: Surety Release Inspection	INSPECTOR(S): Dustin Czaplá	INSP. DATE: August 14, 2020	INSP. TIME: 12:30
OPERATOR: Daren Stone	OPERATOR REPRESENTATIVE:	TYPE OF OPERATION: 112c - Construction Regular Operation	
REASON FOR INSPECTION: Surety Release Requested	BOND CALCULATION TYPE: None	BOND AMOUNT: \$17,232.00	
DATE OF COMPLAINT: NA	POST INSP. CONTACTS: None	JOINT INSP. AGENCY: None	
WEATHER: Clear	INSPECTOR'S SIGNATURE:

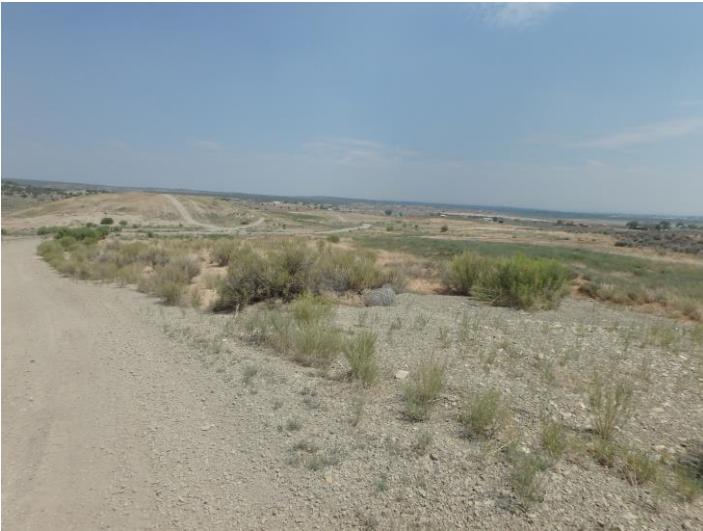
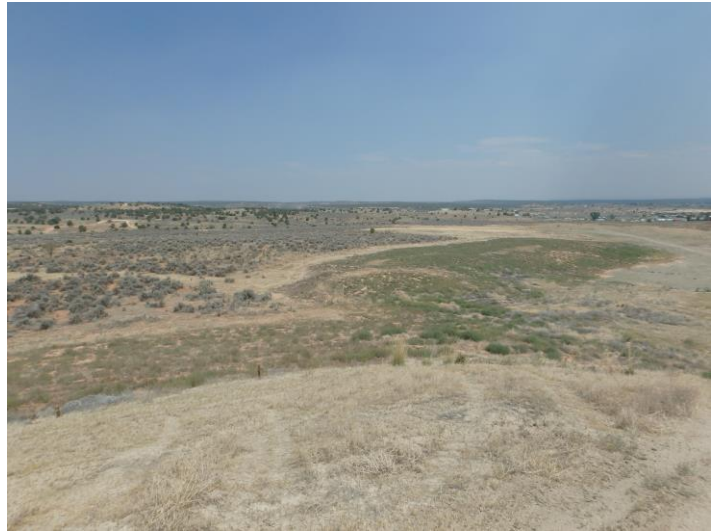
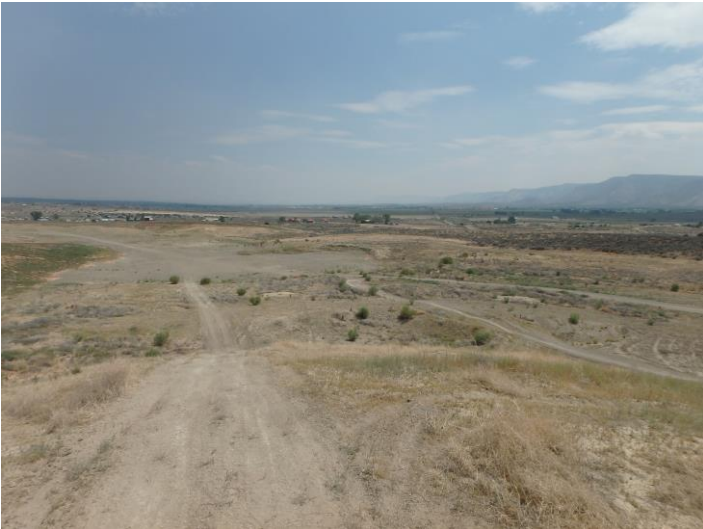
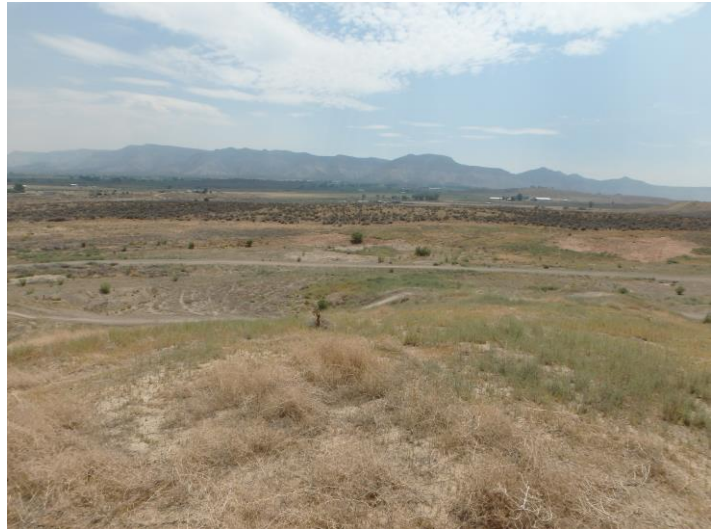
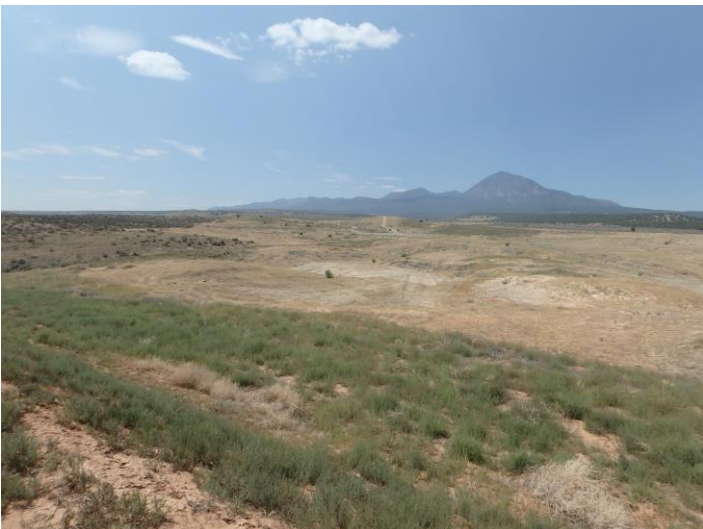
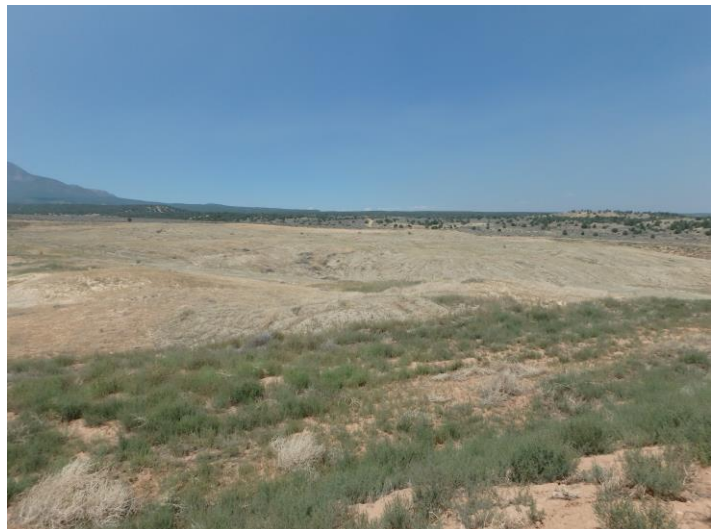
The site has been regraded and blends well with the surrounding area. No significant erosional or stability issues were noted. Vegetation is becoming well established and cover is equal in extent to that of the natural vegetation of the surrounding area. No noxious weed infestations were noted.
