August 19, 2020

**Re: Permit No. M-1980-244; Cripple Creek & Victor Gold Mining Company; Cresson Project; –  
June 2020 Inspection Corrective Action Response**

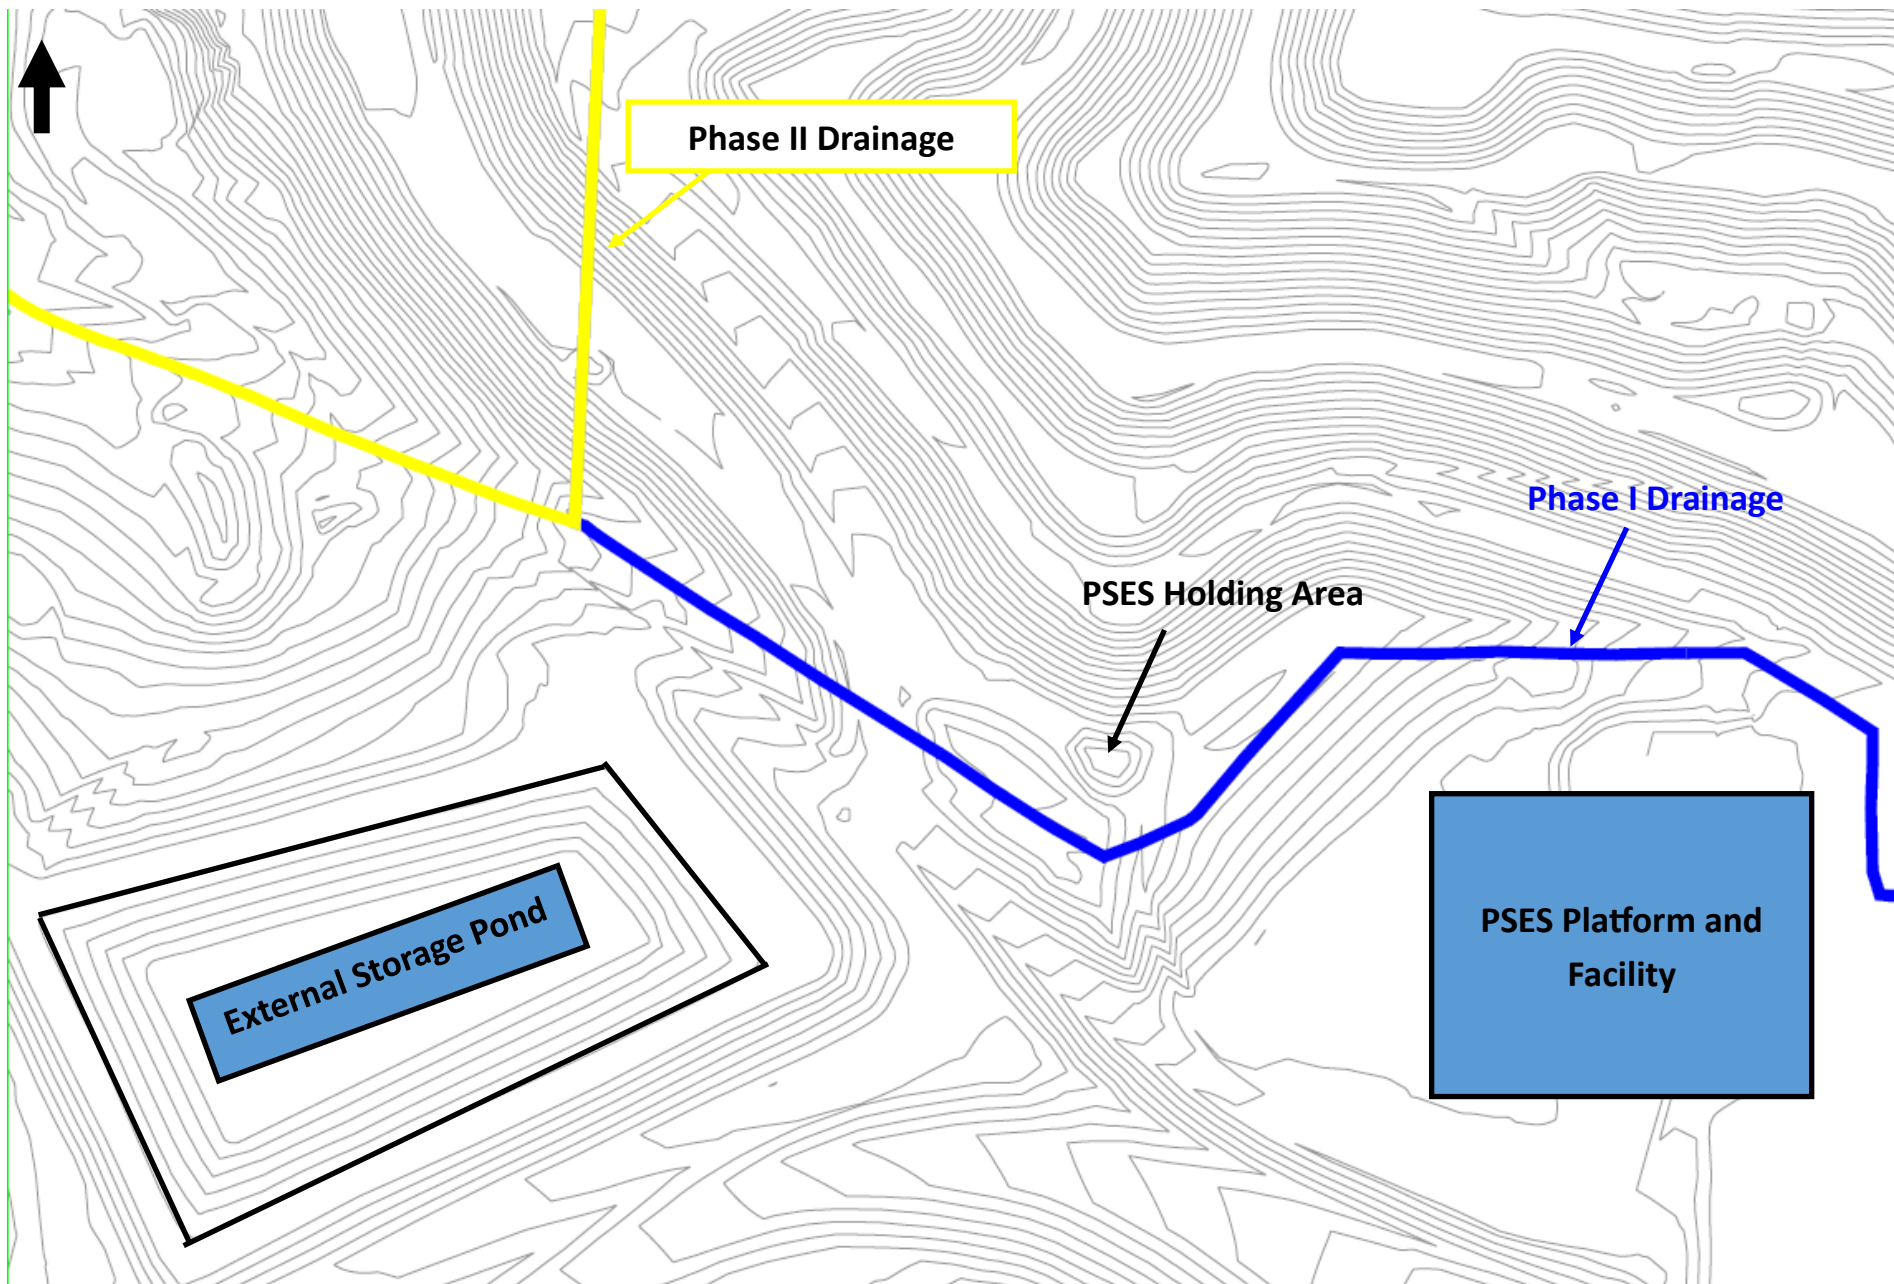
## **ATTACHMENT 1**

2. *Problem: A demonstration must to be submitted to the Division showing that the impacted water observed in the holding pond west of the PSES will be contained within the lined primary containment system area in the event that the pond capacity is exceeded.*

**The holding area located west of the PSES is intended as an auxiliary storage area and drainage control feature within the lined VLF facility. Facility liner and grading for the PSES, including**

the holding area, was submitted and approved in TR-64 (December 16, 2011). As demonstrated in Drawing A110 in that submission and shown in Attachment 1, drainage flows from 'upstream' locations to the holding area, where it is then re-directed into the interior VLF1 primary containment system (liner). The holding area is constructed within the VLF leach ore material, and is composed of homogenous crushed material with high permeability and high rates of infiltration. In the unlikely event that the holding area overtopped the existing berm on the southwest edge, solution would flow along the established drainage pathway into HDPE piping which directs solution to VLF1 Phase II liner area.

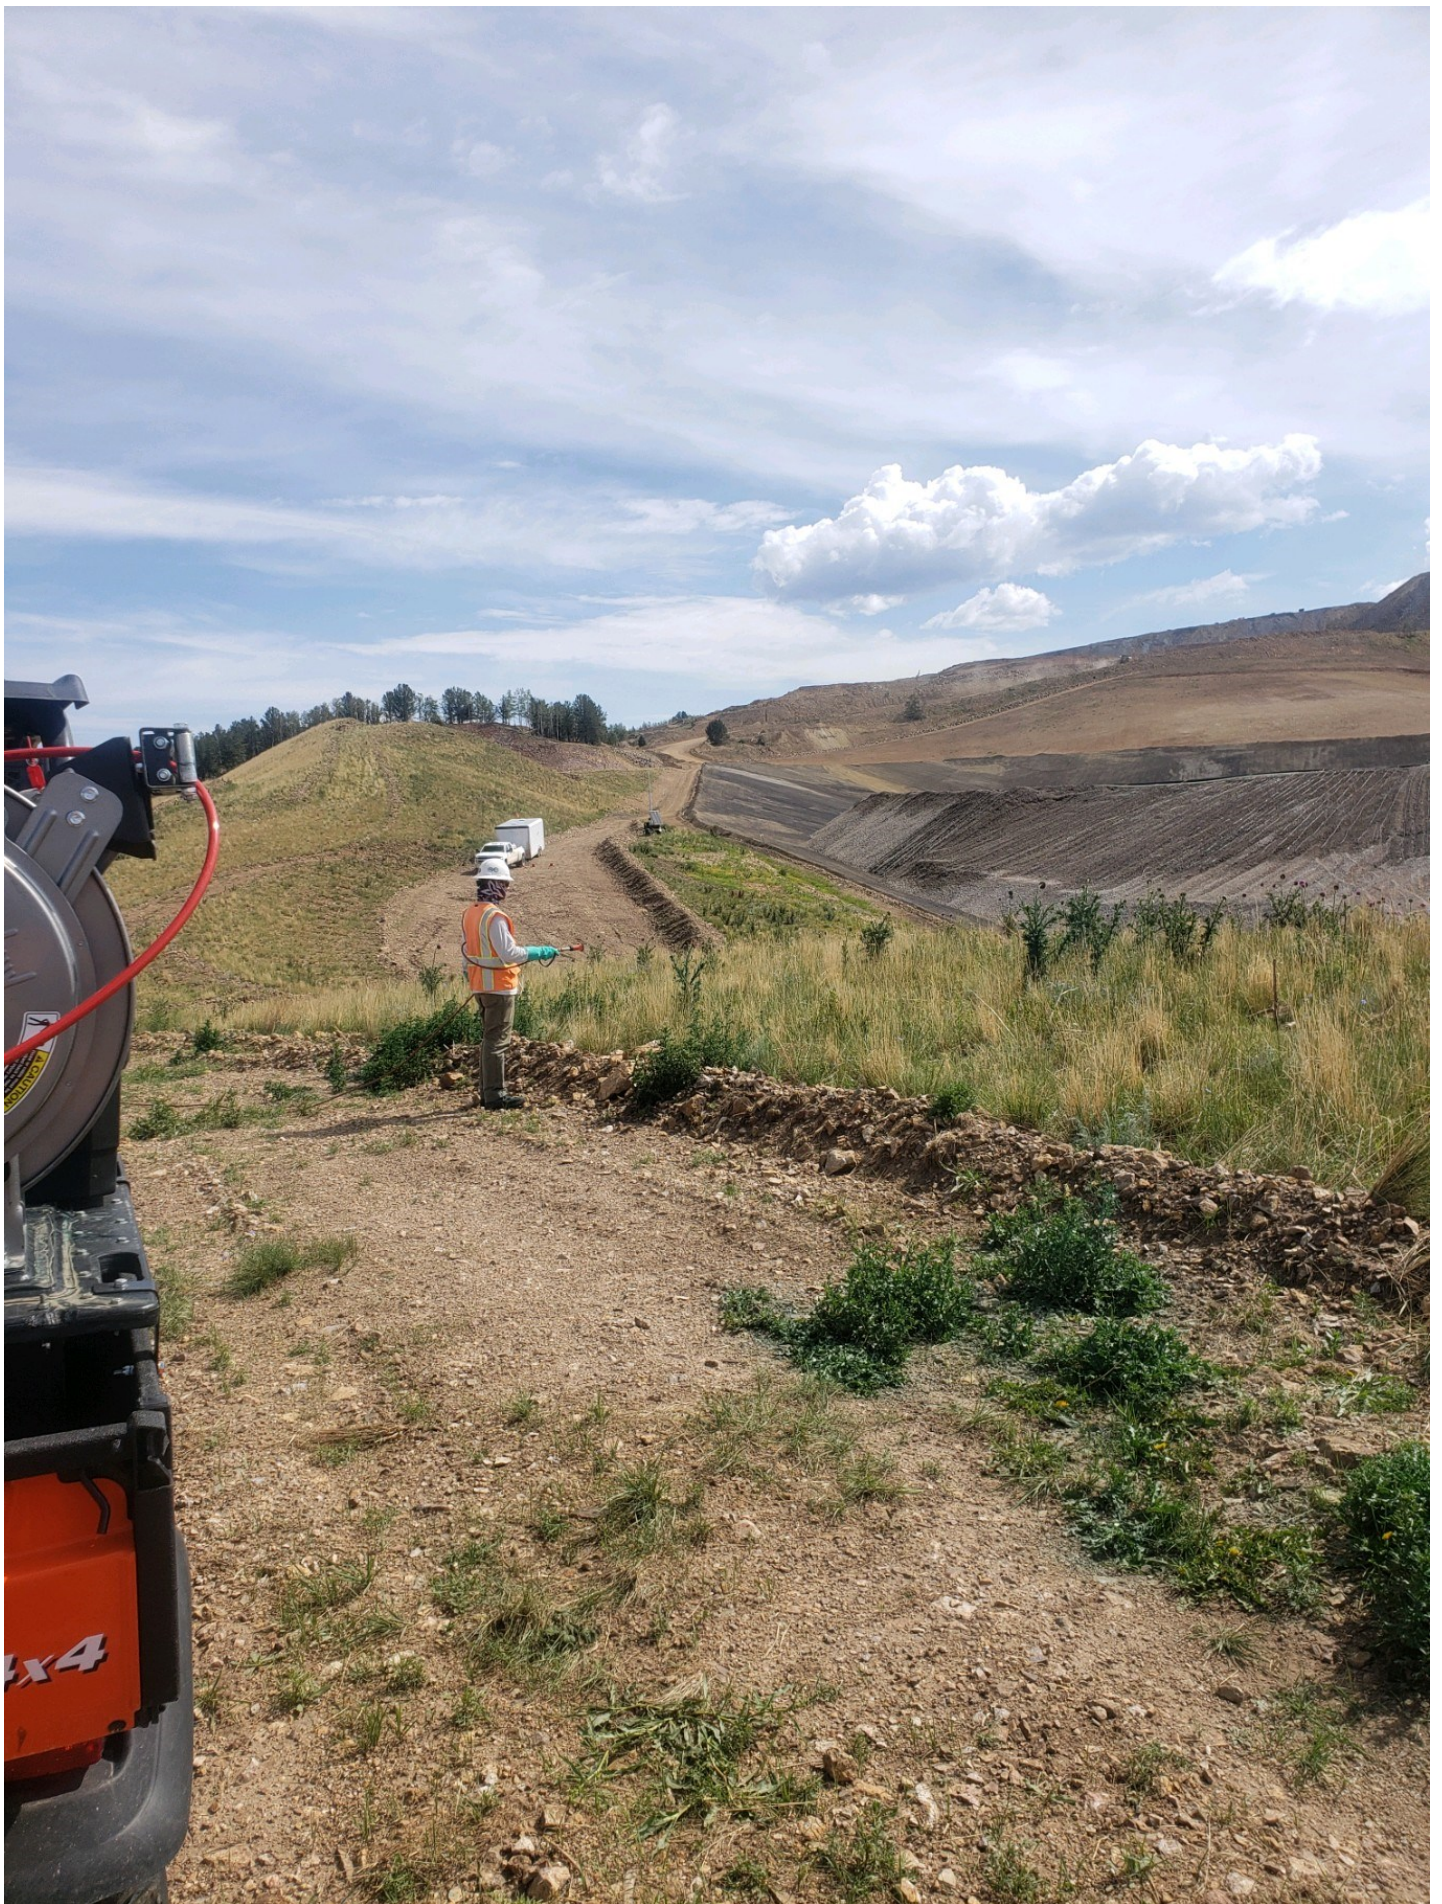
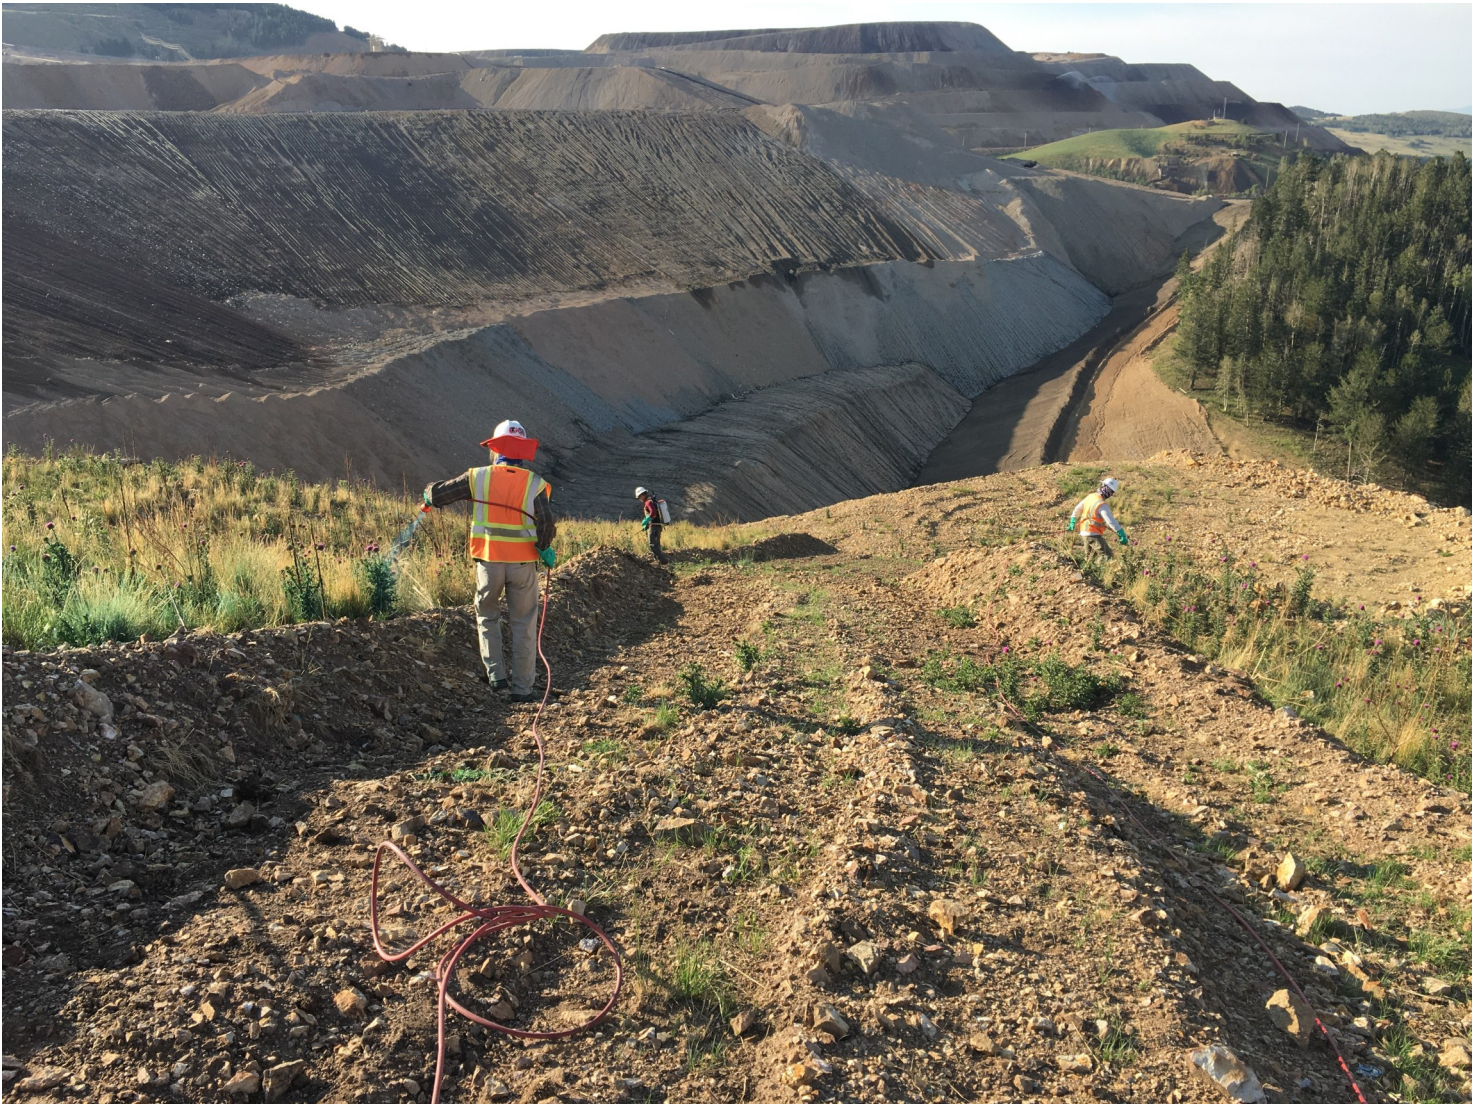
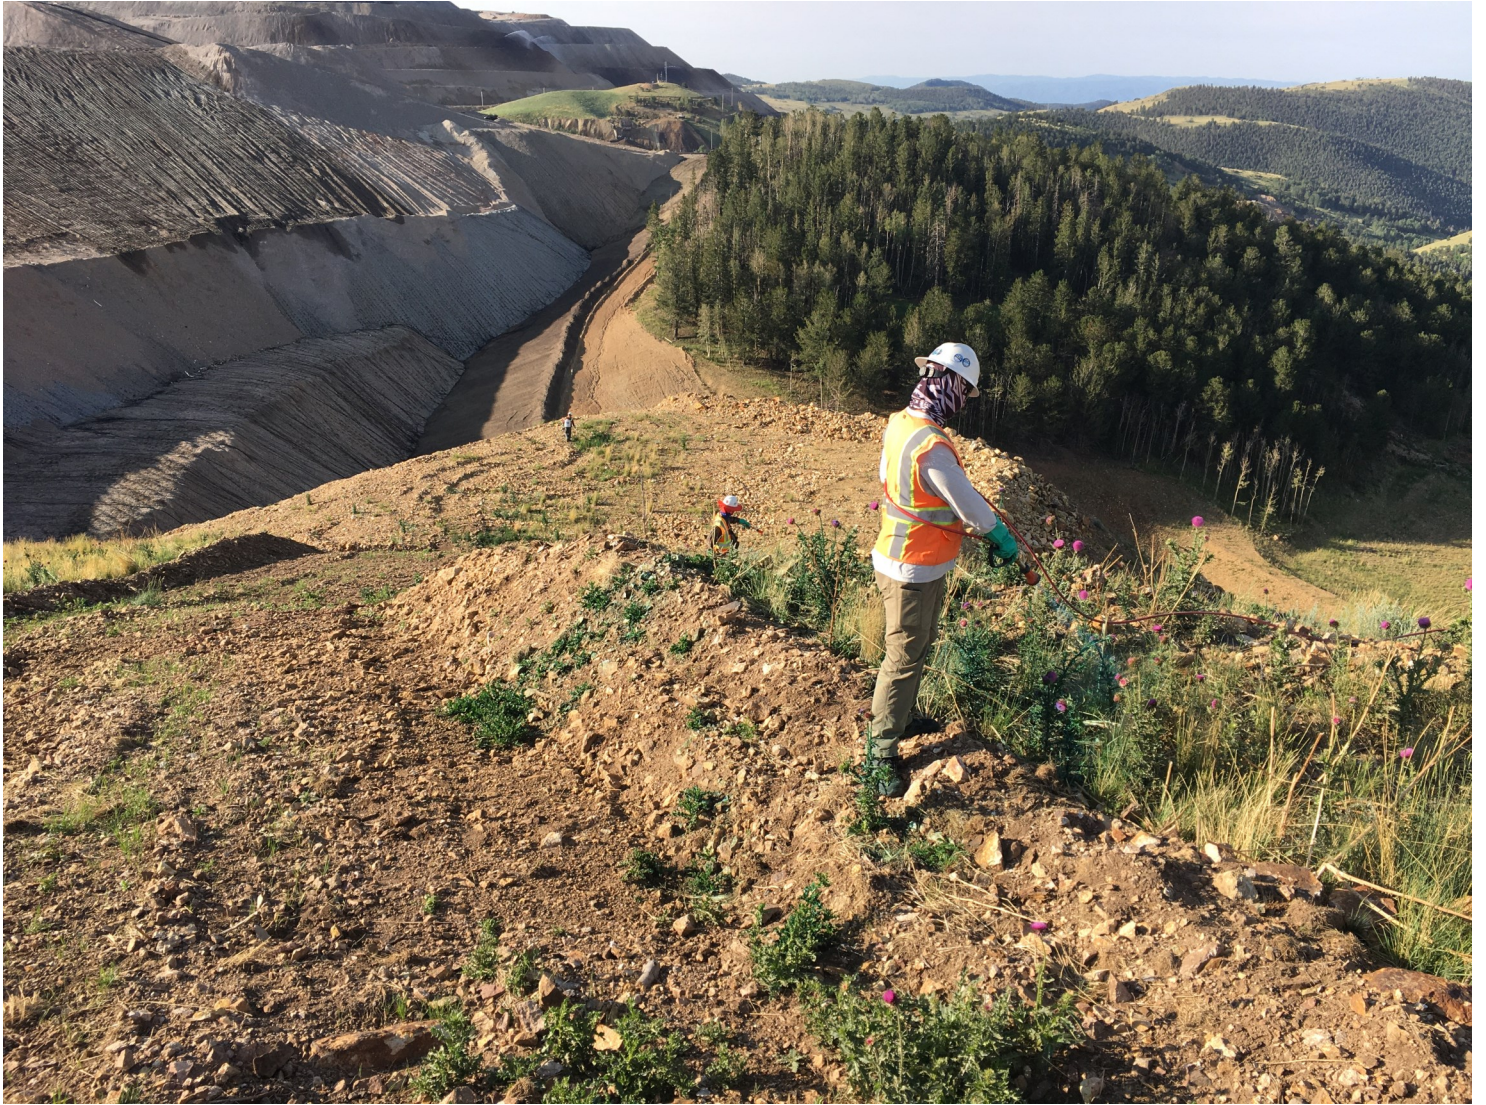
## **ATTACHMENT 2**

The Division also noted a population of musk thistle located on GM-34. The population was treated via chemical management conducted by a third-party contractor, applied on July 16<sup>th</sup>. Photos and the contractor's daily report of spraying activities are documented in Attachment 2.

**Application Notes:** Treated topsoil stock pile except for excluded area because of safety hazards
