**MINERALS PROGRAM INSPECTION REPORT**  
**PHONE: (303) 866-3567**

<b>MINE NAME:</b> Iverson Mine	<b>MINE/PROSPECTING ID#:</b> M-2011-001	<b>MINERAL:</b> Borrow material	<b>COUNTY:</b> Weld
<b>INSPECTION TYPE:</b> Monitoring	<b>INSPECTOR(S):</b> Peter Hays	<b>INSP. DATE:</b> August 5, 2020	<b>INSP. TIME:</b> 13:00
<b>OPERATOR:</b> Martin Marietta Materials, Inc.	<b>OPERATOR REPRESENTATIVE:</b> Julie Mikulas	<b>TYPE OF OPERATION:</b> 112c - Construction Regular Operation	
<b>REASON FOR INSPECTION:</b> Normal I&E Program		<b>BOND CALCULATION TYPE:</b> Partial Bond	
<b>DATE OF COMPLAINT:</b> NA		<b>BOND AMOUNT:</b> \$275,300.00	
<b>WEATHER:</b> Clear		<b>POST INSP. CONTACTS:</b> None	
<b>INSPECTOR'S SIGNATURE:</b>

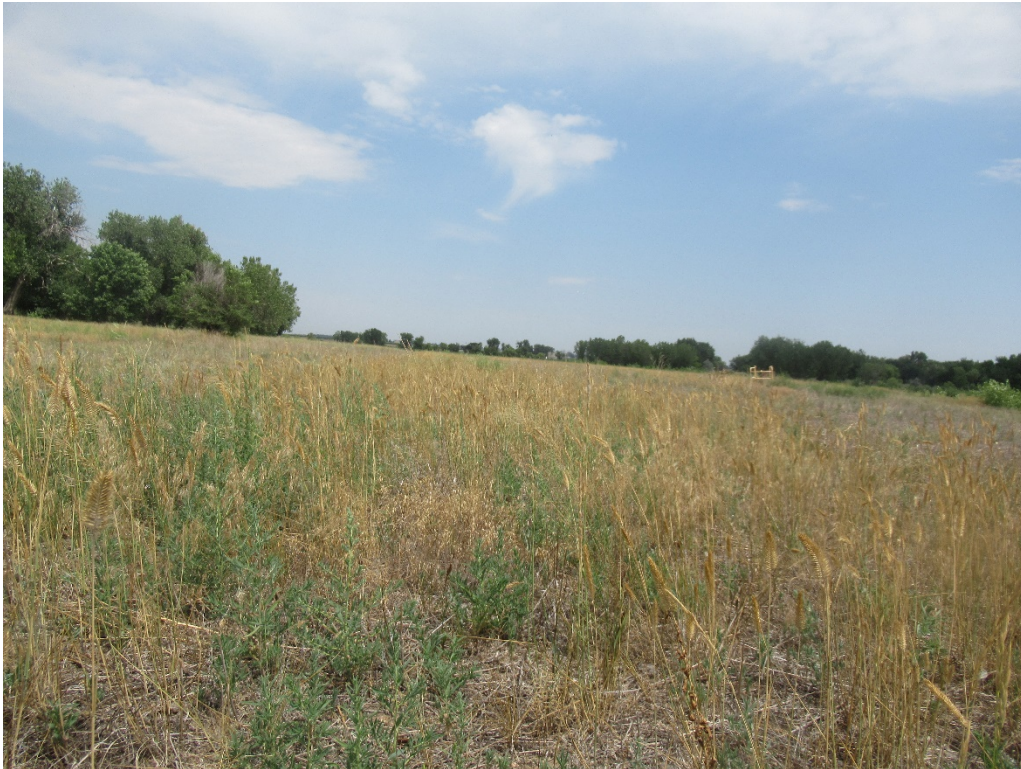
View of vegetation in the southwest corner of the site

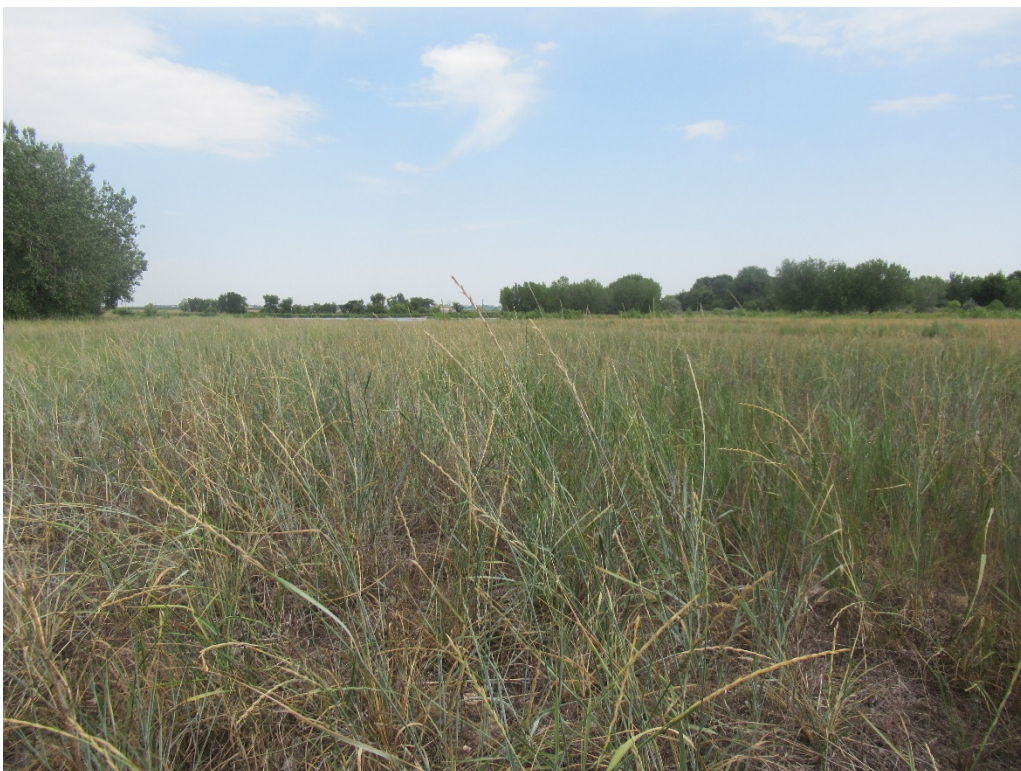
View of vegetation in the western upland area

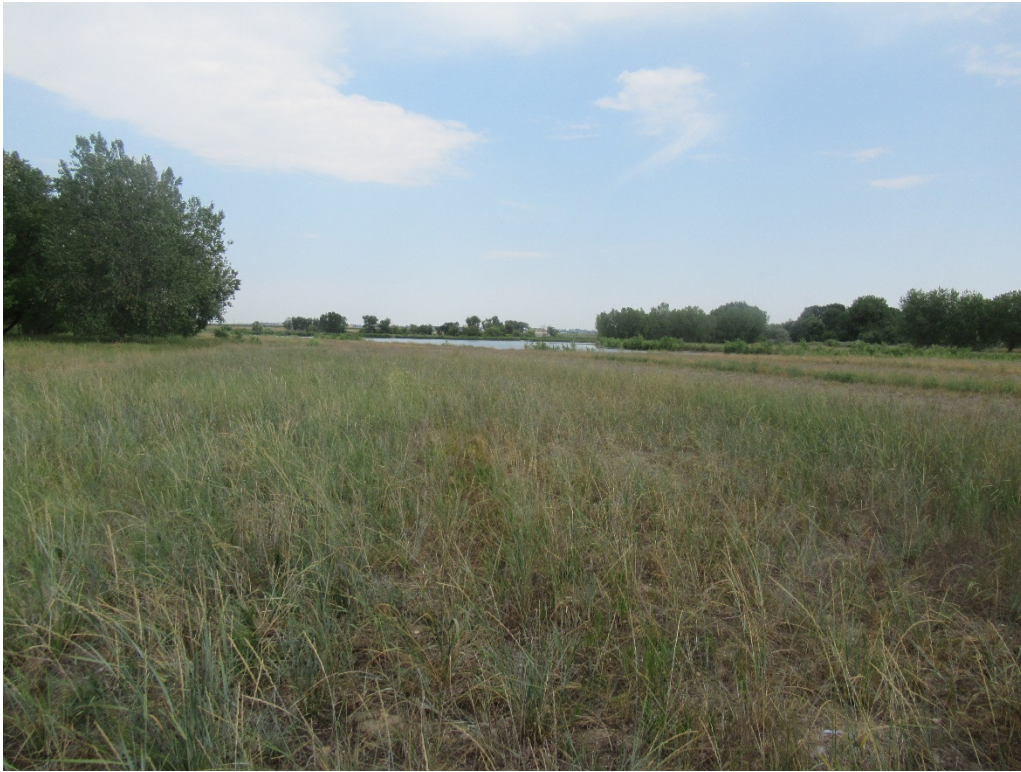
View of vegetation in the western upland area

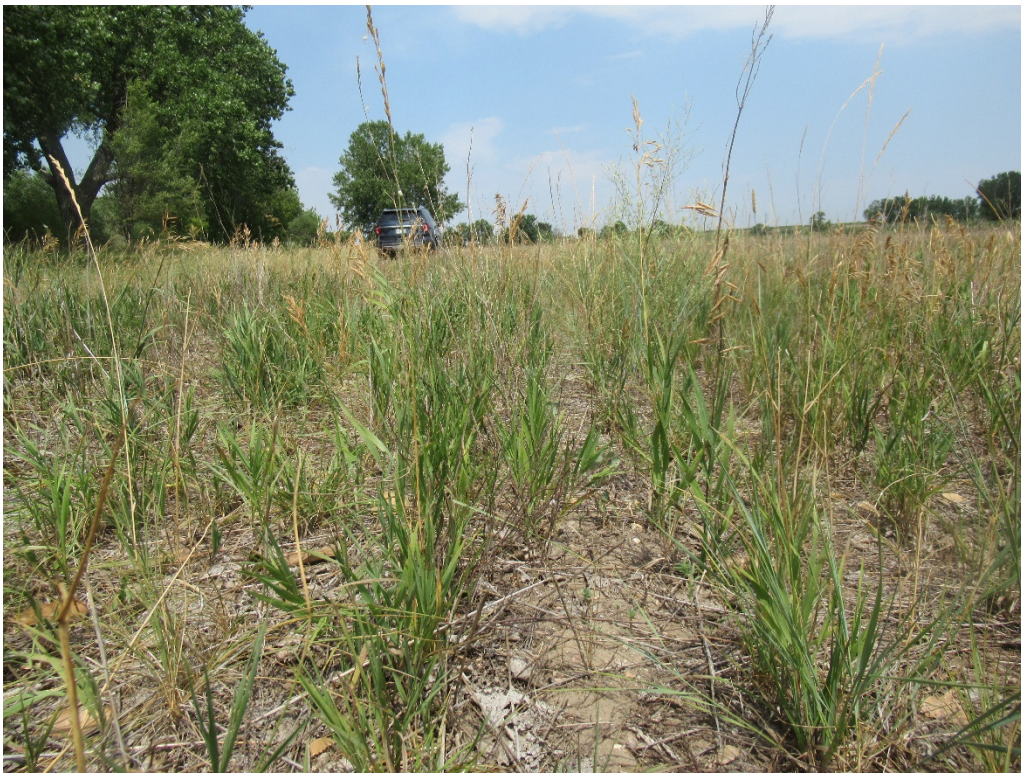
View of vegetation in the northwest corner of the site

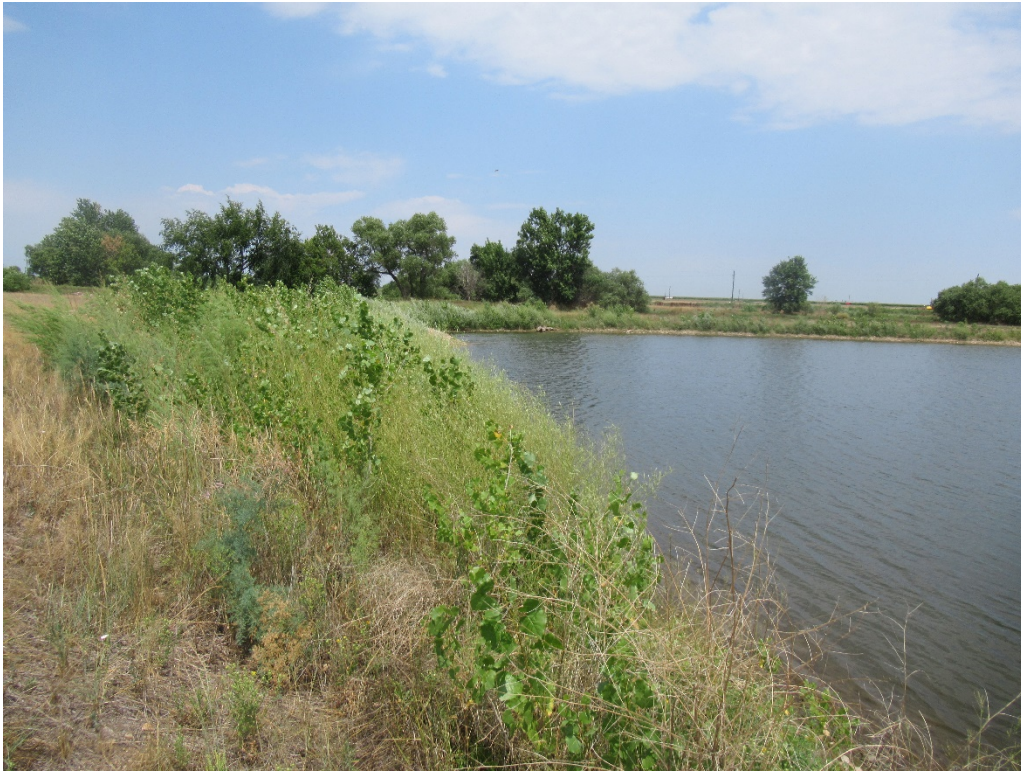
The upland vegetation consisted of western wheatgrass, intermediate wheatgrass, crested wheatgrass, mountain brome and switchgrass. The vegetation was very dry, however the vegetation was mature with developed seed heads and appeared well-established. Annual weeds including, kochia and yellow sweet clover were observed in small patches in the release area. A few areas of space vegetation were observed in the upland areas around the lake. The shoreline vegetation consisted of volunteered cottonwood and willows. The shoreline was stable with no erosion features observed during the inspection. The landowner is creating a road along the shoreline by driving around the lake. The creation of the road is preventing the reclamation grasses from becoming well-established around the shoreline of the upland area.

View of typical shoreline vegetation

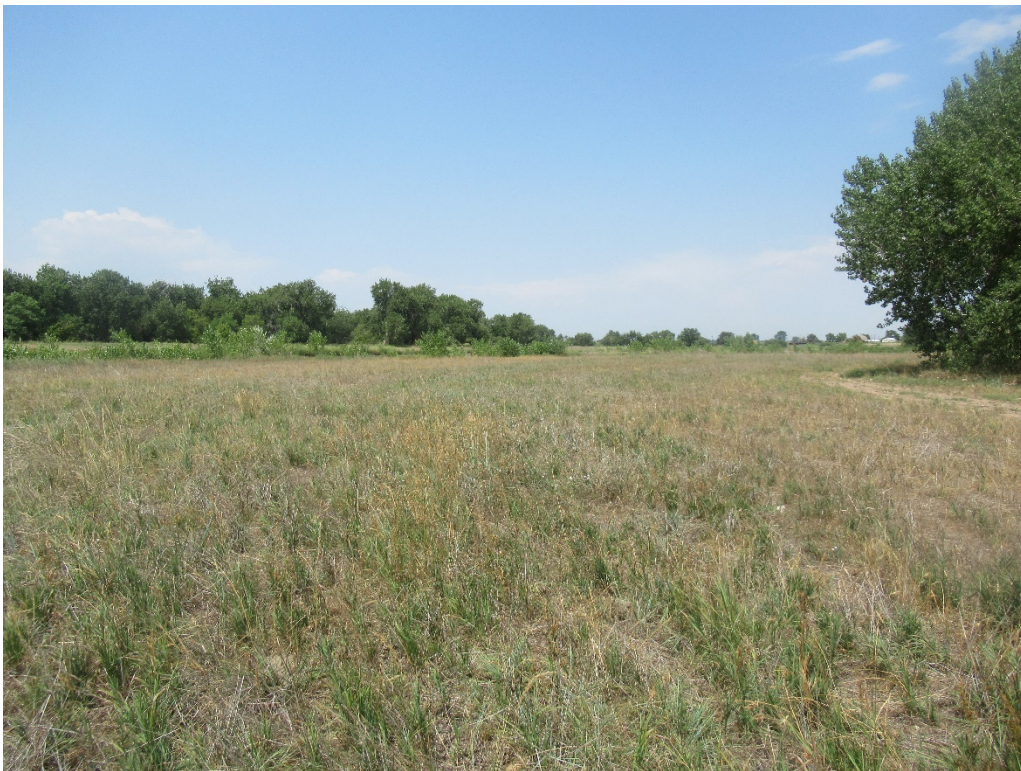
View of the vegetation in the eastern upland area

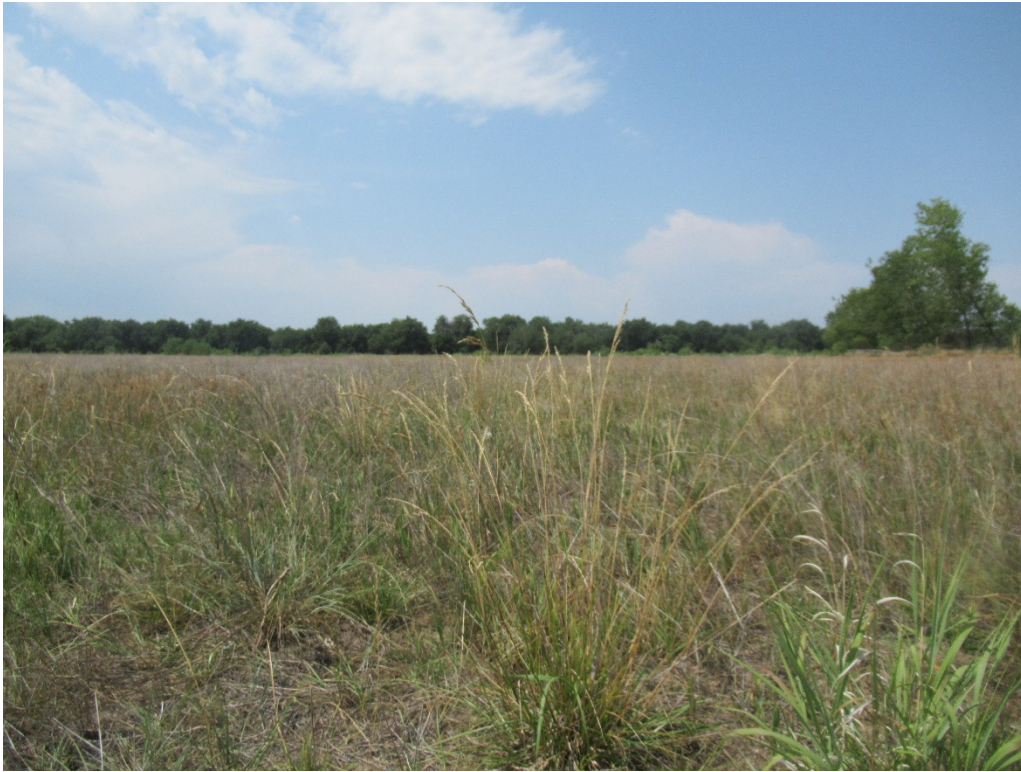
View of the vegetation in the eastern portion of the site

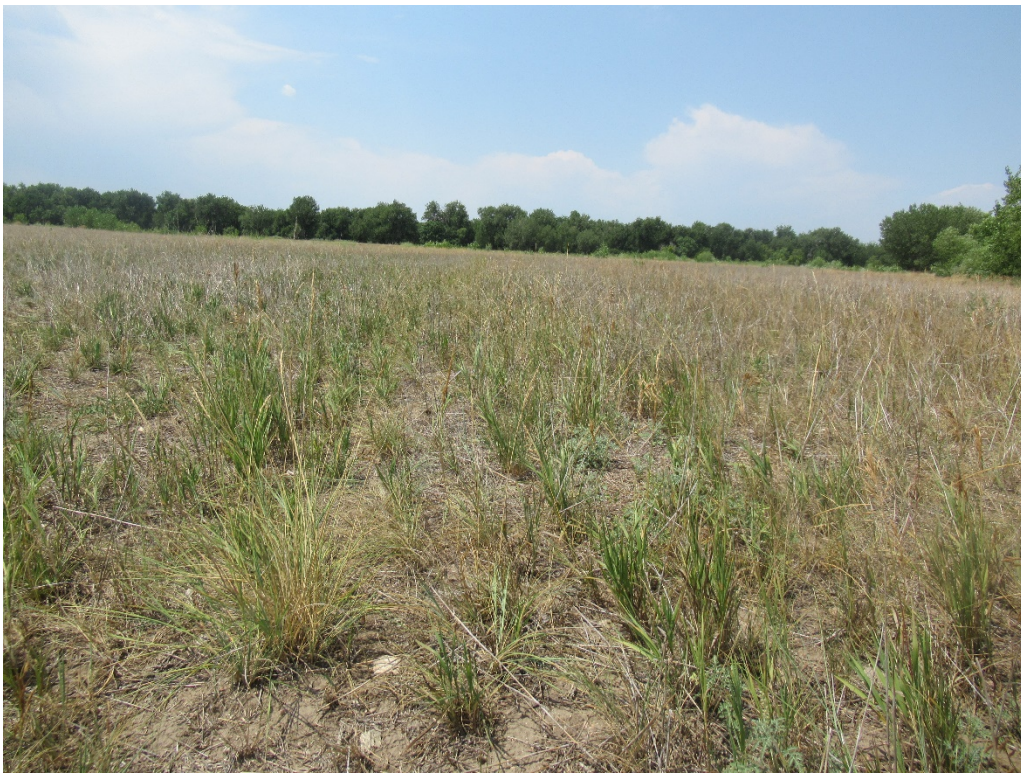
View of the vegetation in the eastern portion of the site
