MINERALS PROGRAM INSPECTION REPORT
PHONE: (303) 866-3567

MINE NAME: Proctor Pit	MINE/PROSPECTING ID#: M-2009-054	MINERAL: Gravel and sand	COUNTY: Otero
INSPECTION TYPE: Monitoring	INSPECTOR(S): Daniel Cunningham	INSP. DATE: August 11, 2020	INSP. TIME: 12:00
OPERATOR: All-Rite Paving & Redi-Mix, Inc.	OPERATOR REPRESENTATIVE: Herb Pearson	TYPE OF OPERATION: 112c - Construction Regular Operation	
REASON FOR INSPECTION: Normal I&E Program	BOND CALCULATION TYPE: Complete Bond	BOND AMOUNT: \$20,972.00	
DATE OF COMPLAINT: NA	POST INSP. CONTACTS: None	JOINT INSP. AGENCY: None	
WEATHER: Clear	INSPECTOR'S SIGNATURE:

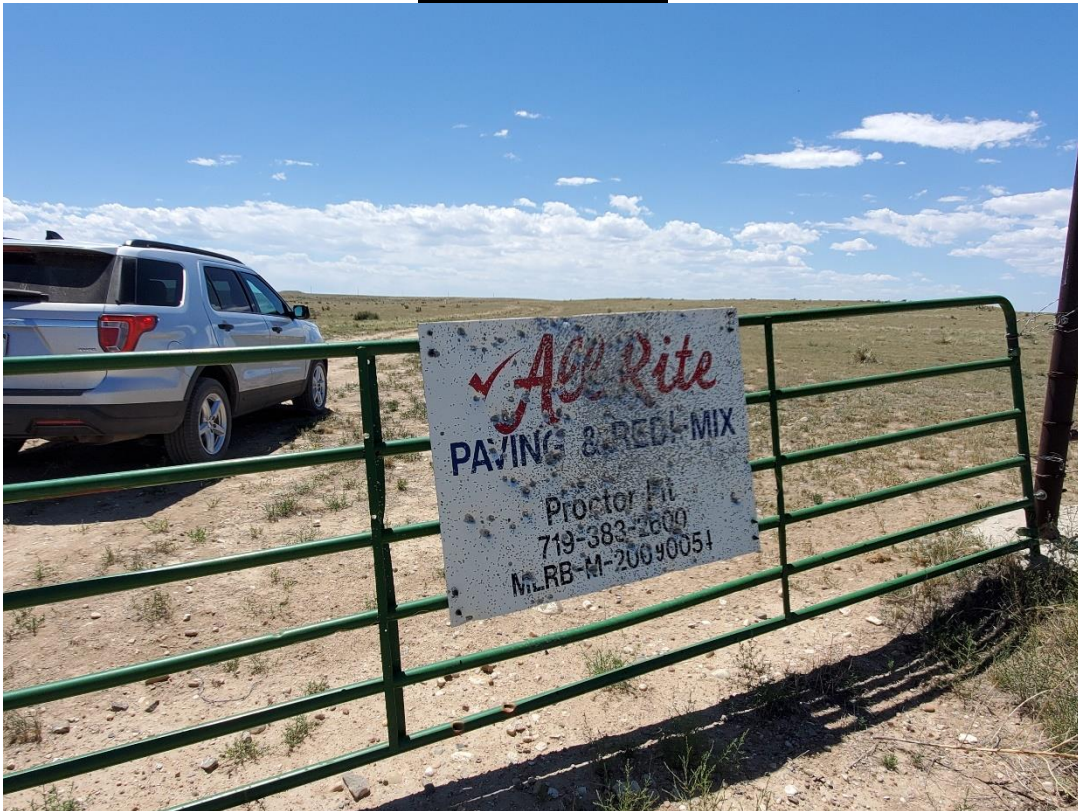
Entrance sign

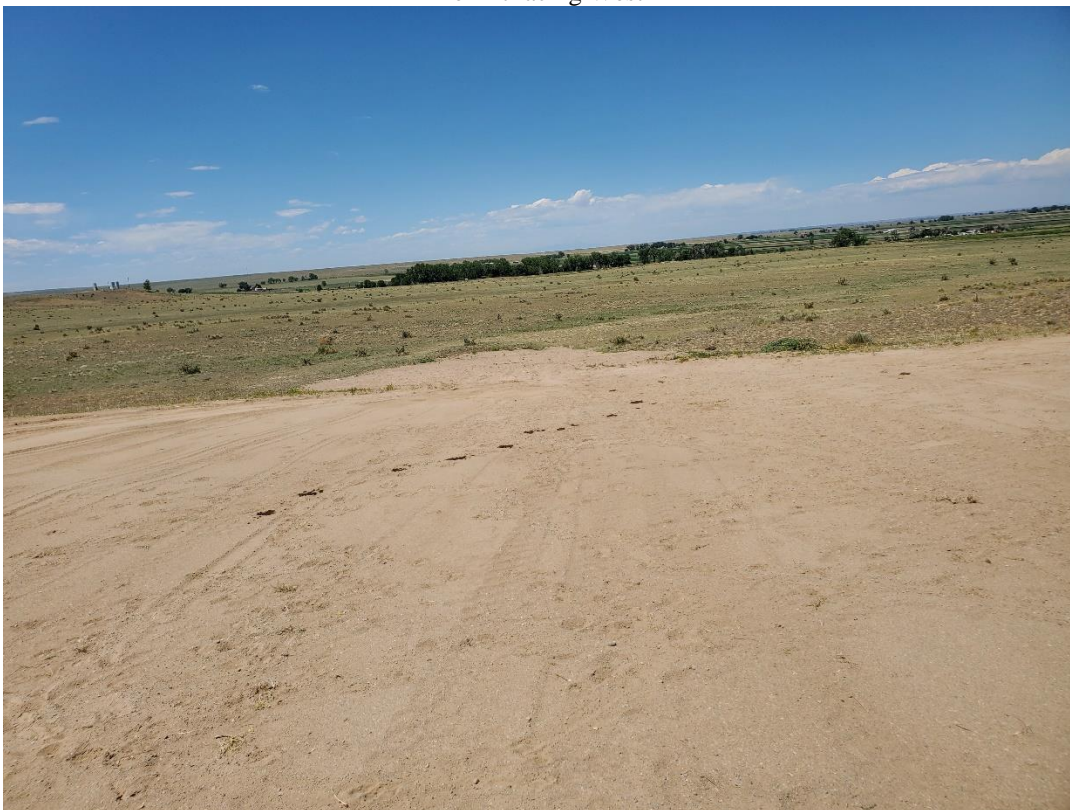
Barren area on permit
