**MINERALS PROGRAM INSPECTION REPORT**  
**PHONE: (303) 866-3567**

<b>MINE NAME:</b> Mendenhall Pit	<b>MINE/PROSPECTING ID#:</b> M-2004-027	<b>MINERAL:</b> Sand and gravel	<b>COUNTY:</b> Otero
<b>INSPECTION TYPE:</b> Monitoring	<b>INSPECTOR(S):</b> Daniel Cunningham	<b>INSP. DATE:</b> August 11, 2020	<b>INSP. TIME:</b> 13:30
<b>OPERATOR:</b> Otero County	<b>OPERATOR REPRESENTATIVE:</b> Lex Nichols	<b>TYPE OF OPERATION:</b> 112c - Construction Regular Operation	
<b>REASON FOR INSPECTION:</b> Normal I&E Program		<b>BOND CALCULATION TYPE:</b> \$0.00	
<b>DATE OF COMPLAINT:</b> NA		<b>JOINT INSP. AGENCY:</b> None	
<b>WEATHER:</b> Clear	<b>INSPECTOR'S SIGNATURE:</b>

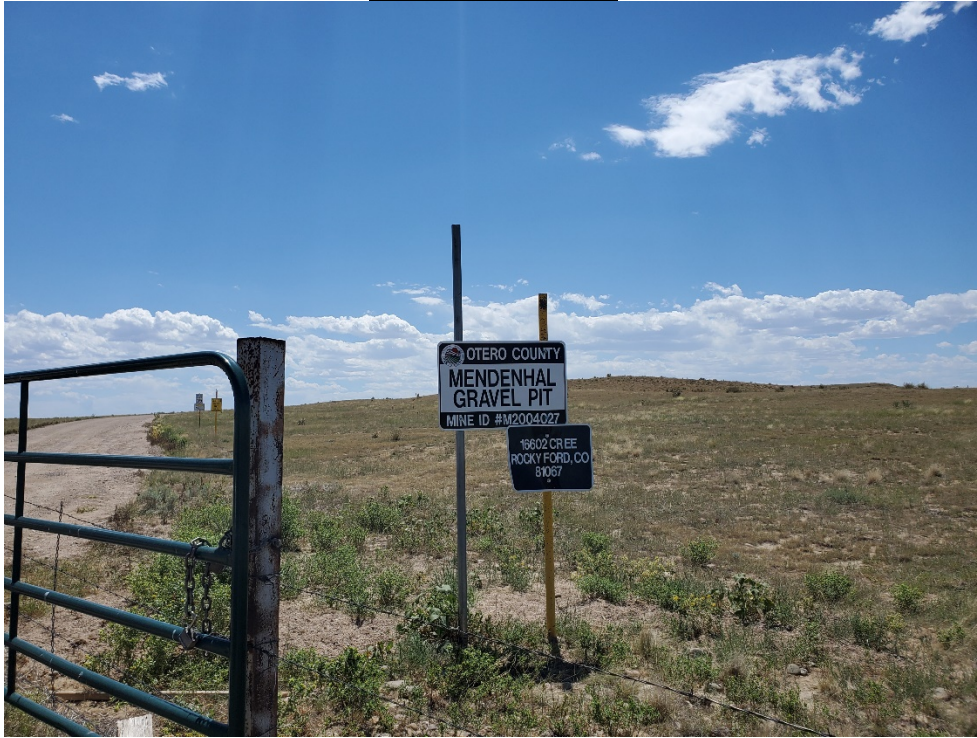
Entrance Sign

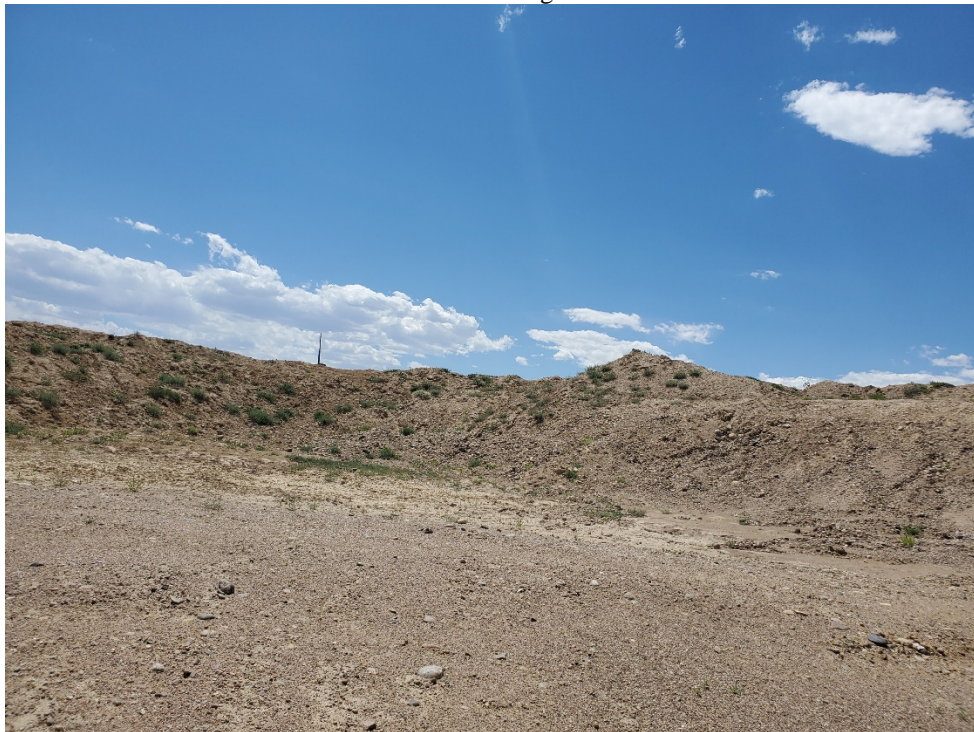
Topsoil Pile

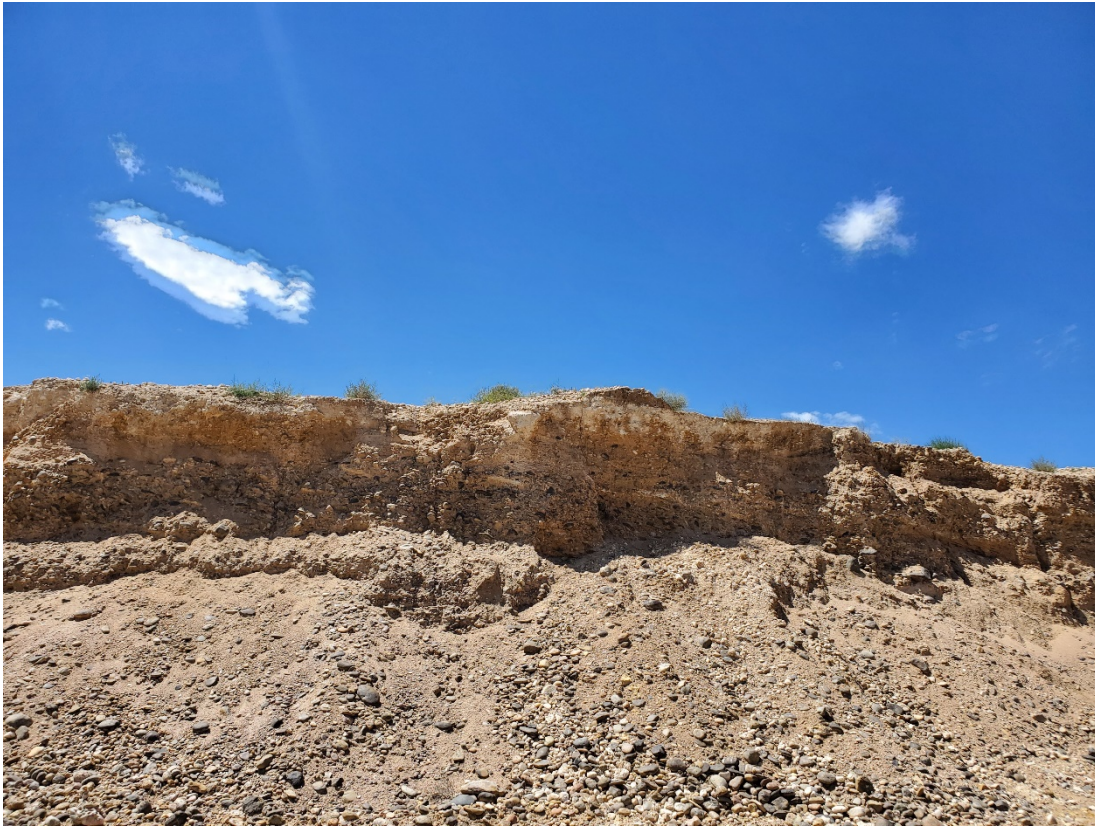
The site identification sign was posted at the mine entrance and the permit boundary were marked. Topsoil was being stored on site around the perimeter. Several large stockpiles of material were seen throughout the permitted area. A small ten foot high by 50 foot long highwall with a gradient of 1H:1V was seen on the southern end of the permit. Top soil was being stored on the western end of the permit, it was stable and no erosional issues were noted.

Highwall

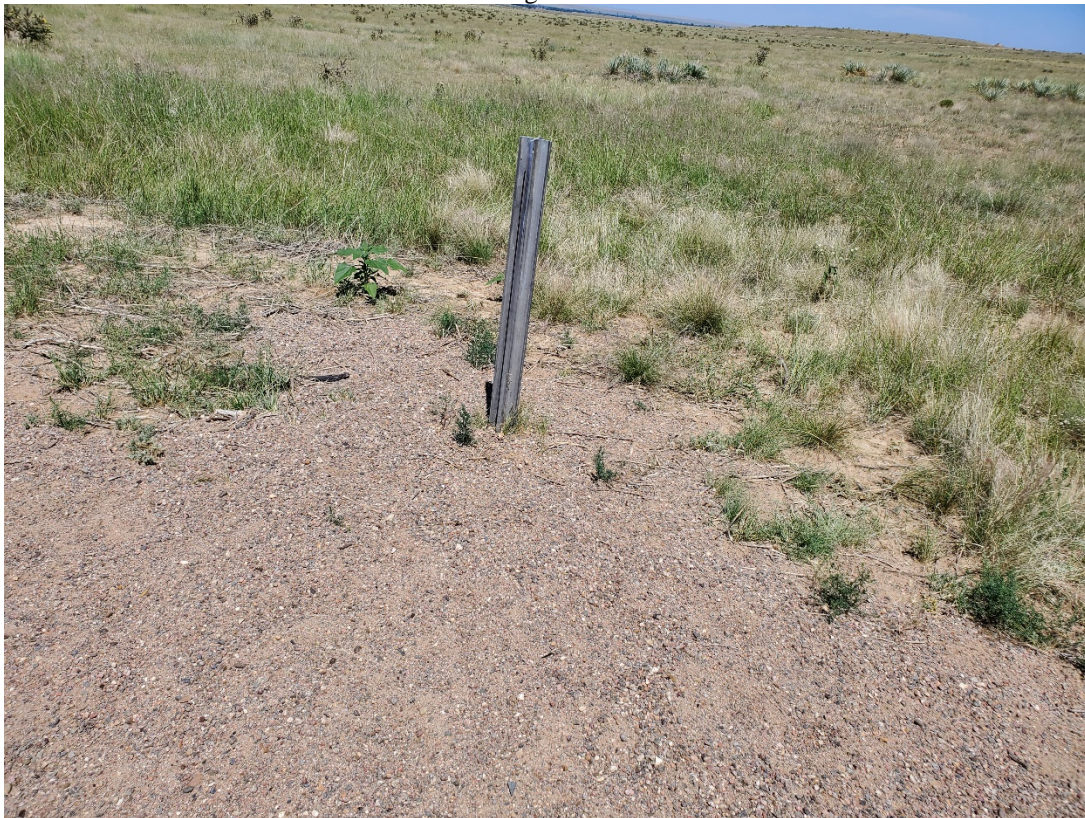
Permit Boundary
