MINERALS PROGRAM INSPECTION REPORT
PHONE: (303) 866-3567

MINE NAME: 6th Avenue Pkwy Borrow Pit	MINE/PROSPECTING ID#: M-2018-035	MINERAL: Borrow material for	COUNTY: Arapahoe
INSPECTION TYPE: Monitoring	INSPECTOR(S): Patrick Lennberg	INSP. DATE: August 21, 2020	INSP. TIME: 11:30
OPERATOR: SEMA Construction, Inc.	OPERATOR REPRESENTATIVE: Cameron Mang	TYPE OF OPERATION: 111 - Construction by Government Agency

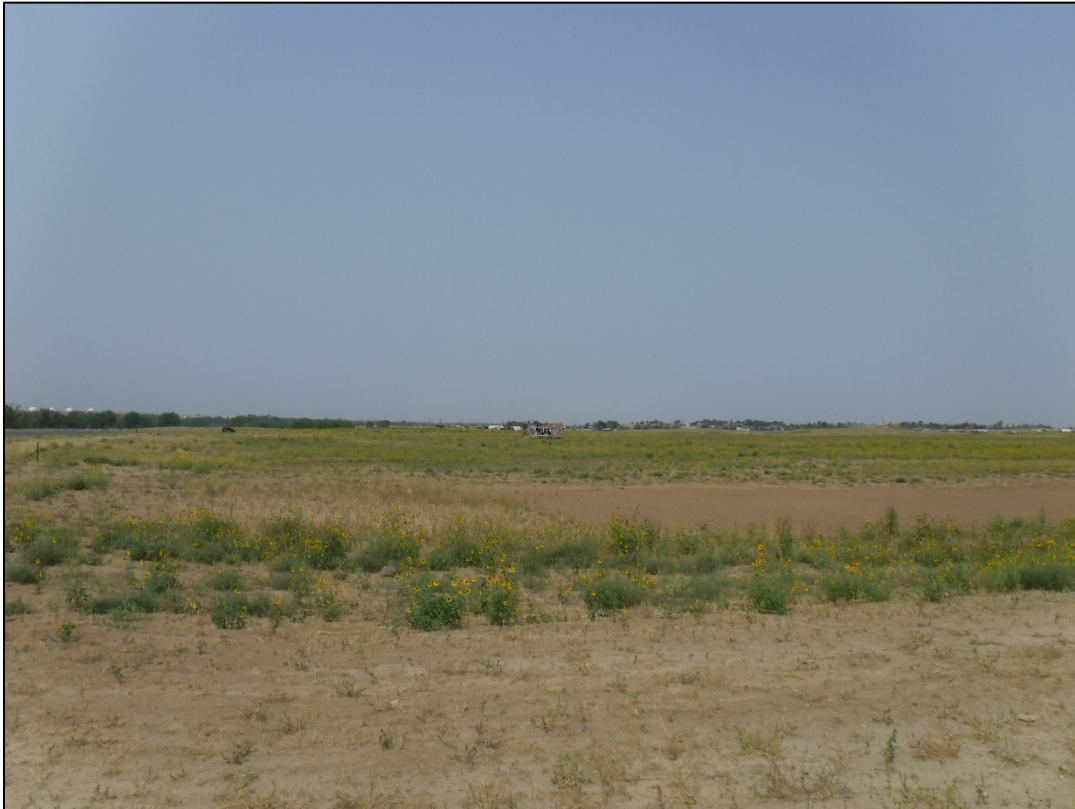
Photo 1: Looking west across southern portion of site near the intersection of 6th Ave and Valdai St

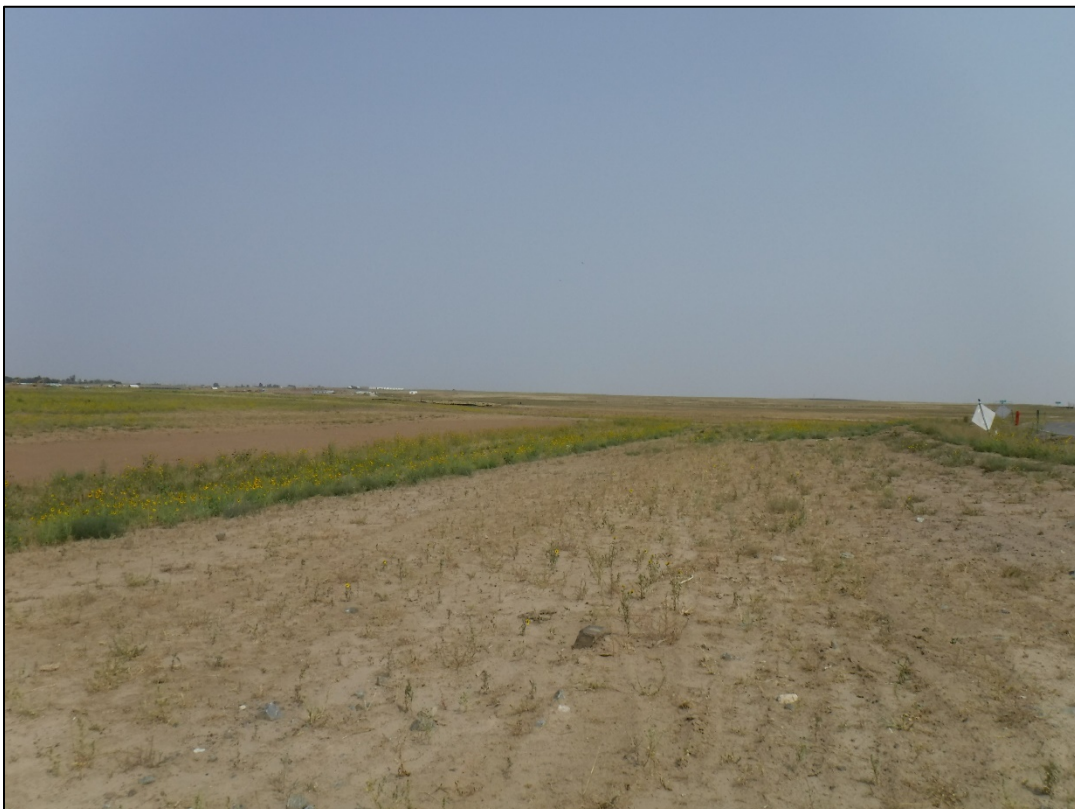
Photo 2: Looking north along eastern portion of site near the intersection of 6th Ave and Valdai St

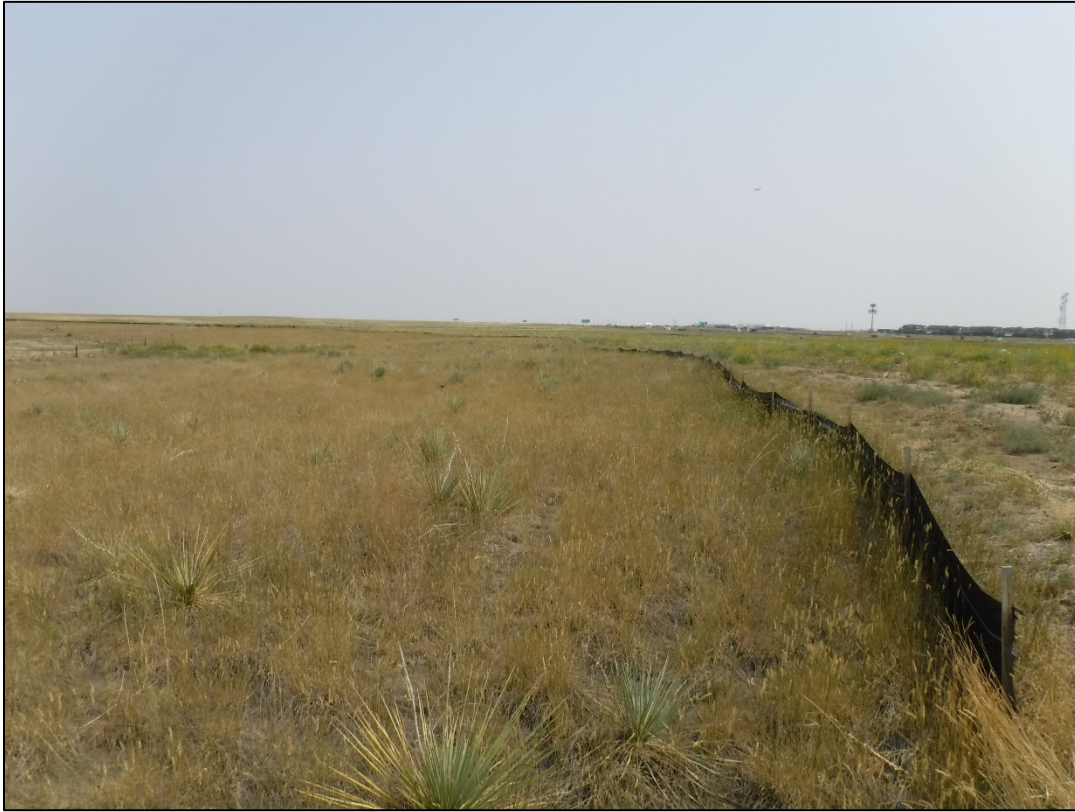
Photo 3: Western portion of site, mined area to the right of the silt fence

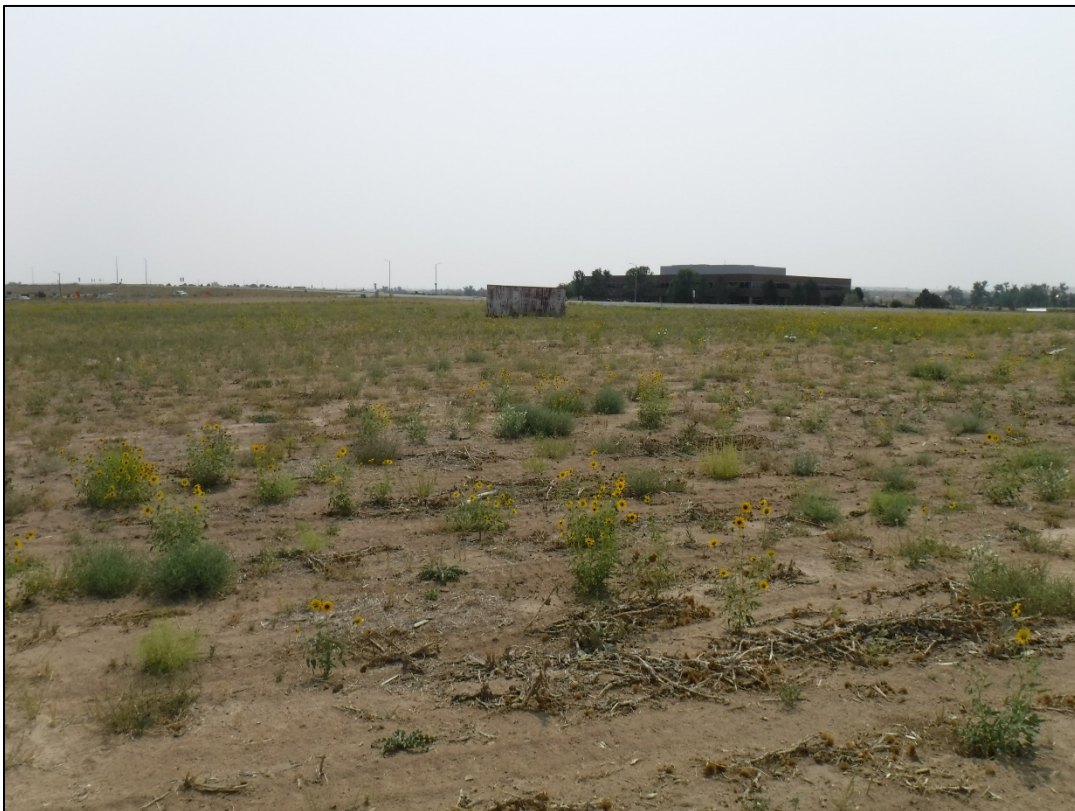
Photo 4: Looking to the southeastern corner of site from the west side of site

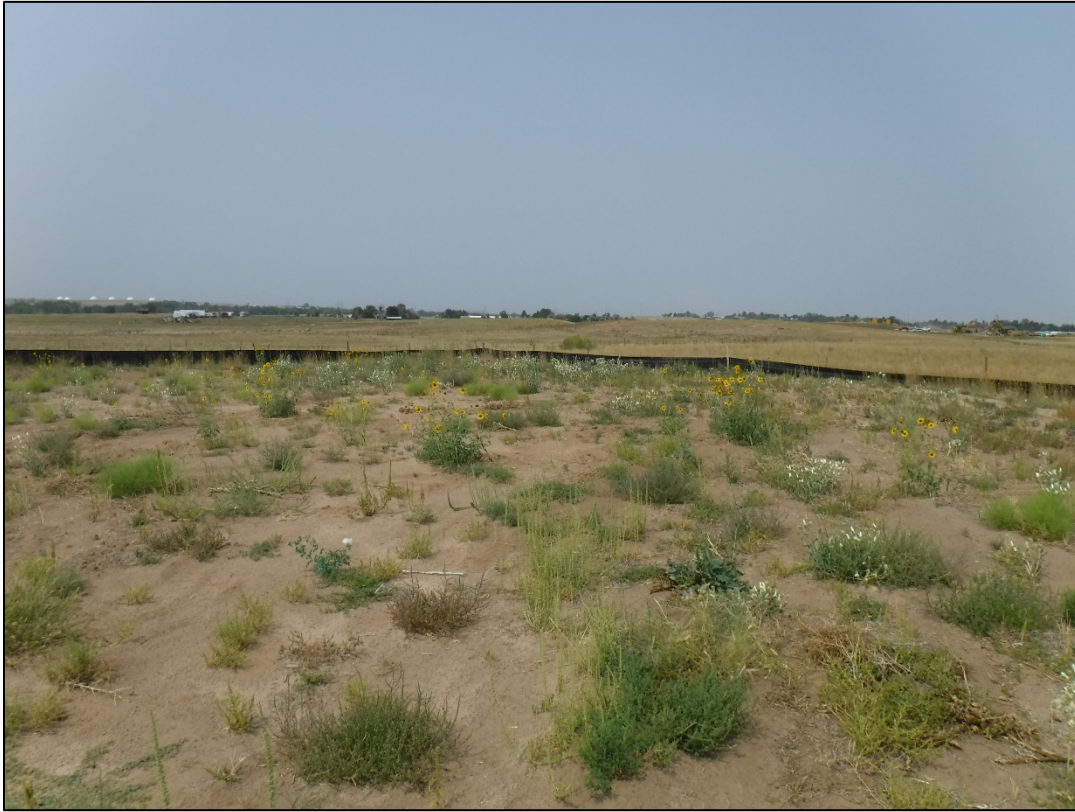
Photo 5: Northwestern corner of site

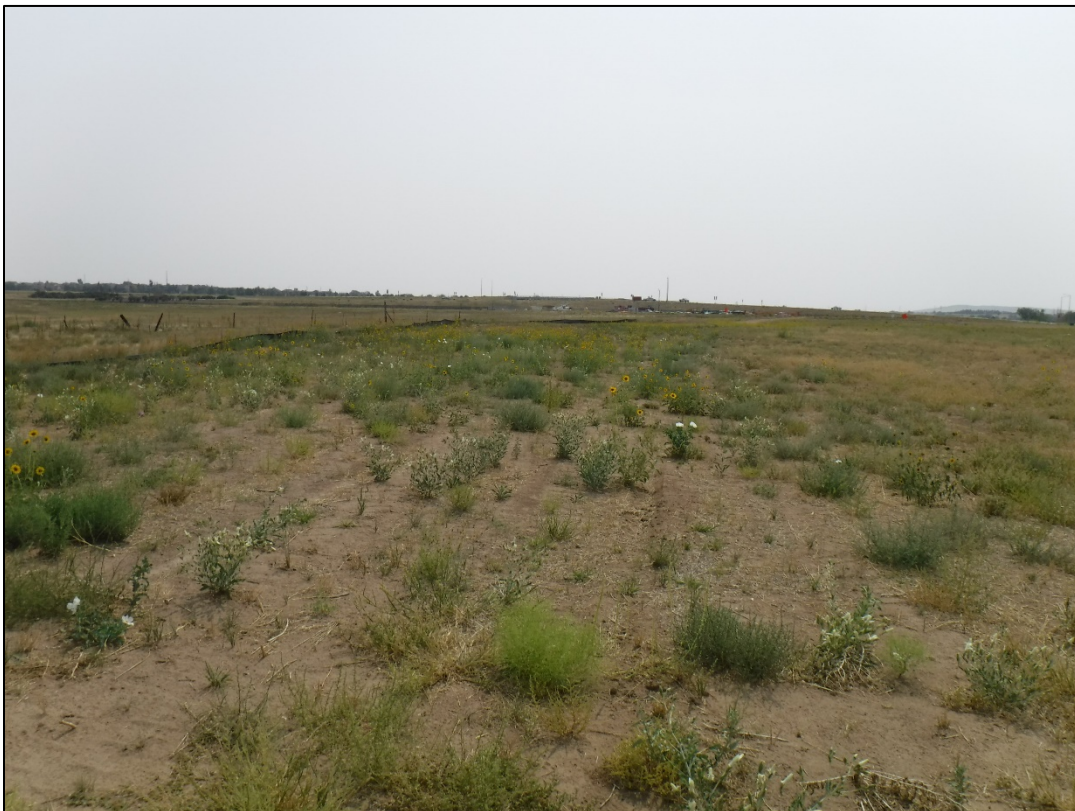
Photo 6: Looking east along northern boundary of site

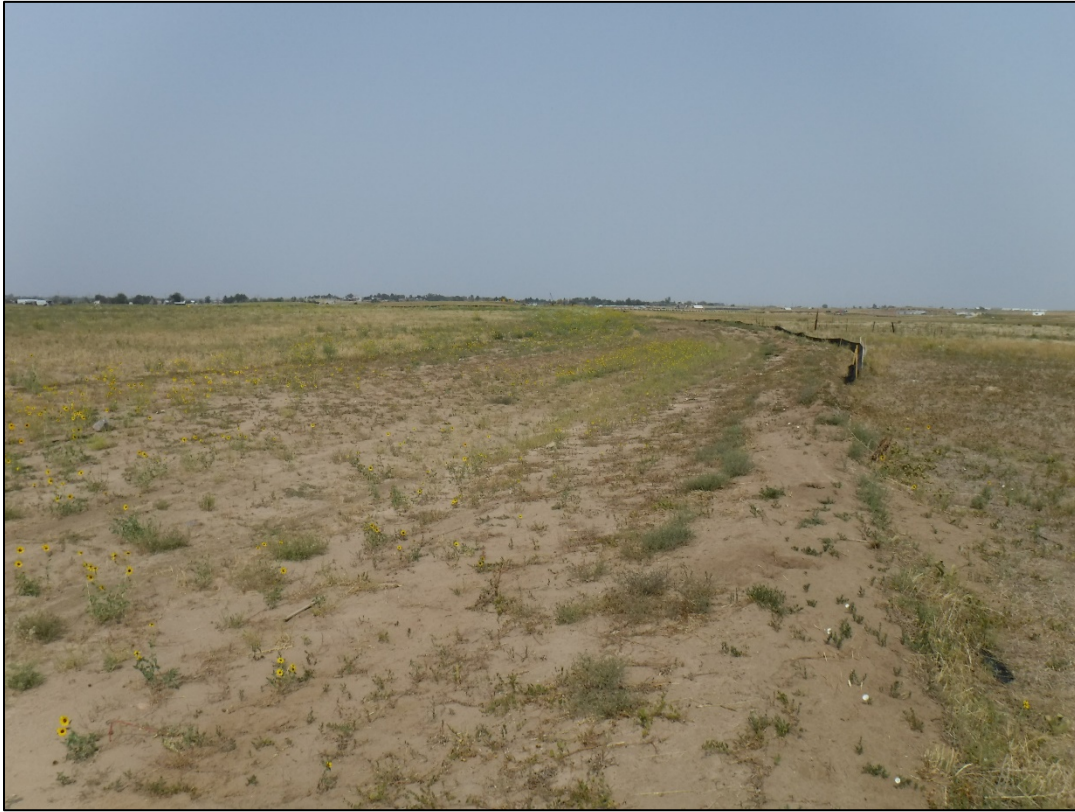
Photo 7: Looking west along northern boundary of site

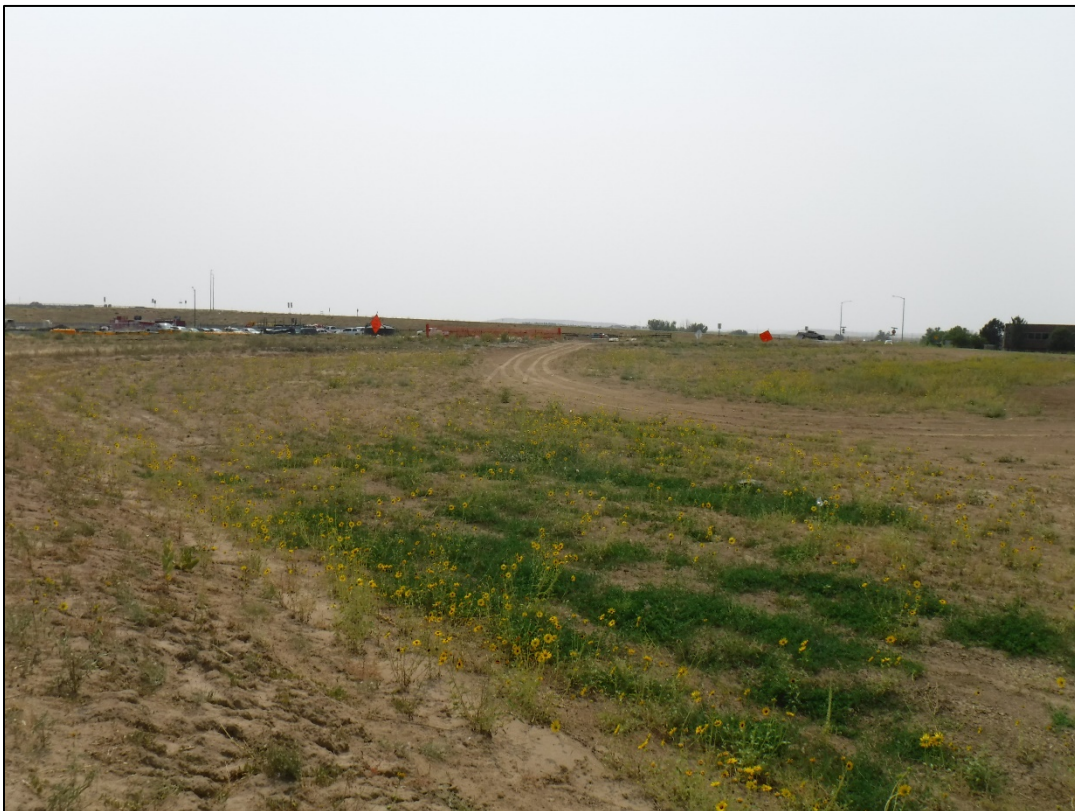
Photo 8: Northeast corner of site
