MINERALS PROGRAM INSPECTION REPORT
PHONE: (303) 866-3567

MINE NAME: Rough Cut Pit	MINE/PROSPECTING ID#: M-2001-033	MINERAL: Sand and gravel	COUNTY: Otero
INSPECTION TYPE: Monitoring	INSPECTOR(S): Daniel Cunningham	INSP. DATE: August 11, 2020	INSP. TIME: 12:00
OPERATOR: Rough Cut, L.L.C.	OPERATOR REPRESENTATIVE: Keith Tucker	TYPE OF OPERATION: 112c - Construction Regular Operation	
REASON FOR INSPECTION: Normal I&E Program	BOND CALCULATION TYPE: Complete Bond	BOND AMOUNT: \$193,000.00	
DATE OF COMPLAINT: NA	POST INSP. CONTACTS: None	JOINT INSP. AGENCY: None	
WEATHER: Clear	INSPECTOR'S SIGNATURE:

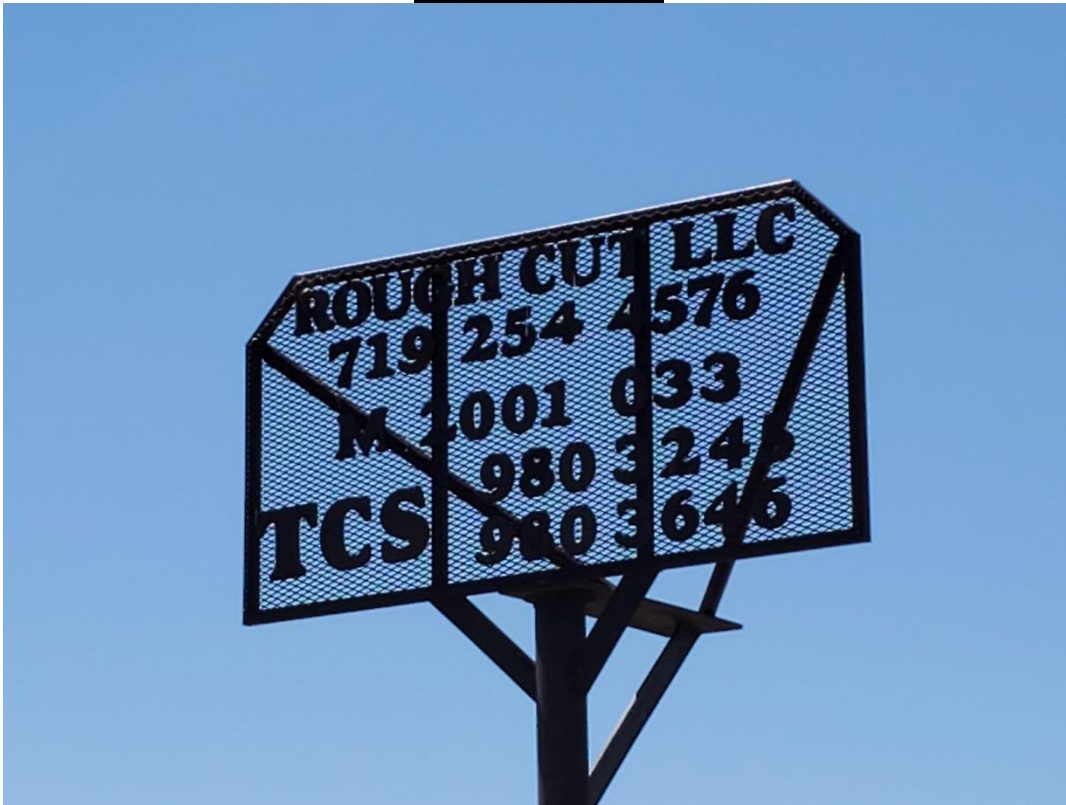
The site identification sign was posted at the mine entrance and the permit boundary were marked with metal posts. The site is separated into three distinct areas; the first site where active mining is occurring; the second site where reclamation work is occurring; and a third site that is in revegetation.

Entrance Sign

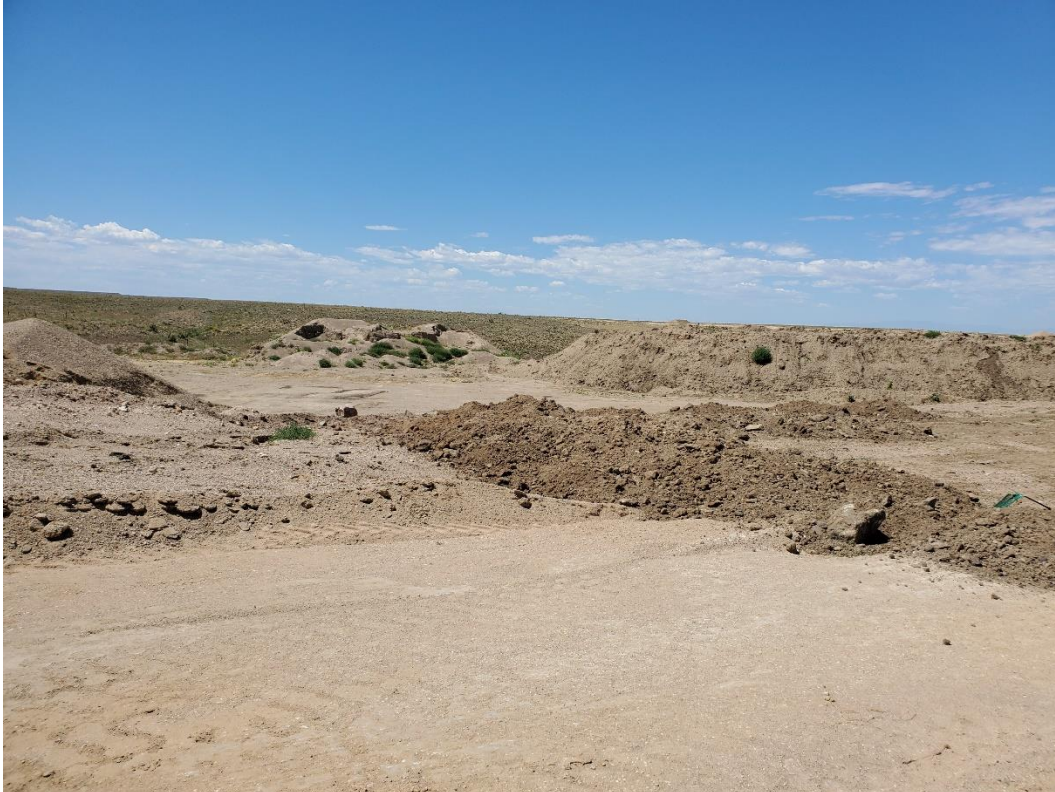
The second site, located North West of the first site, was actively being reclaimed during the inspection. Several large stockpiles were located on the site and an area with concrete blocks. A dozer was moving topsoil from the first site to the second site during the inspection for reclamation. No major issues were noted.

Topsoil being laid down for reclamation

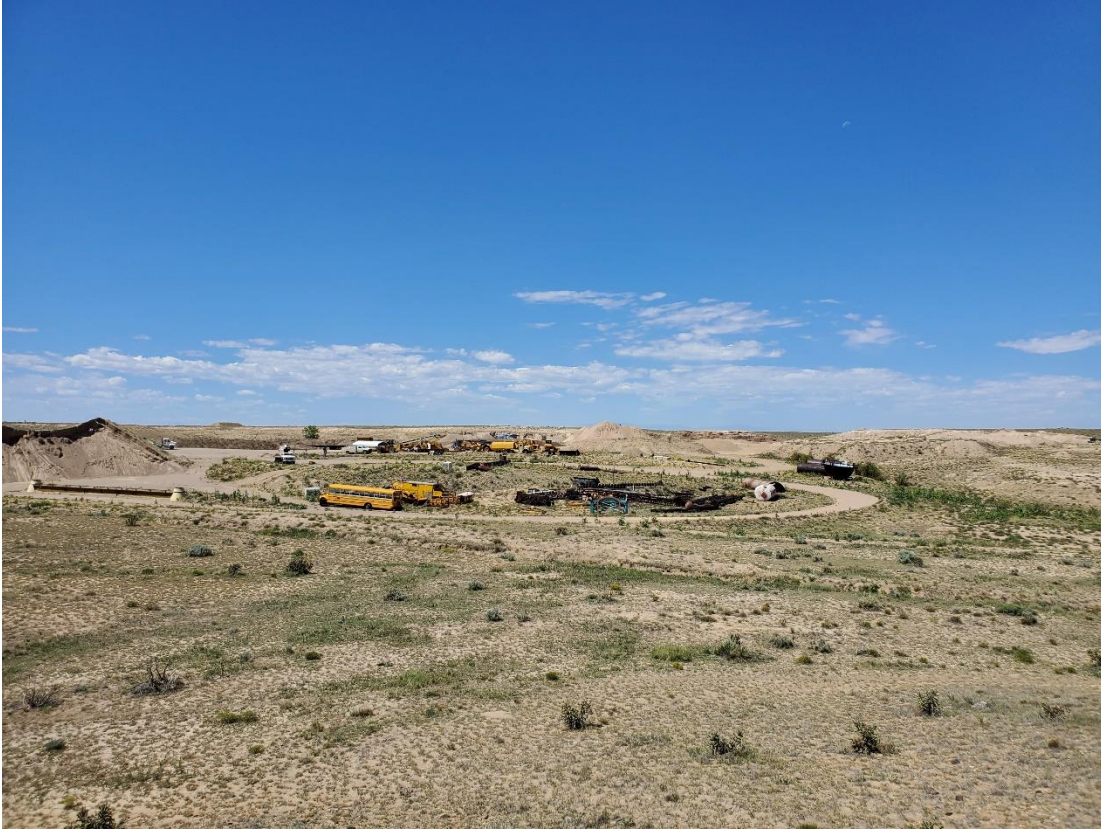
Overlooking area 1 and some of the revegetation area

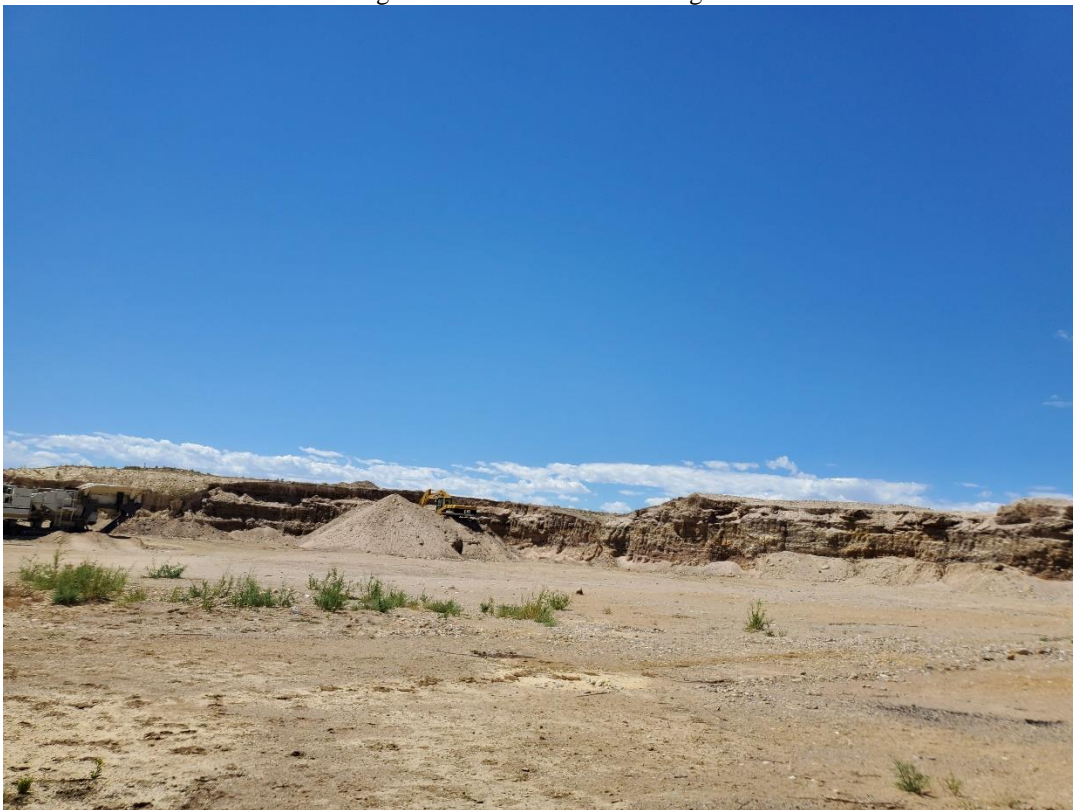
At the first site, topsoil was being stored on the western edge of the area. There were several large stockpiles of material on site and a 20 foot high by 1500 foot long high wall. The area also had the processing equipment on it. Material was actively being transported from this site during the inspection. There were no issues noted in this area.

Highwall

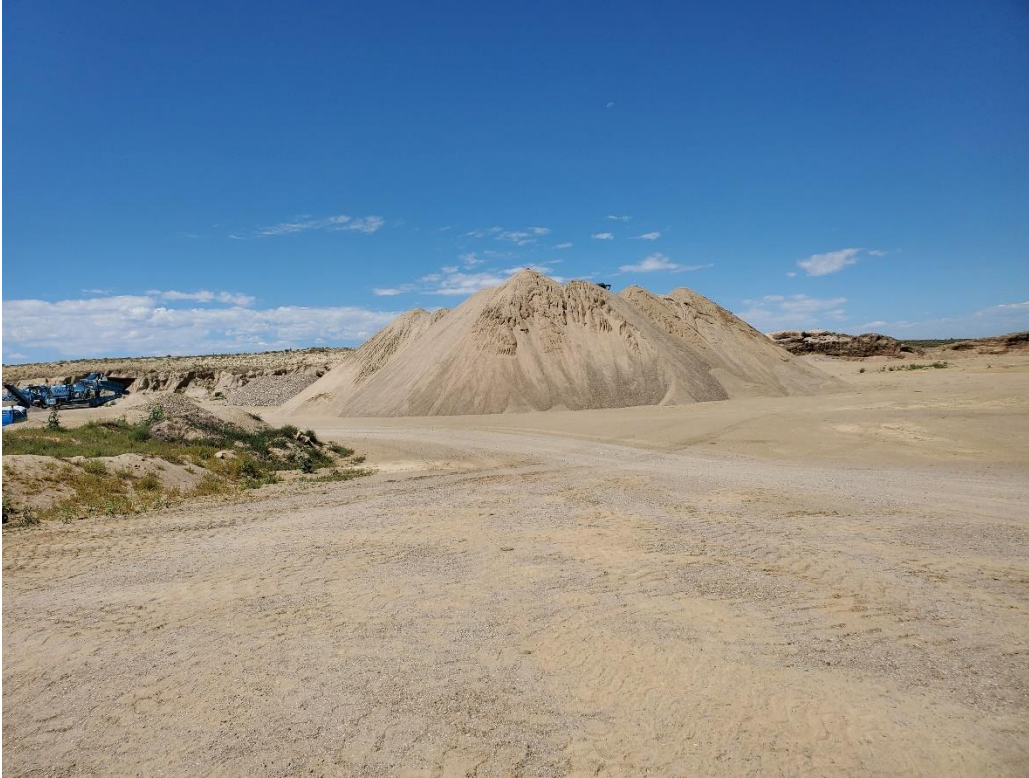
Stockpile and processing area

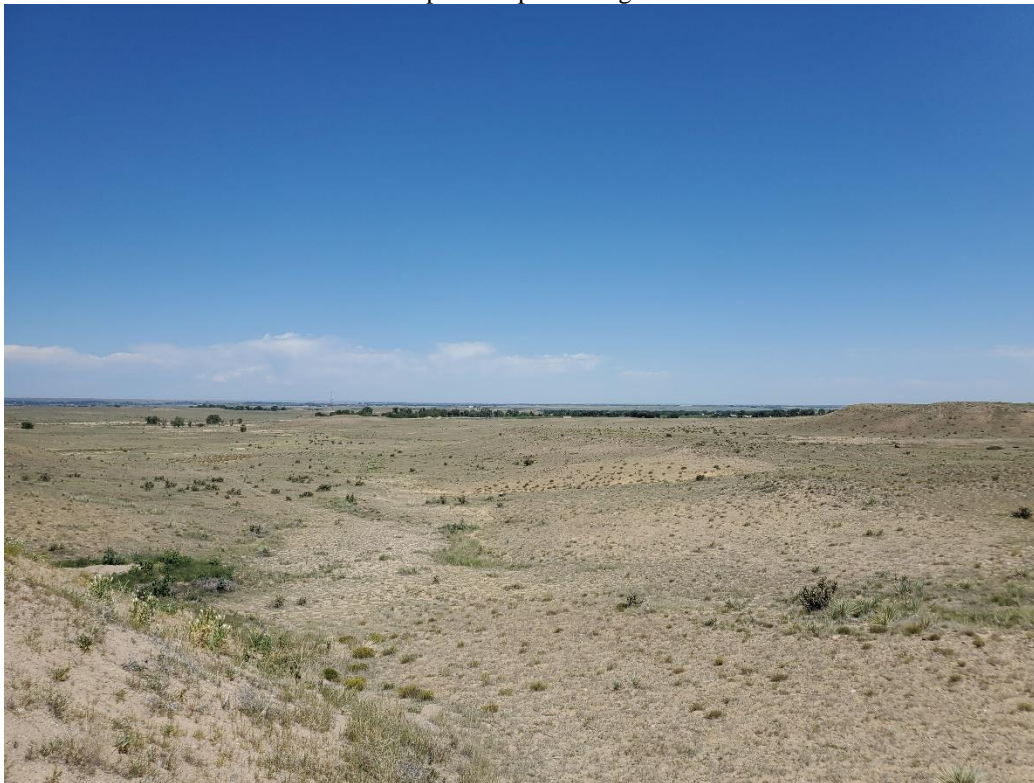
The final area is in active revegetation. No major erosional issues were noted and natural vegetation was seen throughout the area.

Overlooking revegetation area
