MINERALS PROGRAM INSPECTION REPORT
PHONE: (303) 866-3567

MINE NAME: Diamond Rock Pit	MINE/PROSPECTING ID#: M-2000-047	MINERAL: Gravel	COUNTY: Huerfano
INSPECTION TYPE: Monitoring	INSPECTOR(S): Patrick Lennberg	INSP. DATE: August 26, 2020	INSP. TIME: 10:00
OPERATOR: Diamond B Enterprises, LLC	OPERATOR REPRESENTATIVE: Anthony Blasi	TYPE OF OPERATION: 110c - Construction Limited Impact

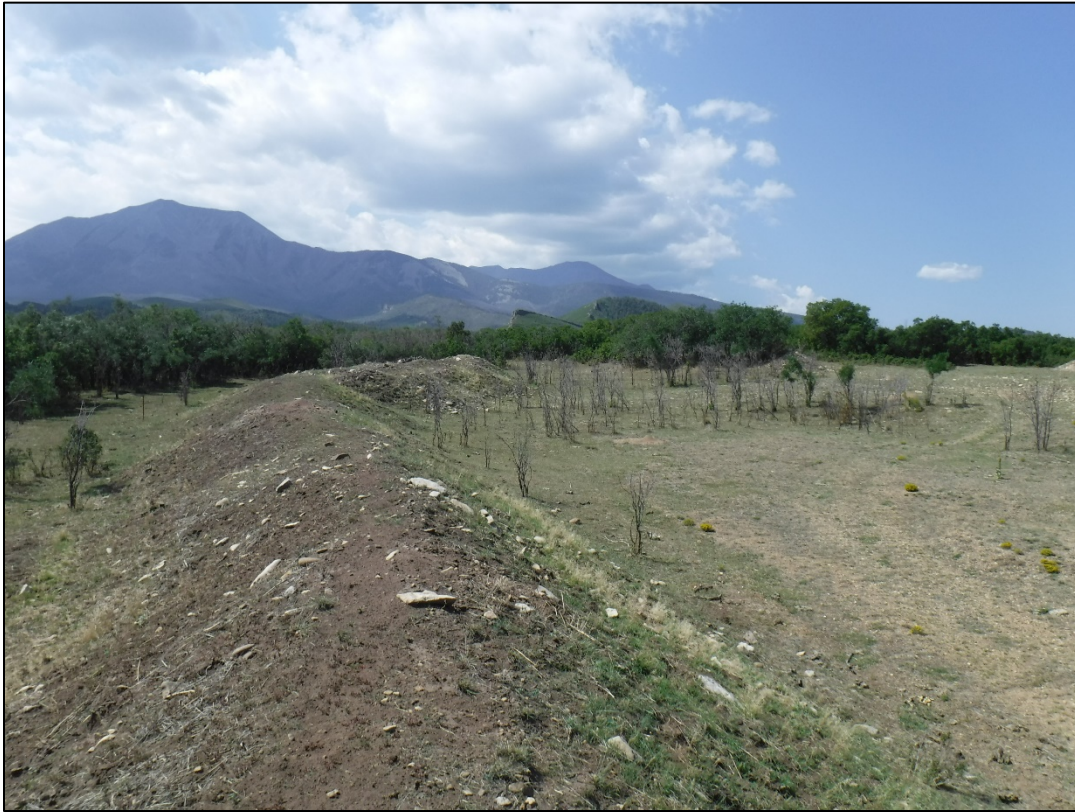
Photo 1: Looking south across the topsoil stockpile that will remain after TR approval

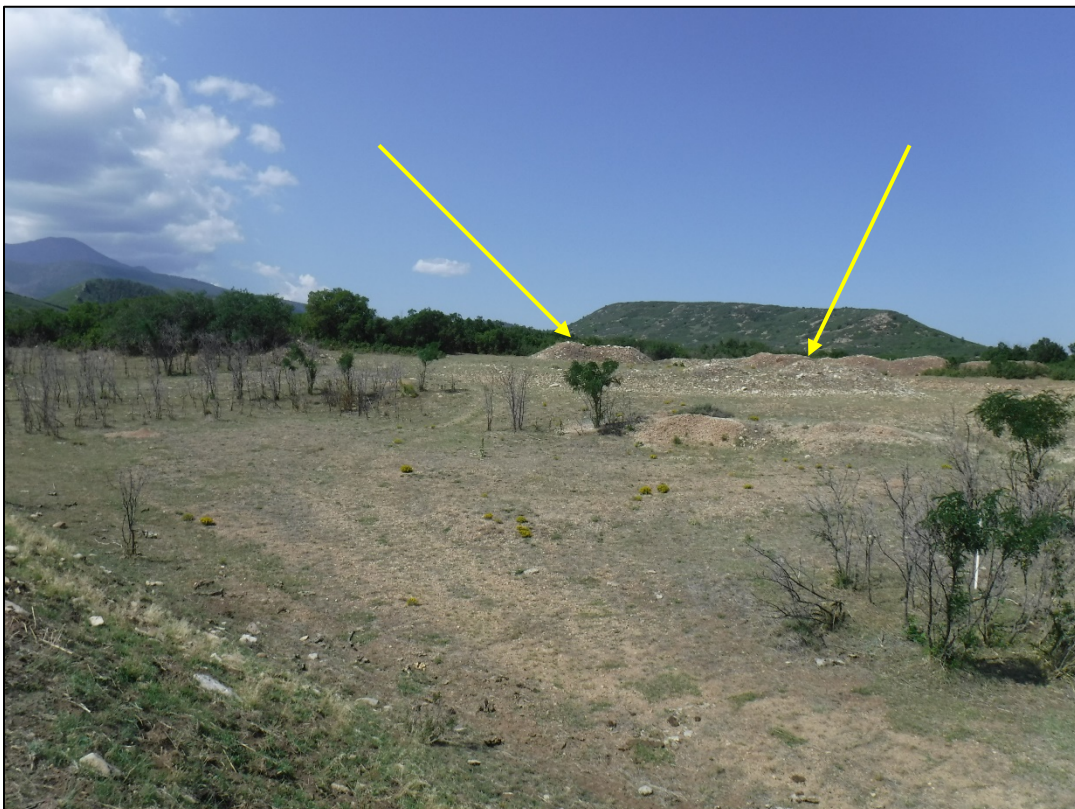
Photo 2: Looking west from the topsoil stockpile, the stockpiles (yellow arrow) will be used for grading

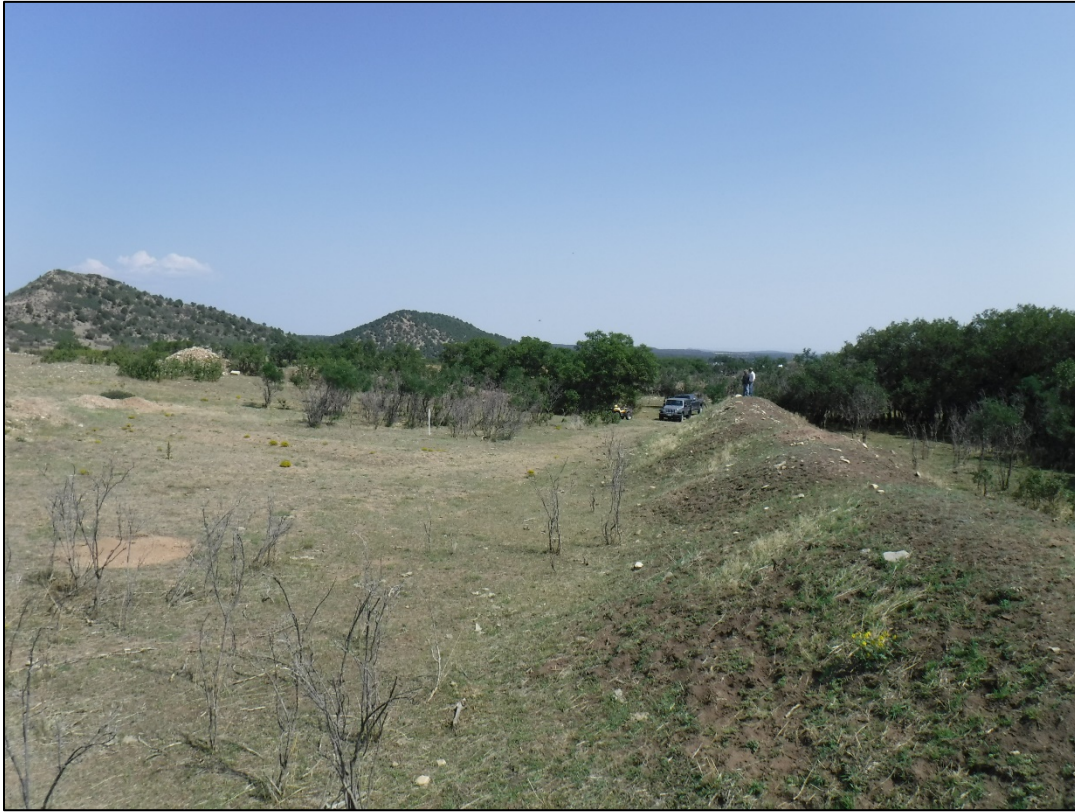
Photo 3: Looking north along the topsoil stockpile

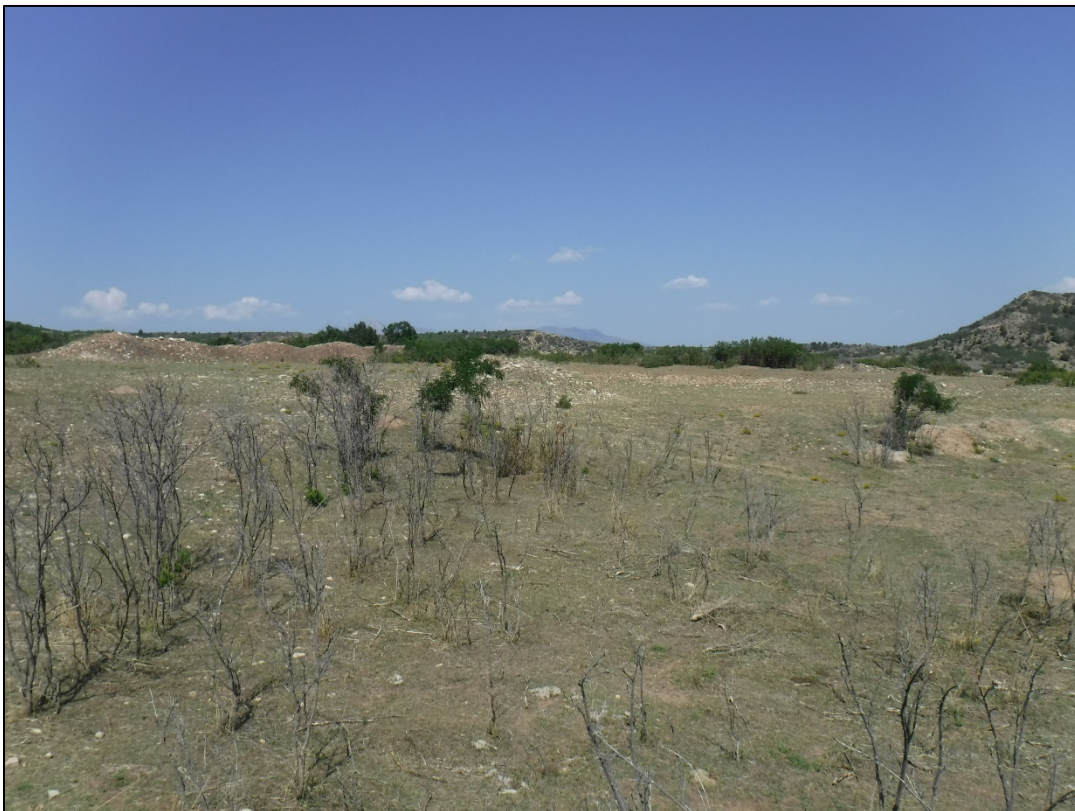
As indicated above the affected area has volunteered native vegetation that has become well established. Few annual weeds were noted. The slopes have been graded to 3H:1V or shallower throughout the affected area.

Photo 4: Typical vegetation conditions

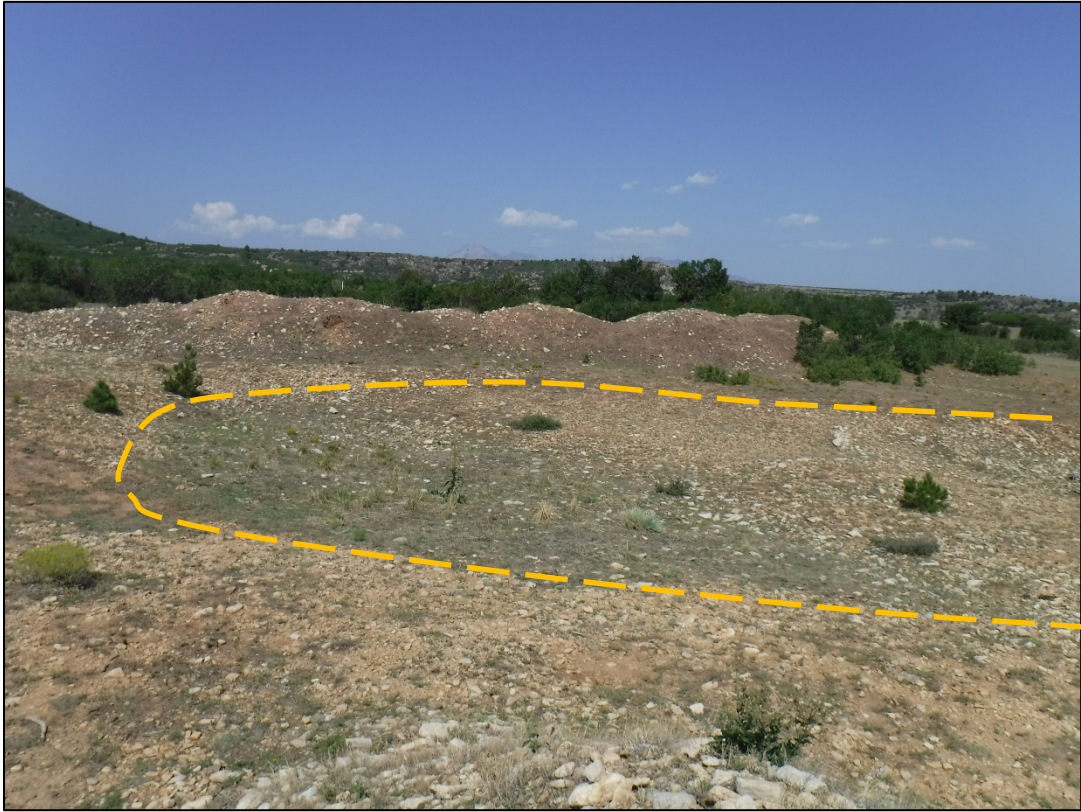
The last activity at the pit is estimated to be May 2006, since that time nothing has occurred at the site including reclamation. Failure to conduct reclamation in a timely manner is being cited as a problem in this report. I was met at the pit by the land owner Bob and the Operator Anthony. During the inspection it was discussed what reclamation needed to occur at the site. It was agreed that the shallow pit area located on the western portion of the disturbed area would be filled in using the adjacent rocky topsoil stockpiles. There are a few minor stockpiles of material that can also be used to fill in the area if needed otherwise the material can be feathered into the surrounding area. Both agreed that minimizing disturbance to the natural vegetation that has volunteered into the pit area was a priority. There is a large stockpile of topsoil material that has a well-established vegetative cover on it that will remain after reclamation is complete. The Operator will need to submit a Technical Revision after reclamation grading and seeding has been completed to update the reclamation plan map to indicate the topsoil stockpile will remain after reclamation is complete. The landowner will have to sign an affidavit agreeing to leave the topsoil stockpile in place.

Photo 5: Shallow pit area (dashed line) that will be filled in with adjacent stockpiled material

CORRECTIVE ACTIONS: The operator shall begin reclamation activities within 60 days of the date on the inspection report. The operator shall submit a Technical Revision, with the required \$216 revision fee, to update and clarify the current approved reclamation plan to reflect existing conditions once reclamation has been completed.

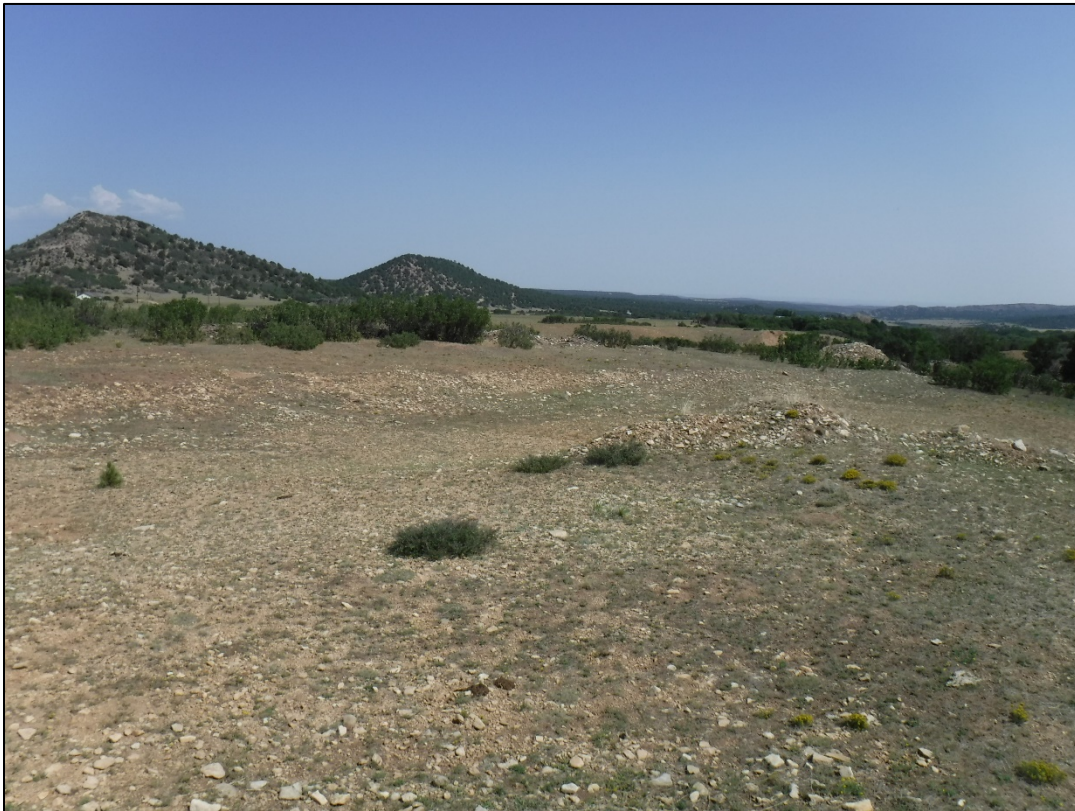
Photo 6: Shallow pit area looking northeast

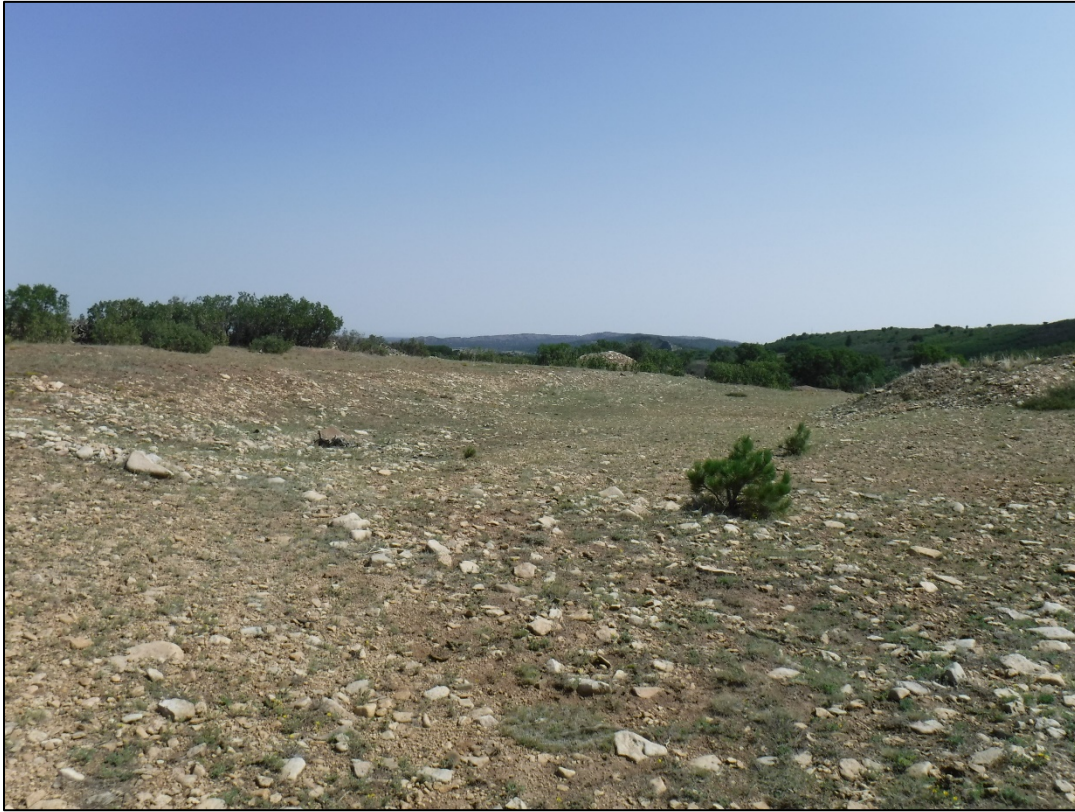
Photo 7: Shallow pit area looking northeast looking along pit floor

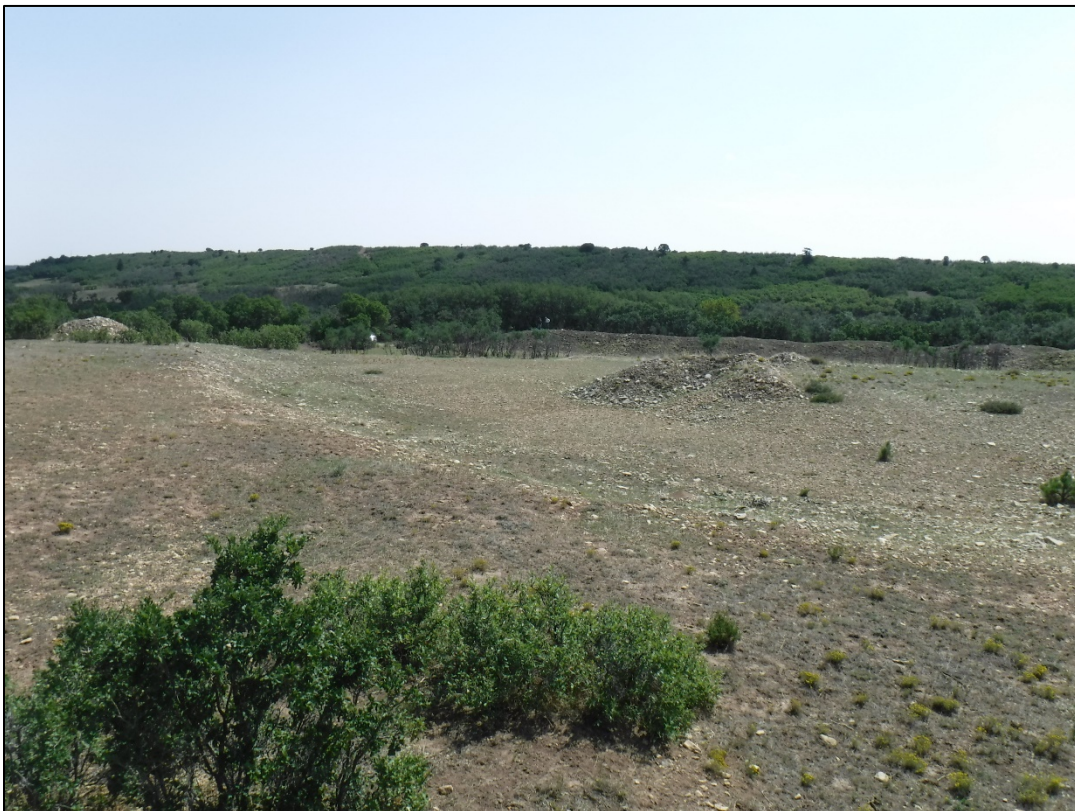
Photo 8: Looking east towards topsoil stockpile across shallow pit area
