**MINERALS PROGRAM INSPECTION REPORT**  
**PHONE: (303) 866-3567**

<b>MINE NAME:</b> Coaldale Quarry	<b>MINE/PROSPECTING ID#:</b> M-1977-247	<b>MINERAL:</b> Anhydrite, gypsum	<b>COUNTY:</b> Fremont
<b>INSPECTION TYPE:</b> Preoperation Inspection	<b>INSPECTOR(S):</b> Timothy Cazier	<b>INSP. DATE:</b> July 16, 2020	<b>INSP. TIME:</b> 14:45
<b>OPERATOR:</b> Holcim (US) Inc.	<b>OPERATOR REPRESENTATIVE:</b> Julio Villon & Tom Newman	<b>TYPE OF OPERATION:</b> 112c - Construction Regular Operation	
<b>REASON FOR INSPECTION:</b> Preoperation Inspection	<b>BOND CALCULATION TYPE:</b> None	<b>BOND AMOUNT:</b> \$707,000.00	
<b>DATE OF COMPLAINT:</b> NA	<b>POST INSP. CONTACTS:</b> None	<b>JOINT INSP. AGENCY:</b> None	
<b>WEATHER:</b> Cloudy	<b>INSPECTOR'S SIGNATURE:</b>

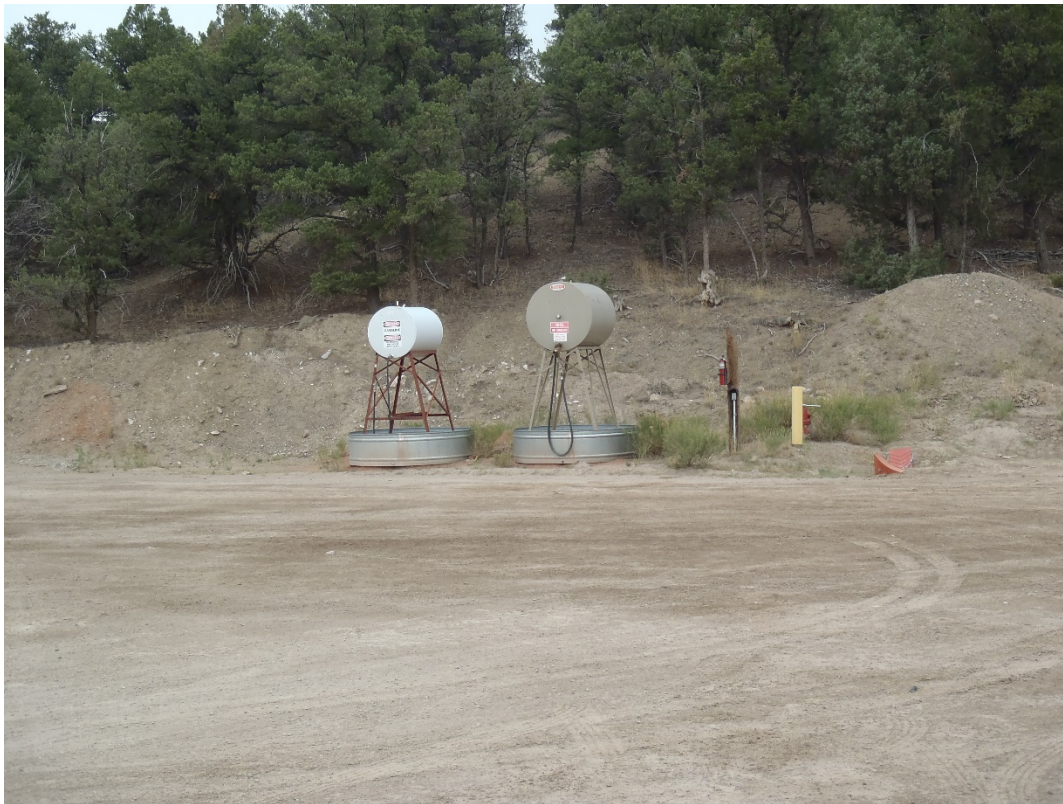
**Acid And Toxic Materials:** No acid or toxic materials are involved in this operation. Above ground fuel/oil storage tanks were observed and had adequate secondary containment (see **Photo 1**).

Photo 1. Fuel storage secondary containment. (near shop area).

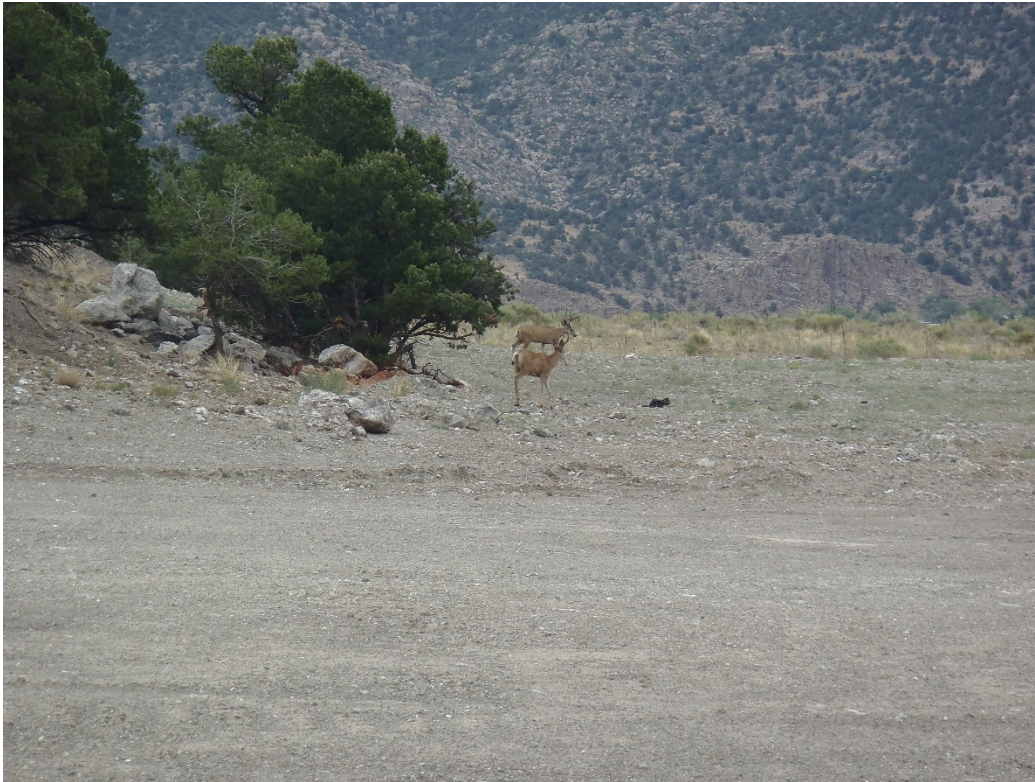
**Fish and Wildlife:** No impact to wildlife was observed. Deer were observed NE of the active pit (see **Photo 2**).

Photo 2. Deer near extended topsoil stockpile.

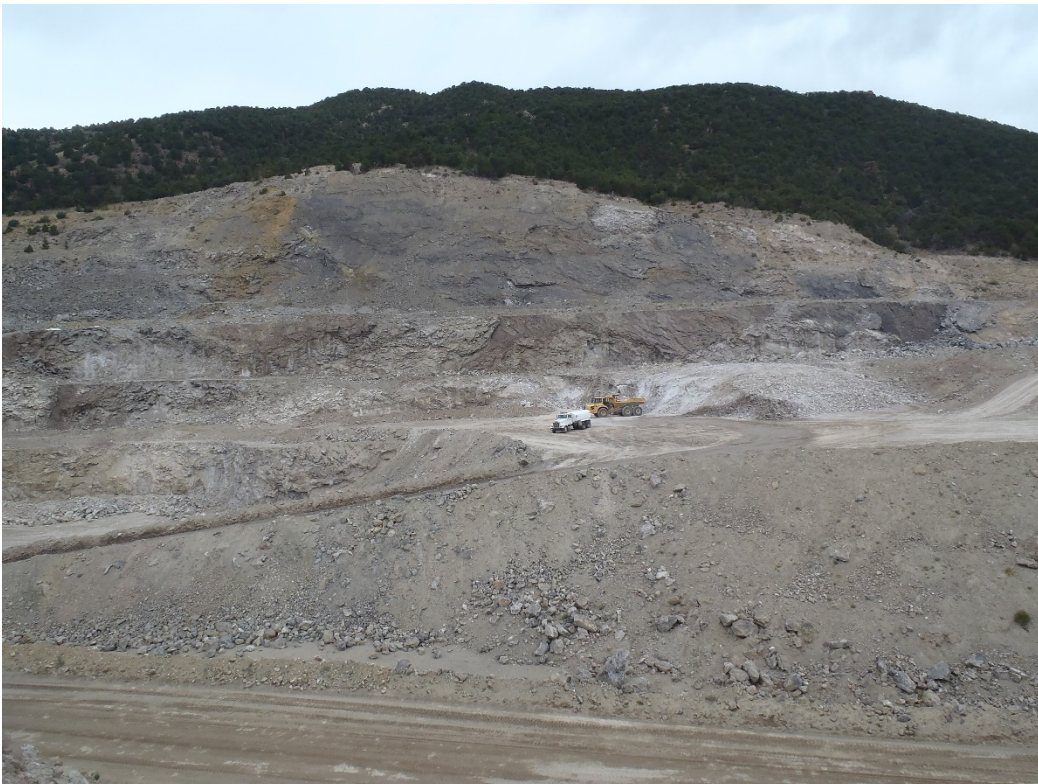
**Gen. Compliance with Mine Plan:** ***The record is unclear as to the maximum allowed disturbed area at any given time. The Division will clarify this with Holcim during the adequacy review process of AM-03.*** Google Earth was used to measure the disturbed area, which was estimated to be approximately 48 acres, based on 2019 imagery. Site representatives indicated final highwalls would be 30 feet high with 25-foot wide benches and an intra-bench angle of 65°. Highwalls were estimated to vary between 25 and 30 feet in height (see **Photo 3**).

Photo 3. North pit active highwall (looking SW).

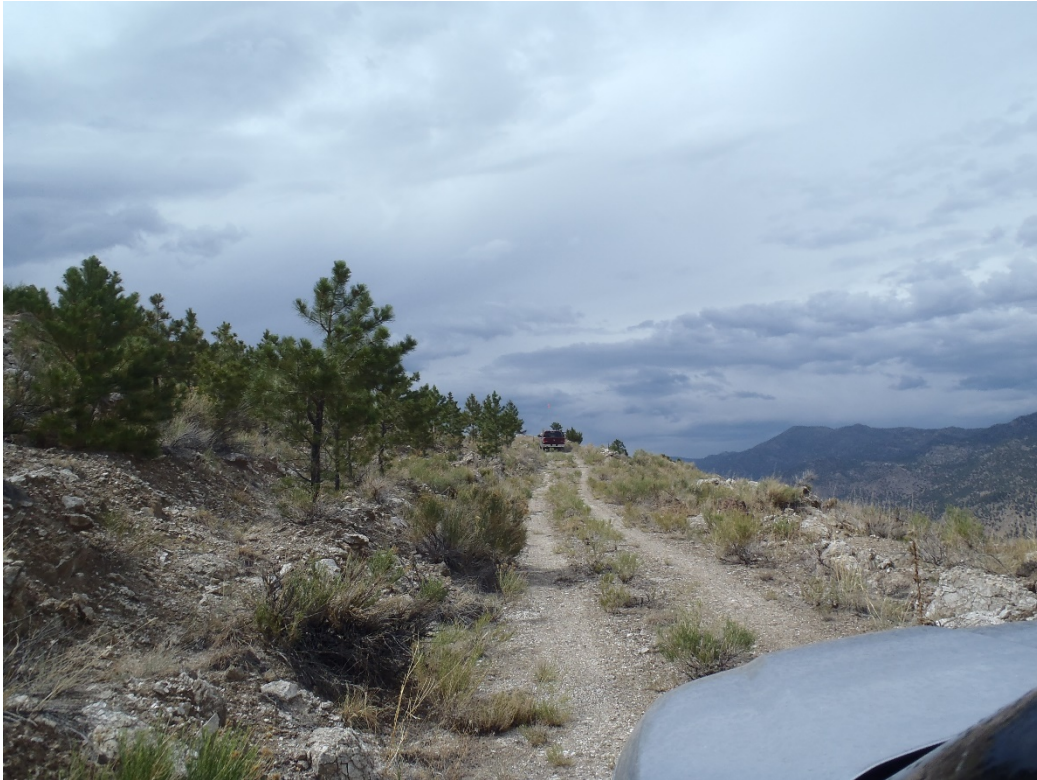
**Roads:** Haul and access roads did not appear to be a source of sediment that could be tracked offsite. Road side ditches were clean. Existing exploration/pre-law roads (see **Photo 4**) were used to access the proposed Titanium Hill area.

Photo 4. Pre-law access road to Titanium Hill area (looking NW).

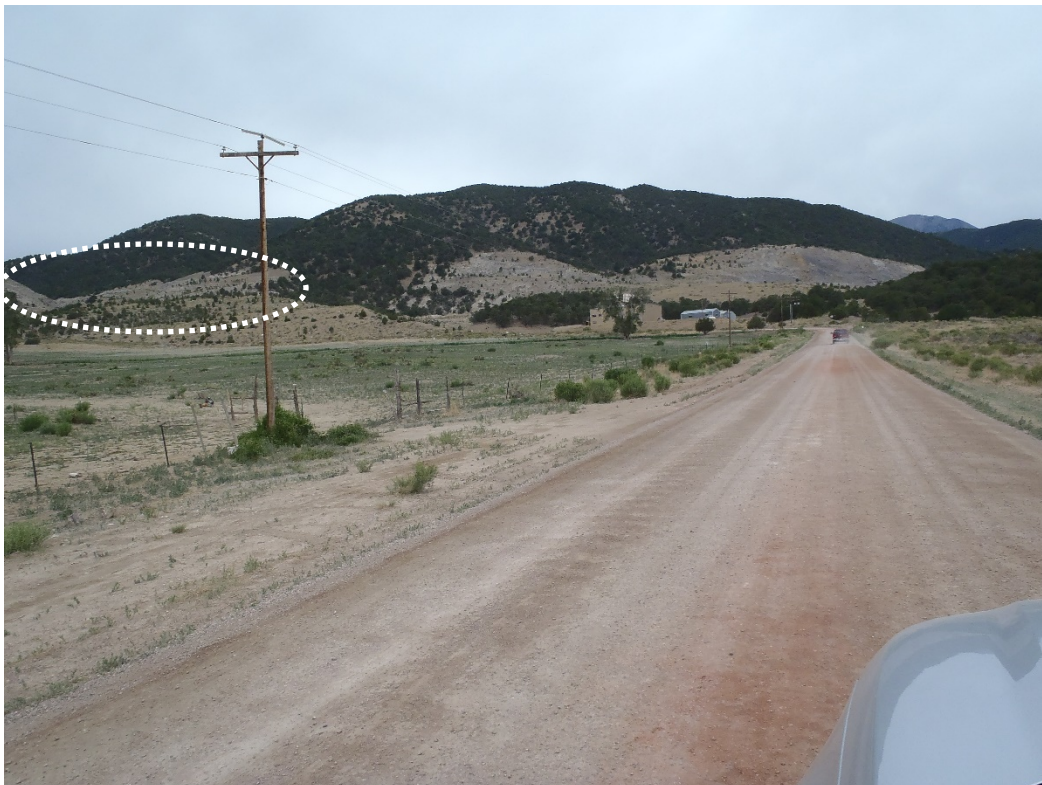
**Reclamation Success:** The proposed Titanium Hill expansion area appears to have been disturbed historically. The 1980 USGS Coaldale quadrangle map shows the area to be "Strip Mine" and the area exhibited some self-reclaimed disturbance (see **Photos 5 through 8**). Once disturbed again by future operations, it will need to be

Structures: A power line (see **Photo 5**) was observed along the entrance road which is in or on the edge of the affected area boundary. A structure damage compensation agreement will be required for the power line (unless it is owned by Holcim) prior to the approval of AM-03. Seven other structures were observed on site that will require demolition for final reclamation: four buildings (see **Photos 10 & 11**) and three storage tanks (see **Photo 12**).

Photo 5. Titanium Hill area pre-law disturbance (circled) and power line along entrance road.

reclaimed per the approved permit amendment.

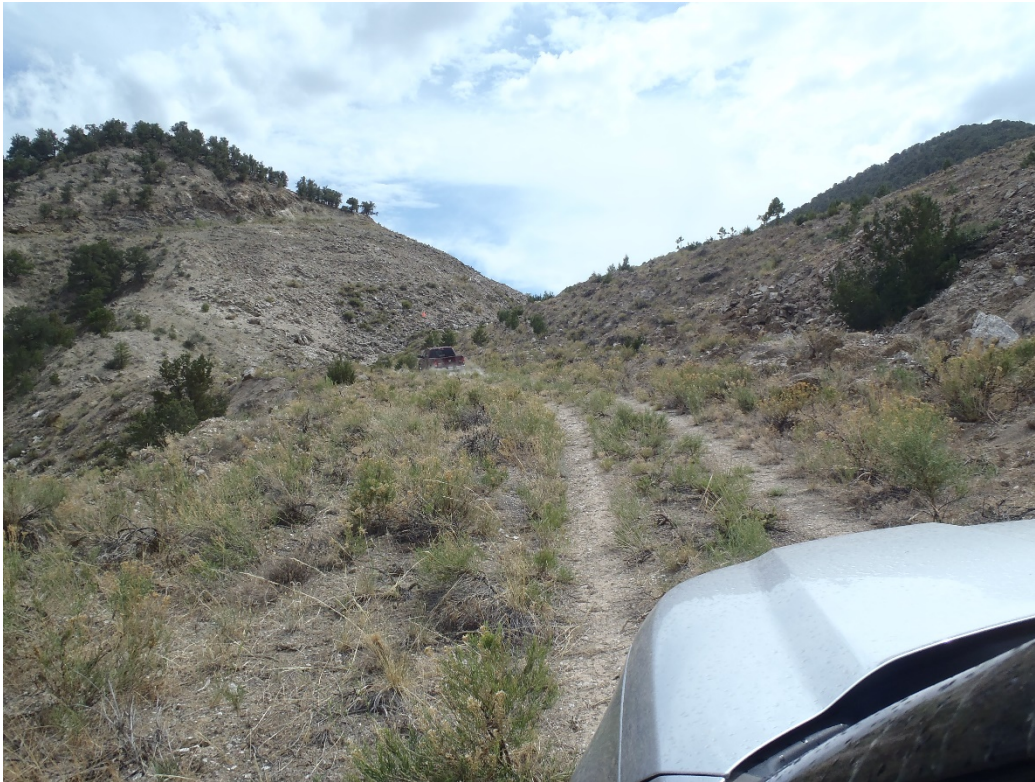
Photo 6. Titanium Hill area self-reclaimed pre-law disturbance and access road (looking SE).

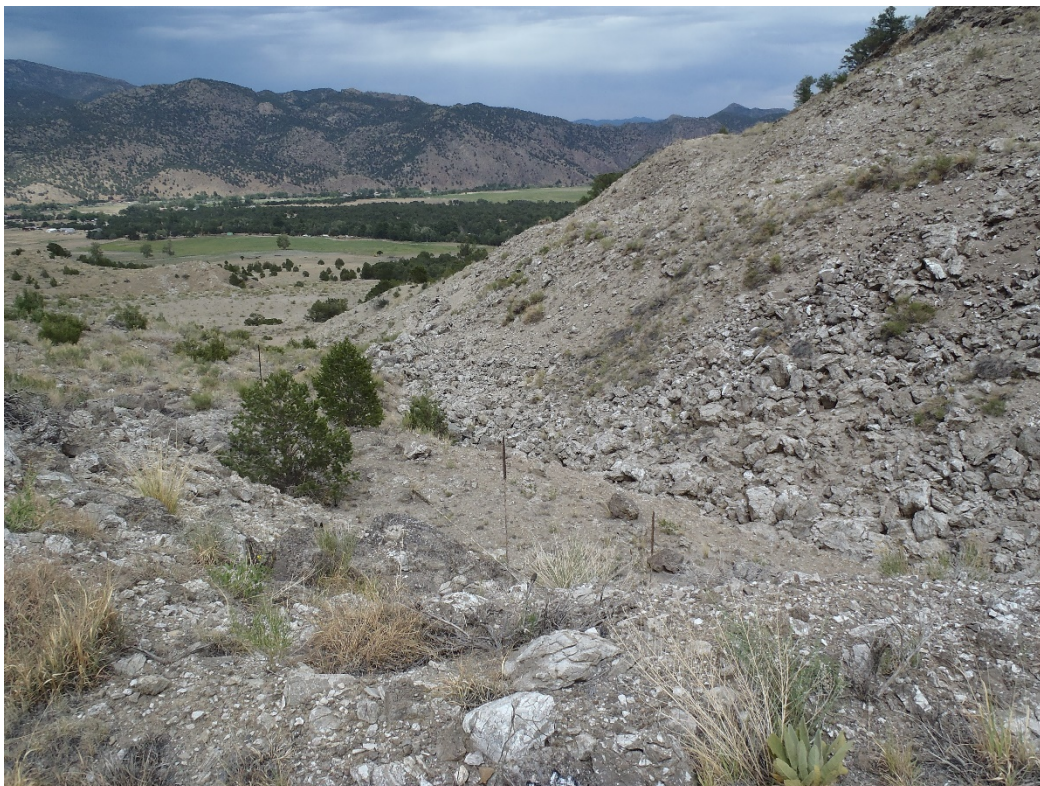
Photo 7. Titanium Hill area self-reclaimed pre-law disturbance (looking NE).

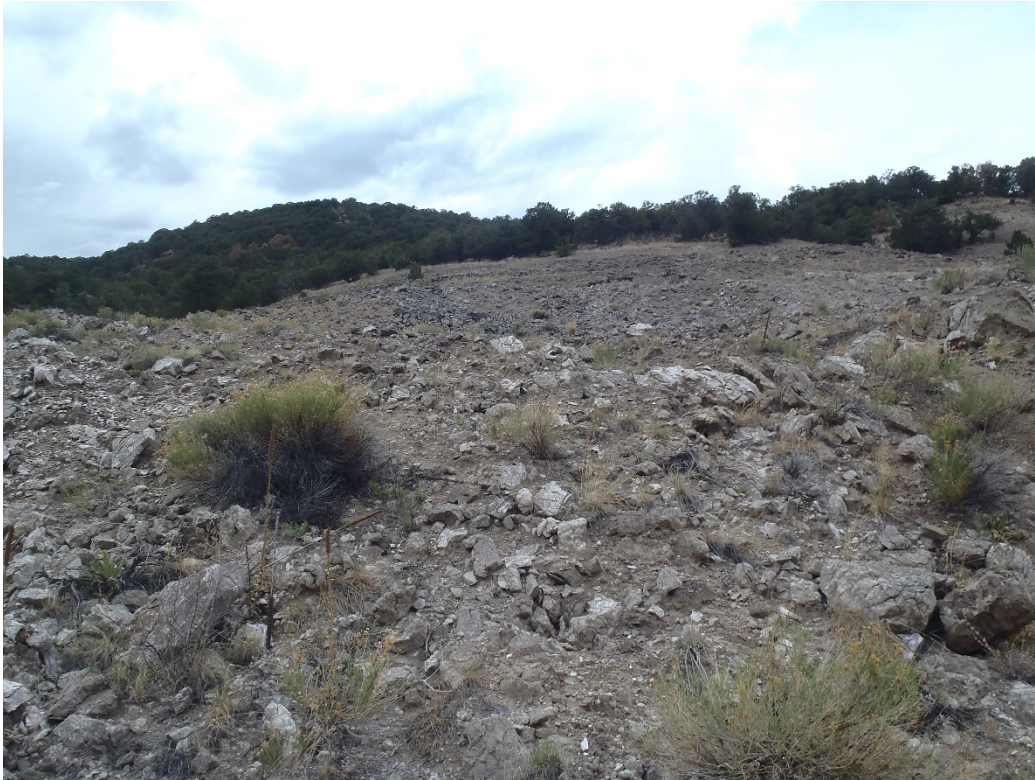
Photo 8. Titanium Hill area self-reclaimed pre-law disturbance (looking uphill to the west).

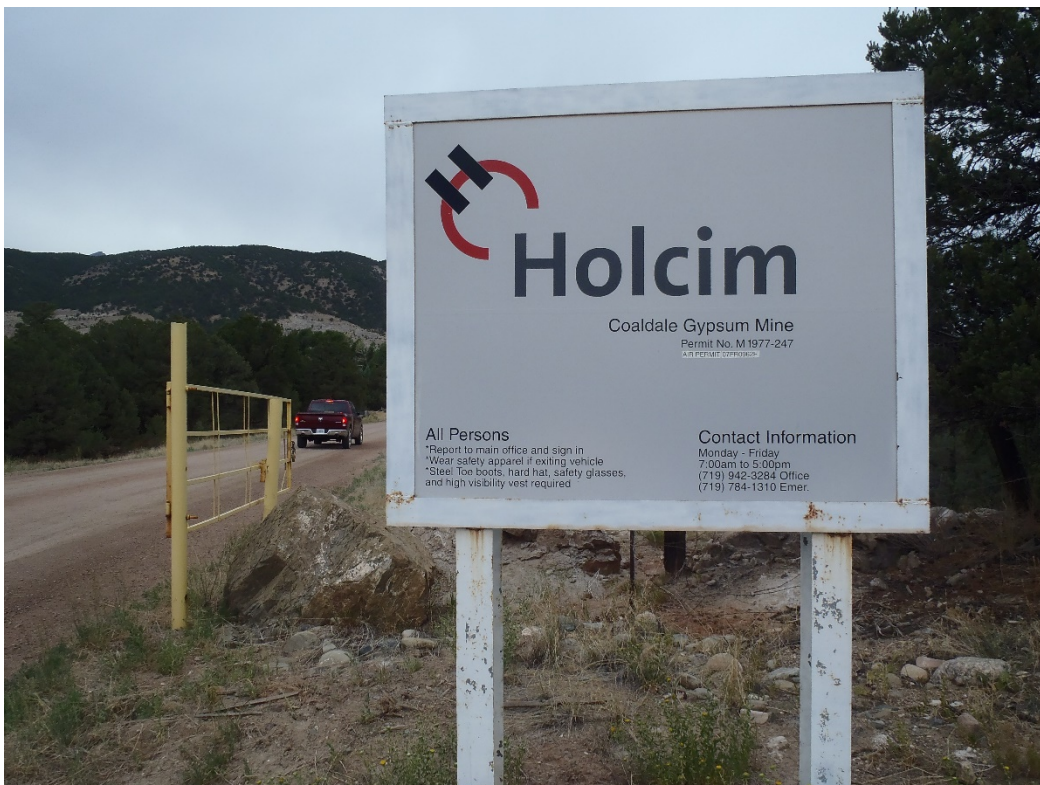
Signs and Markers: The permit sign was properly posted (see **Photo 9**). The Division reminded site representatives the affected area boundary for the expanded permit area will need to be marked.

Photo 9. Permit sign (at entrance).

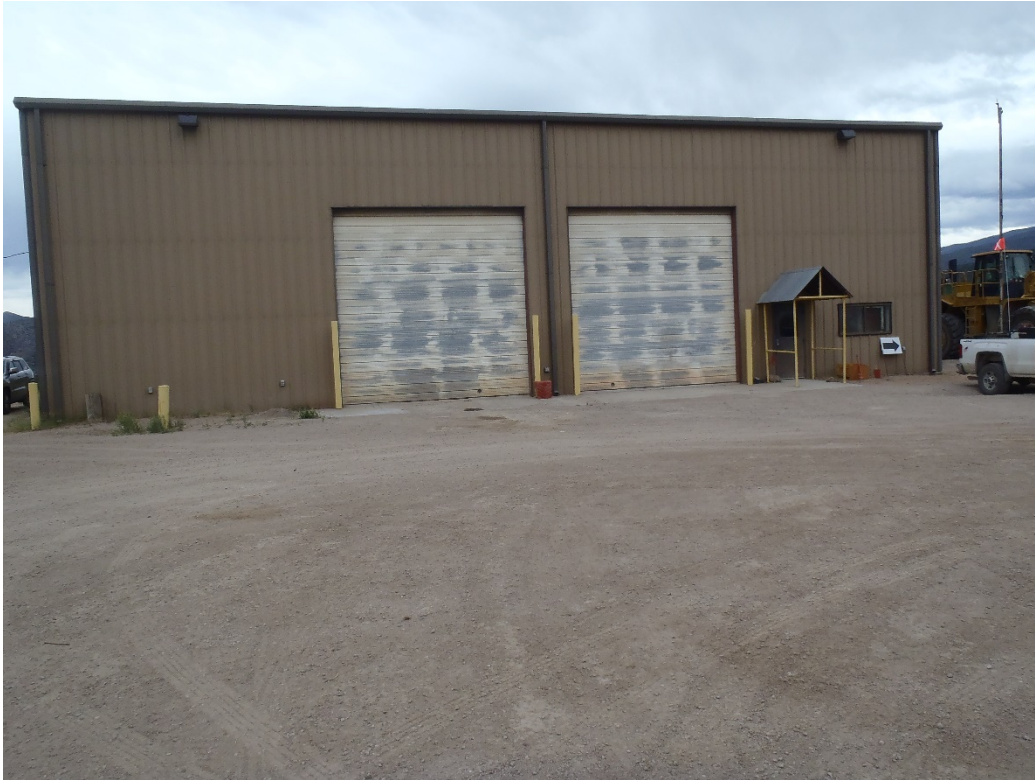
Photo 10. Large shop building (looking east).

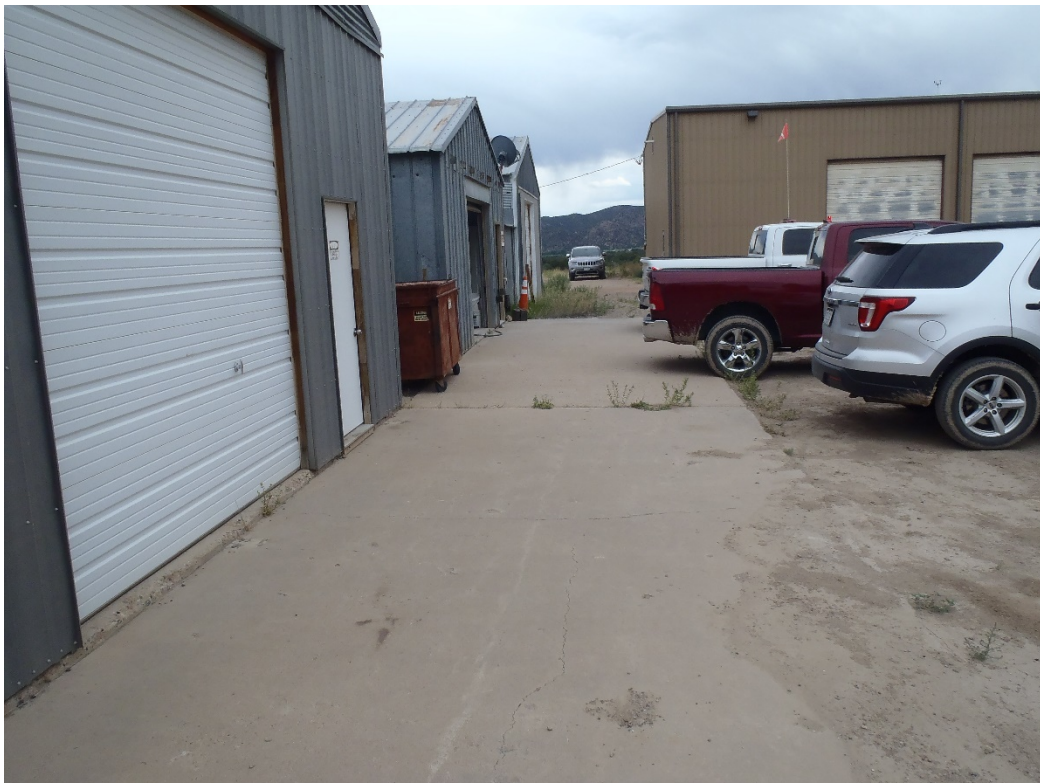
Photo 11. Smaller shop buildings (looking east).

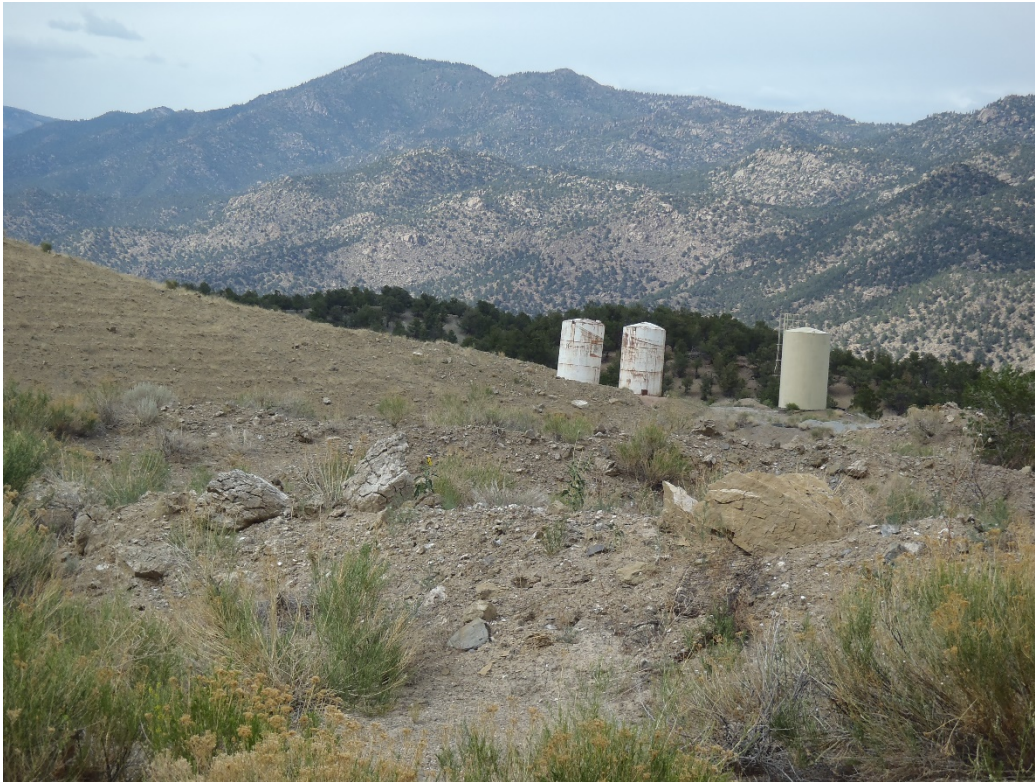
Photo 12. Three storage tanks (looking north from above product stockpile area).
