MINERALS PROGRAM INSPECTION REPORT
PHONE: (303) 866-3567

MINE NAME: Cresson Project	MINE/PROSPECTING ID#: M-1980-244	MINERAL: Gold	COUNTY: Teller
INSPECTION TYPE: Monitoring	INSPECTOR(S): Timothy Cazier	INSP. DATE: July 29, 2020	INSP. TIME: 09:00
OPERATOR: Cripple Creek & Victor Gold Mining Company	OPERATOR REPRESENTATIVE: Katie Blake, Jeana Ratcliff	TYPE OF OPERATION: 112d-3 - Designated Mining Operation	
REASON FOR INSPECTION: Normal I&E Program	BOND CALCULATION TYPE: None	BOND AMOUNT: \$209,491,188.00	
DATE OF COMPLAINT: NA	POST INSP. CONTACTS: None	JOINT INSP. AGENCY: None	
WEATHER: Clear	INSPECTOR'S SIGNATURE:

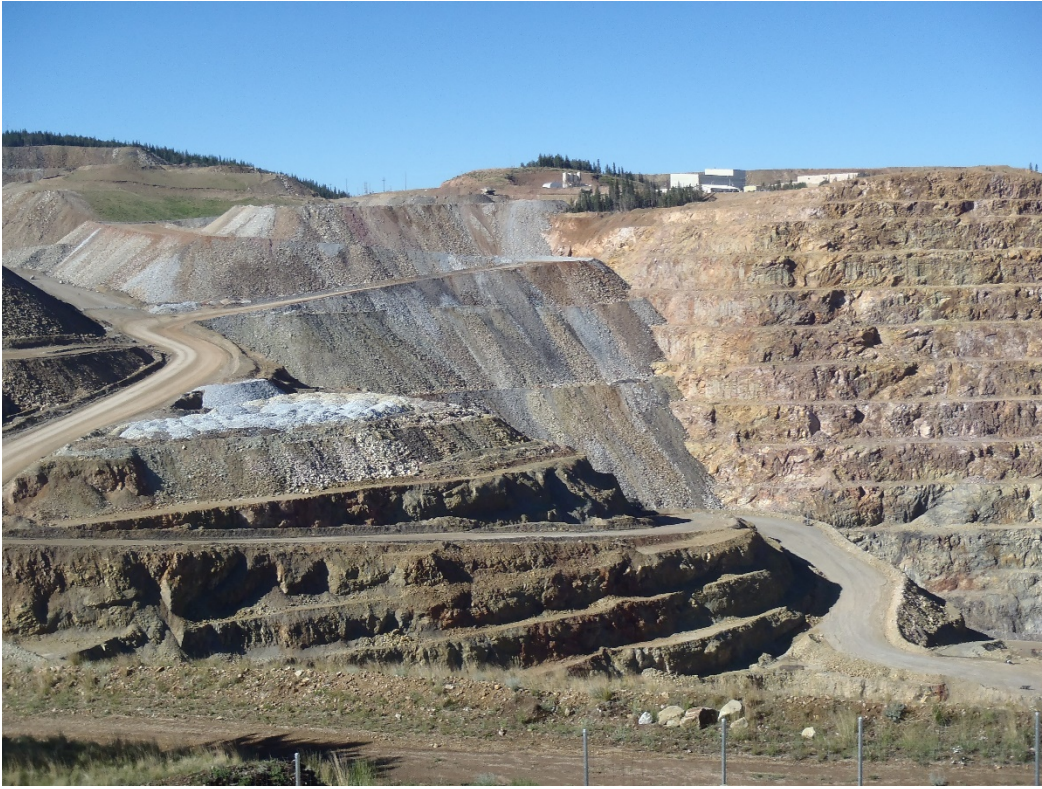
WHEX Backfill: Prior to meeting with CC&V representatives, I stopped at the CR 82 overlook east of the WHEX pit. **Photo 1** shows the progression of the WHEX pit backfill.

Photo 1. WHEX pit backfill from CR 82 Overlook.

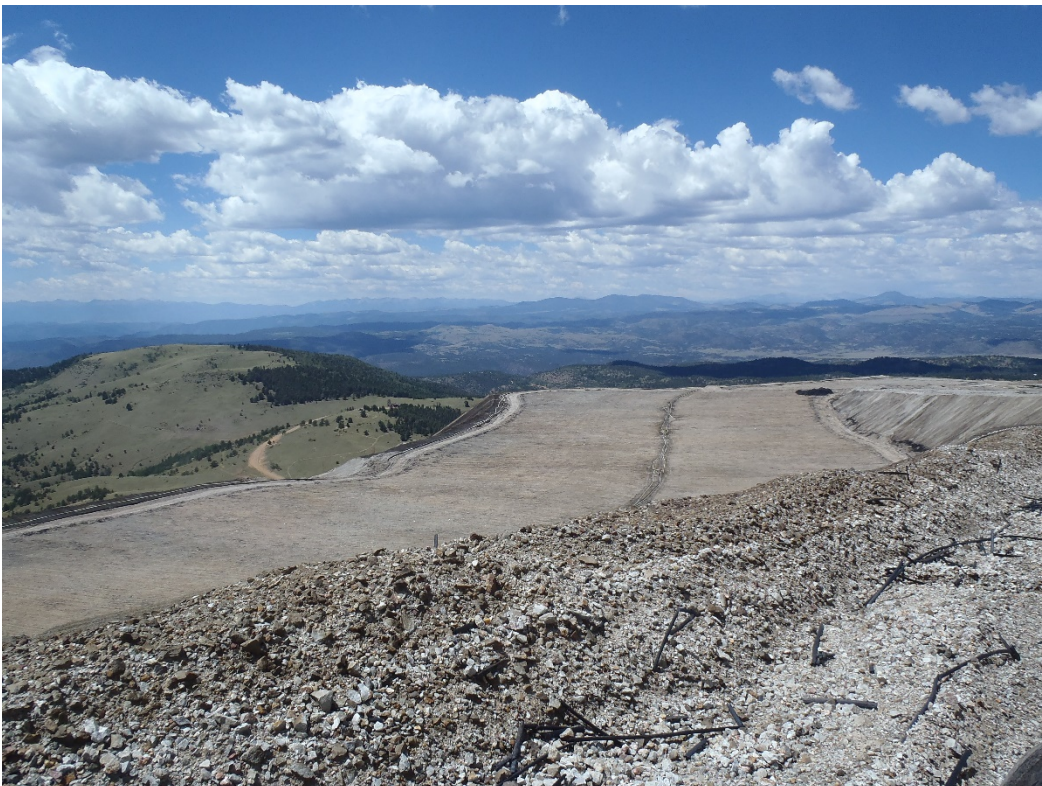
VLF 1 was also checked for solution ponding limits based on the approved wildlife protection plan limiting ponding to areas less than 3 feet by 3 feet. The 10,200 (see **Photo 2**), 10,300 (see **Photo 3**) and 10,400 (see **Photo 4**) levels had been recently ripped and were not being actively leached. The mine has been focusing on leaching the VLF 1 outcrops (see **Photo 5**) using sprinklers in the summer for two years now.

Photo 2. VLF 1 south 10,200 level – no ponded process solution observed (looking west).

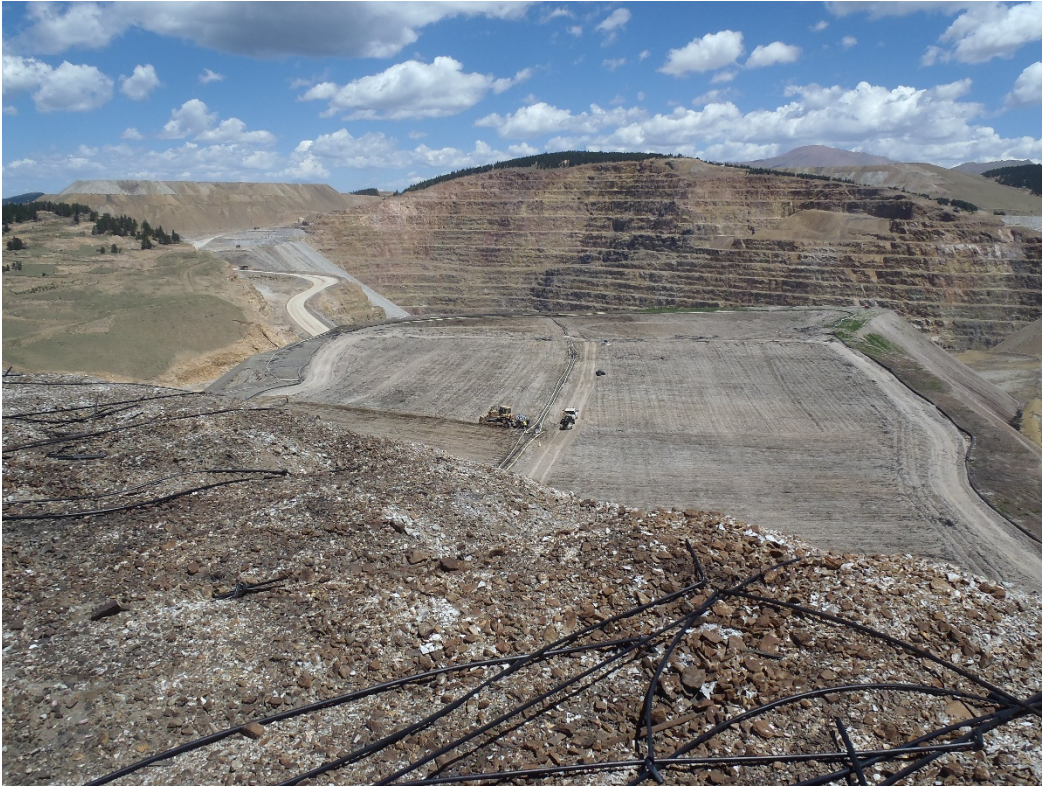
Photo 3. VLF 1 10,300 level – no ponded process solution observed (looking north from the 10,400 level).

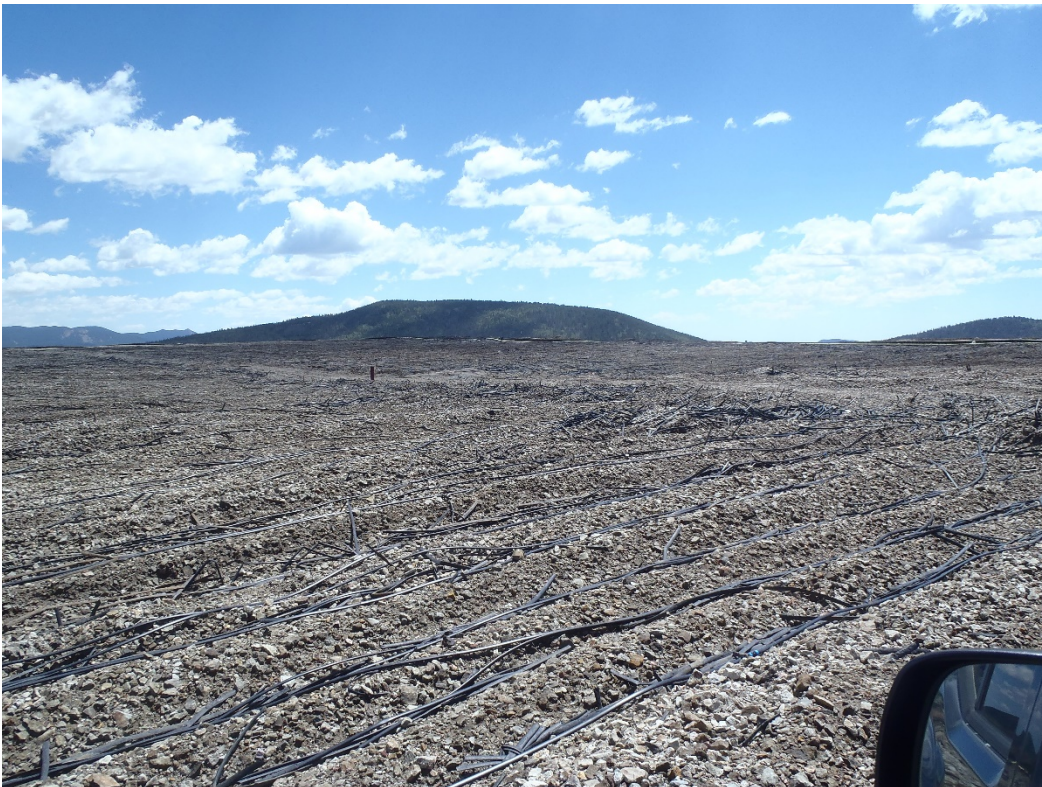
Photo 4. VLF 1 10,400 level – no ponded process solution observed (looking west).

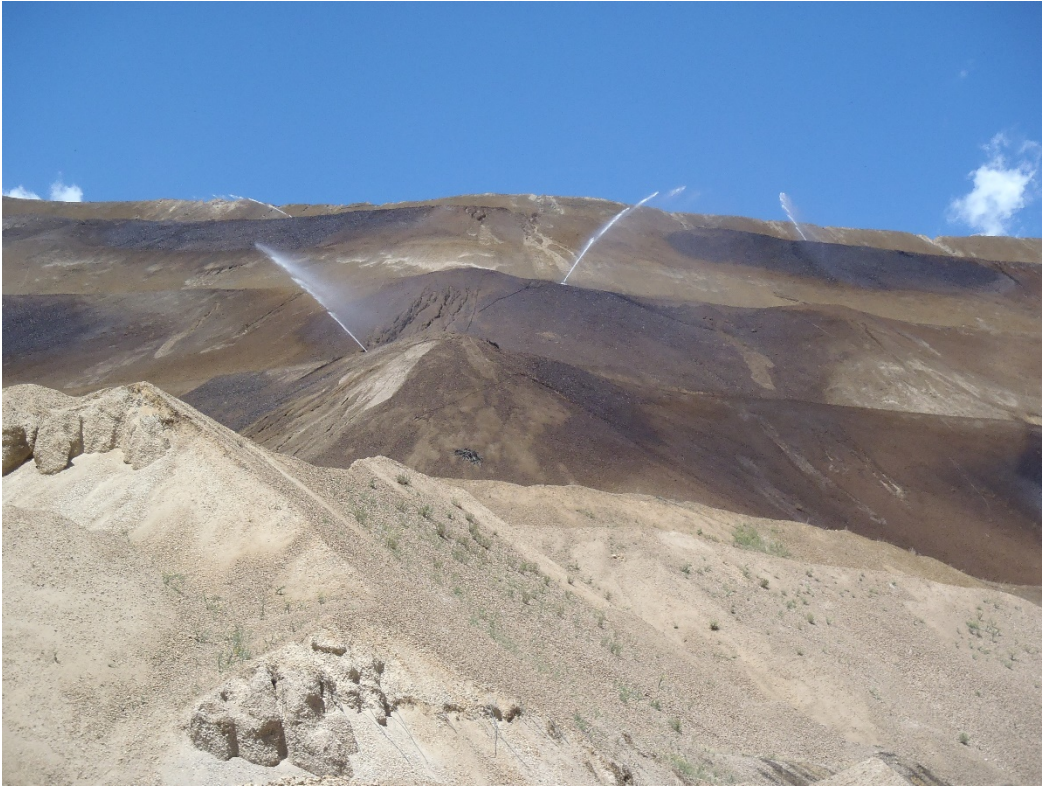
Photo 5. VLF 1 outslope sprinklers applying solution.

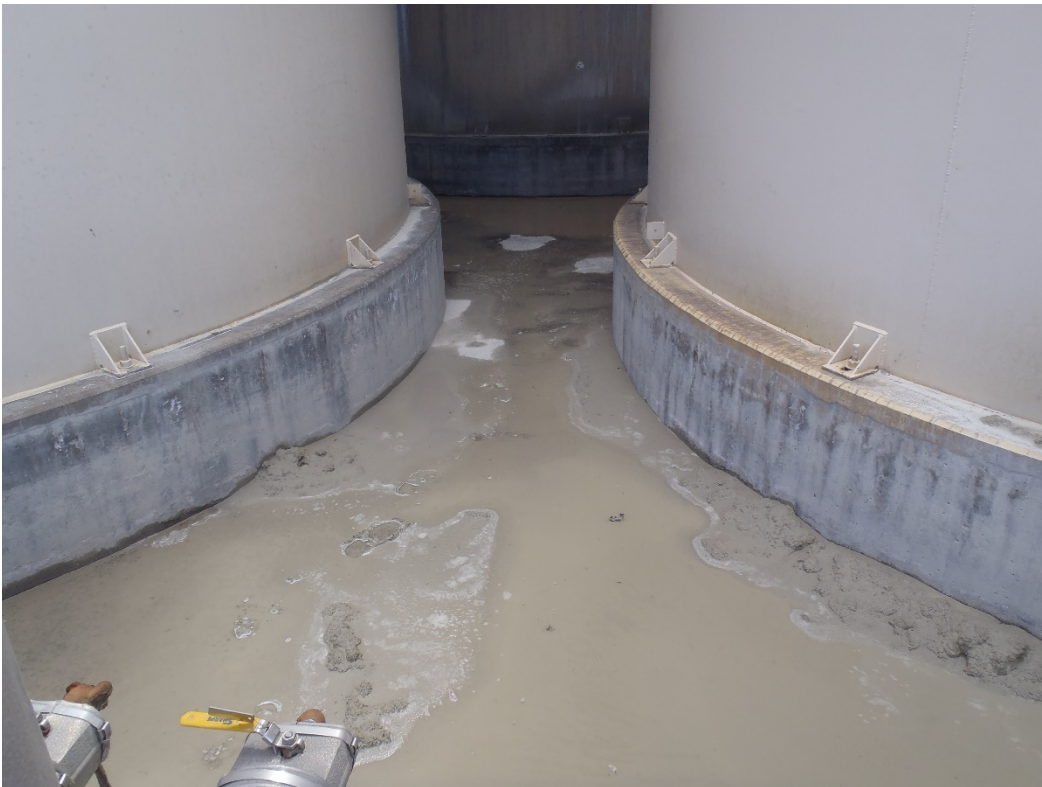
High Grade Mill: Messrs. Charles Bissue and Andrew Orser accompanied the DRMS on the mill exterior walk-around inspection. The purpose was to perform a visual inspection for leaks, spills and secondary containment problems. Both the east and west sides of the mill exterior were inspected, as well as the area around the concentrate storage facility (Con Barn). Some water and minor amount of sludge were observed in the Vat Leach tank area on the west side of the HGM (see **Photo 6**). Mr. Orser stated the water was a result of recent rain and the sludge was from the rain washing off sediment in the vat leach area. CC&V had scheduled maintenance to remove the water and sludge. As it was being addressed and did not appear to significantly impact storage volume, it was not cited as a problem. The east side of the HGM was clear of water and debris (see **Photo 7**). The sump on the southwest corner of the HGM platform was observed to have clear water estimated to be between 1.5 and 2 feet deep (see **Photo 8**).

Photo 6. Vat leach side of High Grade Mill – rain water and sludge, scheduled for removal.

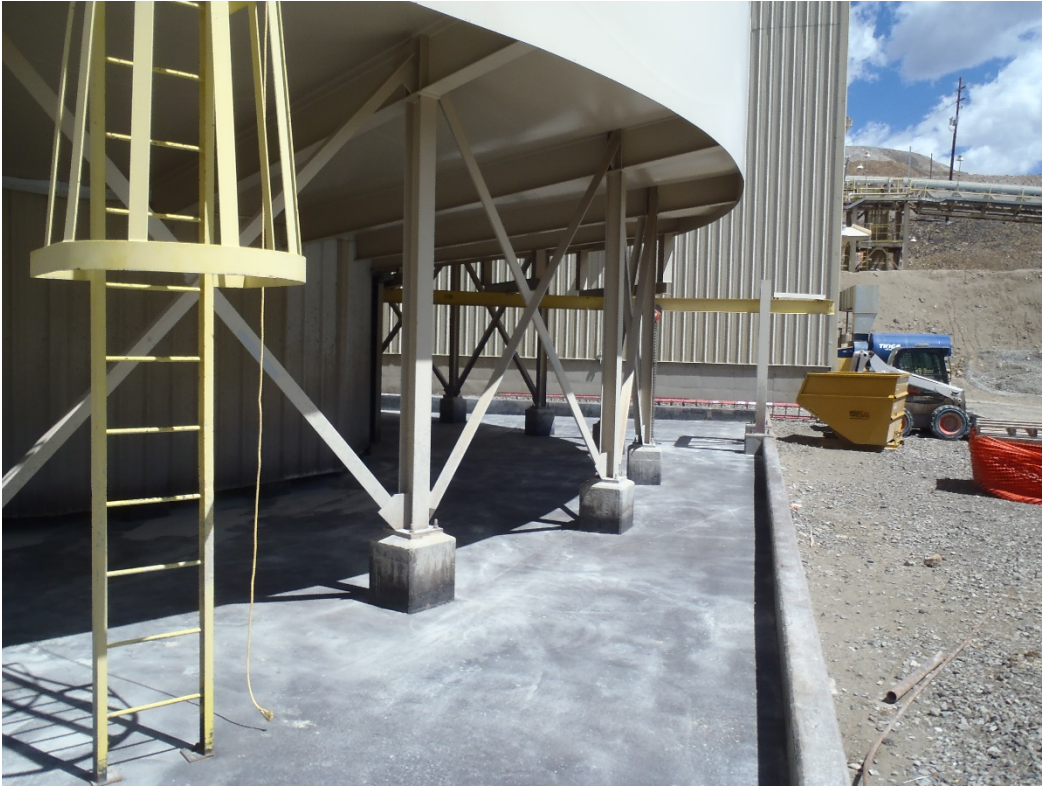
Photo 7. East side of High Grade Mill - clean.

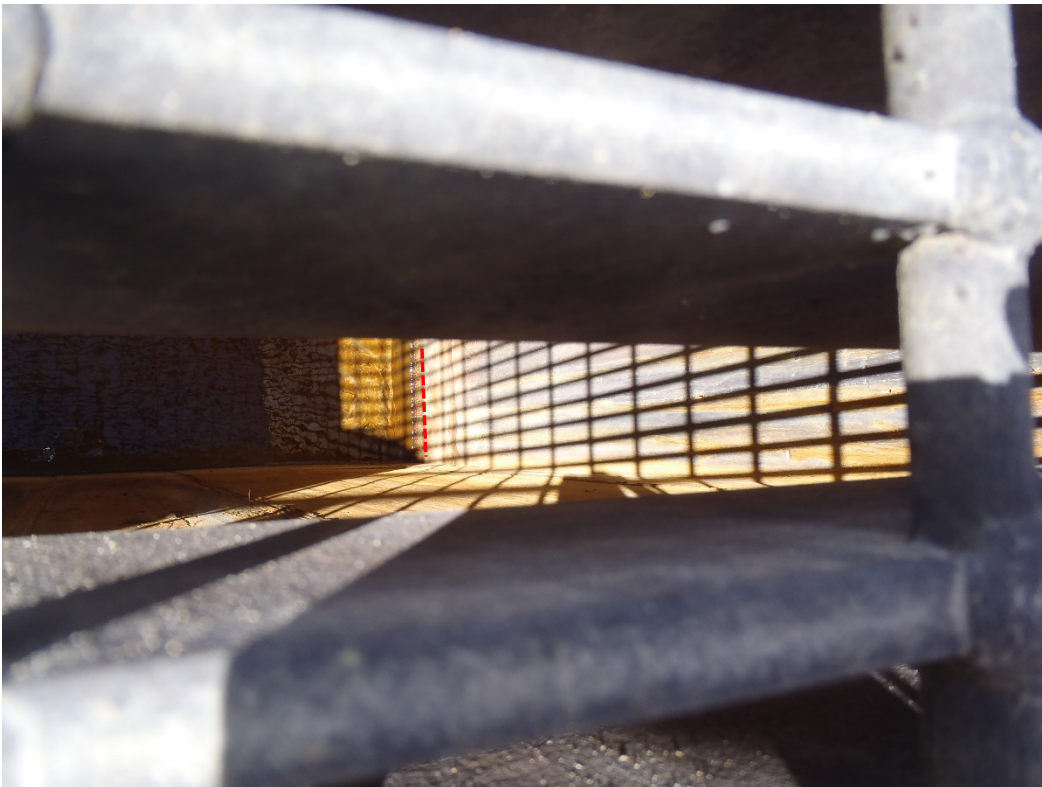
Photo 8. Sump southwest of High Grade Mill – water clear, level marked by red line.

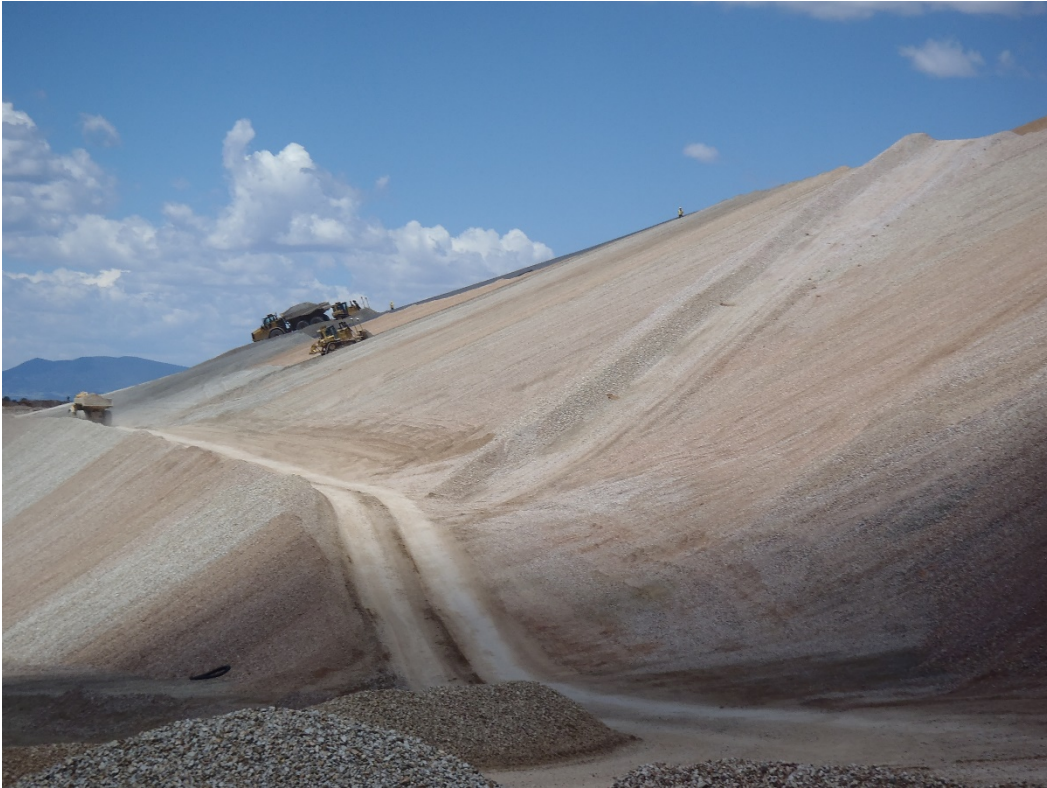
Squaw Gulch Valley Leach Facility (VLF 2): Mr. Steve Blaskovich accompanied the DRMS to the crest of the pad on the north side of VLF 2 to observe construction. Both drain cover fill (DCF) and soil liner fill (SLF) were being placed (see **Photos 9 and 10**). Mr. Blaskovich indicated the DCF was a minimum of four feet thick where the articulated haul trucks were driving over it. The specification minimum thickness is 42 inches. No problems were observed.

Photo 9. VLF 2 construction – DCF placement.

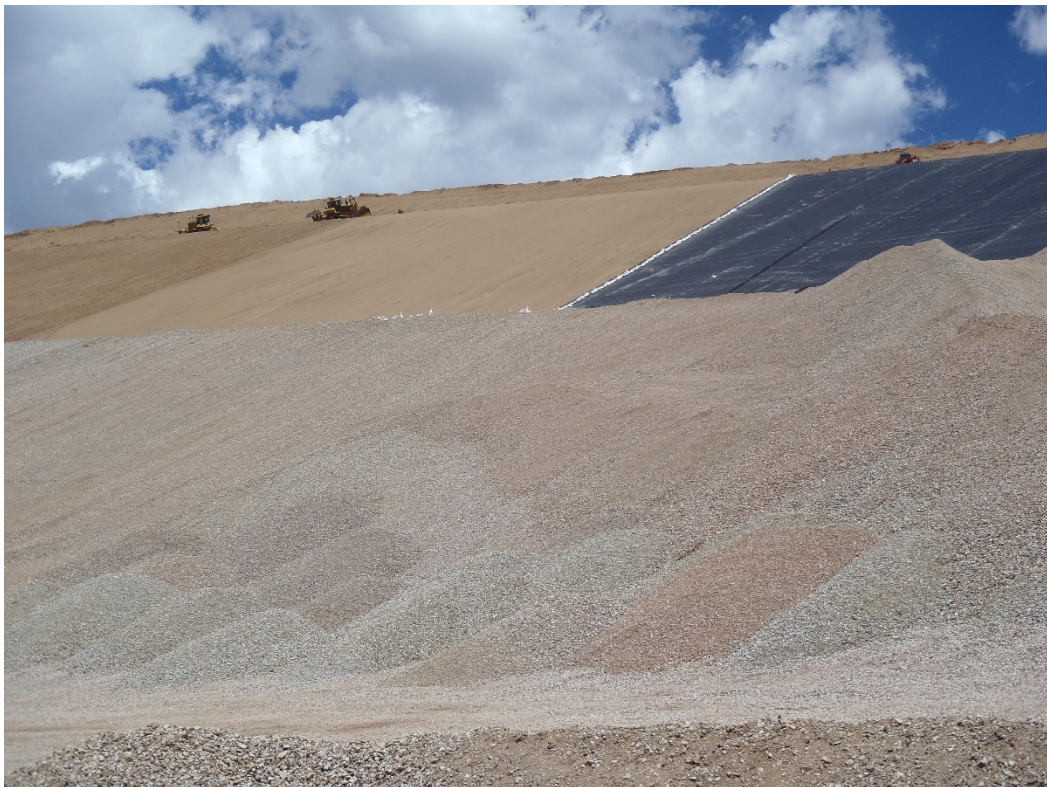
Photo 10. VLF 2 construction – SLF placement (on upper left slope, DCF on lower slope).

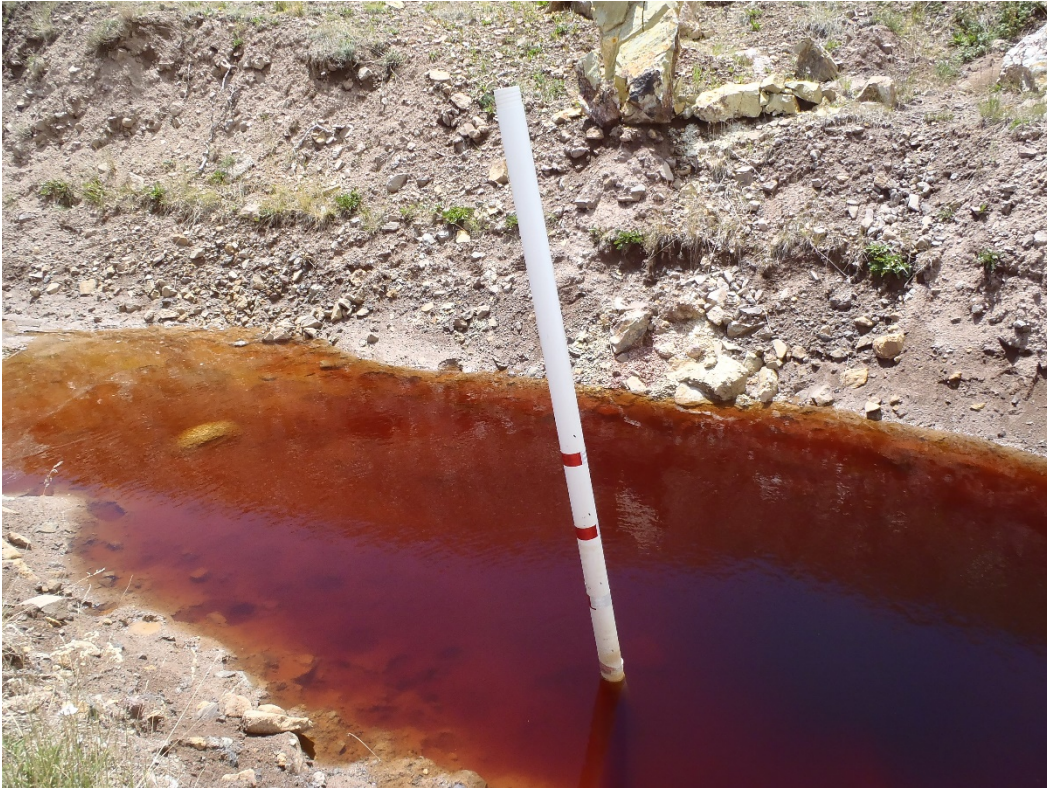
East Cresson Overburden Storage Area (ECOSA) Seep: The seepage area had some ponded water (see **Photo 11**), but near zero inflow was observed (see **Photo 12**). Ms. Ratcliff stated 2 ¾ water truck loads had been

Photo 11. Water level in ECOSA seep pond.

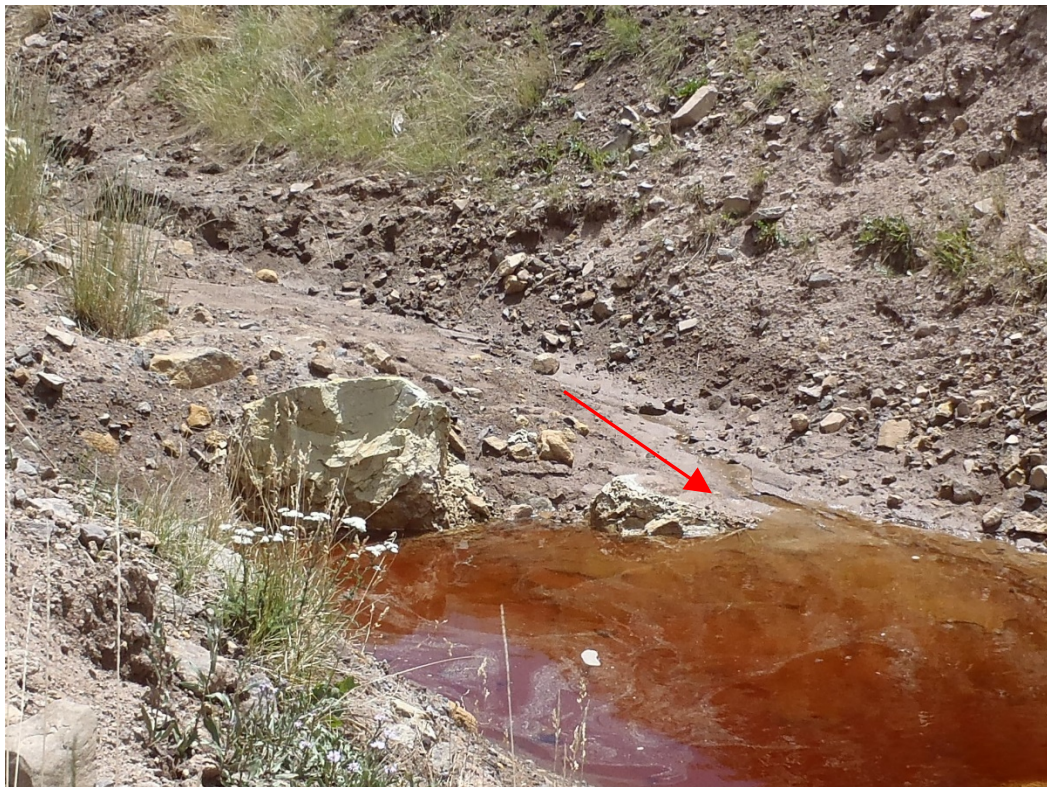
Photo 12. ECOSA seep pond inflow – near zero.

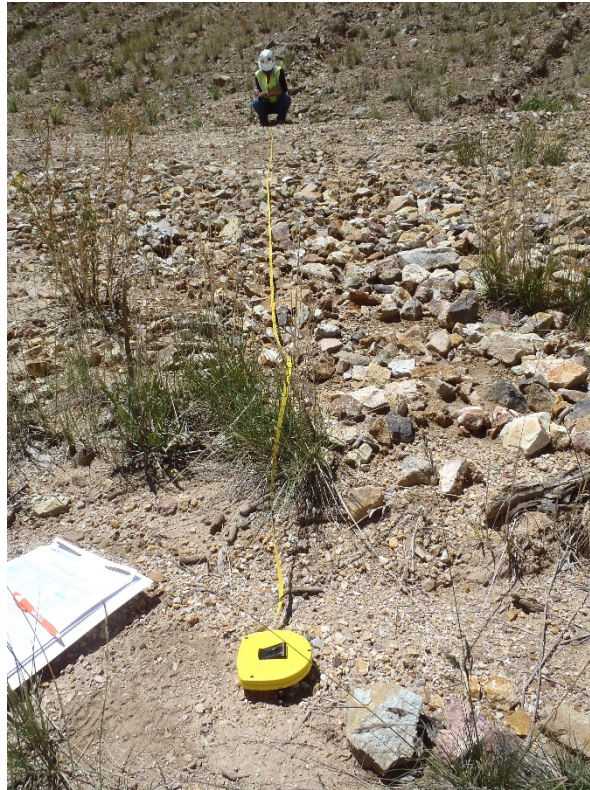
Altman Backfill erosion: The erosion features identified from our May aerial inspection (reference May 18, 2020 inspection report Photo 13A) were investigated. The attached **Figure 1** shows the area in detail. The alluvial fan deposit at the base of the largest erosion gully was measured to be 29 feet at its widest (see **Photo 13**) and 73 feet long (see **Photo 14**). Three primary gullies appeared to be the contributors to the fan deposit (see **Photo 15**). The gullies ranged in size from 28 to 52 inches wide and 14 inches to 38 inches deep (see **Photo 16**). Groin erosion along the contact between the backfill and native ground was also observed (see **Photo 17**). *If stormwater is to continue along this groin alignment for final reclamation, erosion protection armoring will be required.* A hole (see **Photo 18**) which did not get backfilled as part of the Altman reclamation effort is in close proximity of the observed groin erosion. As no apparent offsite impact was observed, the DRMS is not citing a problem for these conditions. *However, CC&V needs to be aware the DRMS cannot approve reclamation release under these conditions as they do not meet the requirements of Rules: 3.1.5(3) – “All grading shall be done in a manner to control erosion and siltation of the affected lands, to protect areas outside the affected land from slides and other damage.”; and 3.1.6(3) – “All surface areas of the affected land, including spoil piles, shall be stabilized and protected so as to effectively control erosion.”.* It should also be noted the observed hole is not allowed under the approved reclamation plan.

Photo 13. Altman backfill erosion fan at widest part (29 feet).

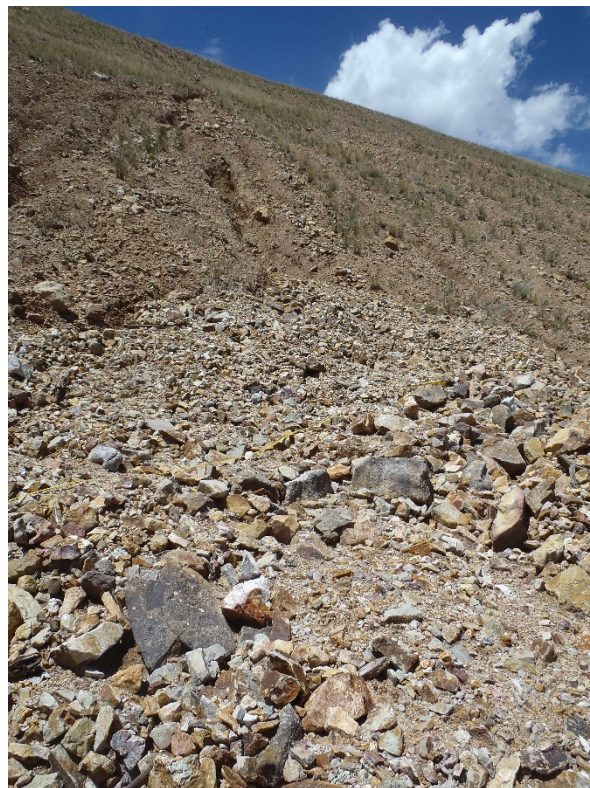
Photo 14. Altman backfill erosion fan along axis of deposition.

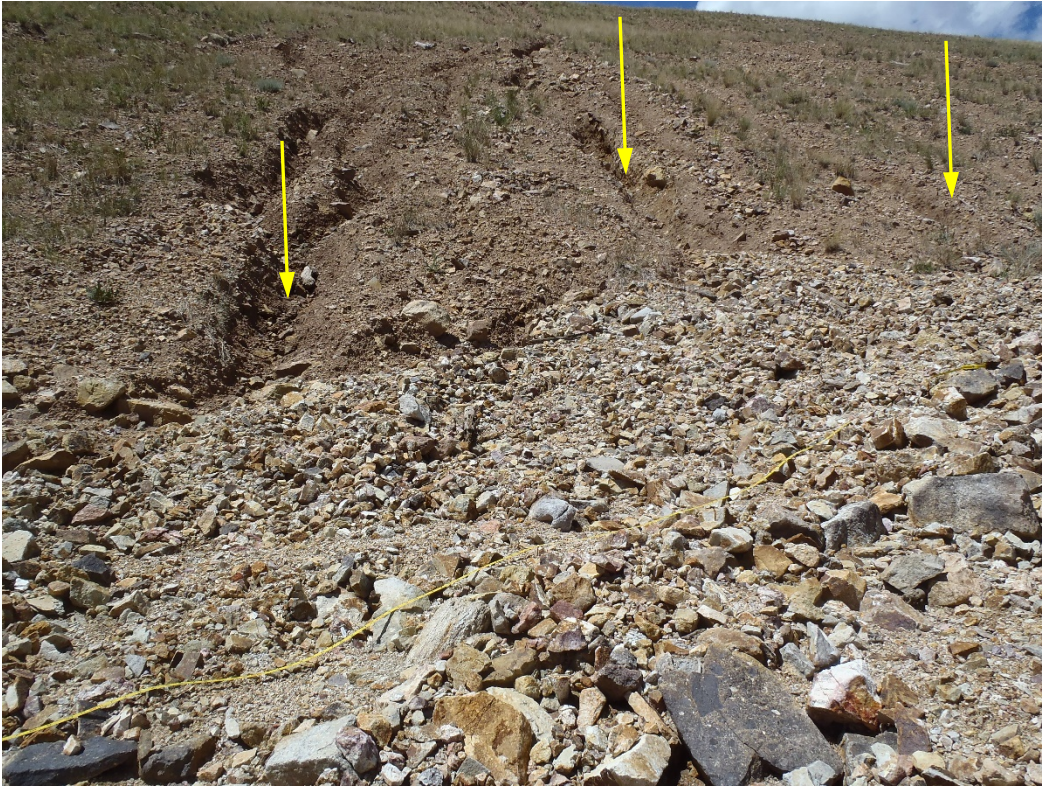
Photo 15. Three primary gullies contributing to erosion deposition fan.

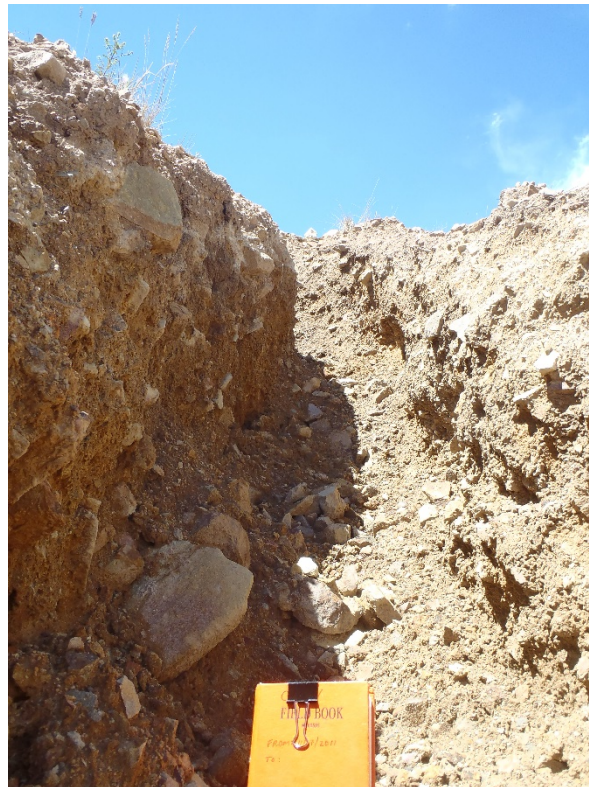
Photo 16. Deepest gully at 38 inches.

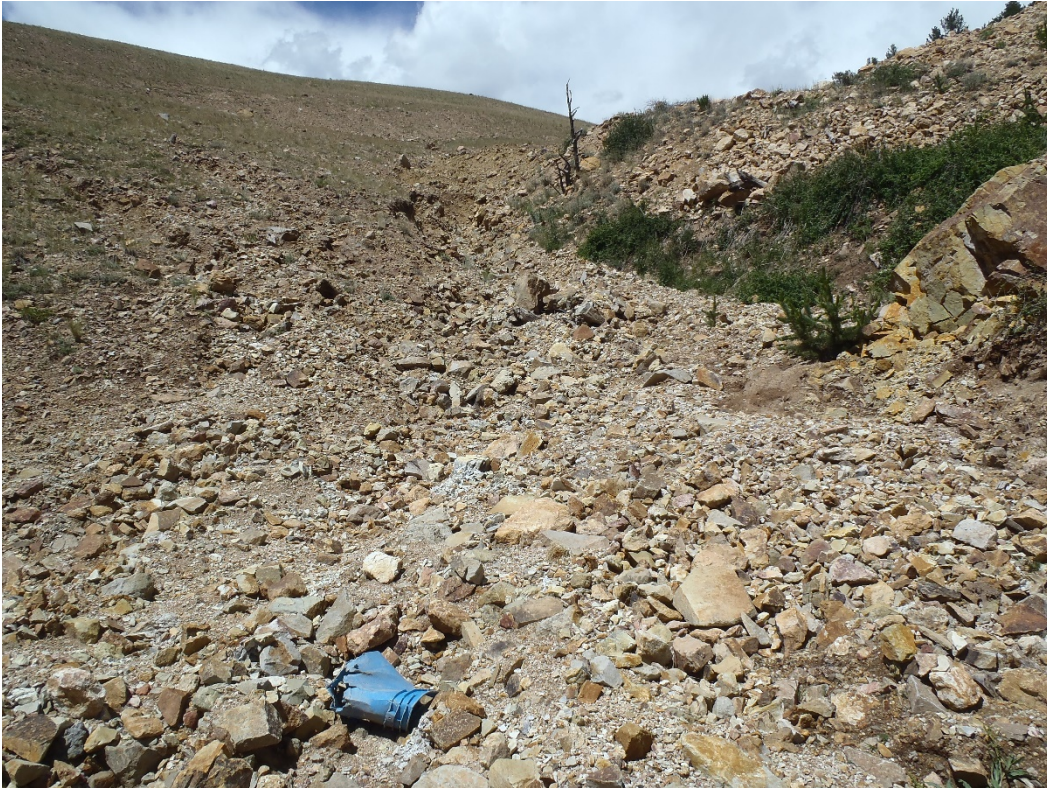
Photo 17. Groin erosion along contact between Altman backfill and native ground (erosion protection will be required for final reclamation).

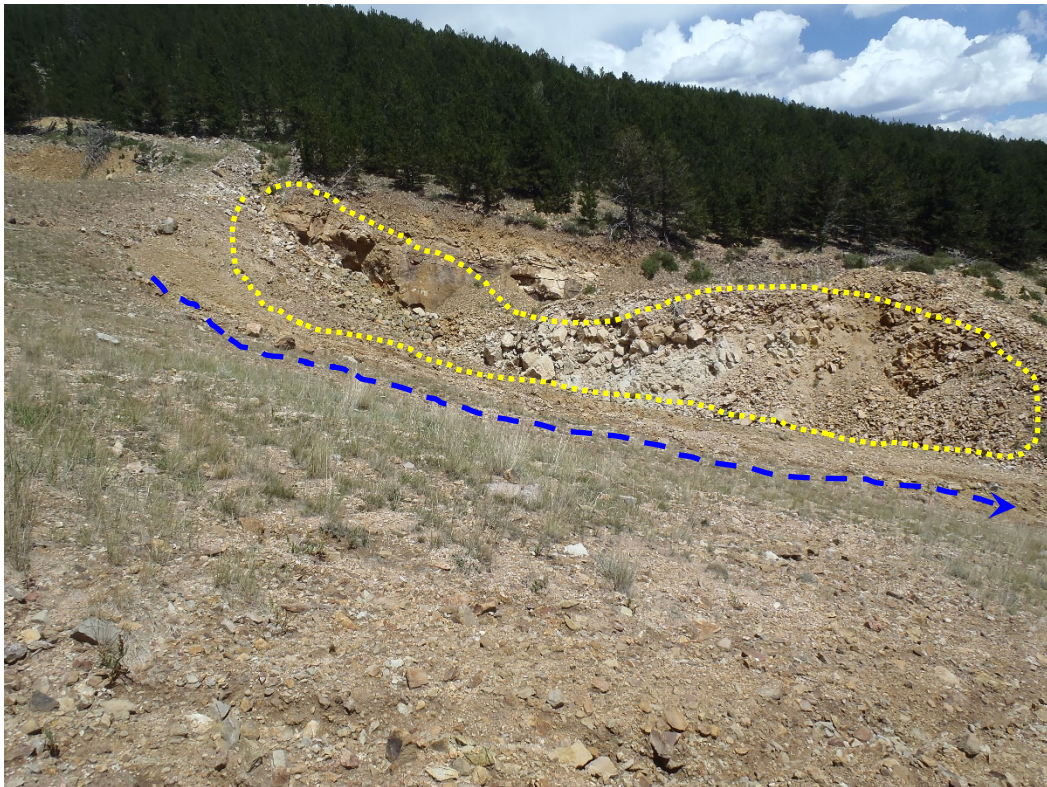
Photo 18. Hole on east side of Altman backfill enclosed in dotted line, groin erosion denoted by dashed arrow.

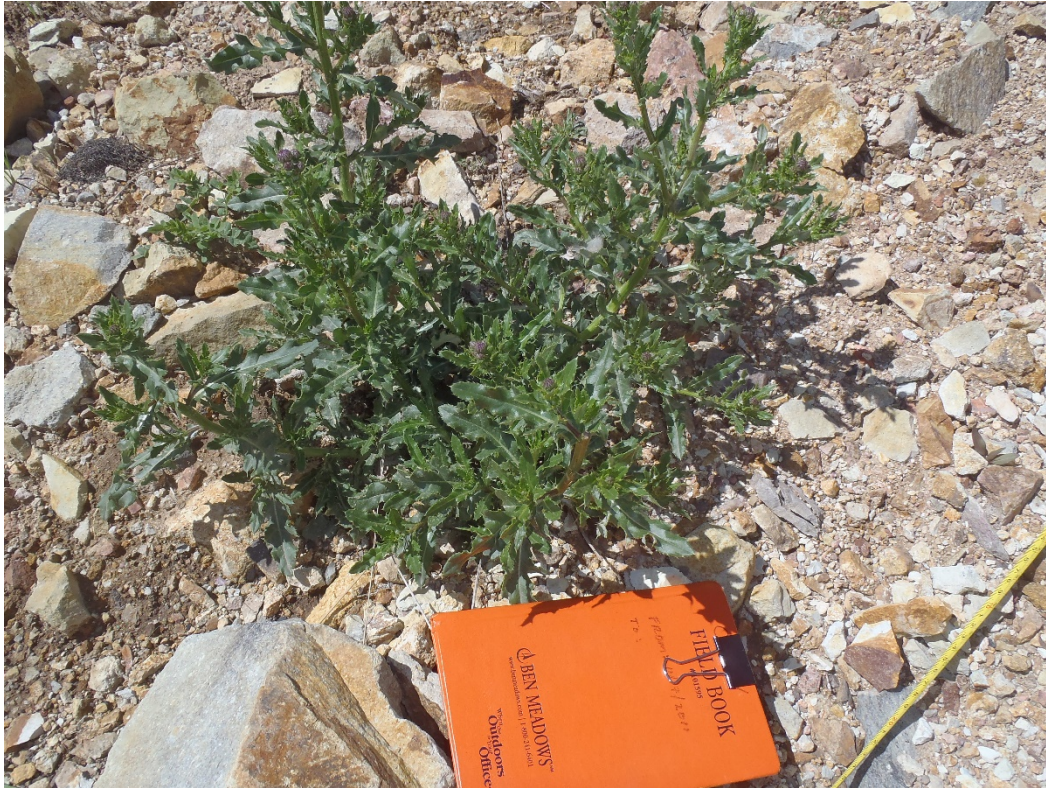
A few patches of thistle (see **Photo 19**) were observed on the bench near the contact groin erosion. Based on photos taken during the inspection, the DRMS identified these as Canada thistle, a B list noxious weed. The DRMS also observed Canada thistle on topsoil stockpiles during the August 18, 2020 inspection (report forthcoming) and we are reviewing CC&V weed control reports to determine whether a problem will be cited for the combined Canada thistle observations between July and August.

Photo 19. Canada thistle near the groin erosion along contact between Altman backfill and native ground.

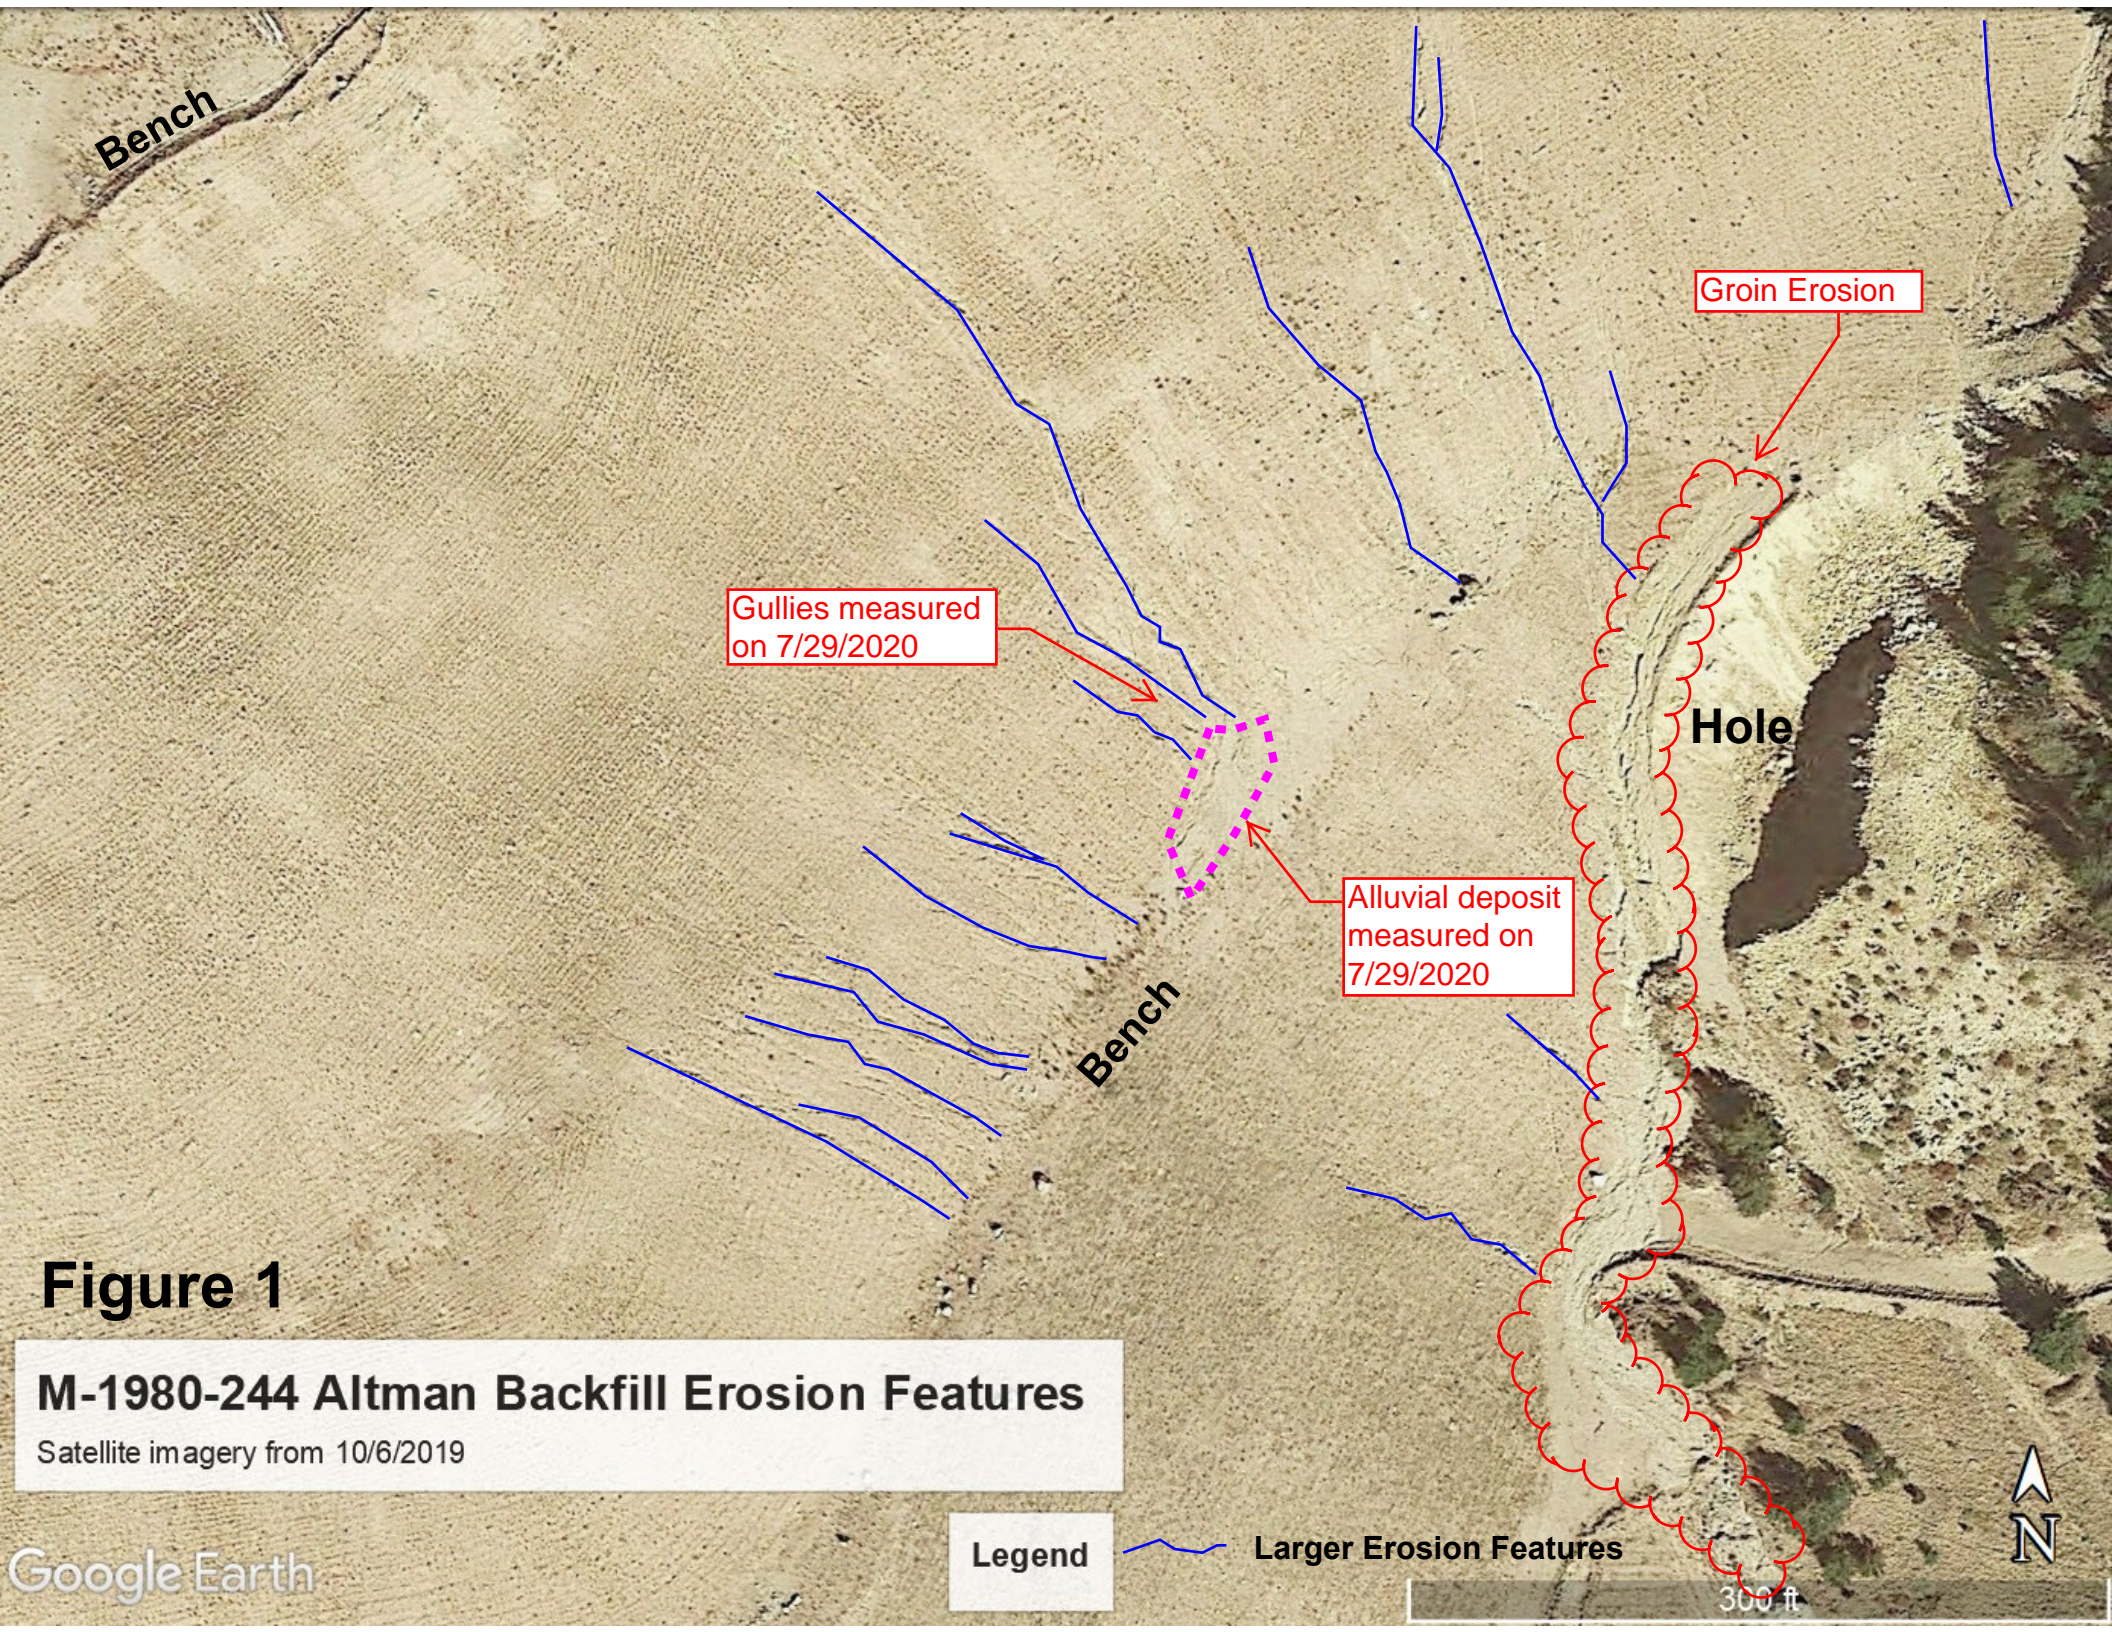
Figure 1

M-1980-244 Altman Backfill Erosion Features
