<b>Permit Number:</b> C-1982-056 <b>Mine Name:</b> Foidel Creek Mine <b>Operator:</b> Twentymile Coal, LLC <b>Operator Address:</b> Ms Miranda Kawcak 29515 Routt County Road No. 27 Oak Creek, CO 80467	<b>County:</b> Routt <b>Operation Type:</b> Underground <b>Permit Status:</b> Active <b>Ownership:</b> Private
	<b>Operator Representative Present:</b>  Miranda Kawcak
<b>Operator Representative Signature:</b> (Field Issuance Only)

<b>Inspection Start Date:</b> August 27, 2020 <b>Inspection Start Time:</b> 09:00 <b>Inspection End Date:</b> August 28, 2020 <b>Inspection End Time:</b> 09:00		<b>Inspection Type:</b> Coal Partial Inspection <b>Inspection Reason:</b> Normal I&E Program <b>Weather:</b> Clear	
<b>Joint Inspection Agency:</b>  None		<b>Joint Inspection Contacts:</b>  	
<b>Post Inspection Agency:</b>  None		<b>Post Inspection Contacts:</b>  	
<b>Inspector(s):</b>  Tabetha Lynch	<b>Inspector's Signature:</b>

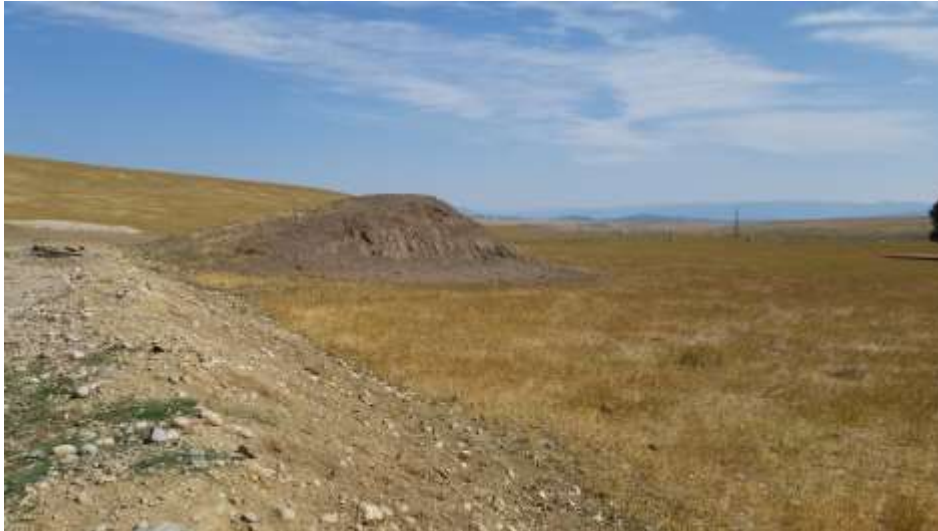
12 Left pad slopes and Topsoil pile need to be reseeded and stabilized.

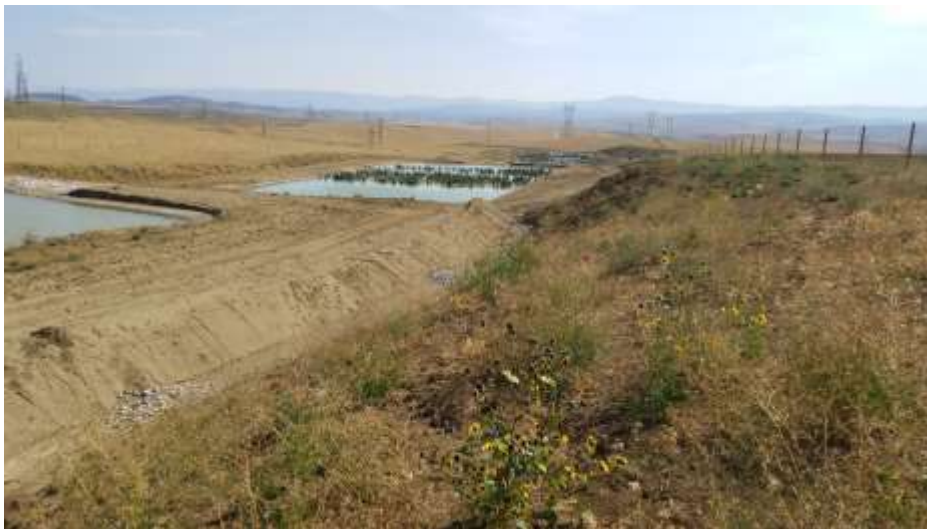
Slopes of passive treatment ponds need to be reseeded.

The success of spring seeding was observed at the Tipple, some topsoil piles, the passive treatment ponds, and the thickener underflow corridor areas. The tipple was reseeded in areas after some work was conducted by Union Pacific railroad. This areas did have some growth, though all the vegetation on site was very dry this August. The topsoil piles at the new pads, the underflow corridor, and slopes to passive treatment ponds should be reseeded this fall as the vegetation is sparse or did not come up well.
