**PERMIT INFORMATION**

<b>Permit Number:</b> C-1992-081 <b>Mine Name:</b> Hayden Gulch Loadout <b>Operator:</b> Hayden Gulch Terminal, LLC <b>Operator Address:</b> Ms Miranda Kawcak  P.O. Box 670 Hayden, CO 81639	<b>County:</b> Routt <b>Operation Type:</b> Loadout <b>Permit Status:</b> Active <b>Ownership:</b> Private  <b>Operator Representative Present:</b>  None
<b>Operator Representative Signature:</b> (Field Issuance Only)

**INSPECTION INFORMATION**

<b>Inspection Start Date:</b> August 27, 2020 <b>Inspection Start Time:</b> 12:00 <b>Inspection End Date:</b> August 28, 2020 <b>Inspection End Time:</b> 09:00		<b>Inspection Type:</b> Coal Partial Inspection <b>Inspection Reason:</b> Normal I&E Program <b>Weather:</b> Clear	
<b>Joint Inspection Agency:</b>  None		<b>Joint Inspection Contacts:</b>	
<b>Post Inspection Agency:</b>  None		<b>Post Inspection Contacts:</b>	
<b>Inspector(s):</b>  Tabetha Lynch	<b>Inspector's Signature:</b>

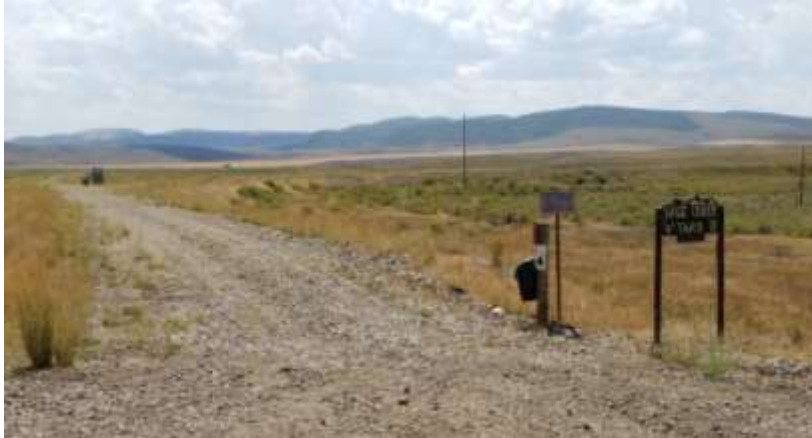
Facing south down the rail loop

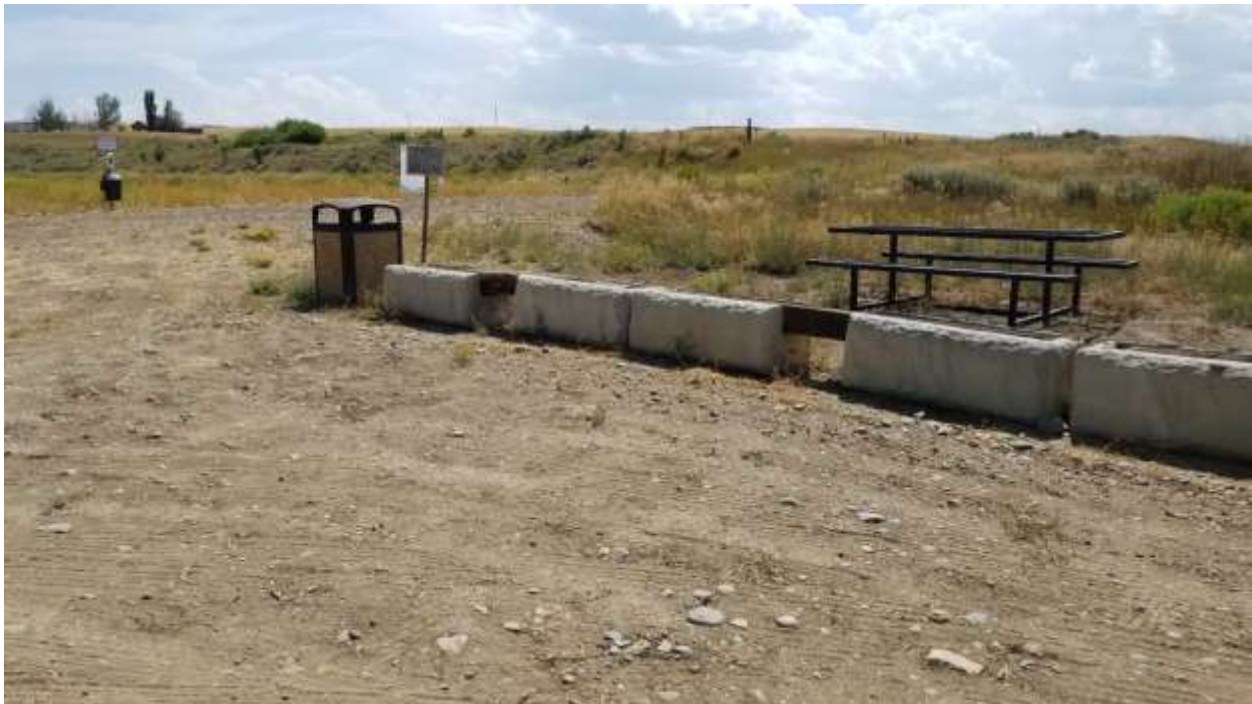
Main trailhead/parking lot
