MINERALS PROGRAM INSPECTION REPORT
PHONE: (303) 866-3567

MINE NAME: Buffalo Stone Quarry	MINE/PROSPECTING ID#: M-2007-050	MINERAL: Stone	COUNTY: Las Animas
INSPECTION TYPE: Monitoring	INSPECTOR(S): Daniel Cunningham	INSP. DATE: August 28, 2020	INSP. TIME: 11:00
OPERATOR: Yocam Stone LLP	OPERATOR REPRESENTATIVE: None	TYPE OF OPERATION: 110c - Construction Limited Impact	
REASON FOR INSPECTION: Normal I&E Program	BOND CALCULATION TYPE: Complete Bond	BOND AMOUNT: \$33,544.00	
DATE OF COMPLAINT: NA	POST INSP. CONTACTS: None	JOINT INSP. AGENCY: None	
WEATHER: Clear	INSPECTOR'S SIGNATURE:

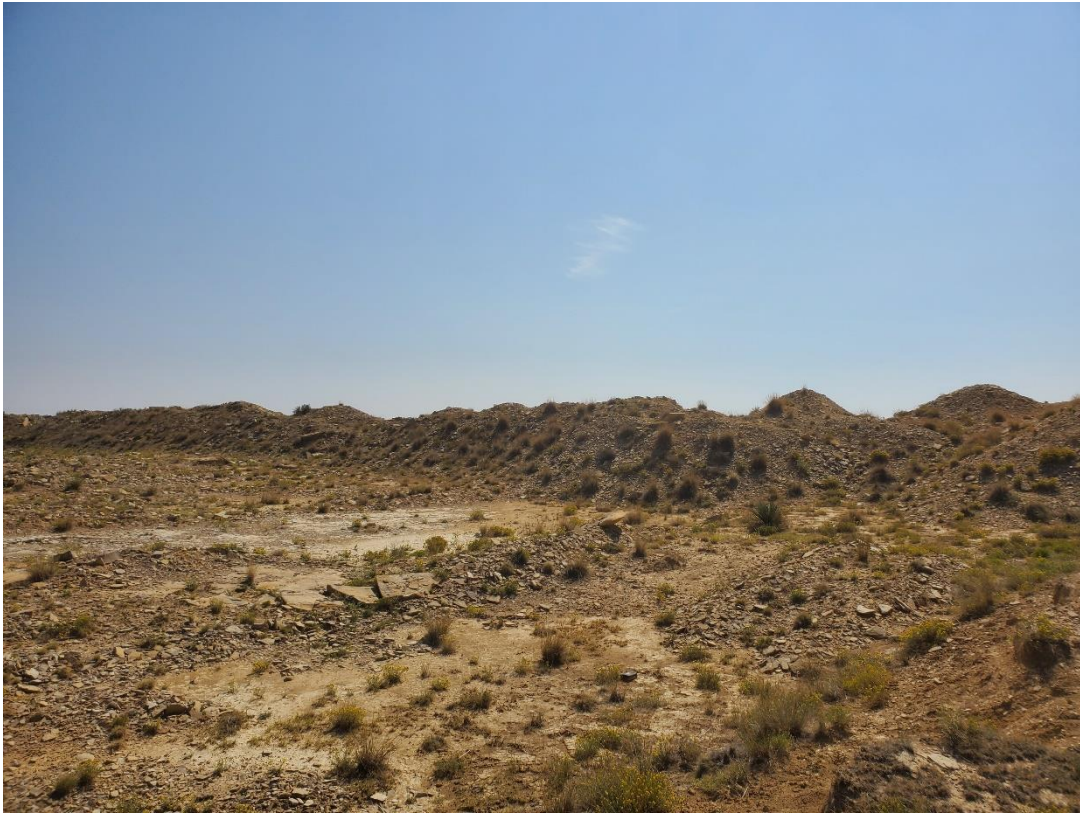
South Topsoil Stockpile

The site identification sign was posted at the mine entrance and the permit boundary were marked. Topsoil was being stored on the north and south side of the pit. Several large stockpiles of cut stone were located on the eastern side of the permit and several pallets were located in the same area.

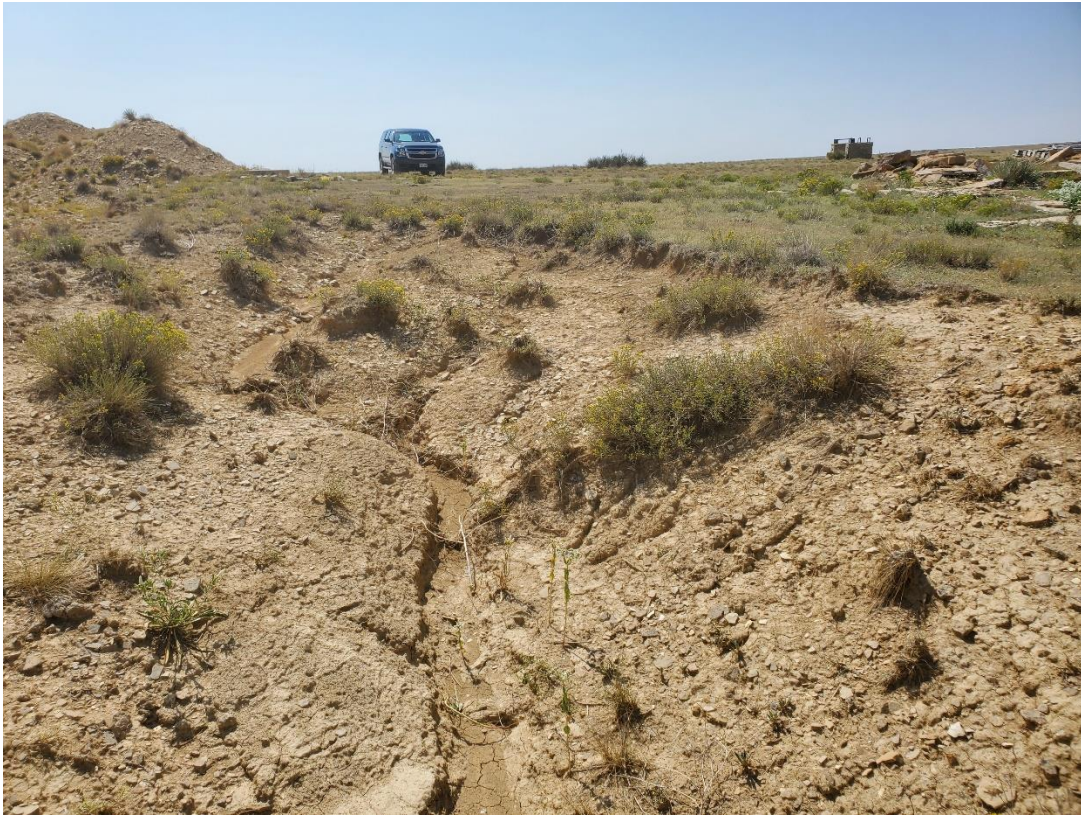
There is a small erosional issues developing along the northern side of the permit that has not yet brought material offsite. The Operator should monitor the erosional issue and place check dams along it to help prevent further erosion.

Beginning Erosional Issue Facing North
