MINERALS PROGRAM INSPECTION REPORT PHONE: (303) 866-3567

MINE NAME:		MINE/PROSPECTING ID#:	MINERAL:	COUNTY:
Unwin Gravel Pit		M-1998-011	Gravel	Las Animas
INSPECTION TYPE:		INSPECTOR(S):	INSP. DATE:	INSP. TIME:
Monitoring		Daniel Cunningham	August 28, 2020	12:00
OPERATOR:		OPERATOR REPRESENTATIVE:	TYPE OF OPERATION:	
Las Animas County		Phil Dorenkamp	110c - Construction Limited Impact	
			T	
REASON FOR INSPECTION:		BOND CALCULATION TYPE:	BOND AMOUNT:	
Normal I&E Program		None	\$0.00	
DATE OF COMPLAINT:		POST INSP. CONTACTS:	JOINT INSP. AGENCY:	
NA		None	None	
WEATHER:	INSPECTOR'S SIGNATURE:		SIGNATURE DATE:	
Clear	September 7, 2020

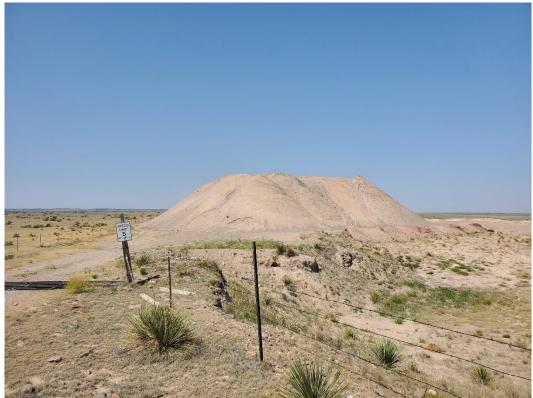
20,000 Ton Stockpile

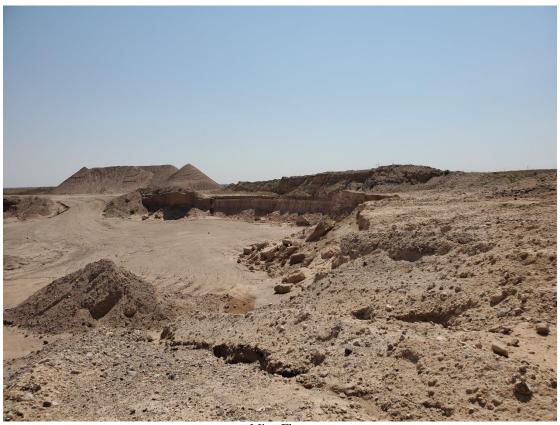
Mine Floor

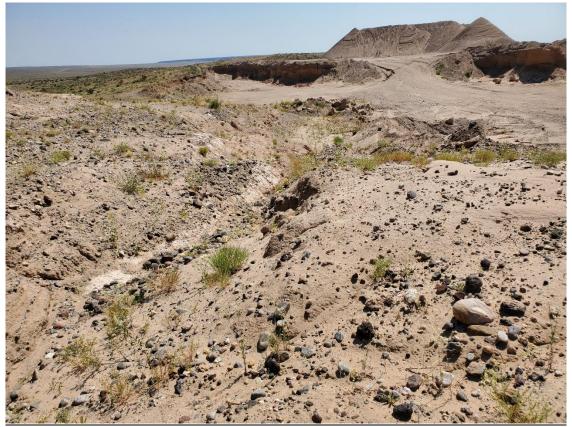
There is a small erosional issues developing in the middle of the mining area that is draining directly to the pit floor. The Operator should monitor the erosion and take necessary steps to help prevent it from developing further.

Erosional Issue developing
