MINERALS PROGRAM INSPECTION REPORT
PHONE: (303) 866-3567

MINE NAME: El Rancho Bondo	MINE/PROSPECTING ID#: M-2018-028	MINERAL: Gold	COUNTY: Fremont
INSPECTION TYPE: Surety-Related Inspection	INSPECTOR(S): Timothy Cazier	INSP. DATE: August 11, 2020	INSP. TIME: 14:25
OPERATOR: Thomas Zimmerman	OPERATOR REPRESENTATIVE: Joe Lovett	TYPE OF OPERATION: 110(1) - Hard Rock Limited Impact	
REASON FOR INSPECTION: Surety Related	BOND CALCULATION TYPE: Complete Bond	BOND AMOUNT: \$2,166.00	
DATE OF COMPLAINT: NA	POST INSP. CONTACTS: U.S.BLM	JOINT INSP. AGENCY: None	
WEATHER: Clear	INSPECTOR'S SIGNATURE:

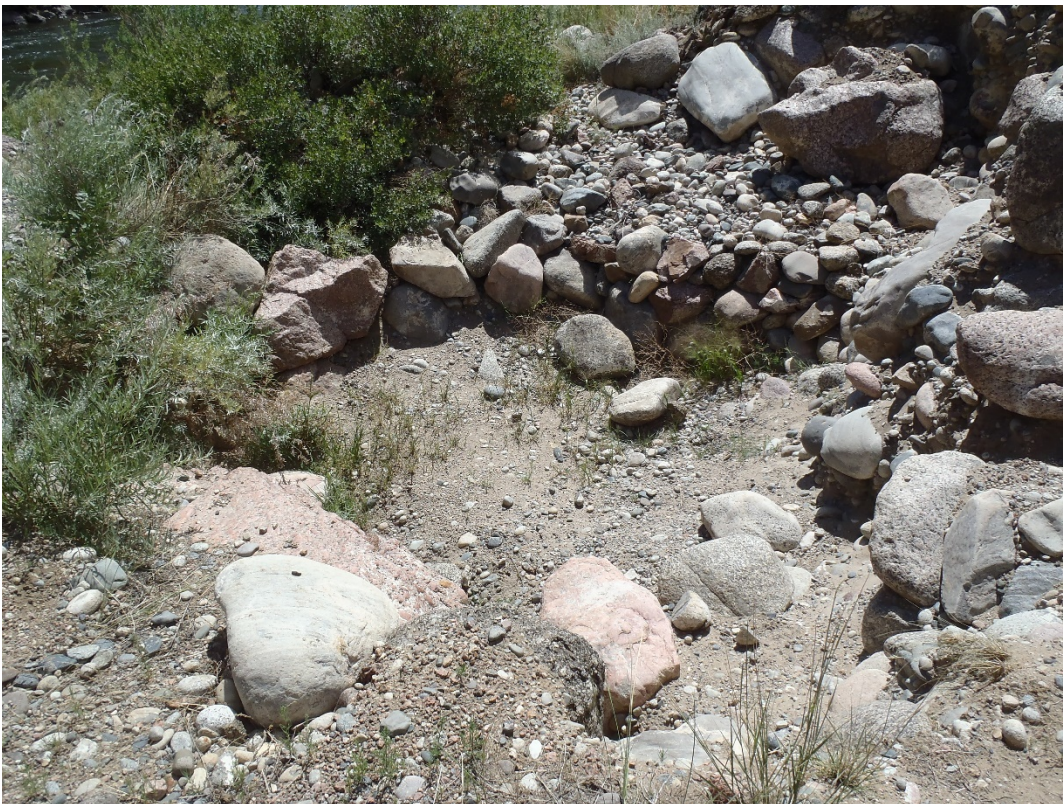
Backfilling and Grading: Sufficient backfill material appeared to be available. Mr. Lovett pointed out where a significant portion of the pit had been backfilled (see **Photo 1**).

Hydrologic Balance: No standing water was observed in the bank excavation (see **Photo 1**) and no exposed groundwater was observed.

Photo 1. Active dry pit, smaller than during the 2018 inspection (looking south).

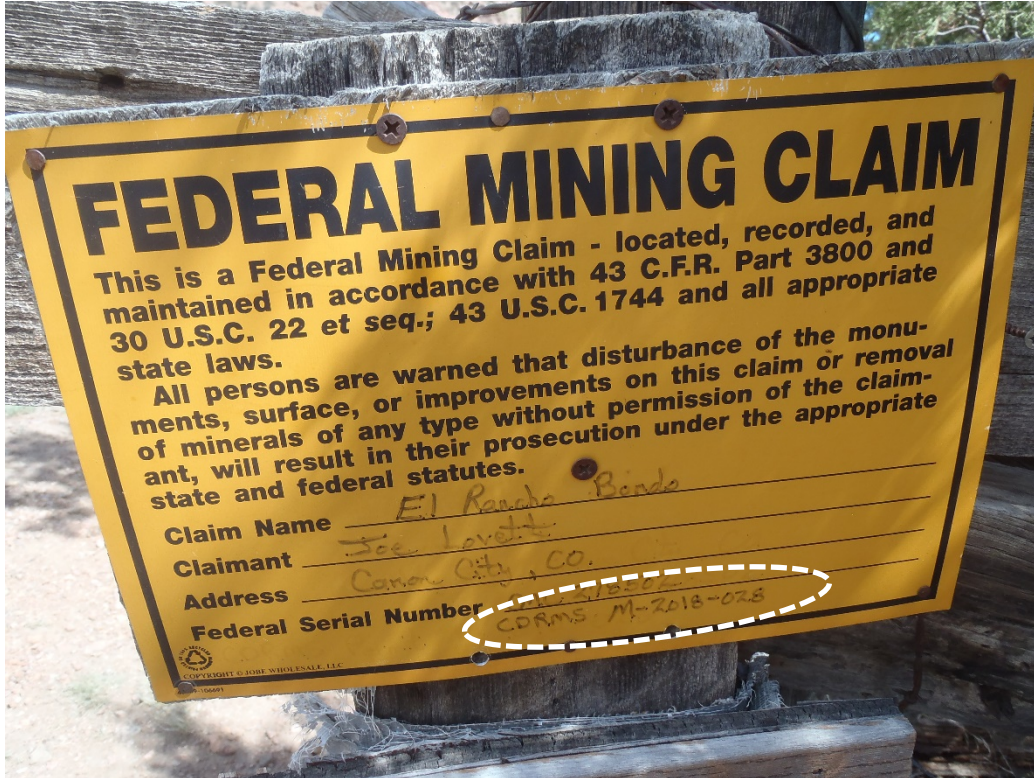
Signs and Markers: A permit sign was posted at the claim entrance (see **Photo 2**) and all four T-post permit

Photo 2. DRMS permit number added to Mining Claim sign (at two-track road entrance).

boundary markers were observed (**Photos 3 and 4**). However, the approved permit boundary is not rectangular in that it has a 20-foot offset from the Arkansas River. **The DRMS recommended to Mr. Lovett he add 3 to 4 T-posts along the river boundary to better mark the river side of the boundary and darken the DRMS permit number on the claim sign as it has faded.**

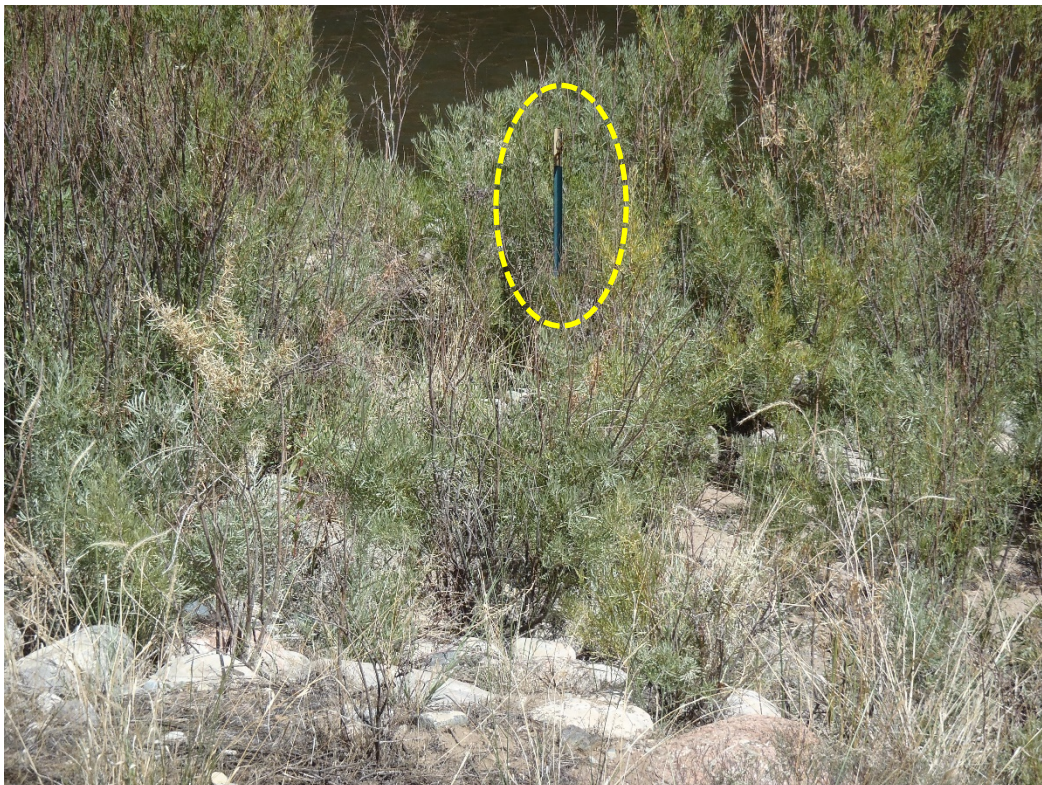
Photo 3. T-post marking permit boundary (east corner).

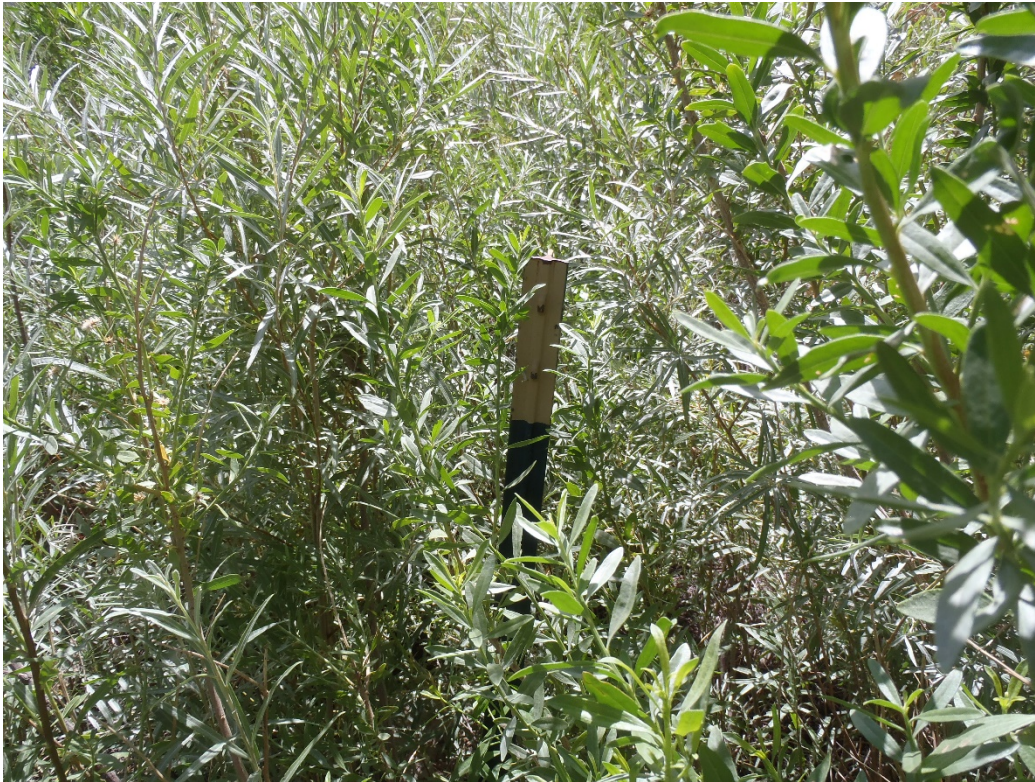
Photo 4. T-post marking permit boundary (south corner).
