**MINERALS PROGRAM INSPECTION REPORT**  
**PHONE: (303) 866-3567**

<b>MINE NAME:</b> Shot Rock Pit	<b>MINE/PROSPECTING ID#:</b> M-2012-023	<b>MINERAL:</b> Crushed stone material	<b>COUNTY:</b> Las Animas
<b>INSPECTION TYPE:</b> Monitoring	<b>INSPECTOR(S):</b> Daniel Cunningham	<b>INSP. DATE:</b> August 28, 2020	<b>INSP. TIME:</b> 14:30
<b>OPERATOR:</b> Tamrock Gravel LLC	<b>OPERATOR REPRESENTATIVE:</b> Mrs. Tamburelli	<b>TYPE OF OPERATION:</b> 112c - Construction Regular Operation	
<b>REASON FOR INSPECTION:</b> Normal I&E Program	<b>BOND CALCULATION TYPE:</b> Complete Bond	<b>BOND AMOUNT:</b> \$22,800.00	
<b>DATE OF COMPLAINT:</b> NA	<b>POST INSP. CONTACTS:</b> None	<b>JOINT INSP. AGENCY:</b> None	
<b>WEATHER:</b> Clear	<b>INSPECTOR'S SIGNATURE:</b>

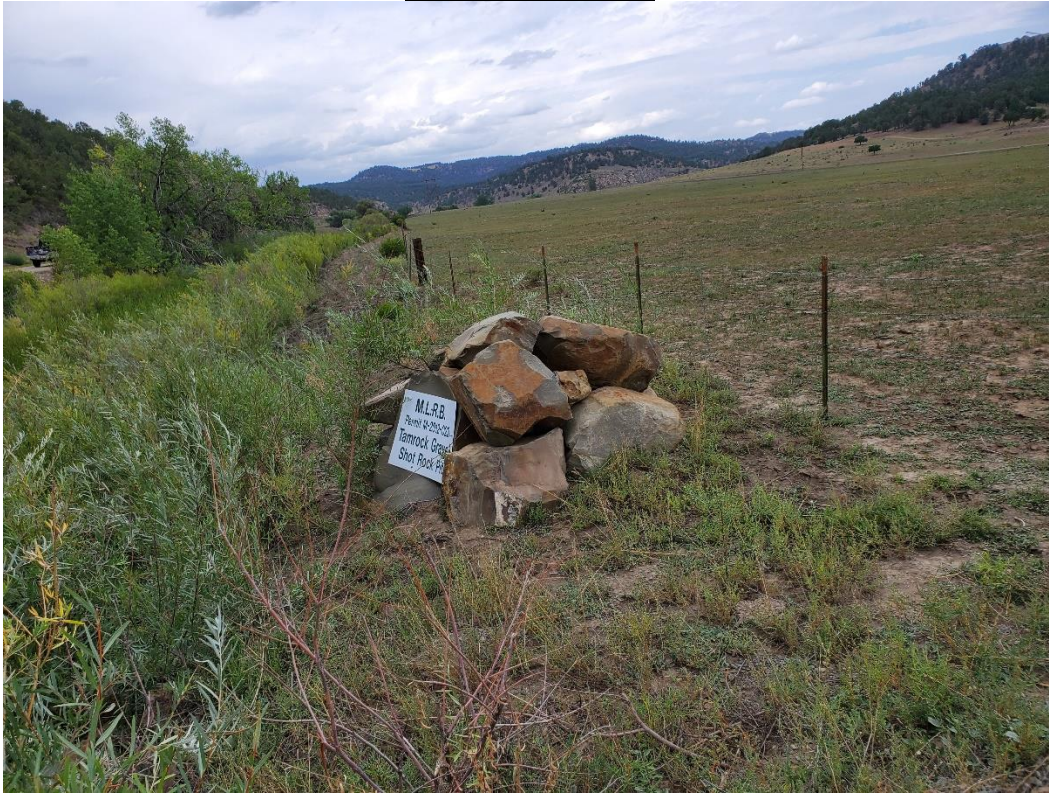
The site identification sign was posted at the mine entrance and the permit boundary were marked. A 20 ft. high by 100 ft. long highwall was observed. An estimate 4,000 tons of stock material was located on site. Topsoil was being stored above the mine floor on the north side of the permit. Blasting records are stored with the blasting contractor.

Mine Entrance Sign

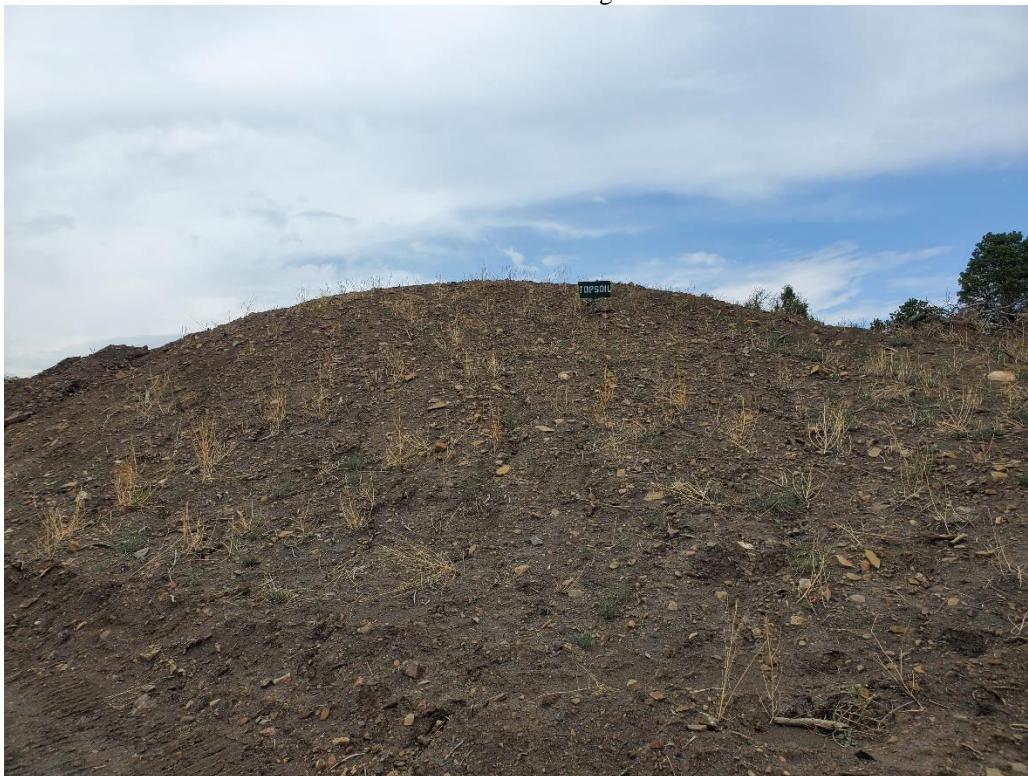
Topsoil Pile

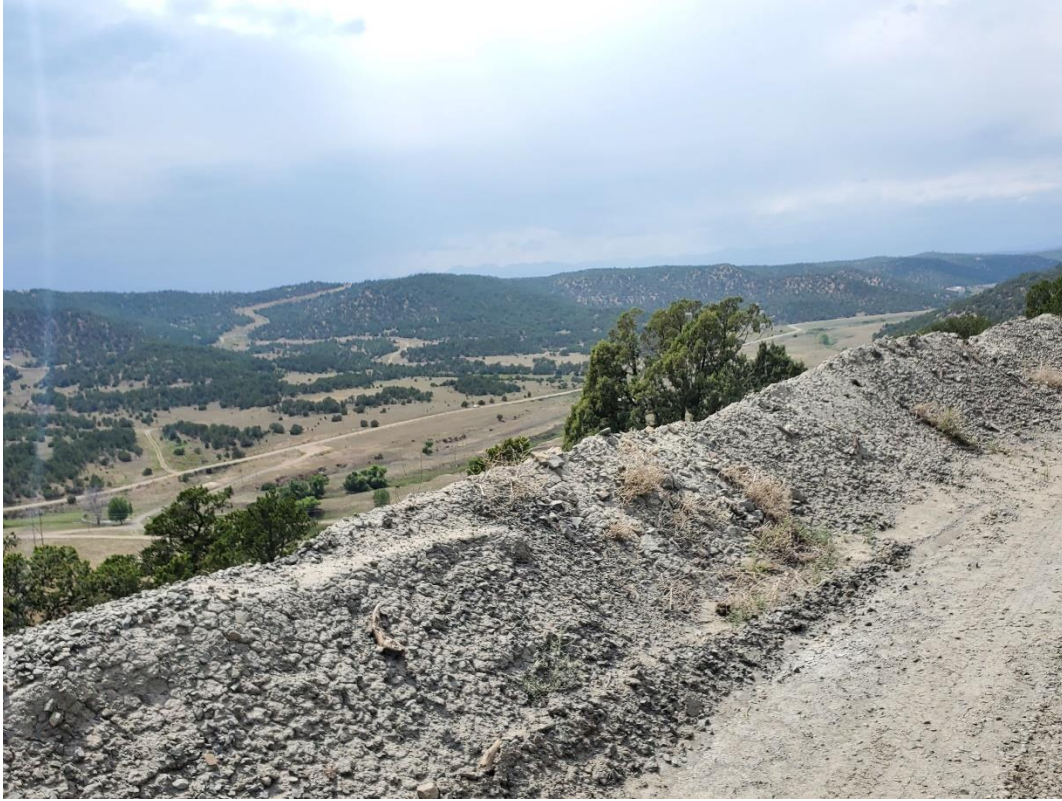
A berm was noted around the haul road to prevent water runoff down the slope. A weight scale was located near the mine entrance.

Berm Along Haul Road

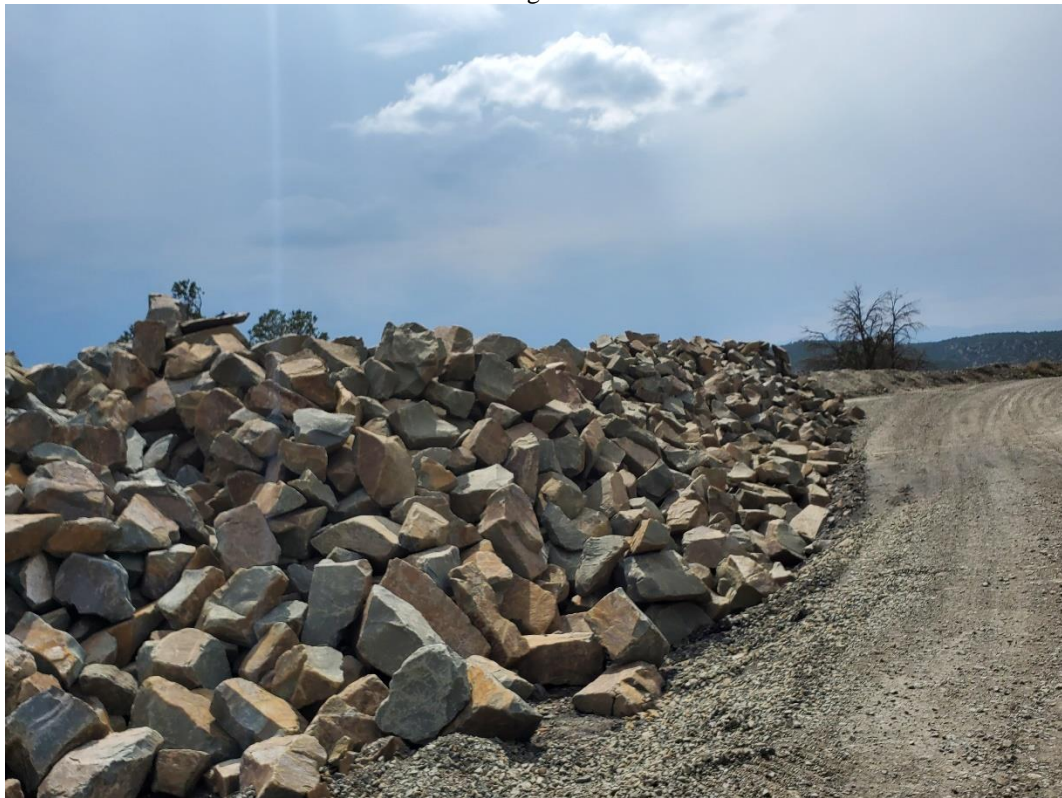
Stock Material

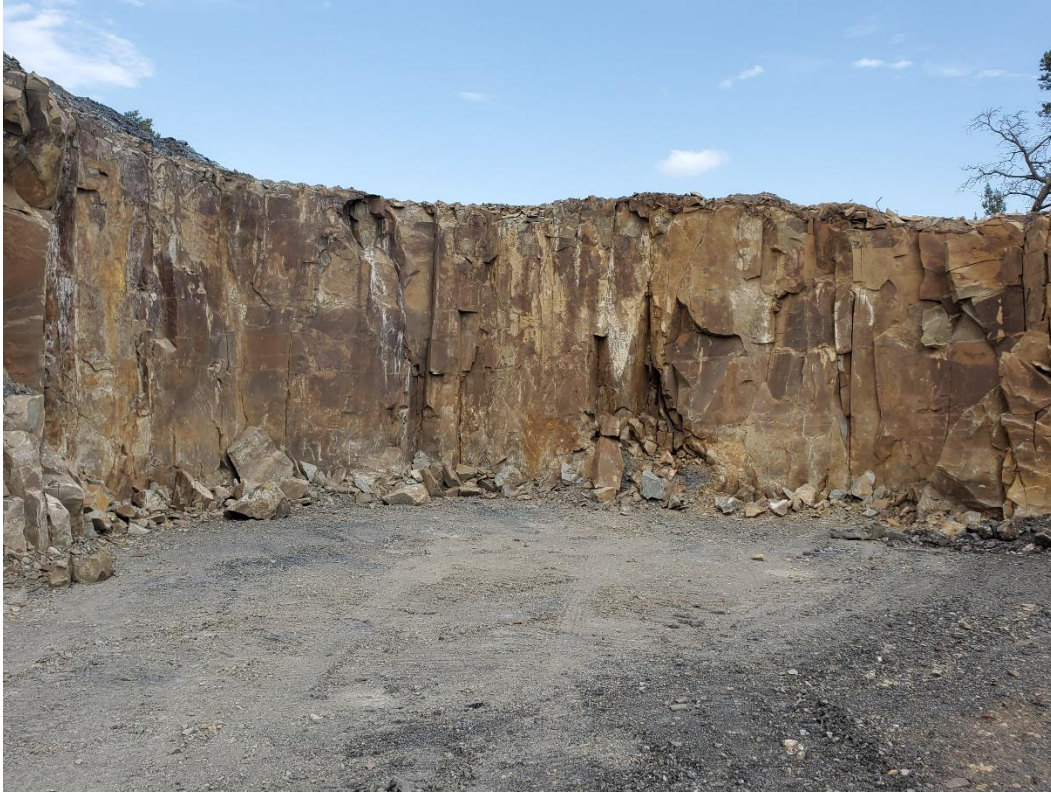
Highwall

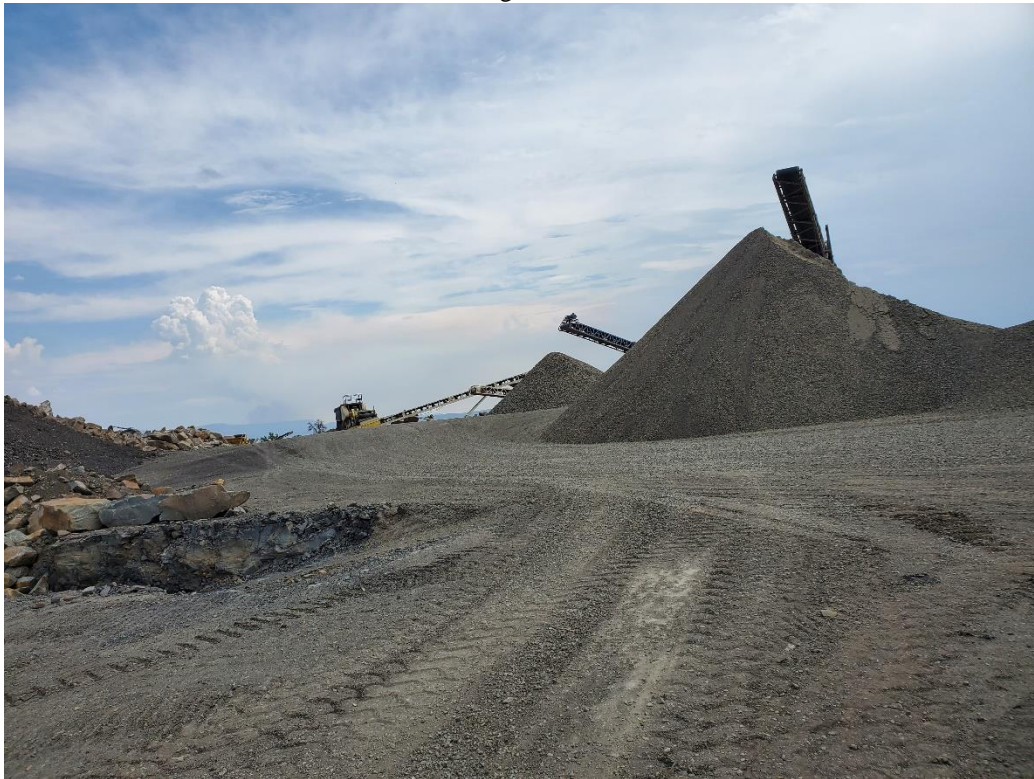
Mine Floor
